**BEFORE
THE PUBLIC UTILITIES COMMISSION OF OHIO**

DIRECT TESTIMONY

DAVID W. CLEAVER

DWC-1: UMS Group Inc. Report

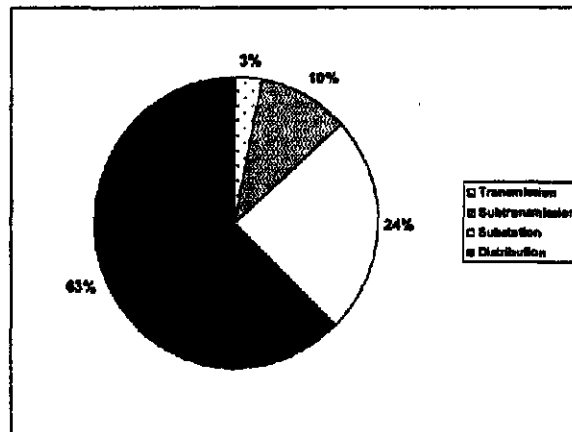
Figure 1-4
2006 SAIFI Stage of Delivery

In reviewing the implications of the Stage of Delivery analysis (Figure 1-4), the following key points are summarized:

- The primary focus on this assessment should be on Distribution (it contributes 0.76 to SAIFI or 63 percent of the customer interruptions)
- Substation SAIFI, contributing 0.29 to SAIFI or 24 percent of the customer interruptions, requires parallel focus. However, the Feeder Breaker and Relay replacements and Animal Protection already being implemented across CEI should be sufficient to maintain steady improvement.
- Subtransmission SAIFI (contributing 0.12 to SAIFI or 10 percent of the customer interruptions) improved significantly between 2005 and 2006 (a 72.4 percent reduction in customer interruptions due to improved operability of the switches on the subtransmission system).
- Transmission SAIFI is negligible (not covered in this assessment).

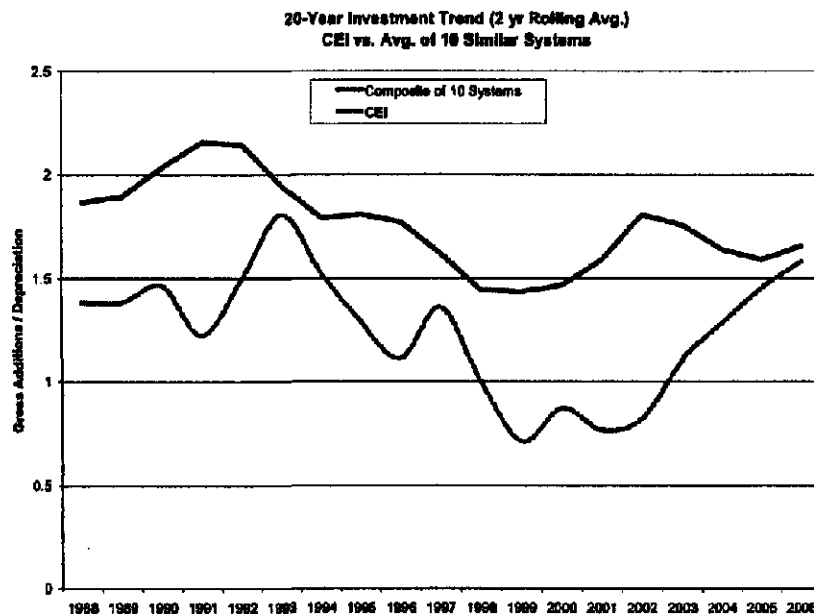
**Figure 1-8
CEI Capital Spending vs. Similar Systems (1988-2006)**

The implications of this comparative analysis are as follows:

- The Company's capital spending pattern over time has been consistent with the industry trends, albeit always at a *lower than average* level of spending for *all* years of this review.

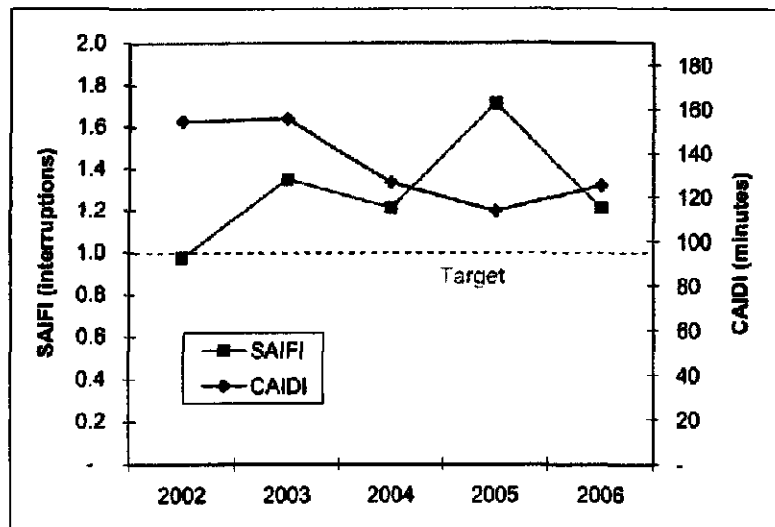
**Figure 3-2
Five Year Trend in Key Reliability Measures**

From Figure 3-2, except for an anomaly in 2005 when SAIFI spiked to 1.71, CAIDI steadily improved through the period to 2005 (it has since leveled out) and SAIFI has been fairly constant (ranging between 1.21 and 1.35 since 2003). While the leveling off is encouraging, the Company clearly needs to improve to reach the 2009 targets as outlined in Figure 3-3 below:

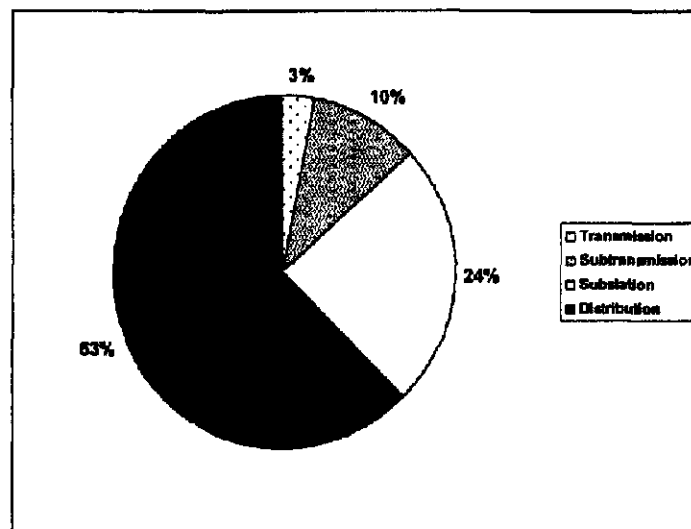
Figure 3-7
2006 SAIFI by Stage of Delivery

Therefore, the remainder of this analysis will **focus on distribution (feeders)**, noting that the initiatives already implemented for the Subtransmission and Substation stage of delivery need to continue.
