Case Number: 08-935-EL-SSO

Description of Document: Testimony of David W. Cleaver

Re: Filing of OCC Witness Cleaver's Testimony in the Public Docket,
Case 08-935-EL-SSO (FirstEnergy Utilities)

**BEFORE
THE PUBLIC UTILITIES COMMISSION OF OHIO**

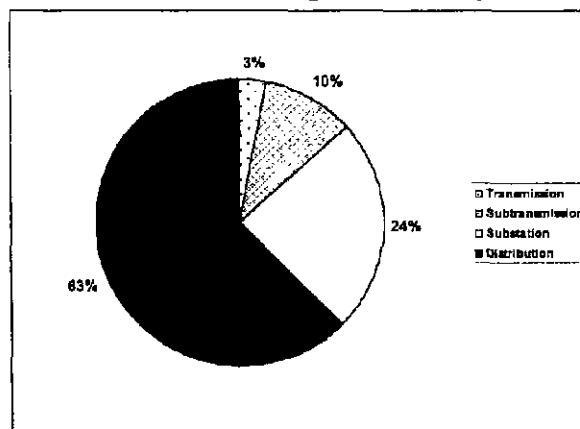
Figure 1-4
2006 SAIFI Stage of Delivery

In reviewing the implications of the Stage of Delivery analysis (Figure 1-4), the following key points are summarized:

- The primary focus on this assessment should be on Distribution (it contributes 0.76 to SAIFI or 63 percent of the customer interruptions)
- Substation SAIFI, contributing 0.29 to SAIFI or 24 percent of the customer interruptions, requires parallel focus. However, the Feeder Breaker and Relay replacements and Animal Protection already being implemented across CEI should be sufficient to maintain steady improvement.
- Subtransmission SAIFI (contributing 0.12 to SAIFI or 10 percent of the customer interruptions) improved significantly between 2005 and 2006 (a 72.4 percent reduction in customer interruptions due to improved operability of the switches on the subtransmission system).
- Transmission SAIFI is negligible (not covered in this assessment).

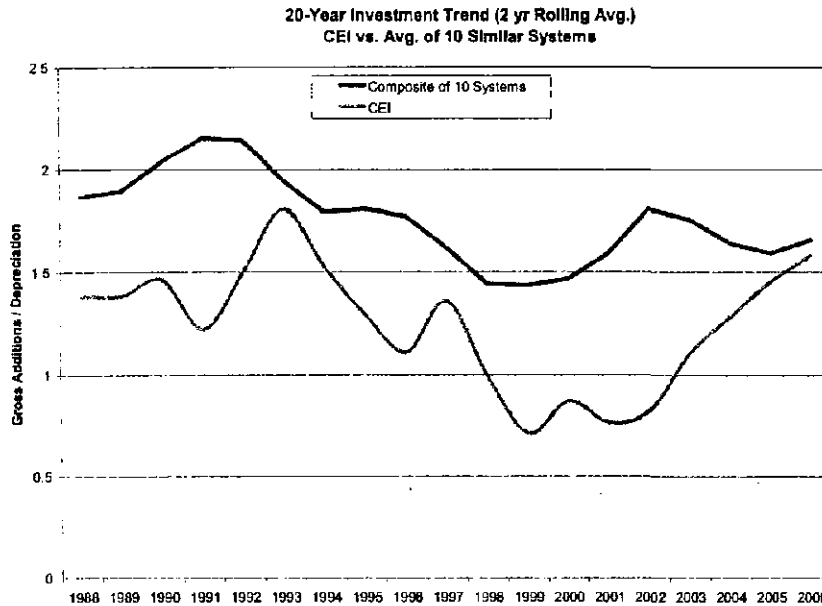
**Figure 1-8
CEI Capital Spending vs. Similar Systems (1988-2006)**

The implications of this comparative analysis are as follows:

- The Company's capital spending pattern over time has been consistent with the industry trends, albeit always at a *lower than average* level of spending for *all* years of this review.

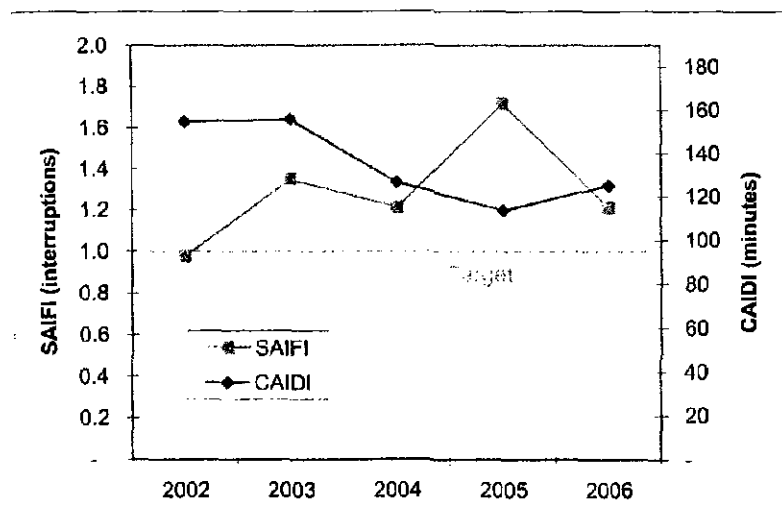
Figure 3-2
Five Year Trend in Key Reliability Measures

From Figure 3-2, except for an anomaly in 2005 when SAIFI spiked to 1.71, CAIDI steadily improved through the period to 2005 (it has since leveled out) and SAIFI has been fairly constant (ranging between 1.21 and 1.35 since 2003). While the leveling off is encouraging, the Company clearly needs to improve to reach the 2009 targets as outlined in Figure 3-3 below:

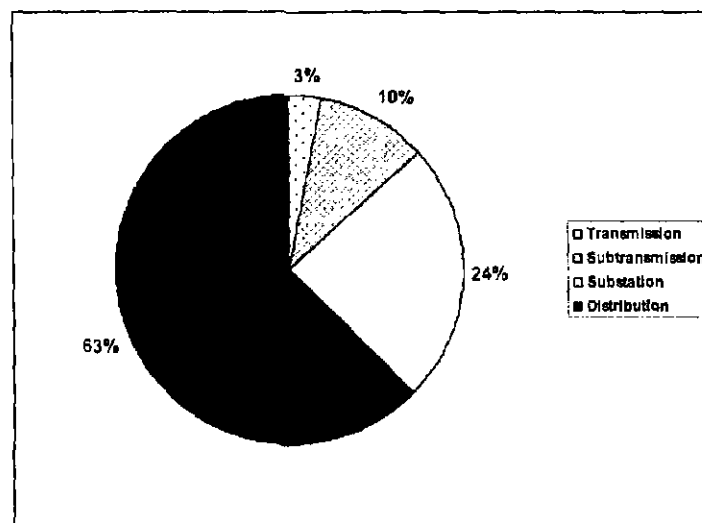
Figure 3-7
2006 SAIFI by Stage of Delivery

Therefore, the remainder of this analysis will **focus on distribution (feeders)**, noting that the initiatives already implemented for the Subtransmission and Substation stage of delivery need to continue.

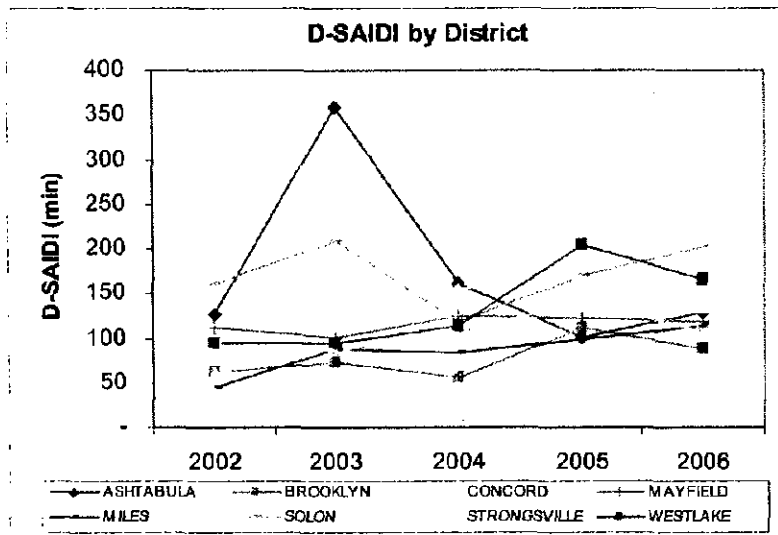
Figure 3-15
Distribution SAIDI by Line District

The overall trend shows a deterioration of SAIFI across all districts (except Ashtabula) and a fairly steady improvement in CAIDI (again, except Ashtabula). Given the rural areas and longer travel times of the Ashtabula district, it is no surprise that restoration times might suffer by comparison to the more urban and suburban districts. (Note that CEI plans to establish a new service center in Claridon Township in southern Geauga County (in service date of 2009). This will improve crew response times in both the southern Geauga and Ashtabula counties. Overall, the district trends are consistent with the company-wide trends. They point to systematic recommendations (rather than "local" ones) to improve SAIFI (presented Section 5.0) and highlight the systematic (as opposed to "one time" or "local") improvements made over the past couple of years in outage response (CAIDI).
