Public Utilities Commission of Ohio

PUCO case No. 09-0815-RR-CSS - Alleged trees blocking view of signal the west end of

Circleville, Ohio (MP 677.0) Norfolk Southern

Subject: COMPLAINT Case # 09-815-RR-CSS Tree limbs blocking a clear view of the

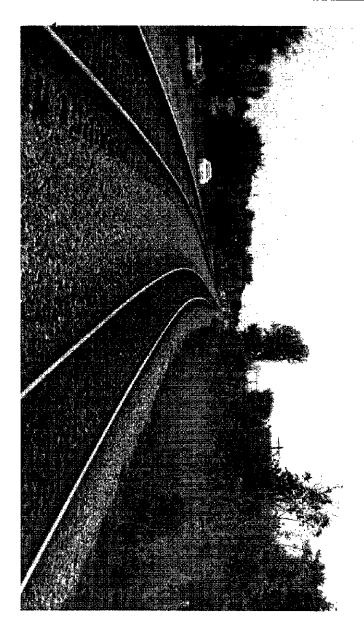
The wayside signal in question is located at approximately N676.9 on the eastbound main track of the Norfolk Southern Railroad Lake Division, Columbus District. An inspection was conducted on September 21, 2009 by Inspector R Heinzman and J Gibson of the Public Utilities Commission of Ohio. The signal was observed by the PUCO from ground level at a distance of approximately 2/10 of one mile (railroad timetable) east of the signal at the west end of the tangent track west of the signal. The clear view of the wayside signal was in fact obstructed as indicated in the complaint.

The re-inspection by the PUCO on September 23, 2009 from ground level from the approximate same location as the initial inspection revealed the defect had been corrected. Tree limbs/brush/vegetation had been removed from the wayside area west of the signal allowing for an unobstructed view from the west end of the tangent track west of the EB 676.9 signal

The visual obstruction of the signal in question has been removed as indicated by visual inspection from ground level, correcting the defect. Therefore I recommend the complaint be closed.
