A report by the Staff of the **Public Utilities Commission of Ohio**

In the Matter of the Investigation of the **Dominion East Ohio Gas Company Relative** to its Compliance with the Natural Gas Pipeline Safety Standards and Related Matters.

Case Number 12-380-GA-GPS

January 23, 2012

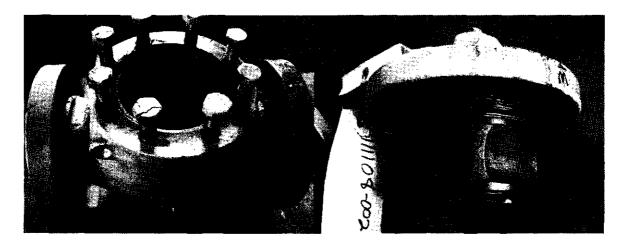
Figure 5: Documentary Photograph of One of the Two Main Regulators

- Parts were covered in a liquid. Subsequent review of a Dominion furnished report indicated that the brown liquid containing a variety of organic chemicals.
