THE PUBLIC UTILITIES COMMISSION OF OHIO

Case No. 96-1010-EL-CSS

EXPERT TESTIMONY OF MERLIN K. GROVES

**EVALUATION OF ADEQUACY OF  
FIRELANDS ELECTRIC COOPERATIVE, INC.'S  
ELECTRICAL SERVICE TO AND FACILITIES SERVING  
MR. CHARLES HANLINE'S RESIDENCE AT 3759 PAUL ROAD**

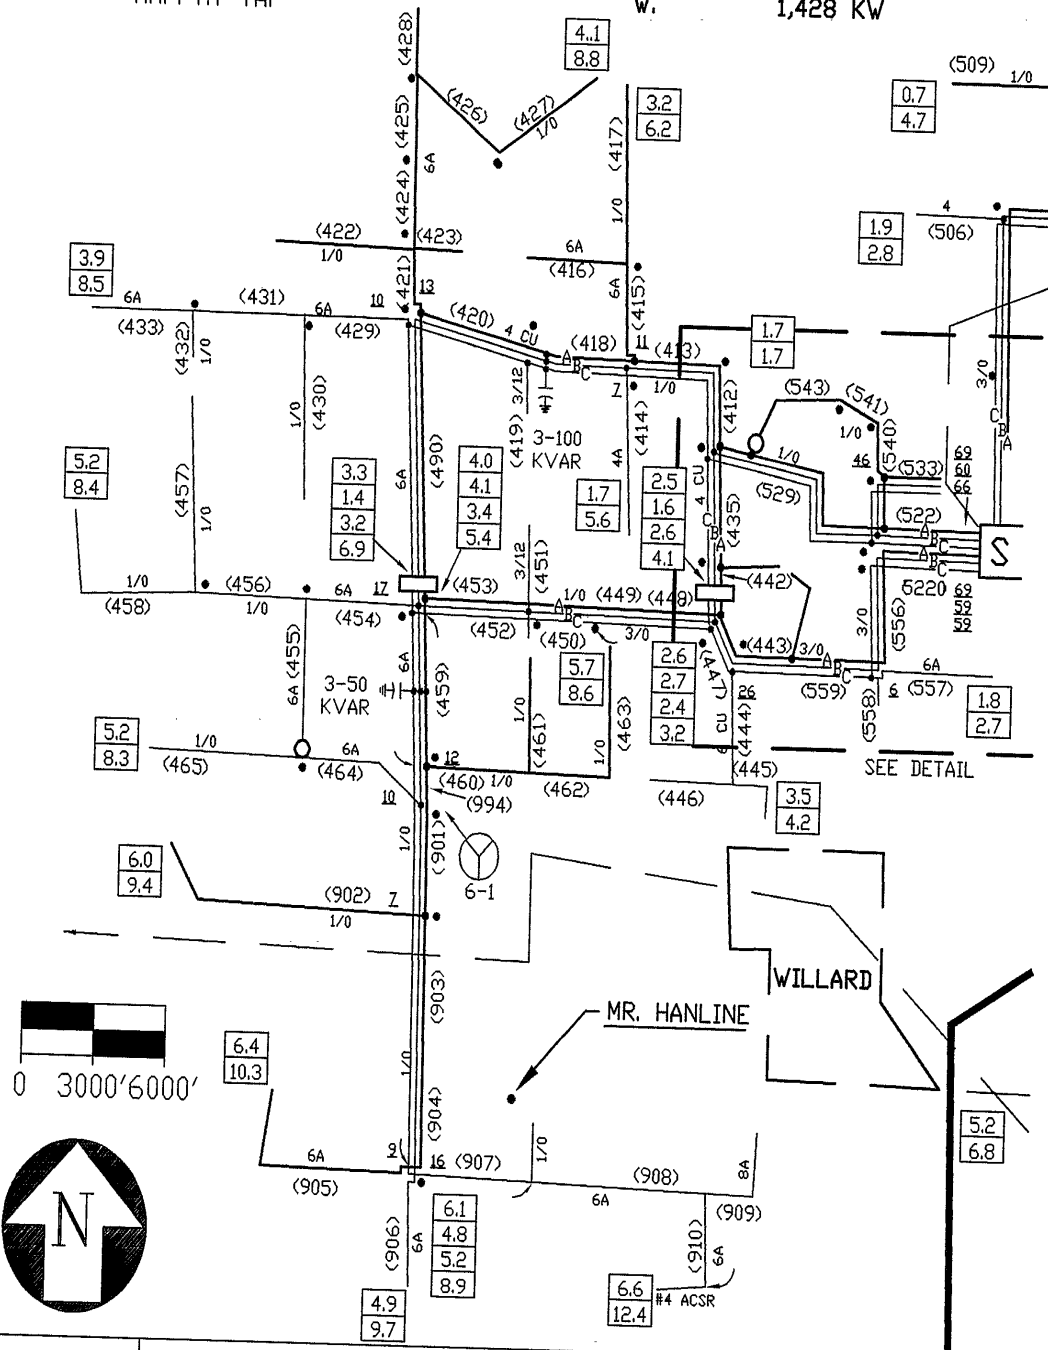
EXHIBIT A

Attached to this report as Exhibit A is a Circuit Diagram Map that provides an engineering overview of the general routing, sizes, and voltages of the wires serving the Premises and the distance of the Premises from the substation serving it. Exhibit A (which is an excerpt from the Four Year Work Plan discussed below) shows the approximate location of the Premises and that the Premises is served from the Cooperative's Steuben Substation (the Substation) through Circuit 2, which is a three phase 7.2/12.5 kv line. The Premises is served from Phase C, which is one of the three phases comprising Circuit 2. All currents are well within the amperage capacity of the line. The Premises is approximately 10.5 miles from the Substation with a

calculated 5.5 volt drop on a 120 volt base. This is well within RUS standards as RUS recommends not greater than an 8.0 volt drop. The distance of the Premises from the Substation is average for an Ohio electric distribution cooperative customer and would not impair service quality or reliability. The electric distribution line serving the Premises runs beyond the Premises to provide service to other Cooperative customers.

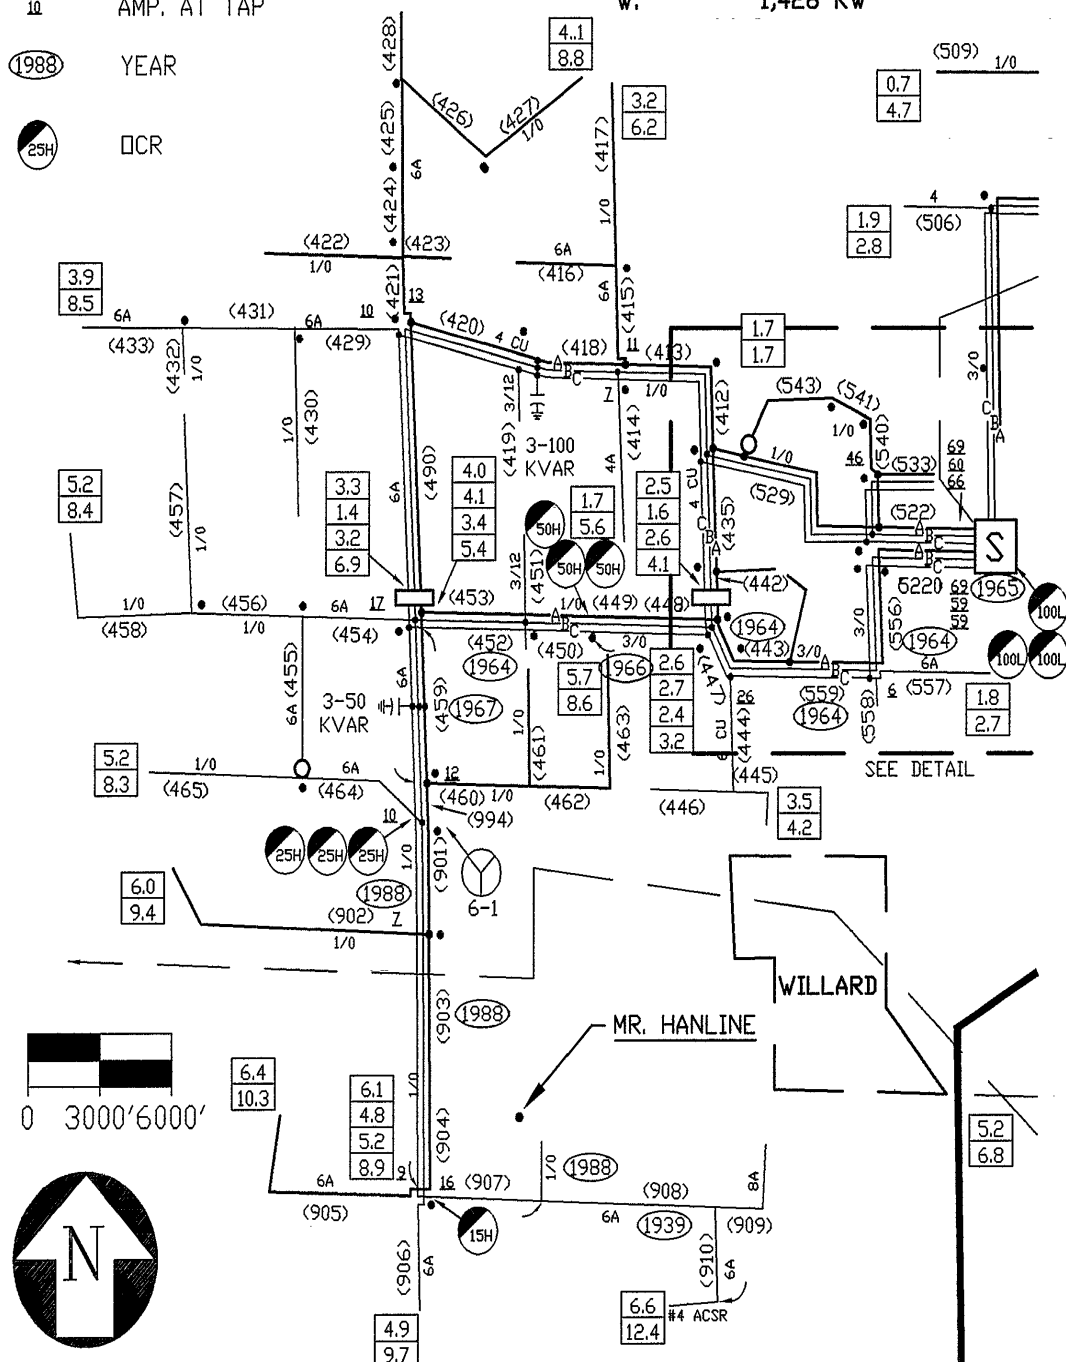
EXHIBIT B

Exhibit B is the same map with the addition of reclosers (protective devices which are discussed below) and the year the wires serving the Premises were constructed. There appears to be nothing unusual.

As stated above, Exhibit B shows the year the facilities serving the Premises were constructed. Staking sheets are detailed descriptions of how electric distribution facilities are to be constructed, which are prepared for use in constructing the facilities and which also indicate the approximate year the facilities are constructed. A review of Exhibit B and the staking sheets for construction of the facilities between the Substation and the Premises shows that the first two-thirds of the facilities were constructed in the 1960's and that, with the exception of one-half mile of line that is marked as having been erected in 1939, the last several miles of facilities were built in 1988. By industry standards, the facilities are fairly new.
