Petronas Abrasion Testing

Purpose	Test reinforced thermoplastic pipes and the associated termination fittings for abrasion resistance to sand and fluid flow at high velocities
Method	<p>Target Flowing Velocities: Over 8ft/sec (Critical Steel Velocity) Target % Sand: 10%</p> <p>Sections of Reinforced Thermoplastic Pipe (RTP) is looped around the exit and entrance of a pump suitable to provide the acceptable flow rates for testing. End terminations should be raw steel and Fortron lined steel to see the impact of the sand on both surfaces as well as the pipe itself.</p> <p>The pumps should be run with a water slurry with sand at the desired concentration. The pump impeller will witness severe erosion and the test should be performed until slippage of fluid around the impeller dramatically slows the flow and the test is stopped</p> <p>Nylon and Fortron Lined Samples of Pipe were inserted in the test loop and Fortron lined and raw steel couplings were inserted</p>

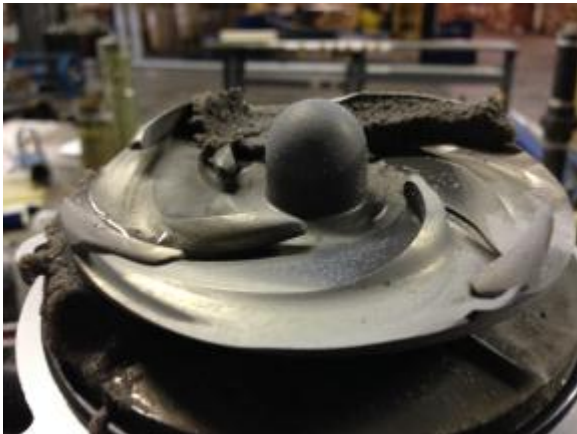
Results	<p>Inch pipe was used for the test and ran a a flow rate of 4 gallons per minute which equates to just over 8ft/sec velocity</p> <p>After 72 hours of flow the pump impeller became so eroded that it no longer would flow. The pipe was split open and inspected and there was no indication of wear in either the nylon or Fortron lined pipe samples</p> <p>The impeller was completely eroded (aluminum construction) and the raw steel couplings indicated severe wear. The Fortron lined coupling experienced very little wear</p>
Conclusion	<p>Nylon and Fortron liners do not exhibit any significant abrasion wear. Raw steel couplings did exhibit abrasion wear and Fortron lined couplings.</p> <p>Specialty RTP suggests in areas of high velocity and high sand or solids the couplings should be constructed from Stainless Steel because coatings (zinc Chromate or Fortron) will eventually wear and cannot be relied on for long term corrosion resistance</p>

Eroded Pump Impeller

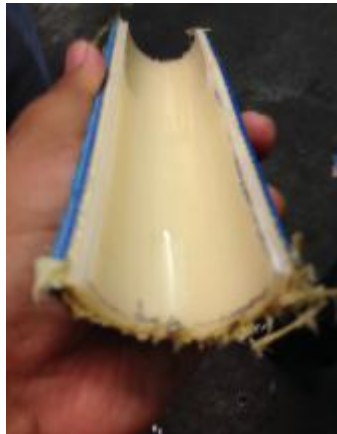
Nylon Before

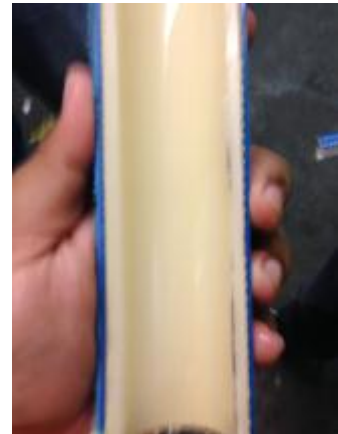
Nylon After

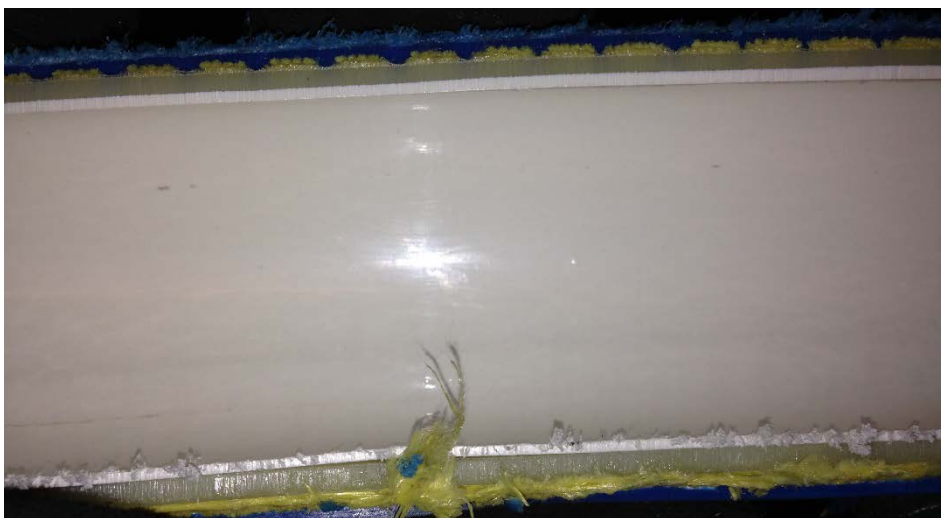
Fortron Remained Un-affected after Testing

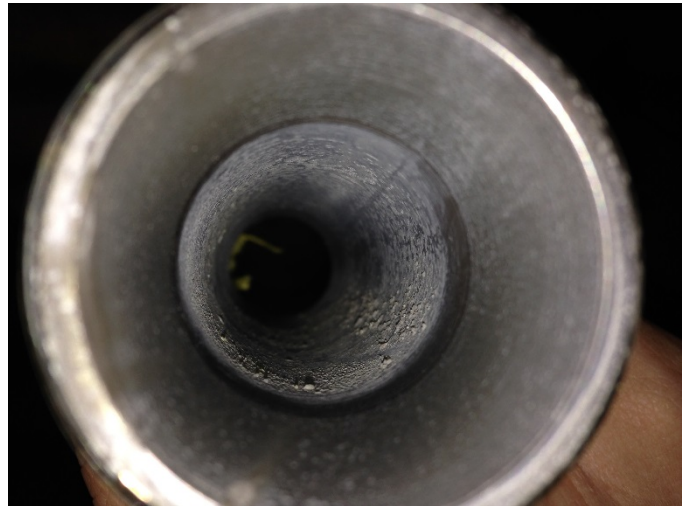
Eroded Coupling after Testing

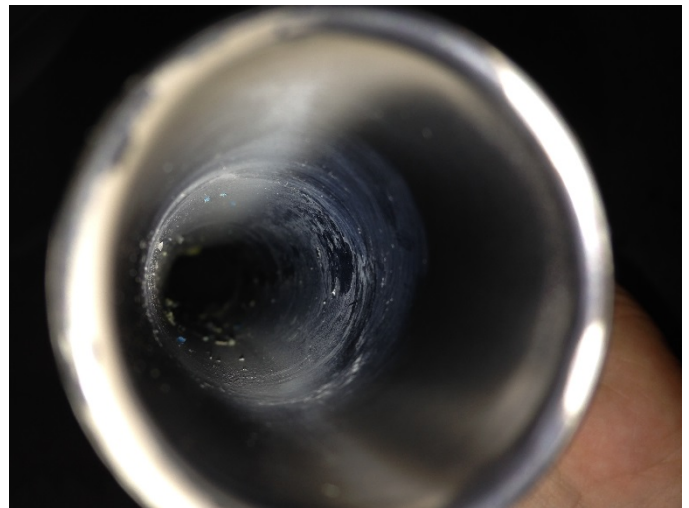
Fortron Coated Coupling after Testing
Slight Erosion
