729 W Elm Street, Lima Ohio – Excavation Damage Summary

Damage Investigation

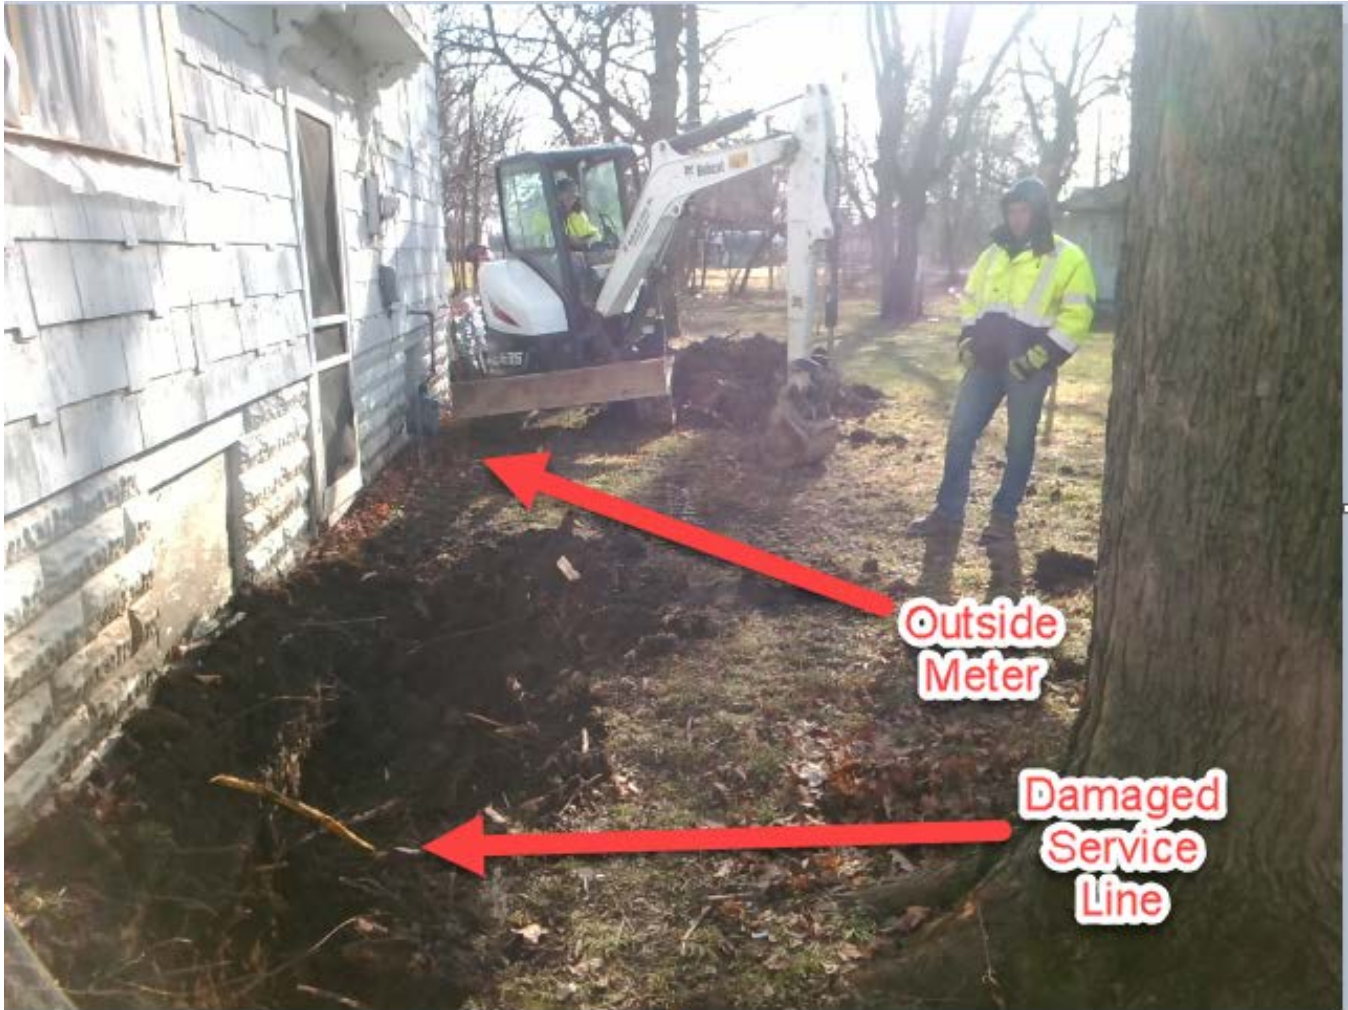
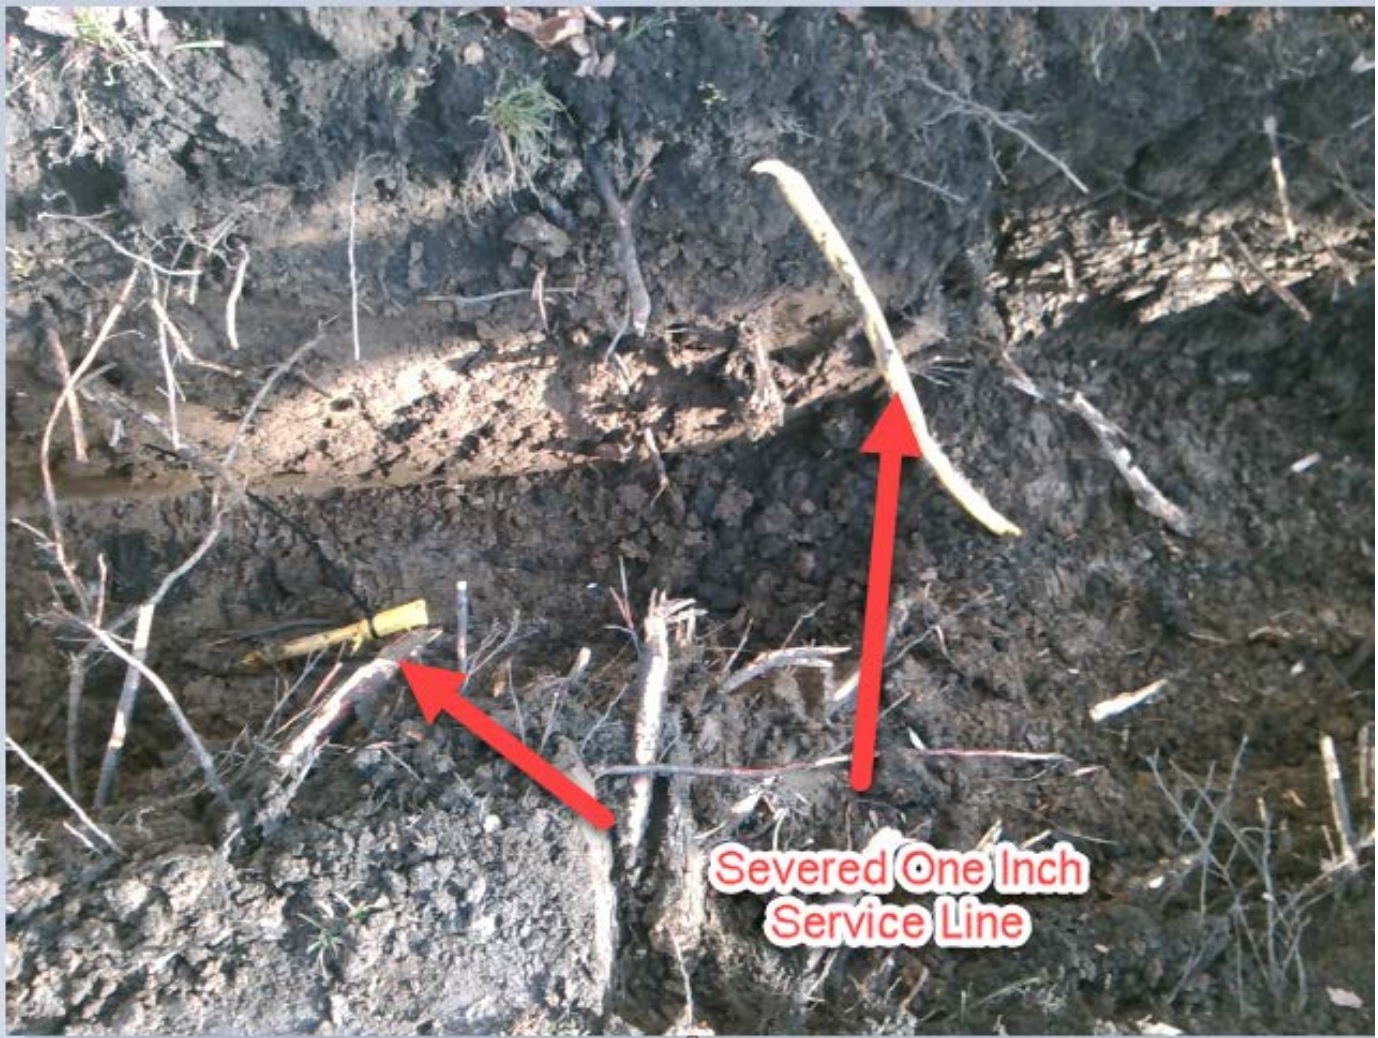
The damage investigation revealed that Cornerstone Basement Solution did not generate a one call ticket prior to initiating their excavation.

The picture(s) below details the severed service line along the side house wall at 729 W Elm Street in Lima, Ohio

Cornerstone Basement Solution failed to generate an excavation one call ticket prior to excavating, resulting in an unmarked facility being damaged. Upon damaging the one (1) inch natural gas service line, Cornerstone Basement Solution failed to contact DEO to report the damaged service line. Had a DEO employee not inadvertently driven by the excavation taking place without locate marks, Cornerstone Basement Solution employees indicated they would have made the repair. If the situation had played out

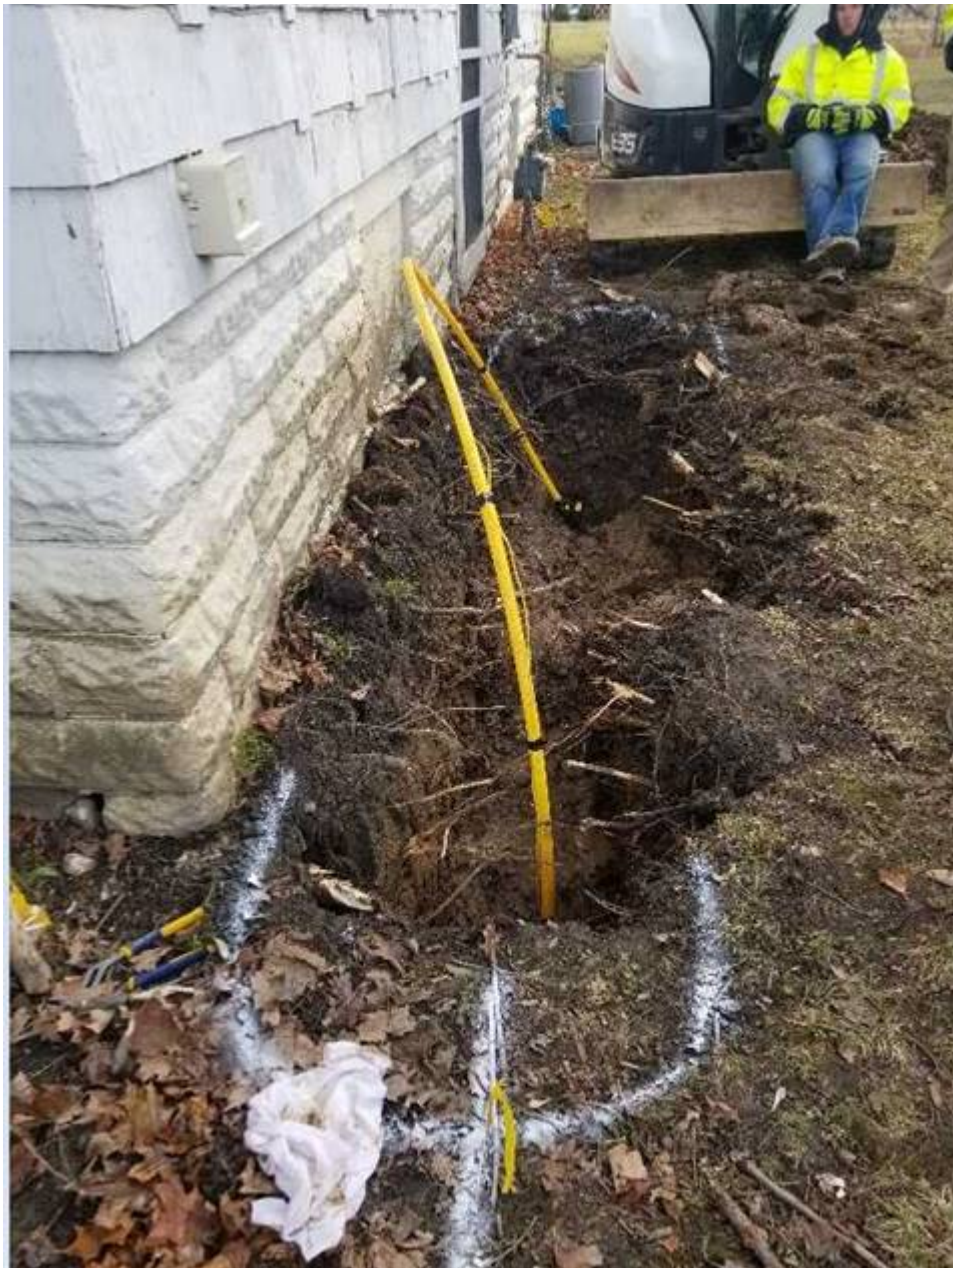
The picture below details the temporarily repaired service line at 729 W Elm Street on 1/6/2020

At 2:34 PM on 1/6/2020, DEO generated an emergency excavation ticket (A000602667) to expose the damaged service line and made the appropriate repairs to the one (1) inch natural gas service line.
