**BEFORE
THE OHIO SITING BOARD**

In the matter of the Application of Birch)	
Solar 1, LLC for a Certificate of)	
Environmental Compatibility and Public)	Case No. 20-1605-EL-BGN
Need to Construct a Solar-Powered Electric)	
Generation Facility in Allen and Auglaize)	
Counties, Ohio.)

TESTIMONY OF

May 11, 2022

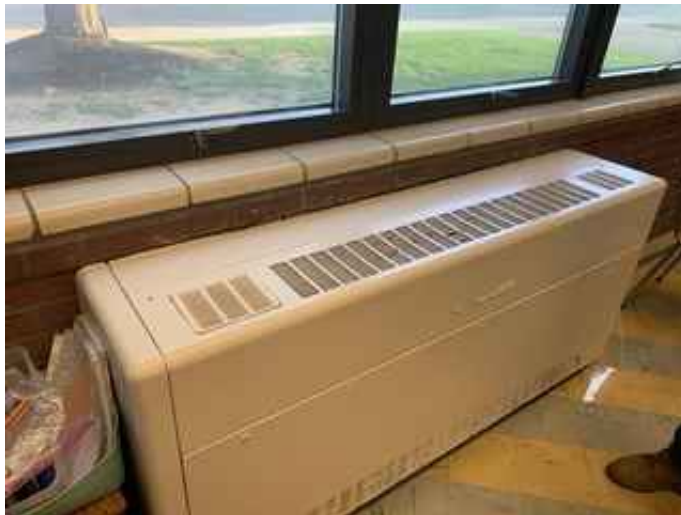
steam unit ventilator

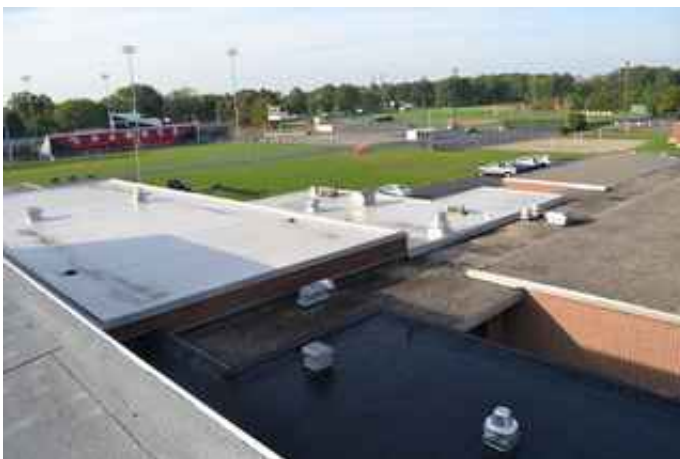
EPDM, TPO, and Ballasted Roofing

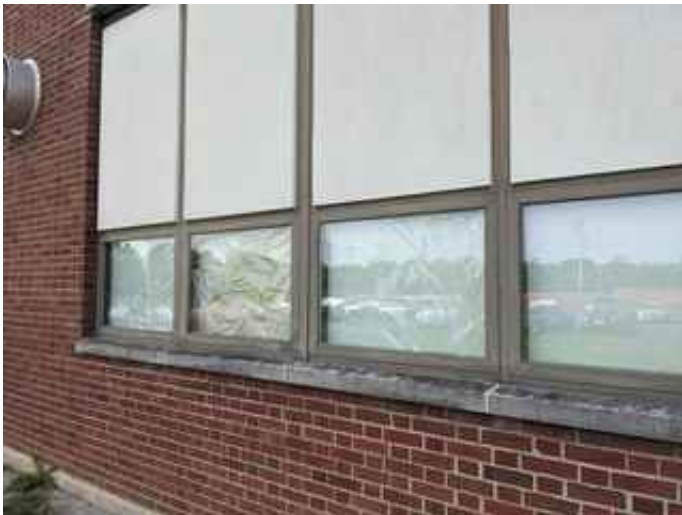
Windows with Peeling Coating

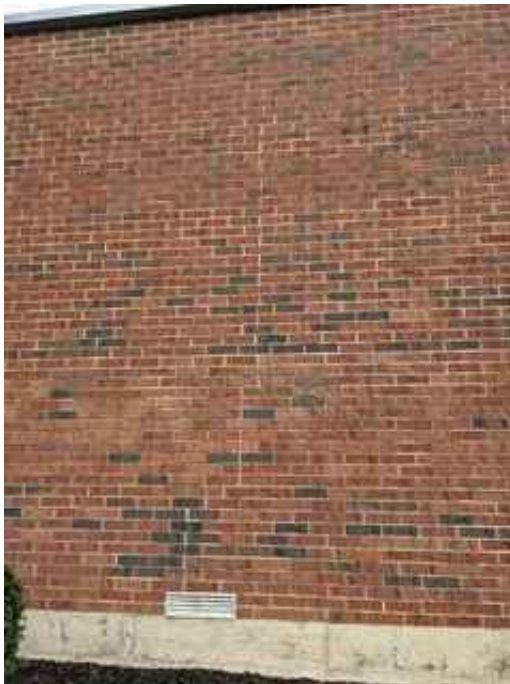
Masonry Needing Cleaning

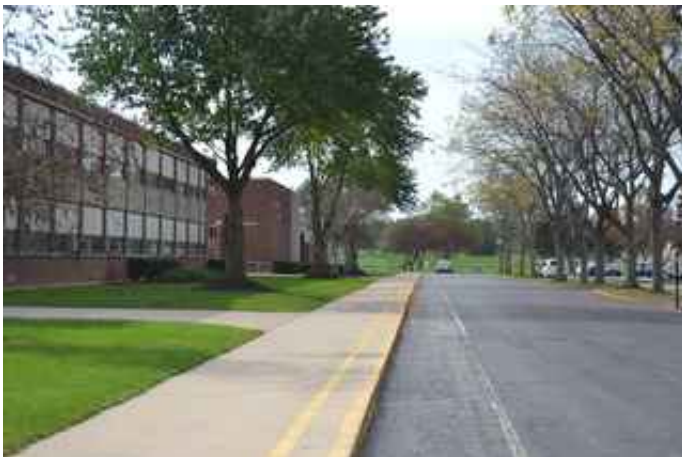
Drop-Off Lane Asphalt and Curb

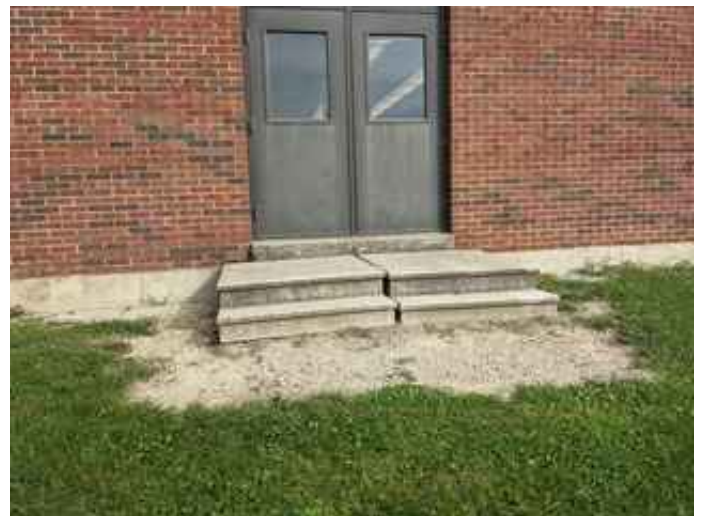
Stairs to Repair

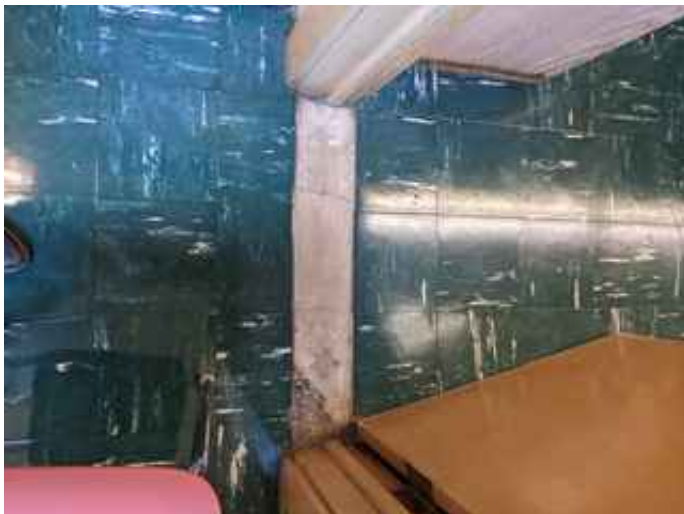
VAT Floor Tile

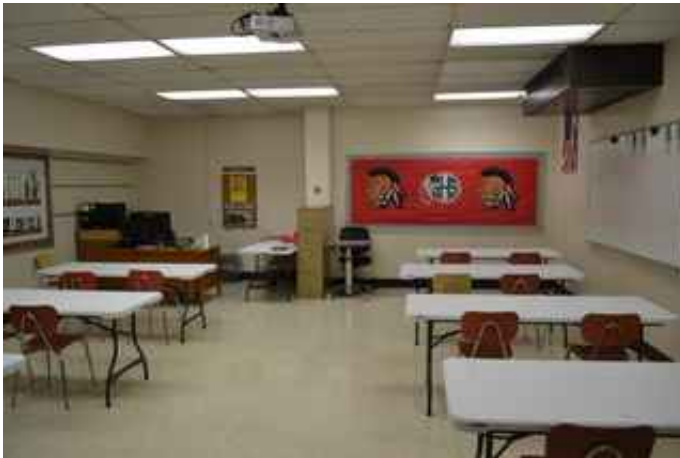
Incomplete Classroom Furniture

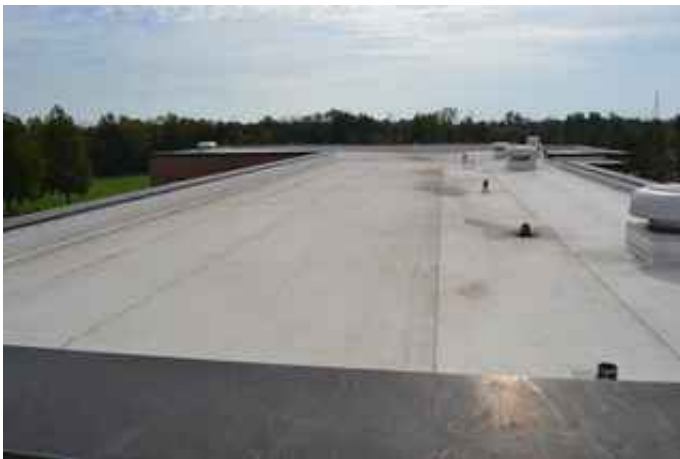
TPO Roofing with Evidence of Previous Ponding

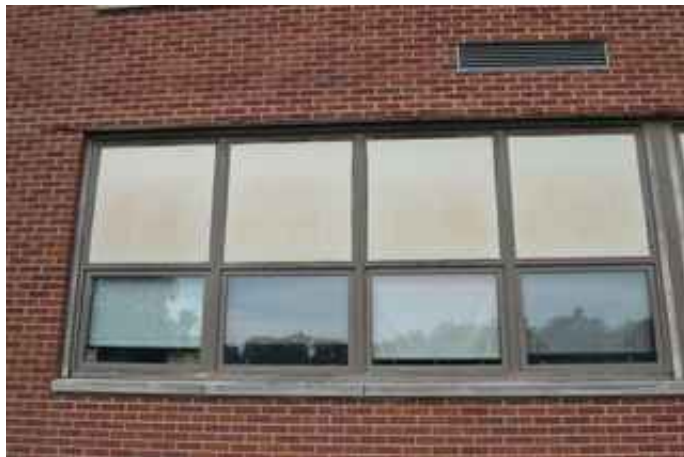
Windows Without Screens

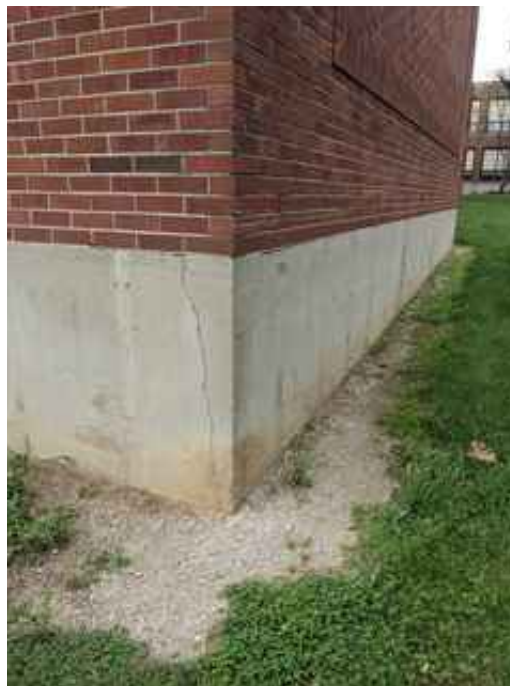
Foundation Crack

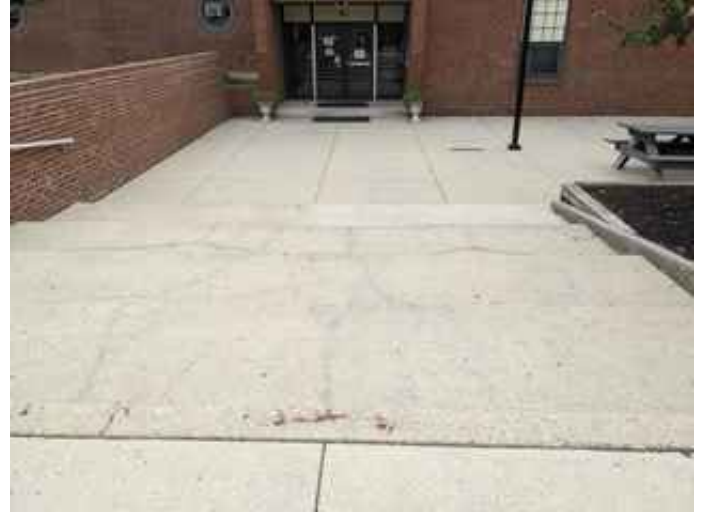
Concrete Steps Needing Repair

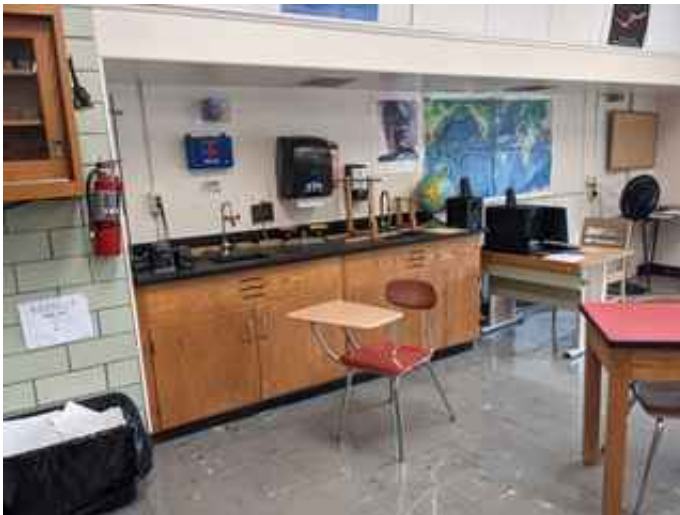
VAT Floor Tile

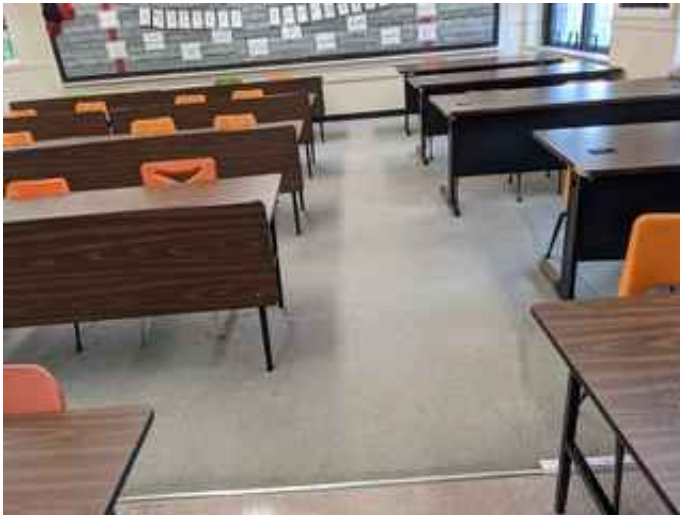
Dated Classroom Furniture

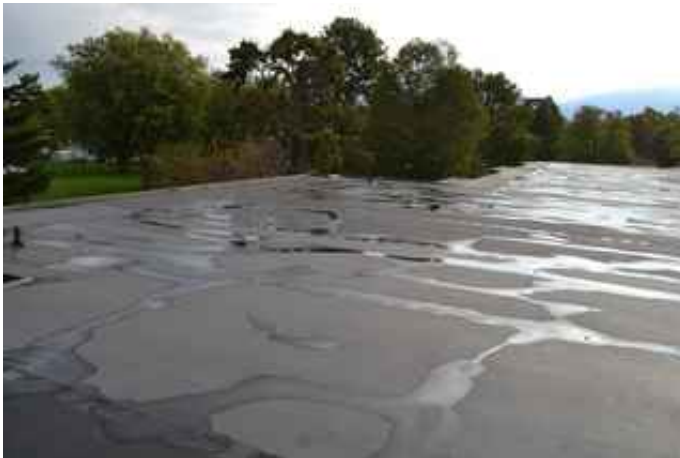
Ponding on Roofs

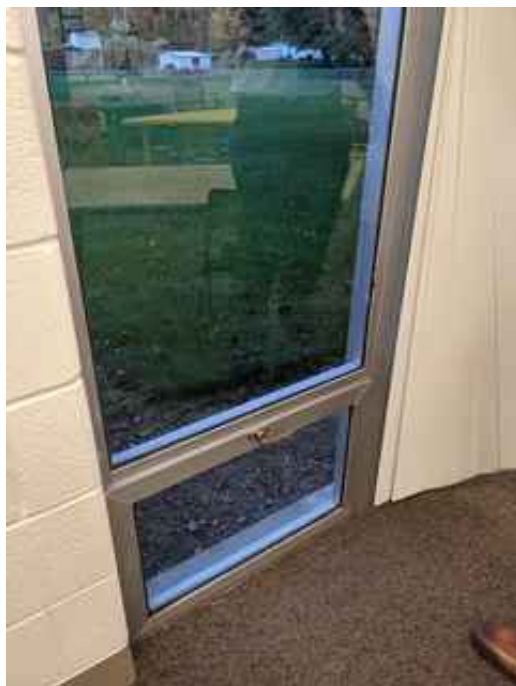
Single Pane Windows

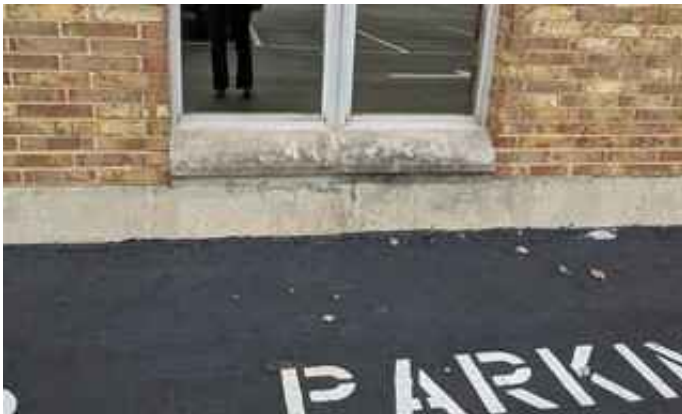
Window Sills to be Replaced

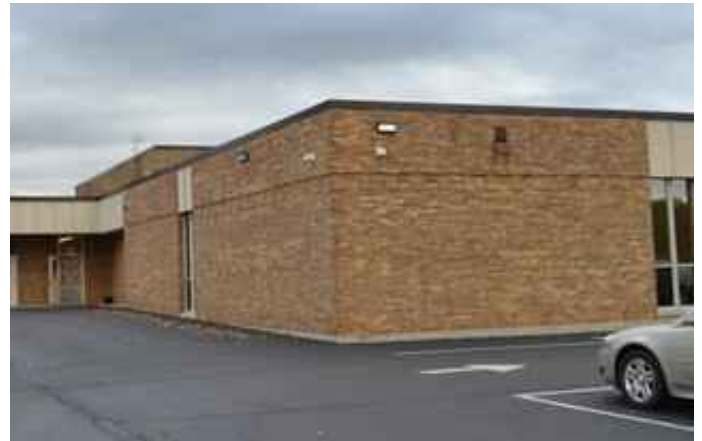
Masonry to be Cleaned

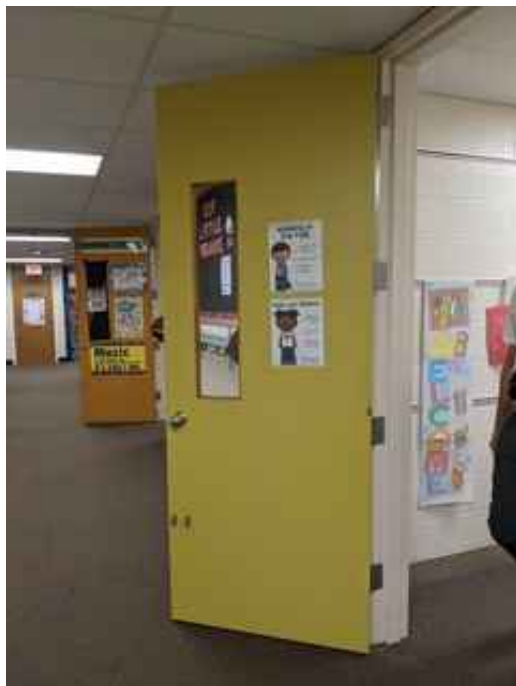
Interior Door Without ADA Compliant Hardware

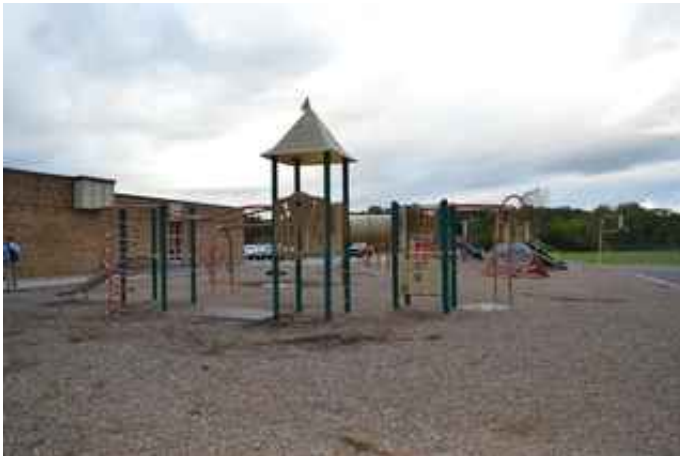
Worn Mulch and Playground Equipment

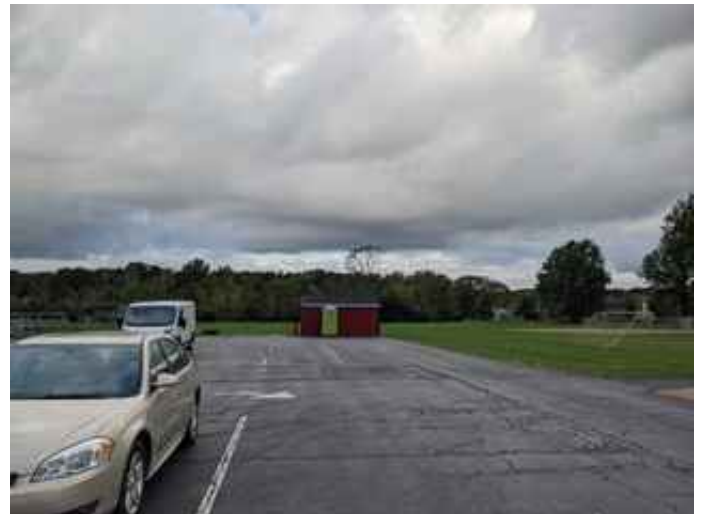
Asphalt Needing Resurfacing

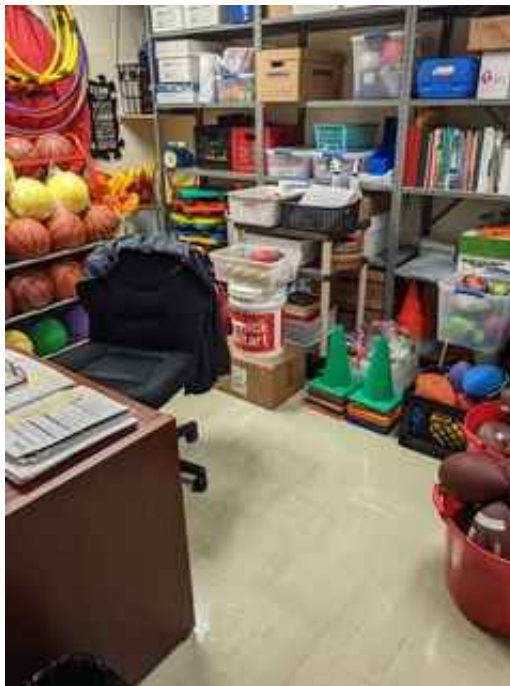
VAT Floor Tile

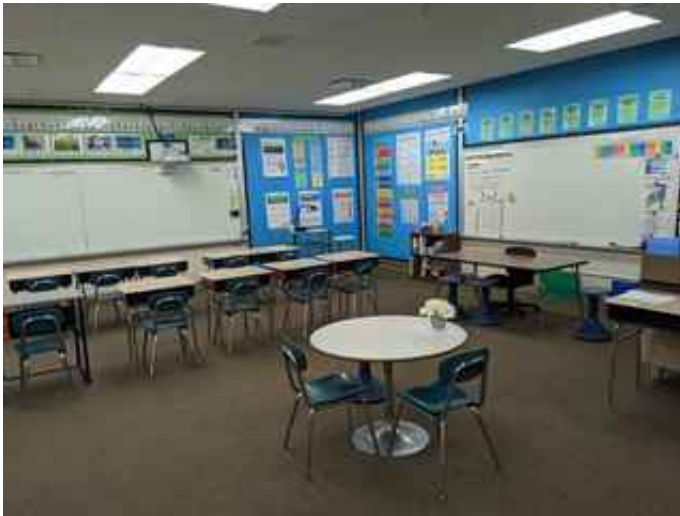
Dated Classroom Furniture

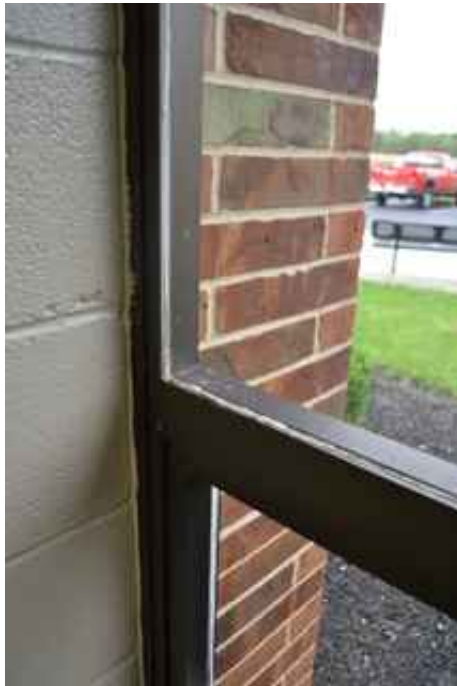
Single Pane Windows

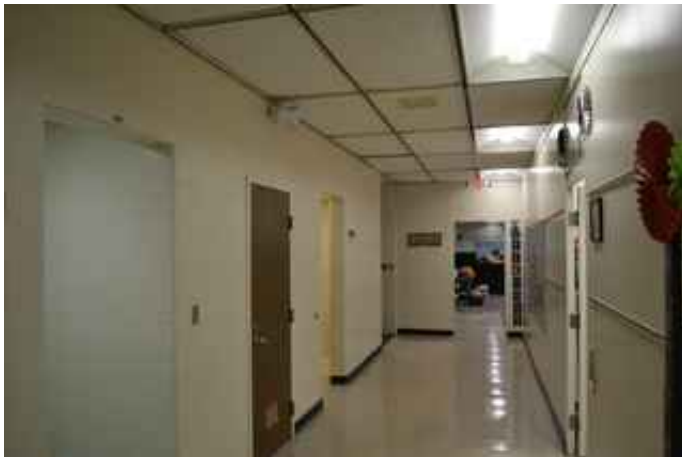
No ADA Signage Present

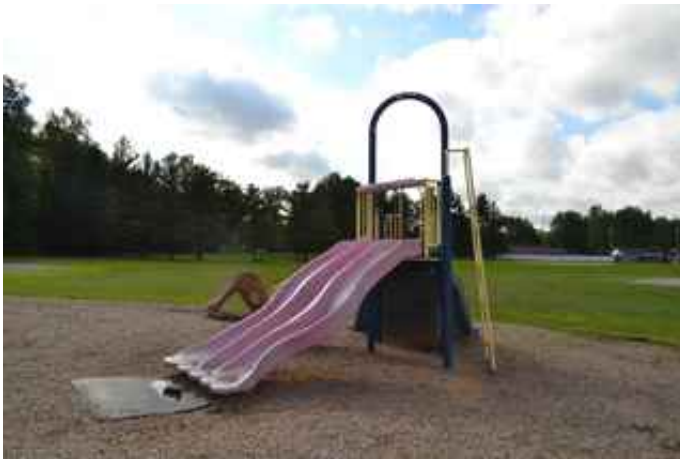
Worn and Un-fenced Playground Equipment

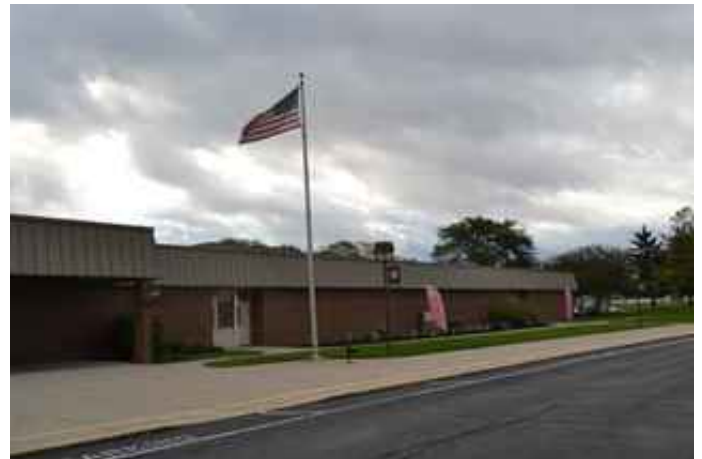
Curbs and Asphalt Needing Replacement

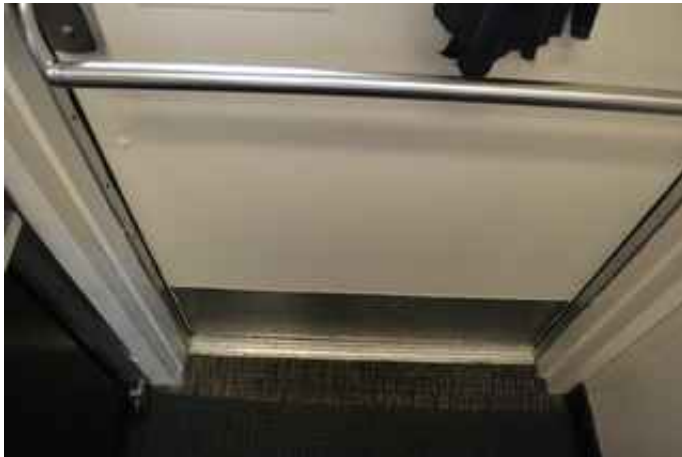
Exterior Door Threshold

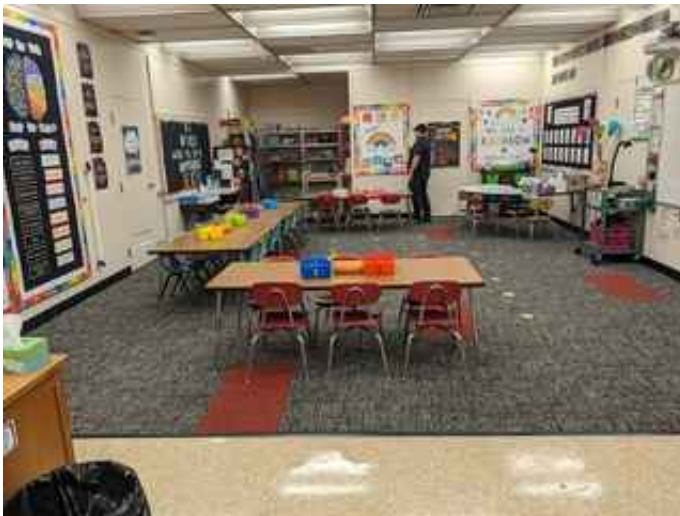
Dated and Inconsistent Furniture
