Re: Case No 07-723-EL-UNC

MICHAEL L. HOFMANN

Subject: Evaluation of Failed Turbine Blades from Zimmer Station  
Metallurgy File #3791

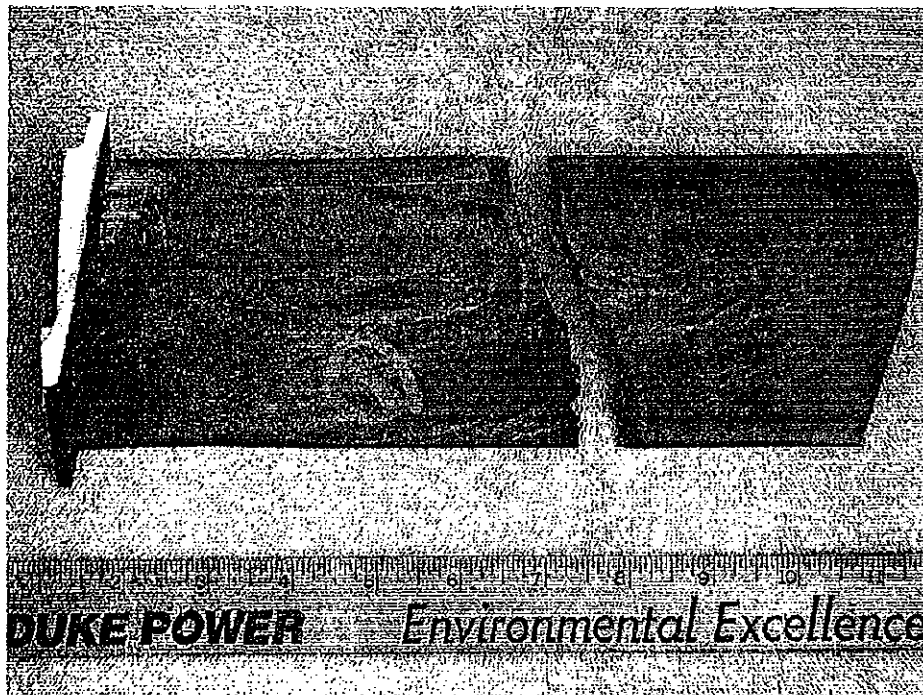
Macro 01

Figure: 1 LPA blade 115, number 4 in group.

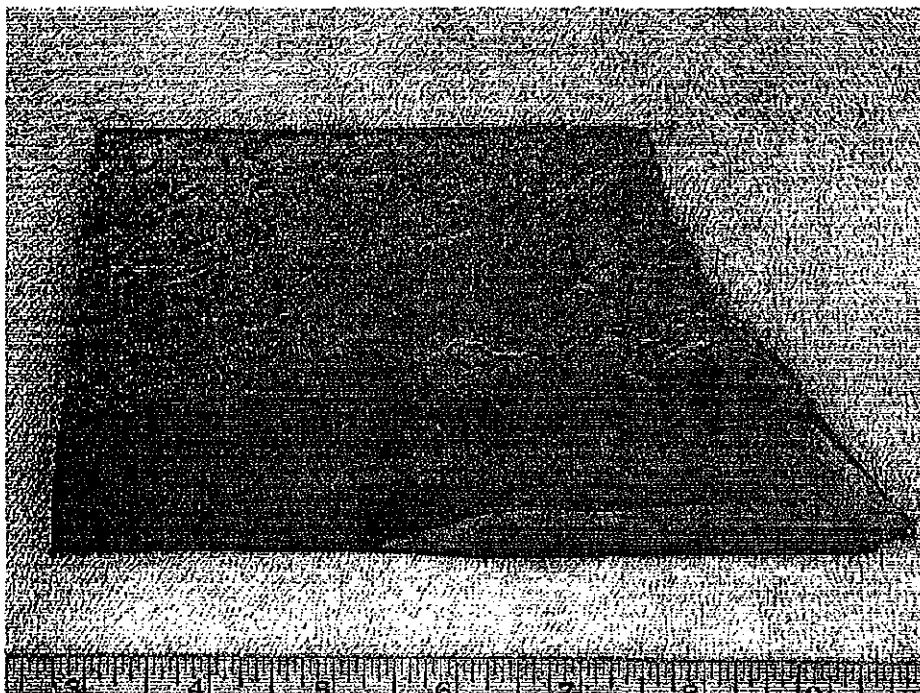
Macro-06

Figure: 2 LPA blade 58, start of group.

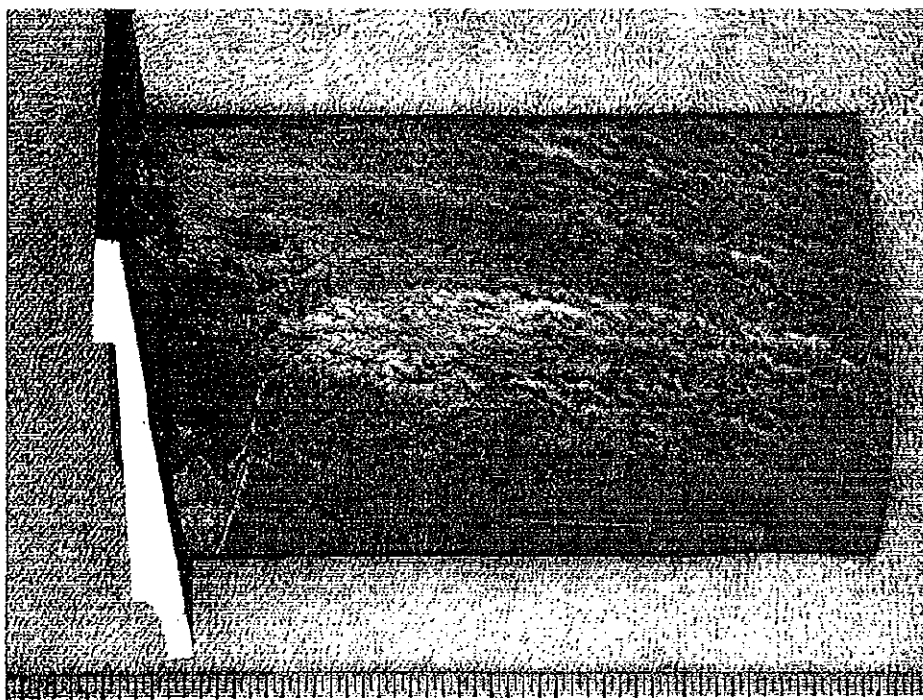
Macro -04

**Figure: 3** LPB blade 150, third in group.

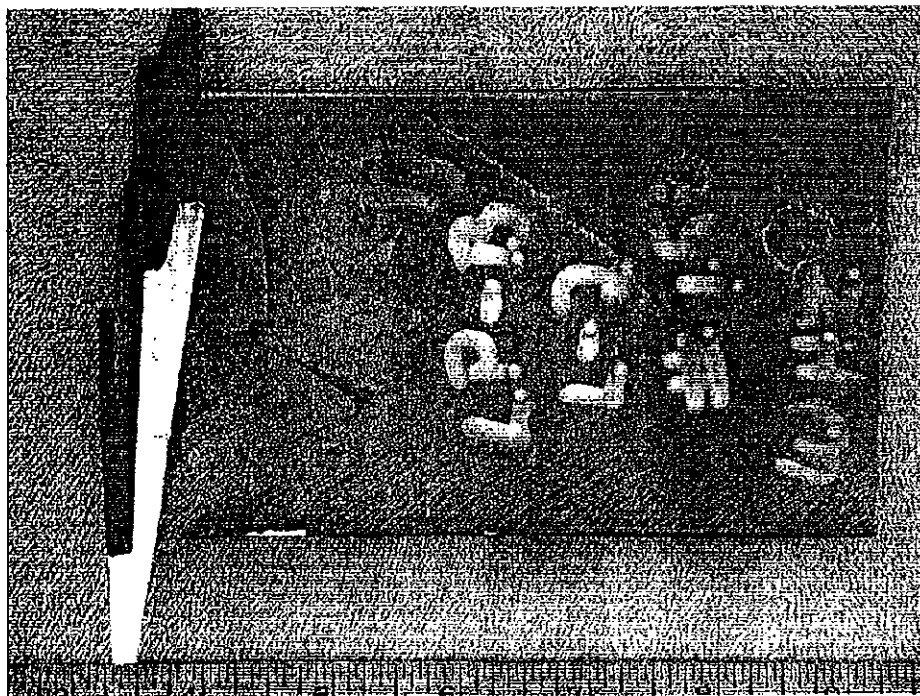
Macro-05

**Figure: 4** LPB blade 150, third in group. Enlarged View of cracks looking on concave side (opposite side of Figure 3)

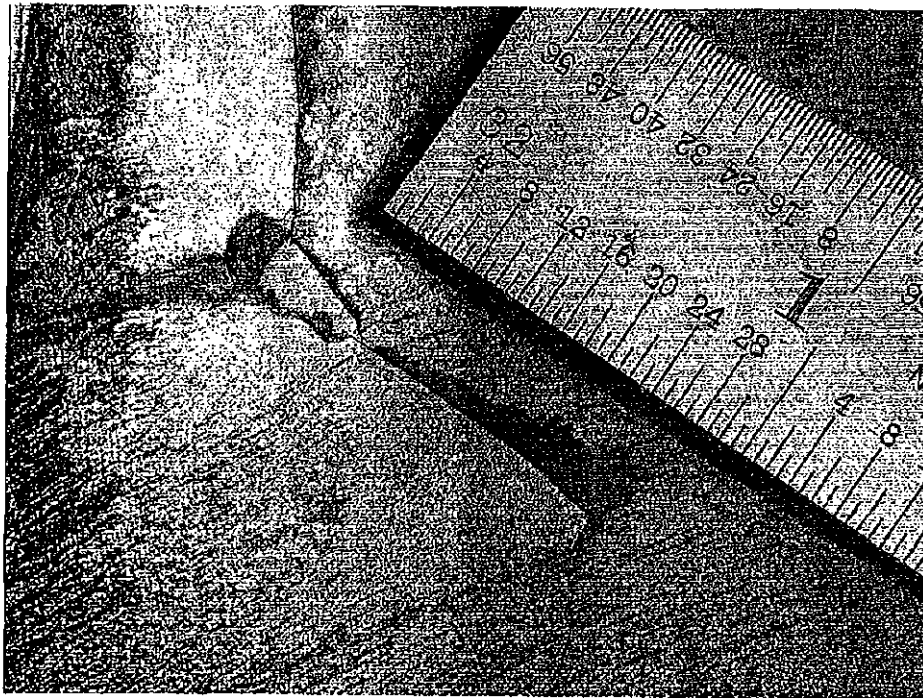
Macro-08

**Figure: 5** LPB blade 150, third in group. Enlarged View of cracks looking on concave side (opposite side of Figure 3)

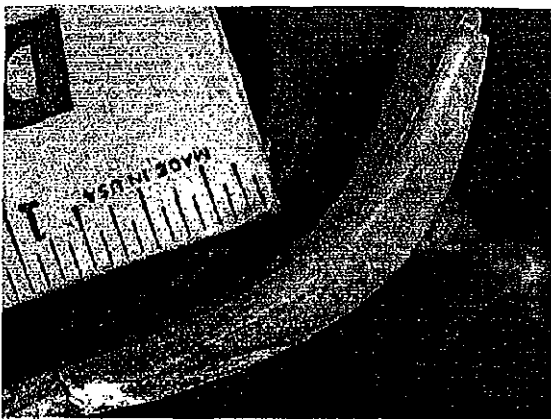
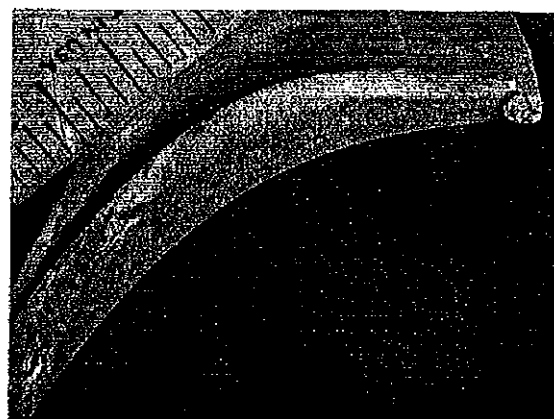
Macro-12  
Macro-14

The portion of the fracture faces near the leading edge of the two broken blades shown in Figure 6 have the macroscopic characteristics of fatigue. Some portions of each face is relatively deposit free suggesting that the final fracture probably occurred recently. Further toward the trailing edge, the fracture surface is much rougher (stepped) and has more deposit which suggests corrosion rather than fatigue.

The results of macroscopic examination indicate both corrosion and mechanical fatigue were associated with the failures of the blades from LPA L-2. The complex crack pattern on the LPB blade does not rule out mechanical fatigue but suggests corrosion as the predominant mechanism.

**Figure: 6** Fracture surfaces from LPA-115 (left) and LPA-58 blades that were broken as received in laboratory.

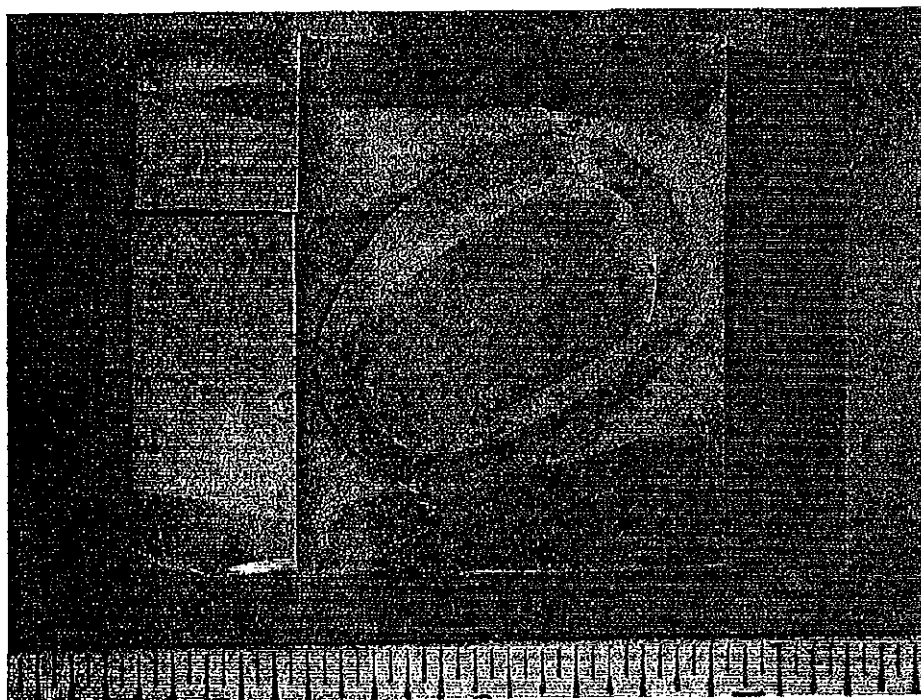
Macro-16

Figure 7 illustrates the as-received condition of the L-3 blade. The face of the crack in the shroud of this blade was covered with a tenacious brown deposit similar to that seen on the convex surface of the other blades. No secondary or branch cracking was observed either on the shroud or on the tenon. The shroud and tenon were cut to separate the parts for further

**Figure: 7** .L-3 blade as-received. Note crack in shroud aligned with crack in tenon.

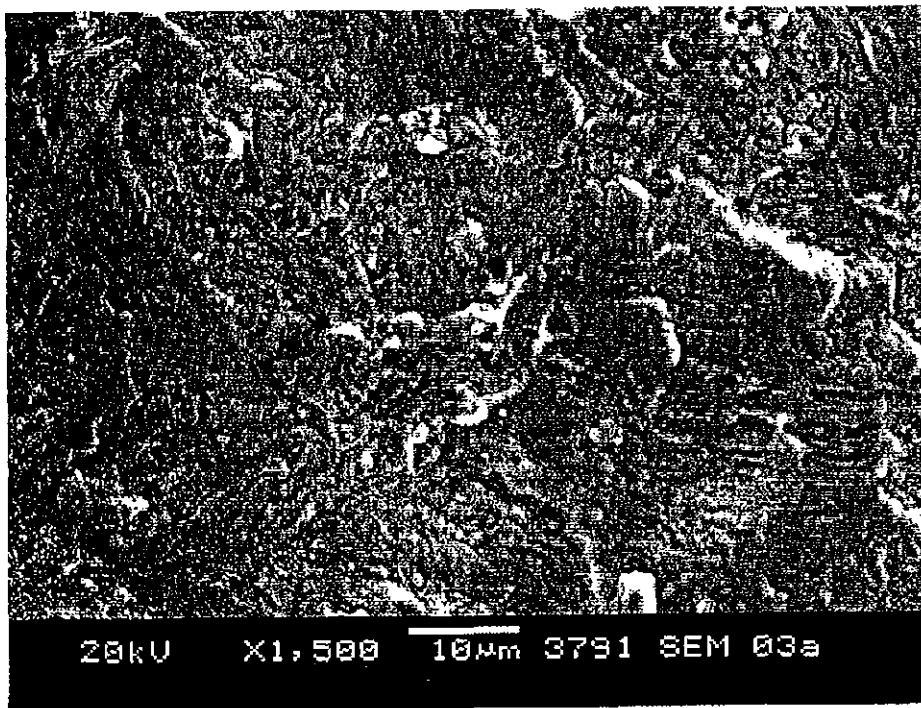
SEM-3a  
SEI

**Figure: 8** SEM micrograph of fracture face near leading edge of blade from LPA. Features are characteristic of striated fatigue.

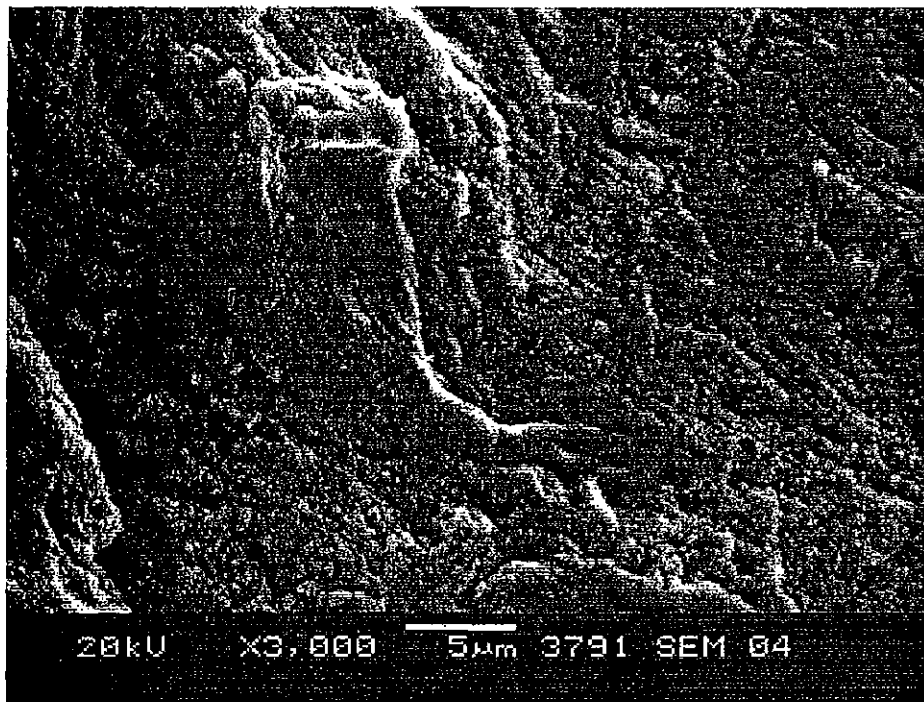
SEM-04  
SEI

**Figure: 9** SEM micrograph of fracture face near trailing edge of blade from LPA. Features are characteristic of striated fatigue.

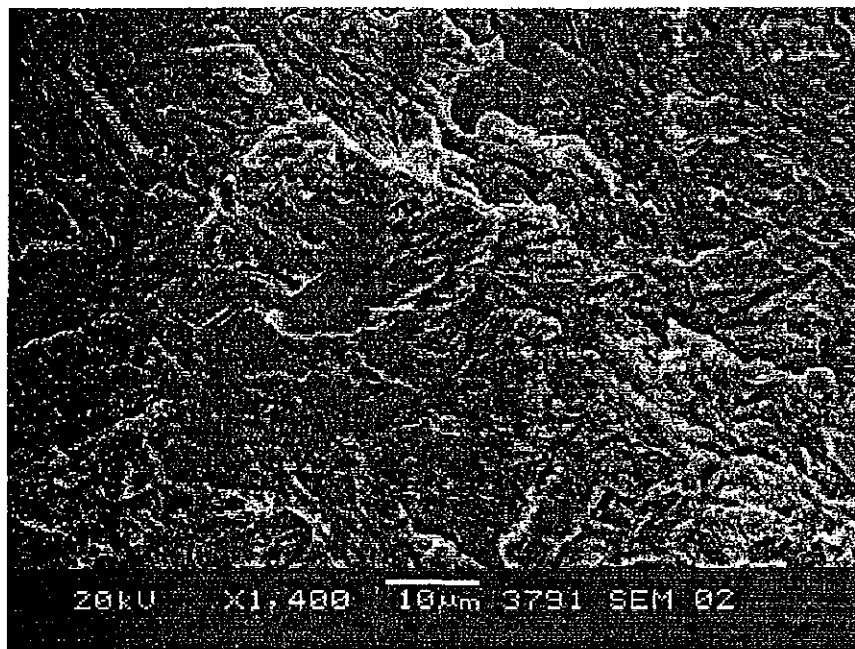
SEM-02  
SEI

**Figure: 10** SEM micrograph of opened crack near leading edge of blade from LPB. Features are characteristic of striated fatigue.

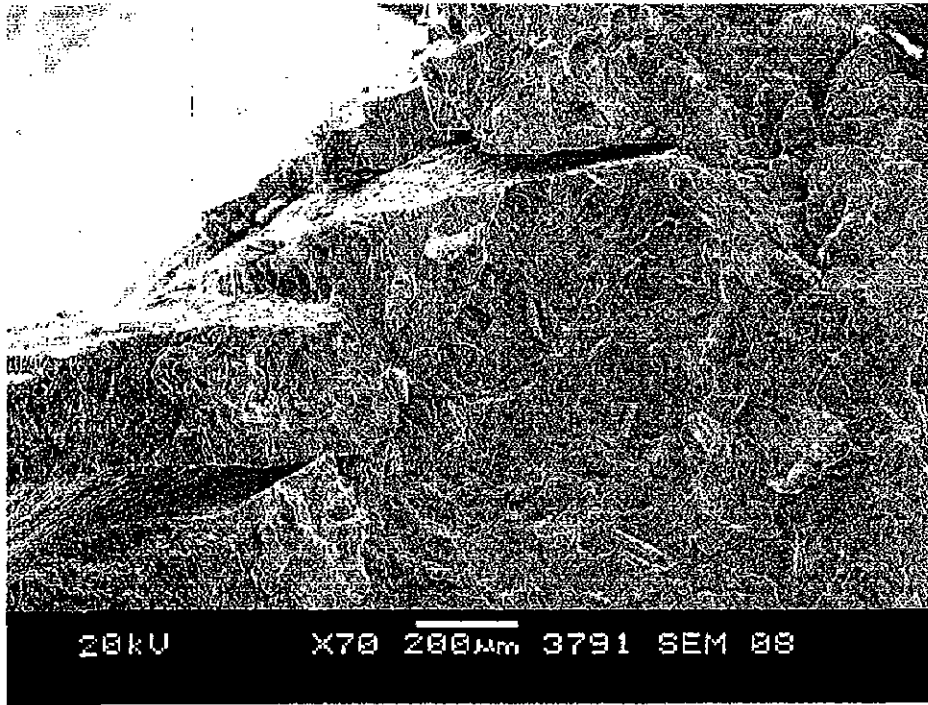
SEM-08  
SEI

**Figure: 11** Fracture produced in lab by opening crack in tenon. Note secondary cracking at top edge of picture

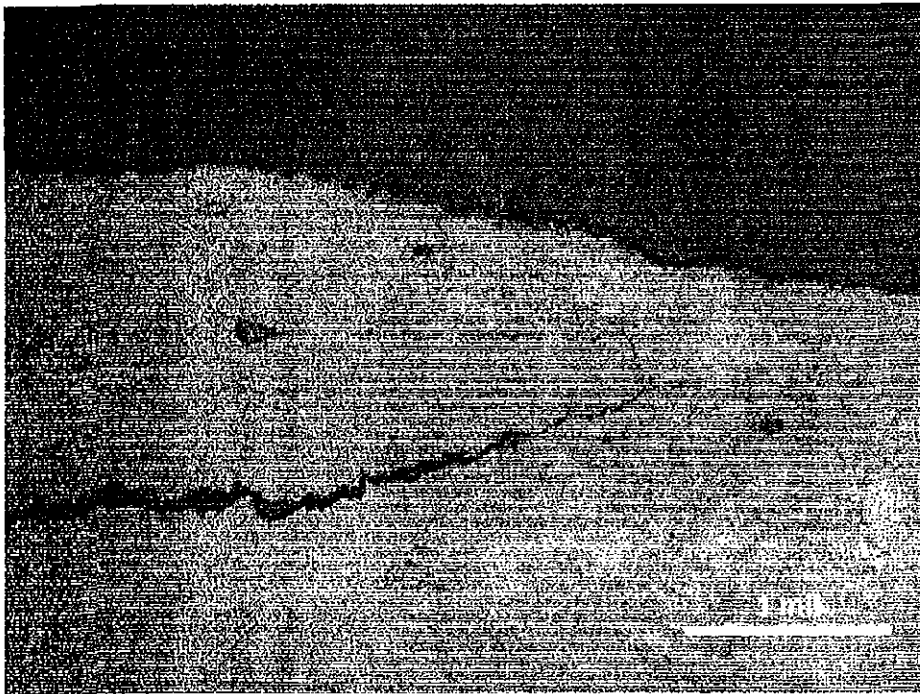
Micro-01a  
Vilela's etch

**Figure: 12** Transverse cross section through crack in LPB blade (axis of blade runs into paper). Cracking is mixed transgranular and intergranular.

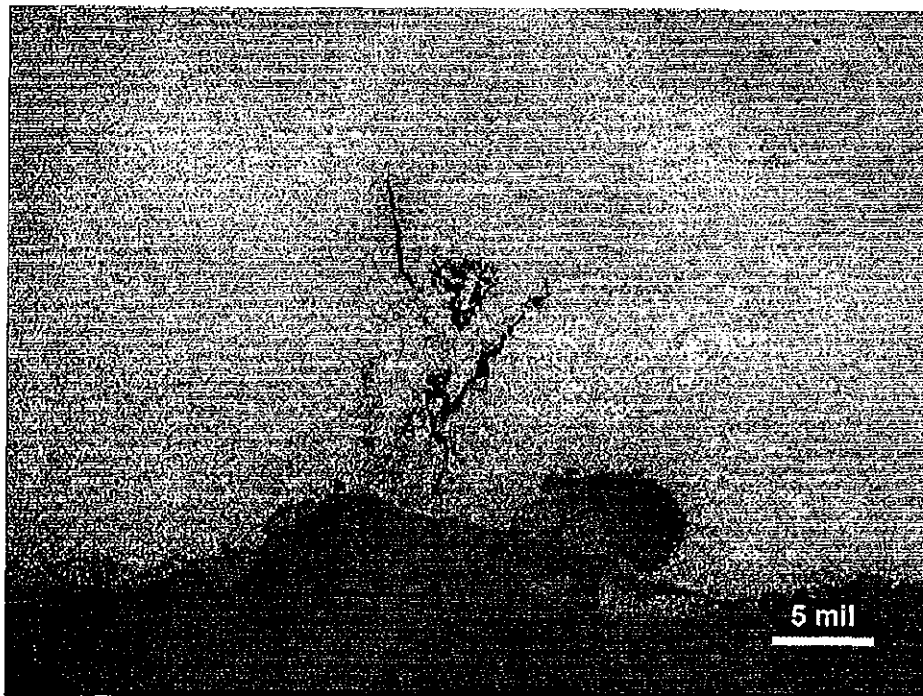
Micro-03  
Villèle's etch

**Figure: 13** Stress corrosion cracking at base of a pit on convex surface.

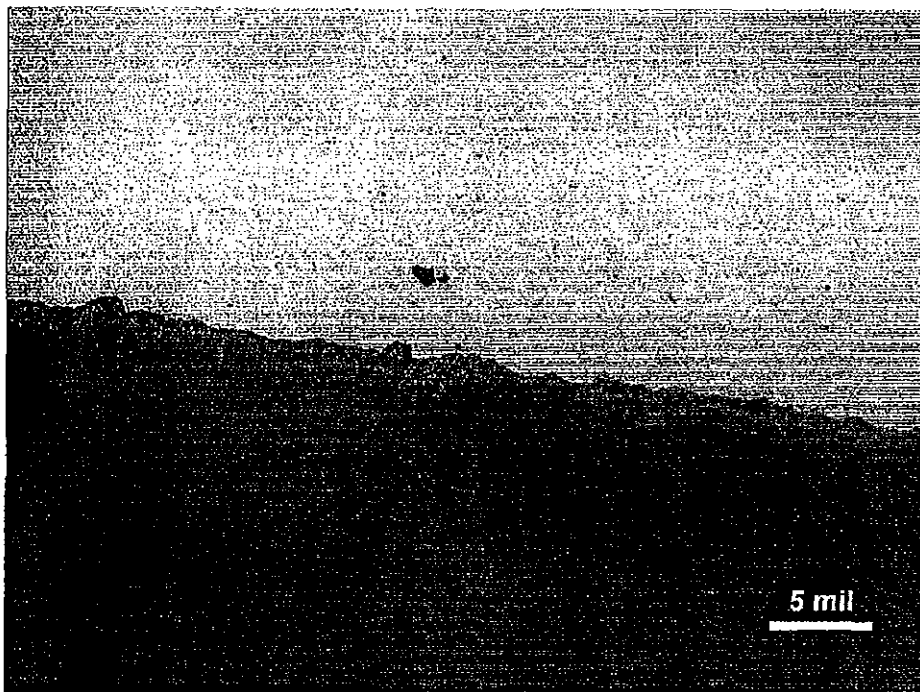
Micro-04  
Unetched

**Figure: 14** Cross section through typical deposit on convex face. Note copper association with pits.

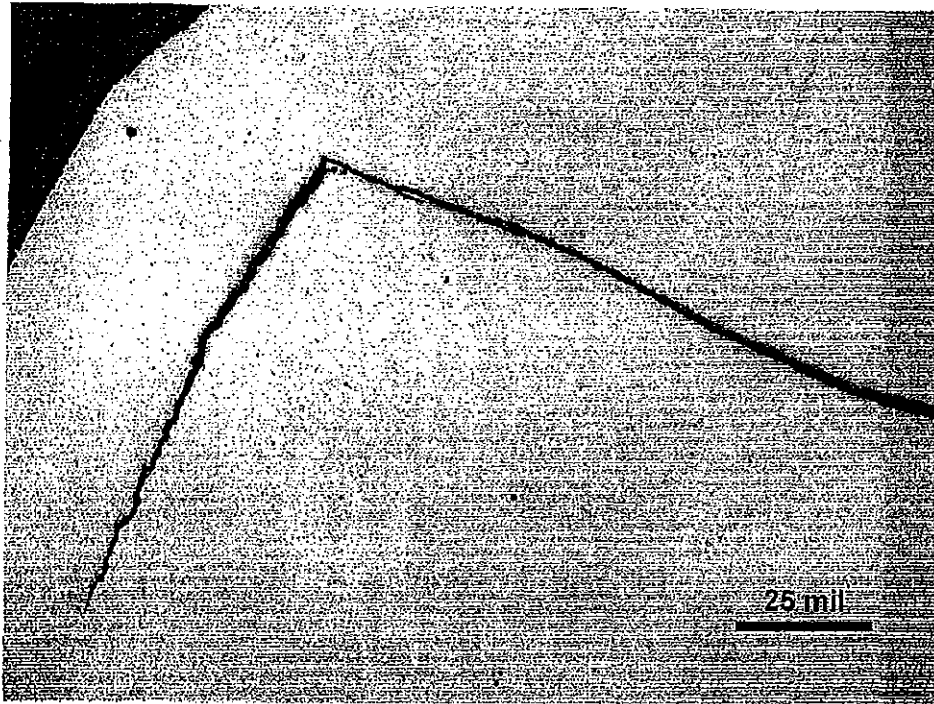
Micro-09  
Unetched

**Figure: 15** Section through crack in tenon. Axis of tenon is parallel to crack. Peened head is at upper left.

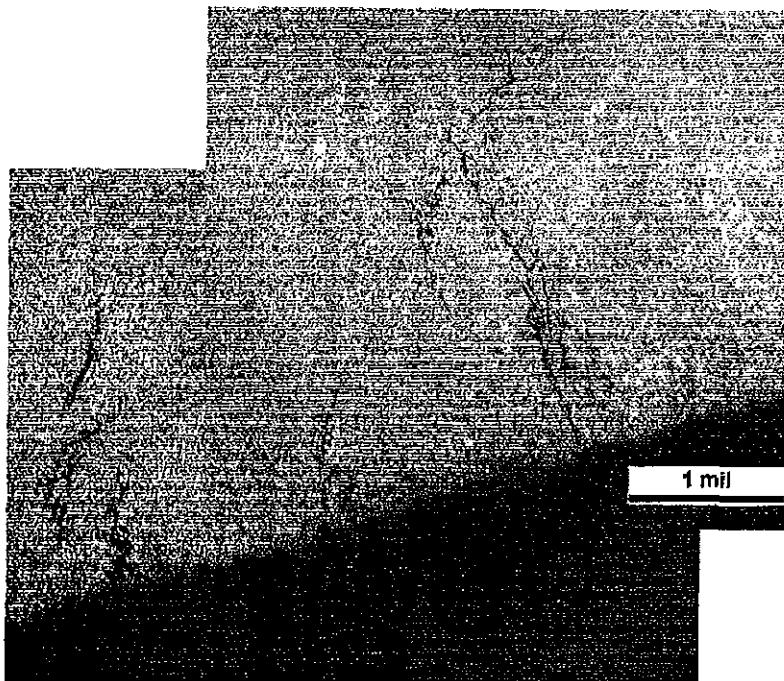
Micro-14  
Vilella's etch

**Figure: 16** Secondary cracking along main crack in tenon. Edge at bottom of photo is surface of main crack parallel to tenon axis.

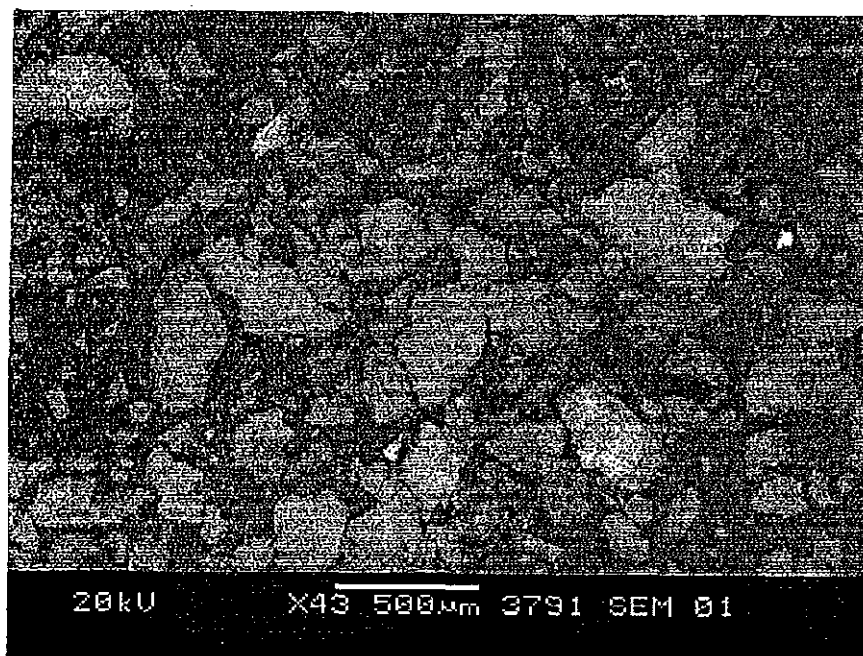
SEM-01  
BEI

**Figure: 17** Deposit particles scraped from the surface of one of the LPA L-2 blades. Lighter areas indicate the presence of heavier elements such as copper, iron, chromium and nickel.

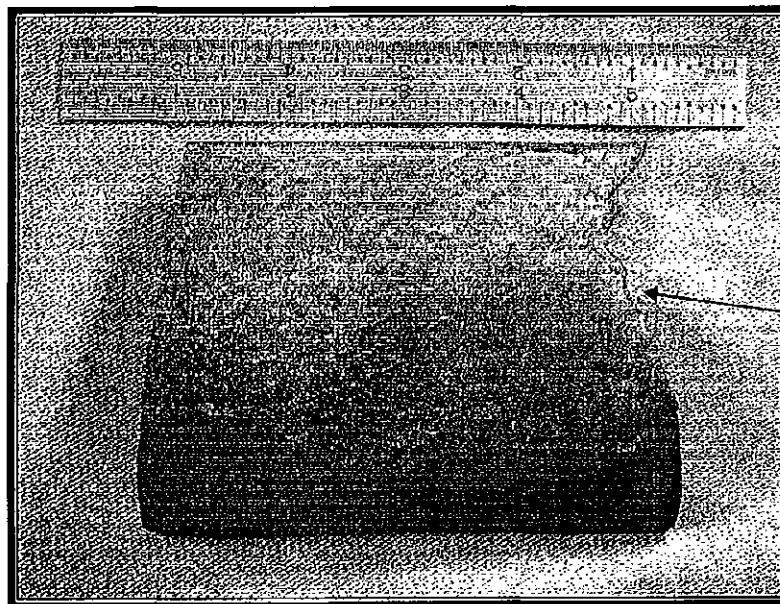
Figure 2: As received LP-A L-2 #49 blade convex side. Reddish brown deposit is seen on the convex side.

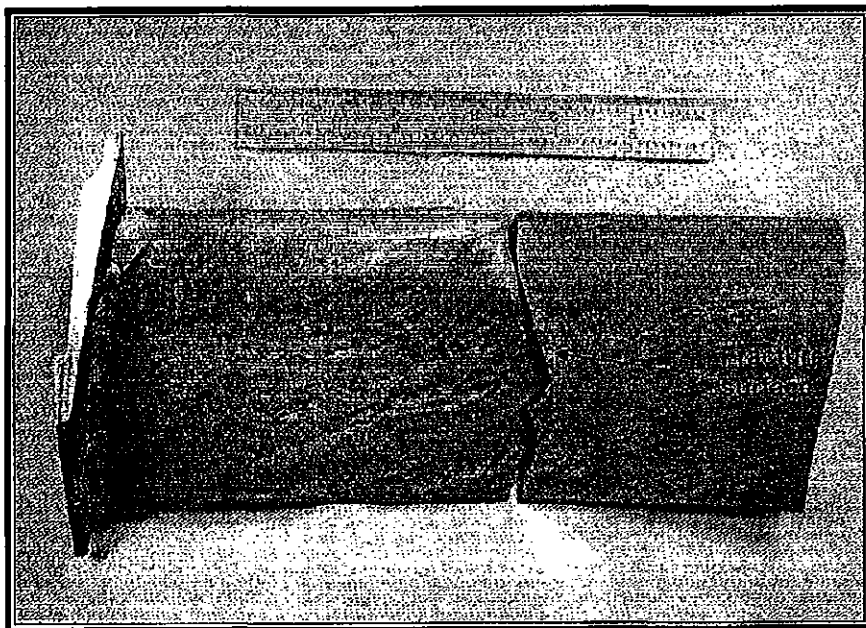
Figure 4: As received LP-A L-2 #175 blade convex side. Reddish brown deposit is seen on the convex side.

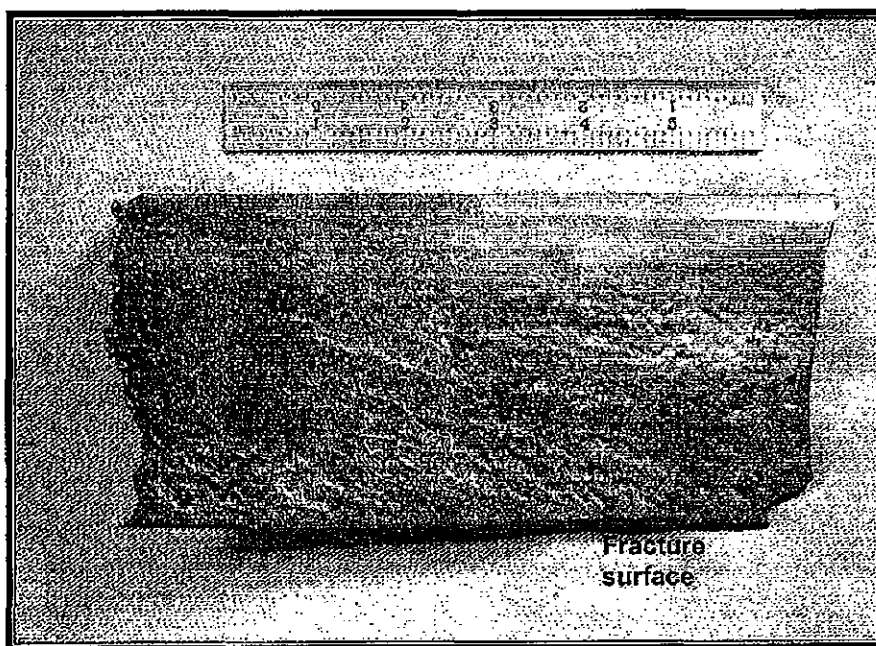
Figure 6: As received LP-B L-2 #103 blade convex side. Reddish brown deposit is seen on the convex side.

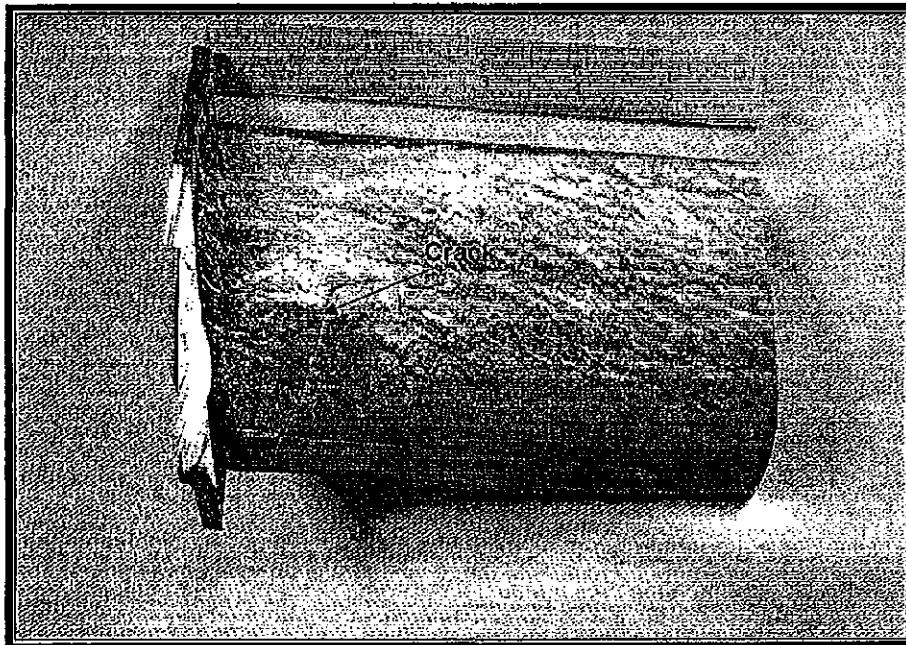
Figure 8: As received LP-B L-2 #141 blade convex side. Reddish brown deposit is seen on the convex side.

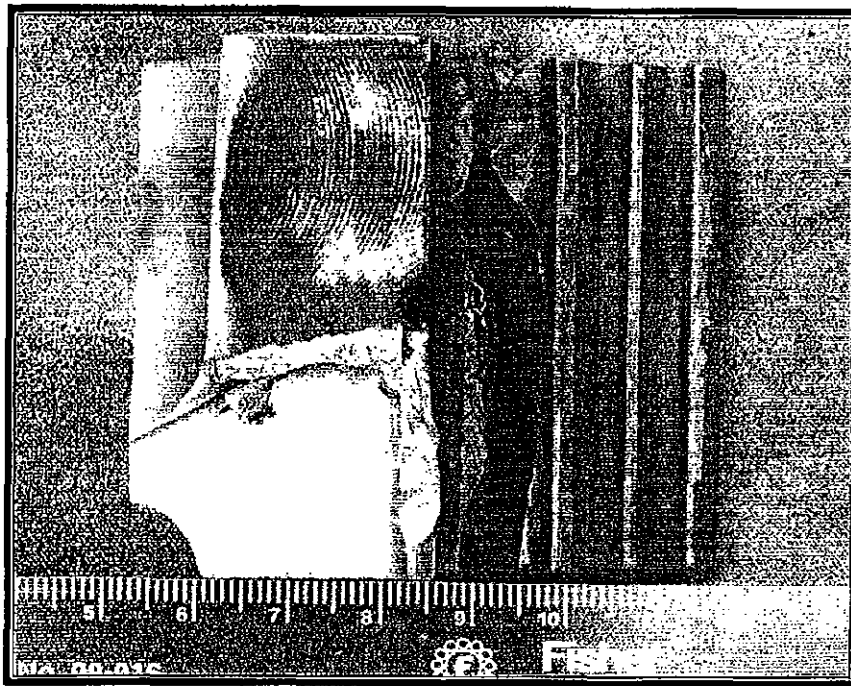
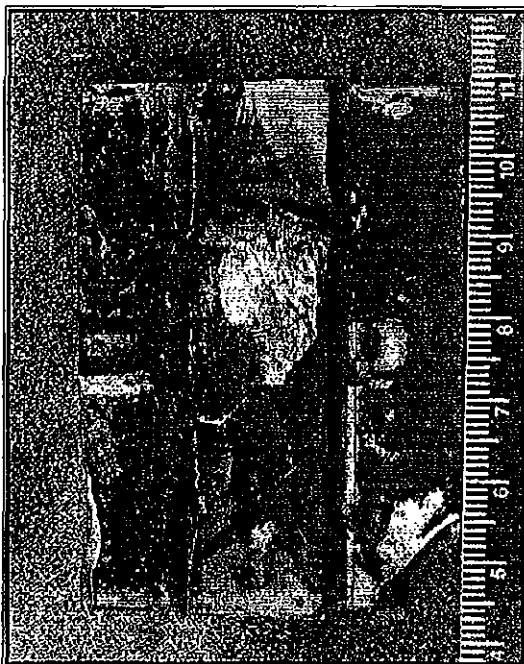
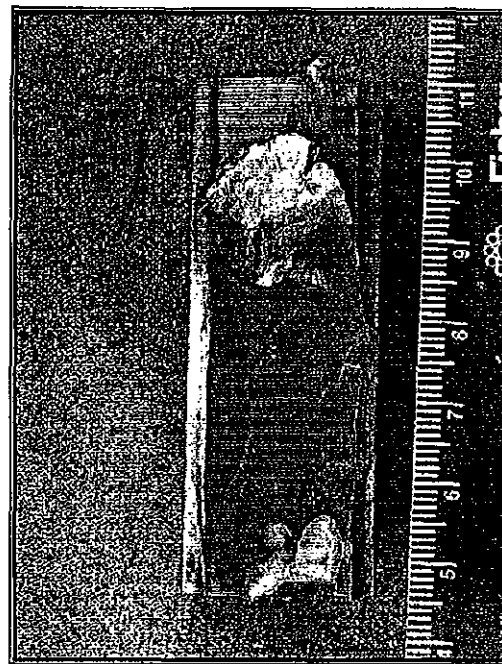
Figure 9: As received LP-A L-3 #4 blade cracked in the root. Fracture surface is covered by reddish brown oxide deposits.

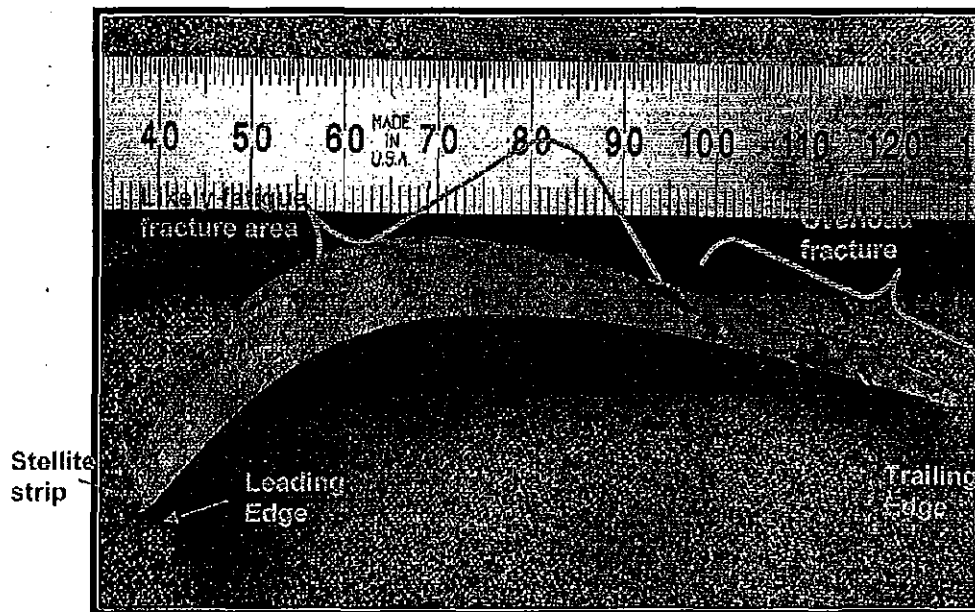
Figure 10: Macro photograph of fracture surface of LP-A L-2 #49 blade. Fracture surface was cleaned to remove thick oxide deposit. Flat fracture surface can be seen from the leading edge continuing into a fracture surface due to overload towards the trailing edge.

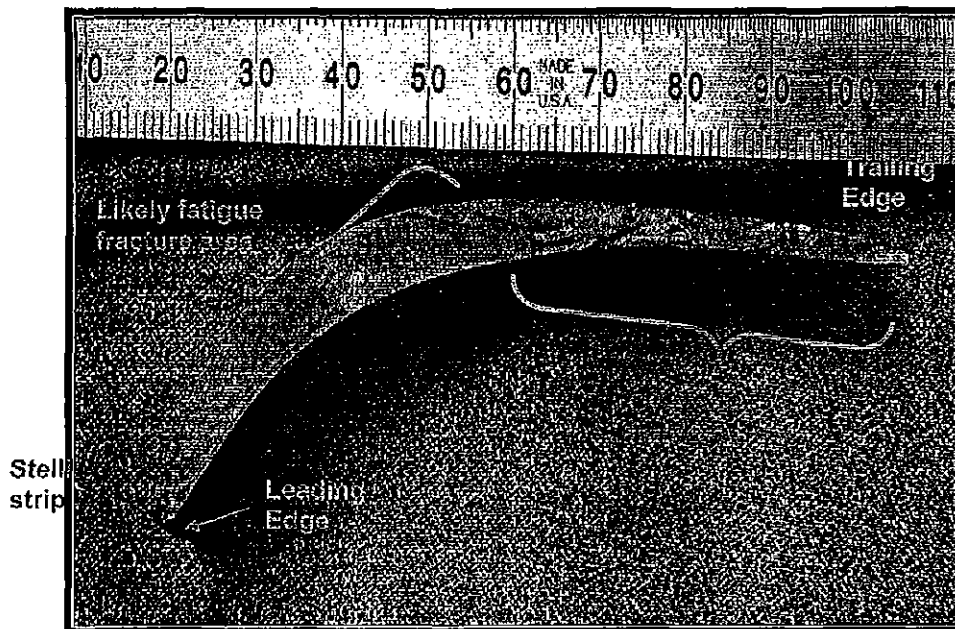
Figure 11: Macro photograph of fracture surface of LP-A L-2 #175 blade. Fracture surface was cleaned to remove thick oxide deposit. Flat fracture surface can be seen from the leading edge continuing into a fracture surface due to overload towards the trailing edge.

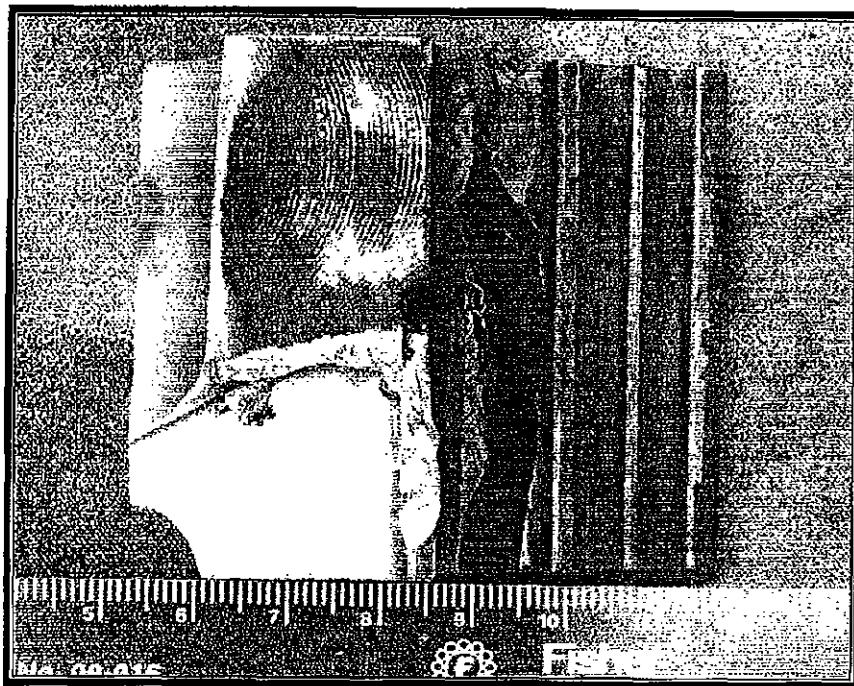
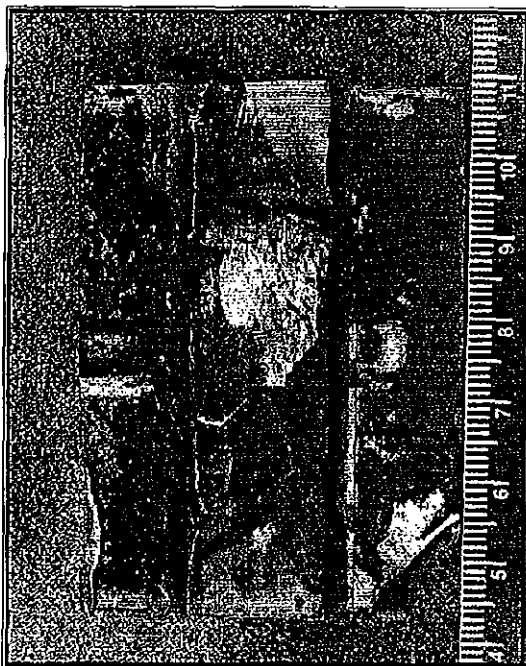
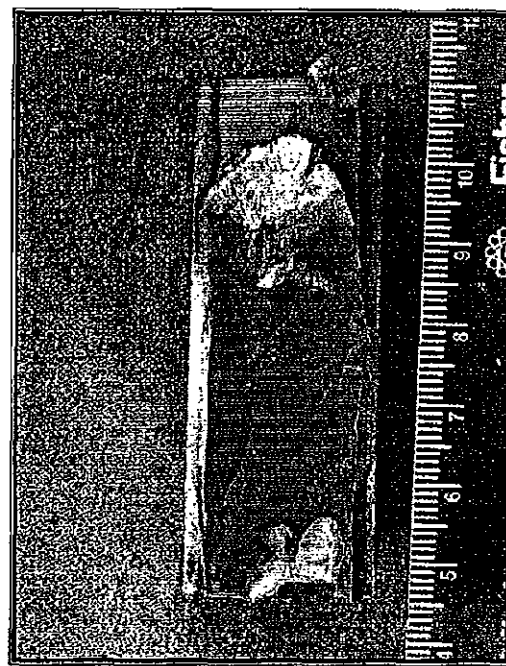
Figure 9: As received LP-A L-3 #4 blade cracked in the root. Fracture surface is covered by reddish brown oxide deposits.

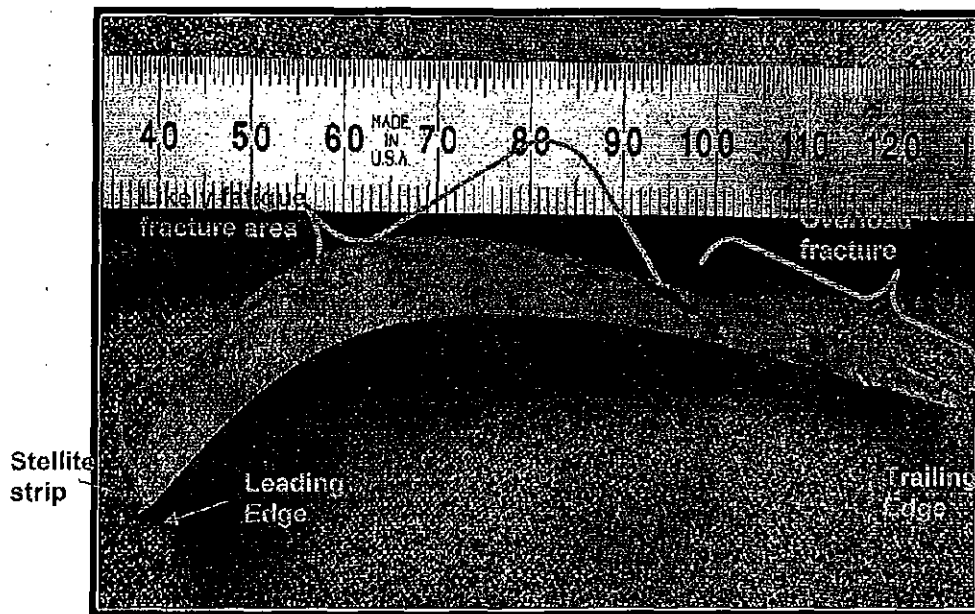
Figure 10: Macro photograph of fracture surface of LP-A L-2 #49 blade. Fracture surface was cleaned to remove thick oxide deposit. Flat fracture surface can be seen from the leading edge continuing into a fracture surface due to overload towards the trailing edge.

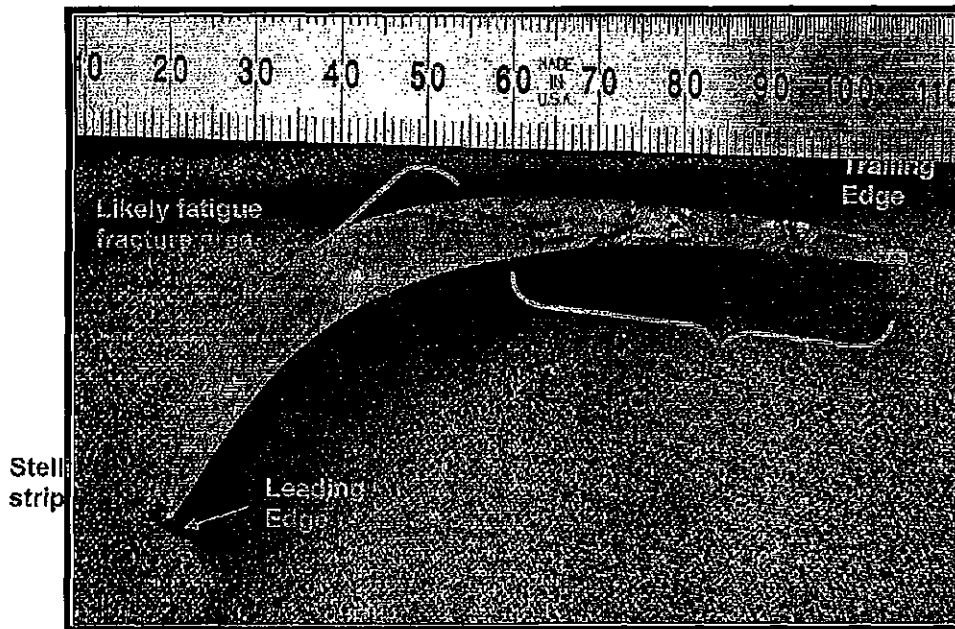
Figure 11: Macro photograph of fracture surface of LP-A L-2 #175 blade. Fracture surface was cleaned to remove thick oxide deposit. Flat fracture surface can be seen from the leading edge continuing into a fracture surface due to overload towards the trailing edge.

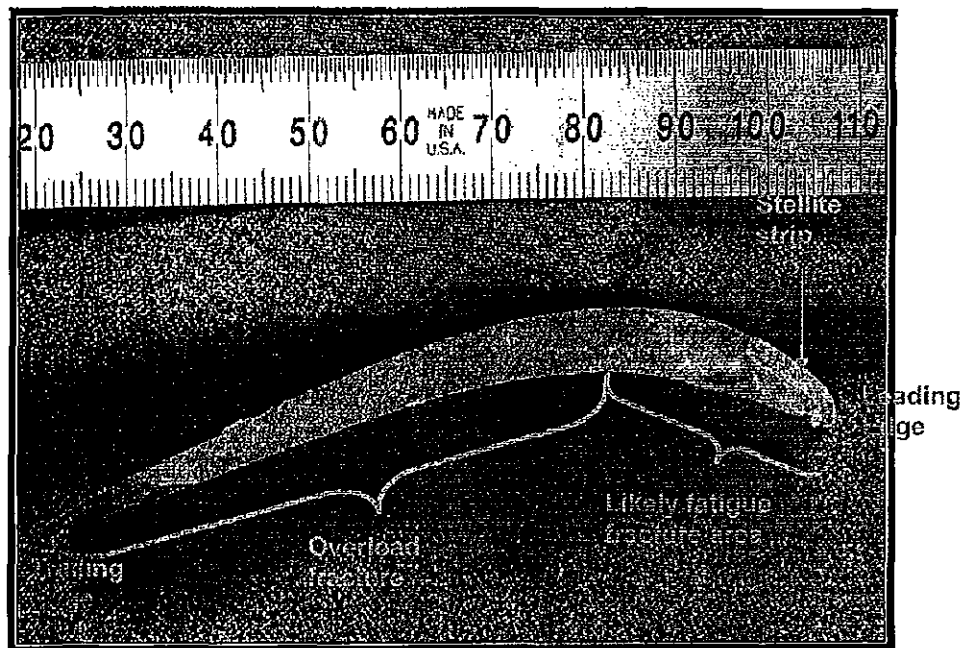
Figure 12: Macro photograph of fracture surface of LP-B L-2 #103 blade. Fracture surface was cleaned to remove thick oxide deposit. Flat fracture surface can be seen from the leading edge continuing into a fracture surface due to overload towards the trailing edge.

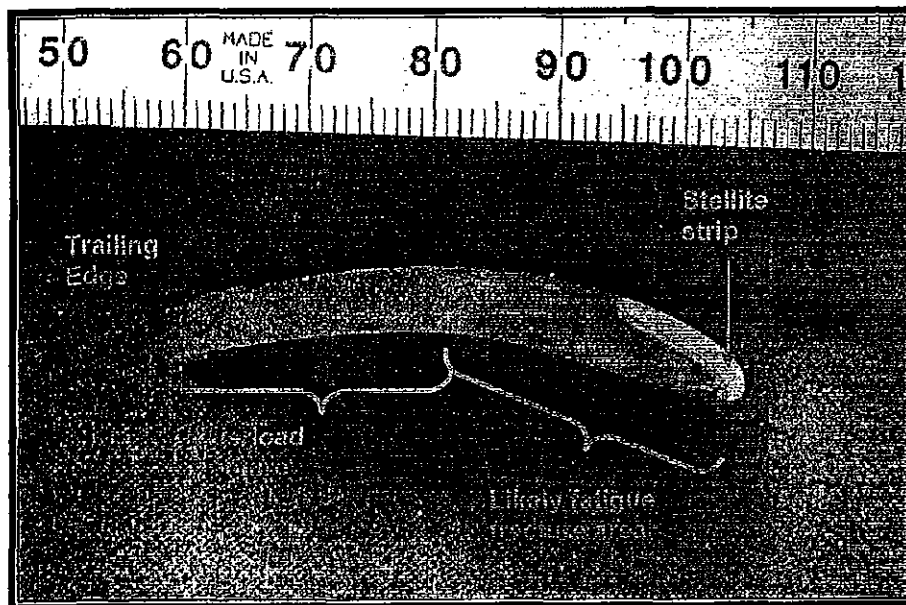
Figure 13: Macro photograph of fracture surface of LP-B L-2 #141 blade after opening the crack. Fracture surface was cleaned to remove thick oxide deposit. Flat fracture surface can be seen from the leading edge continuing into a fracture surface due to overload towards the trailing edge.

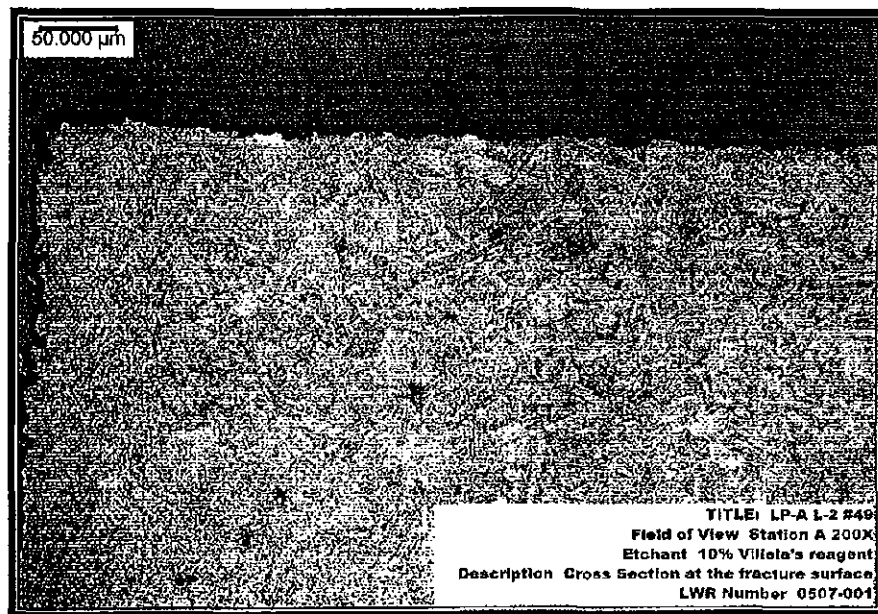
Figure 14: Photomicrograph of the cross section of the flat fracture surface of LP-A L-2 #49 blade. Microstructure indicates that the crack propagated in a transgranular fashion. The microstructure consists of tempered martensite.

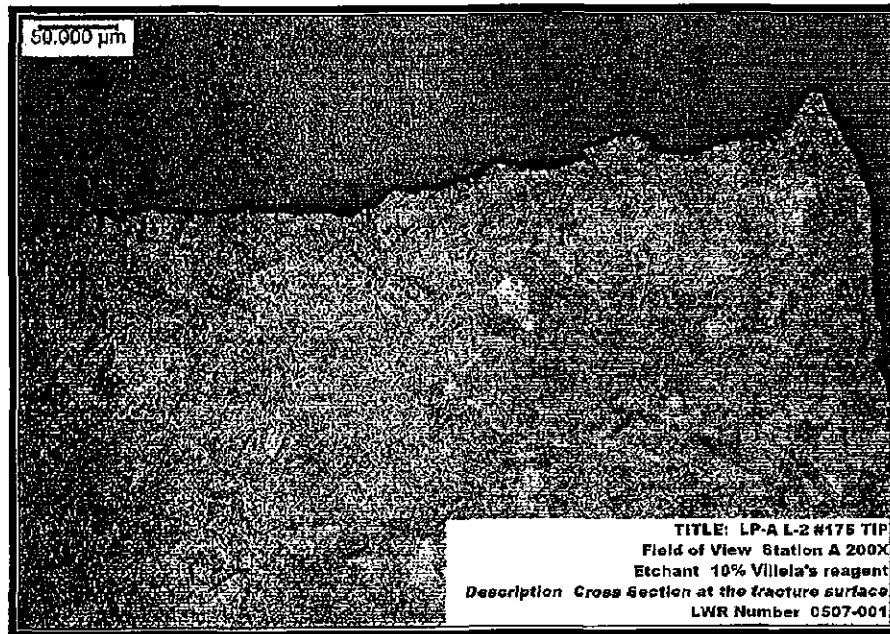
Figure 15: Photomicrograph of the cross section of the flat fracture surface of LP-A L-2 #175 blade. Microstructure indicates that the crack propagated in a transgranular fashion. The microstructure consists of tempered martensite.

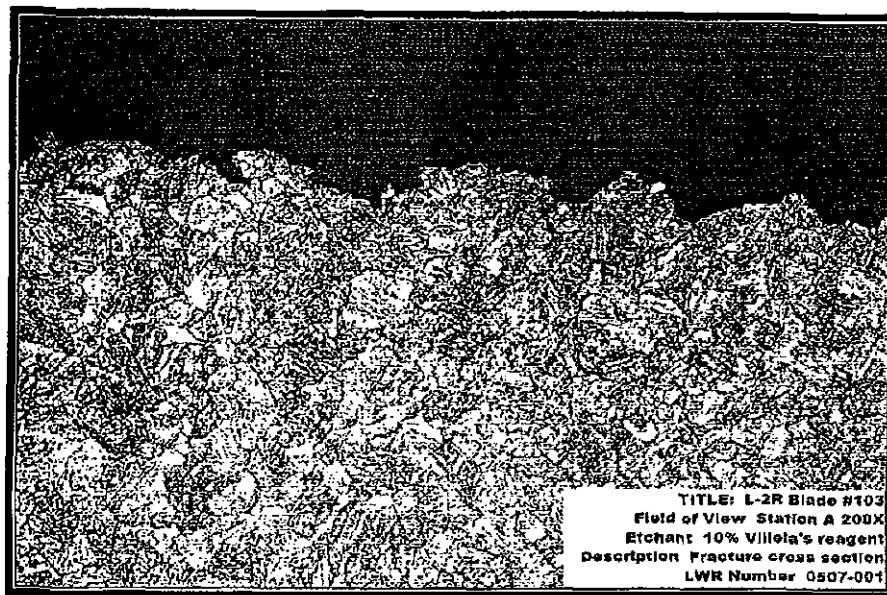
Figure 16: Photomicrograph of the cross section of the flat fracture surface of LP-B L-2 #103 blade. Microstructure indicates that the crack propagated in a transgranular fashion. The microstructure consists of tempered martensite.

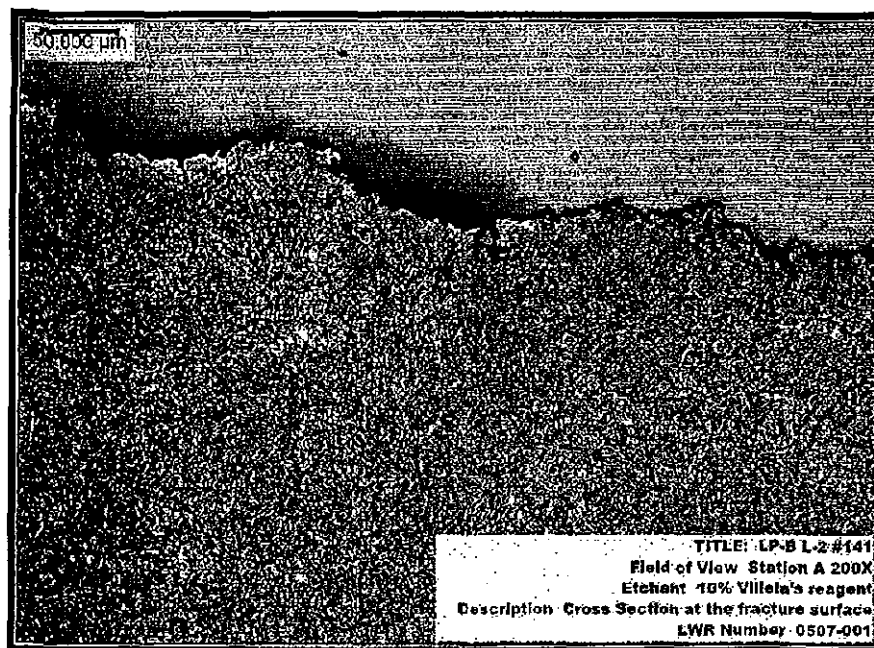
Figure 17: Photomicrograph of the cross section of the flat fracture surface of LP-B L-2 #141 blade. Microstructure indicates that the crack propagated in a transgranular fashion. The microstructure consists of tempered martensite and delta ferrite.
