Re: Case No 07-723-EL-UNC

MICHAEL L. HOFMANN

Subject: Evaluation of Failed Turbine Blades from Zimmer Station  
Metallurgy File #3791

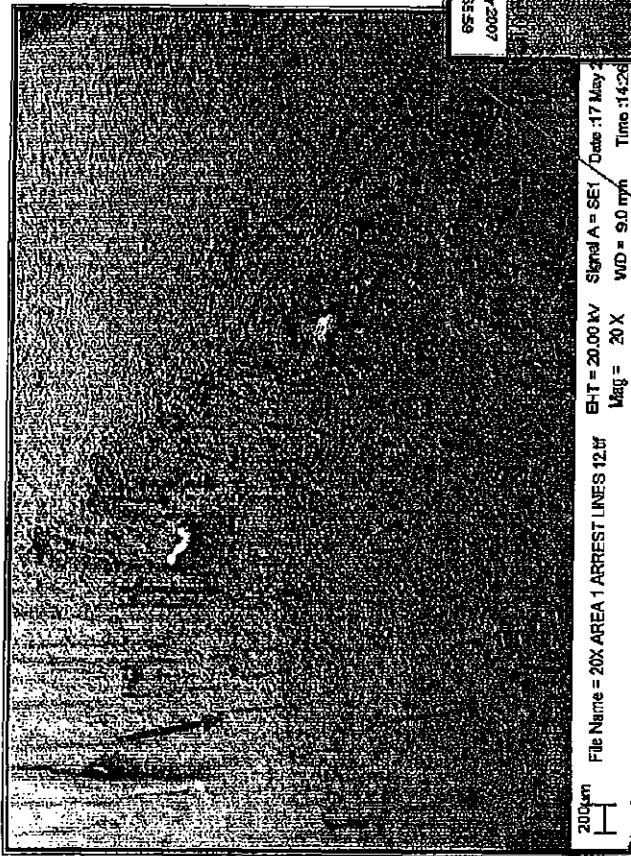
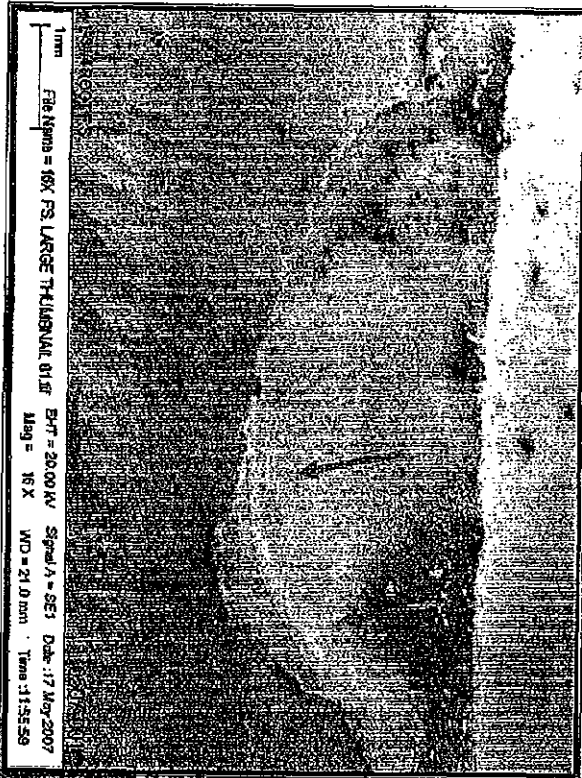
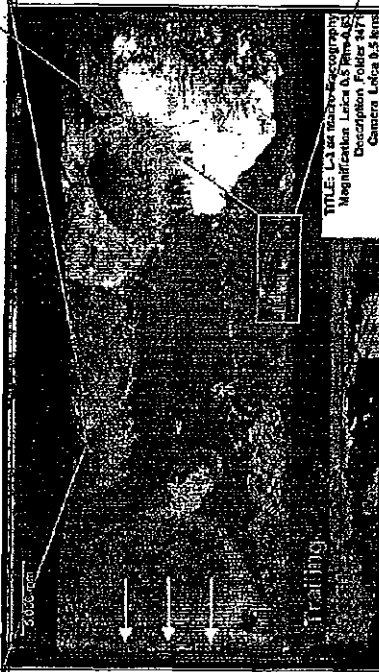
Figure 24: Macrograph of the upper half (tip side) of the L-3 #4 blade root after cleaning. SEM fractographs of the secondary cracks are shown taken at two different locations. Secondary cracks propagated in transcrystalline mode as shown by the red arrows. Beach / arrest marks (dashed red lines) can be seen consistent with fatigue fracture. Smooth thumb nail print area at the trailing edge indicates that primary crack originated at the at the trailing edge shown by yellow arrow and propagated towards leading edge as shown by blue arrow.

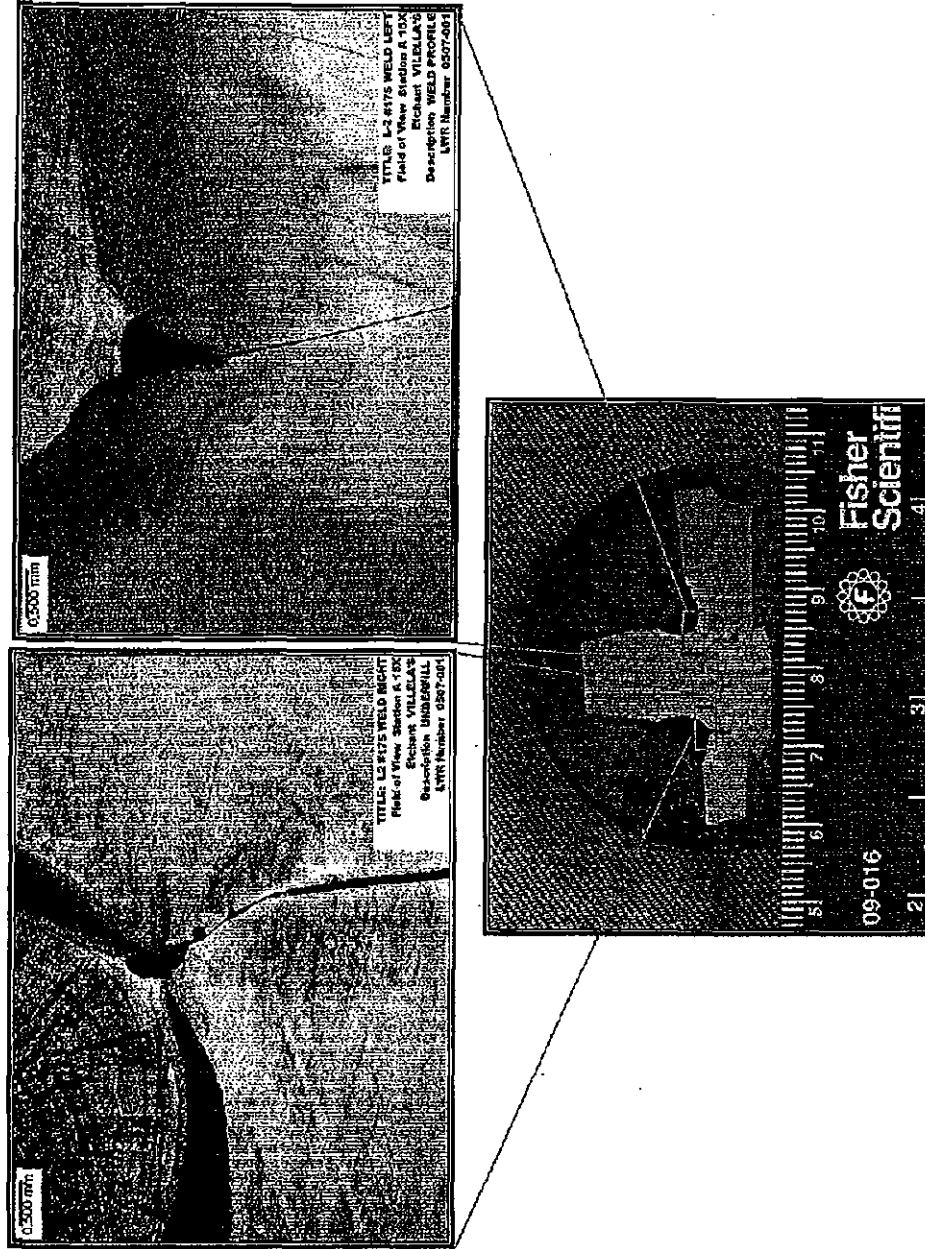
Figure 25: Micrographs of undershroud welding joint of LP-A L-2R #175 blade. Lack of penetration at the weld root was found on both sides of the blade.

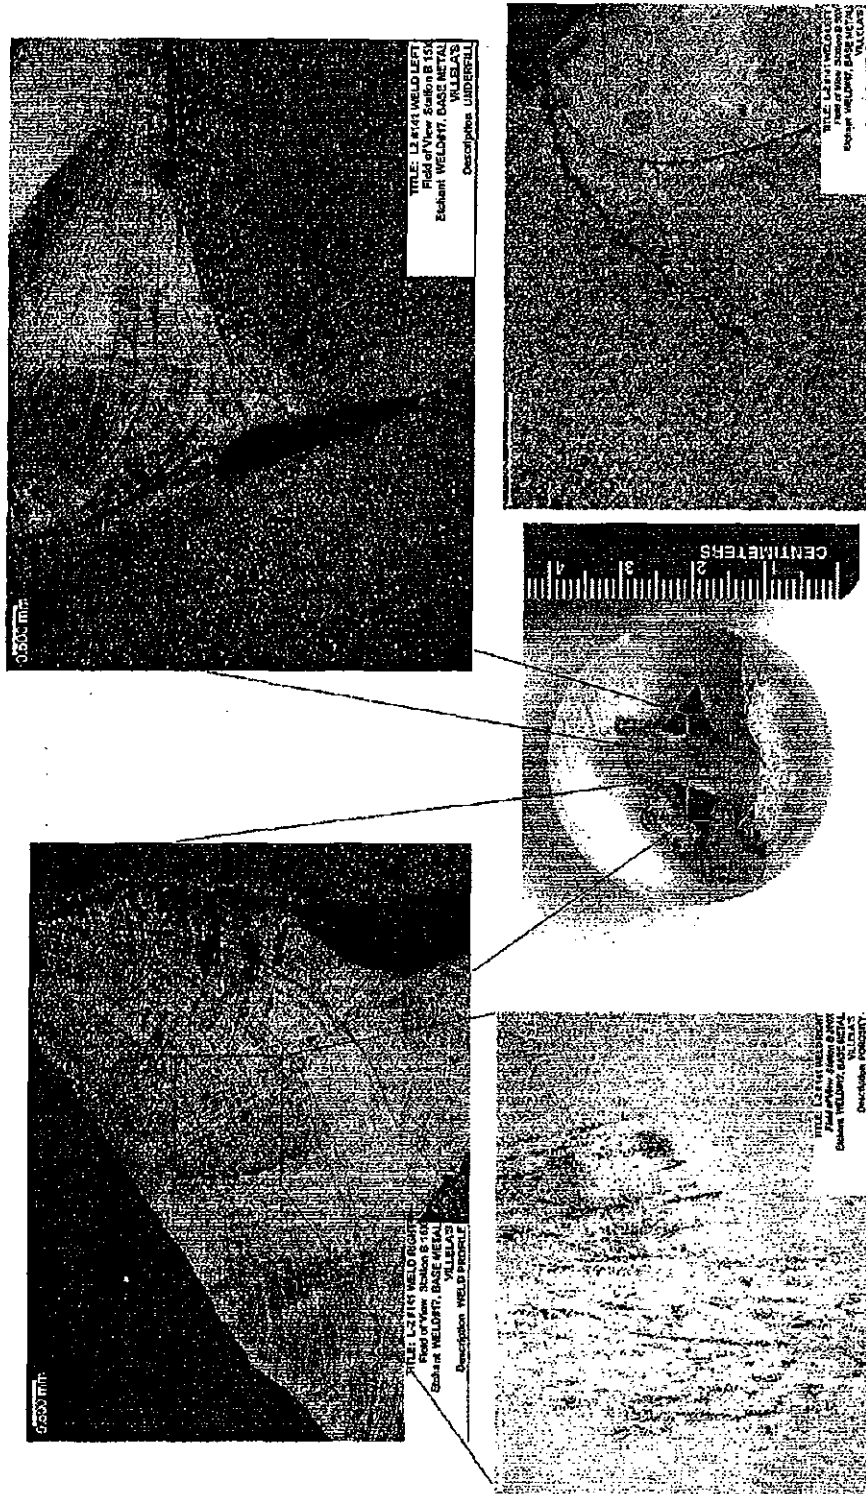
Figure 26: Micrographs of undershroud welding joint of LP-B L-2R #141 blade. Lack of penetration at the weld root was found on both sides of the blade. Shrinkage porosity was found in the left side weld and crack originating at the interface of fusion and heat affected zone was found in the right side weld. The crack propagated along the grain boundary.
