**BEFORE
THE PUBLIC UTILITIES COMMISSION OF OHIO**

In the Matter of the Application of Ohio)
American Water Company for Authority to)
Increase its Rates For Water and Sewer) Case No. 07-1112-WS-AIR
Service Provided to its Entire Service Area.)

**OHIO AMERICAN WATER COMPANY RESPONSE
TO
DOCUMENTS FILED BY STEVE KENNEDY, PRAIRIE TOWNSHIP TRUSTEE**

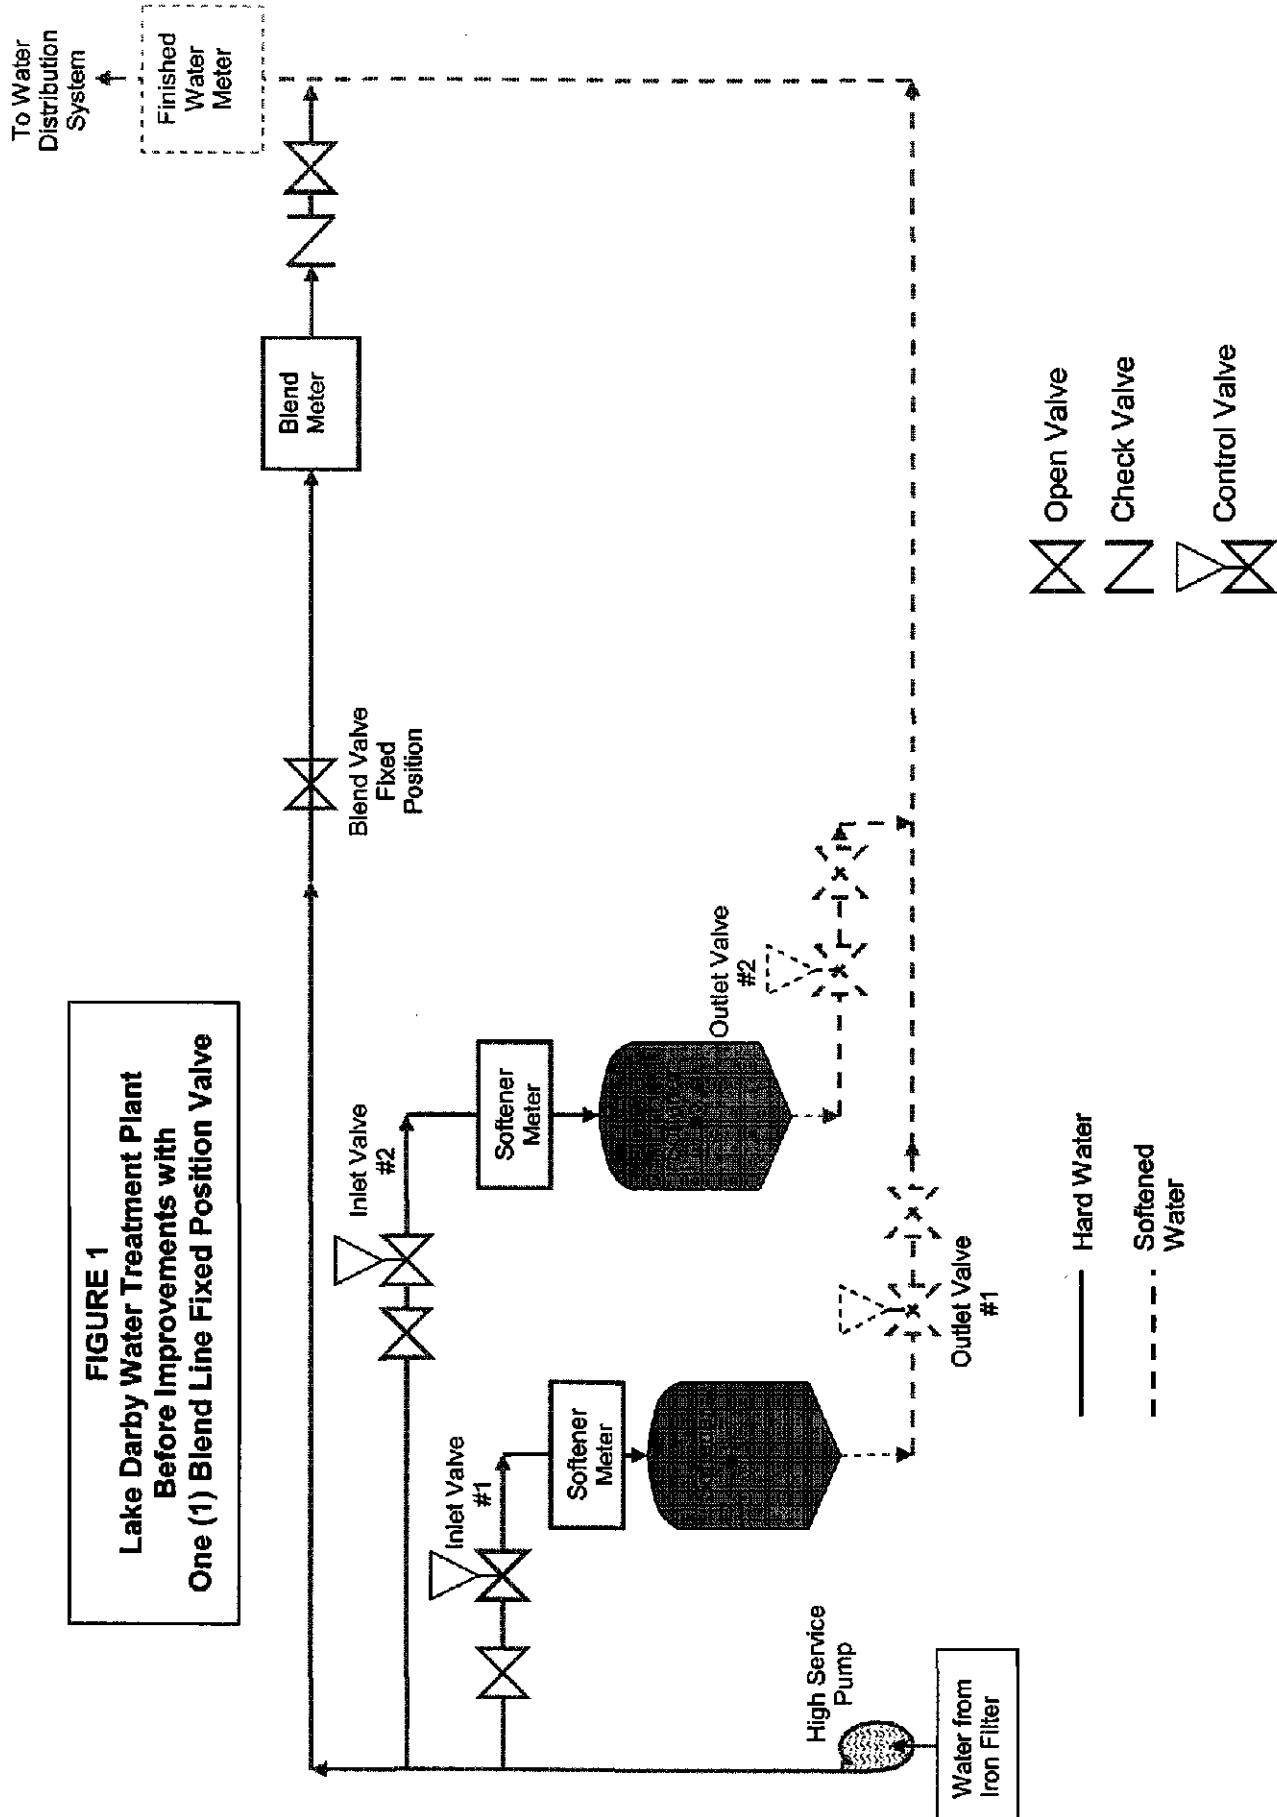
Moreover, in the original construction of the LDWTP 35 years ago, there was a single fixed position valve that established a hard water blend flow rate to generate a finished water hardness based on a formula that assumed both water softeners in operation. This same piping configuration was in place when Citizens Utilities Company of Ohio placed the water softening units into service in 1994, 14 years ago. Undoubtedly Ohio American personnel were the first managers since 1973 to evaluate the design and certainly they were the first to implement an improvement in the design of the LDWTP. Figure 1 shows the single blend control valve arrangement before the improvements were installed in January 2008 in response to the December 21, 2007 meeting and Mr. Kennedy's first letter.

When one softener is removed from operations for regeneration, the total soft water volume decreases. This causes the finished water hardness to temporarily increase because the blend volume was fixed based on a formula that contemplates two water softeners in operation. The data presented in Table I shows normal operations, while Table II shows the problem created with a single hard water blend line, as is the case with the LDWTP.

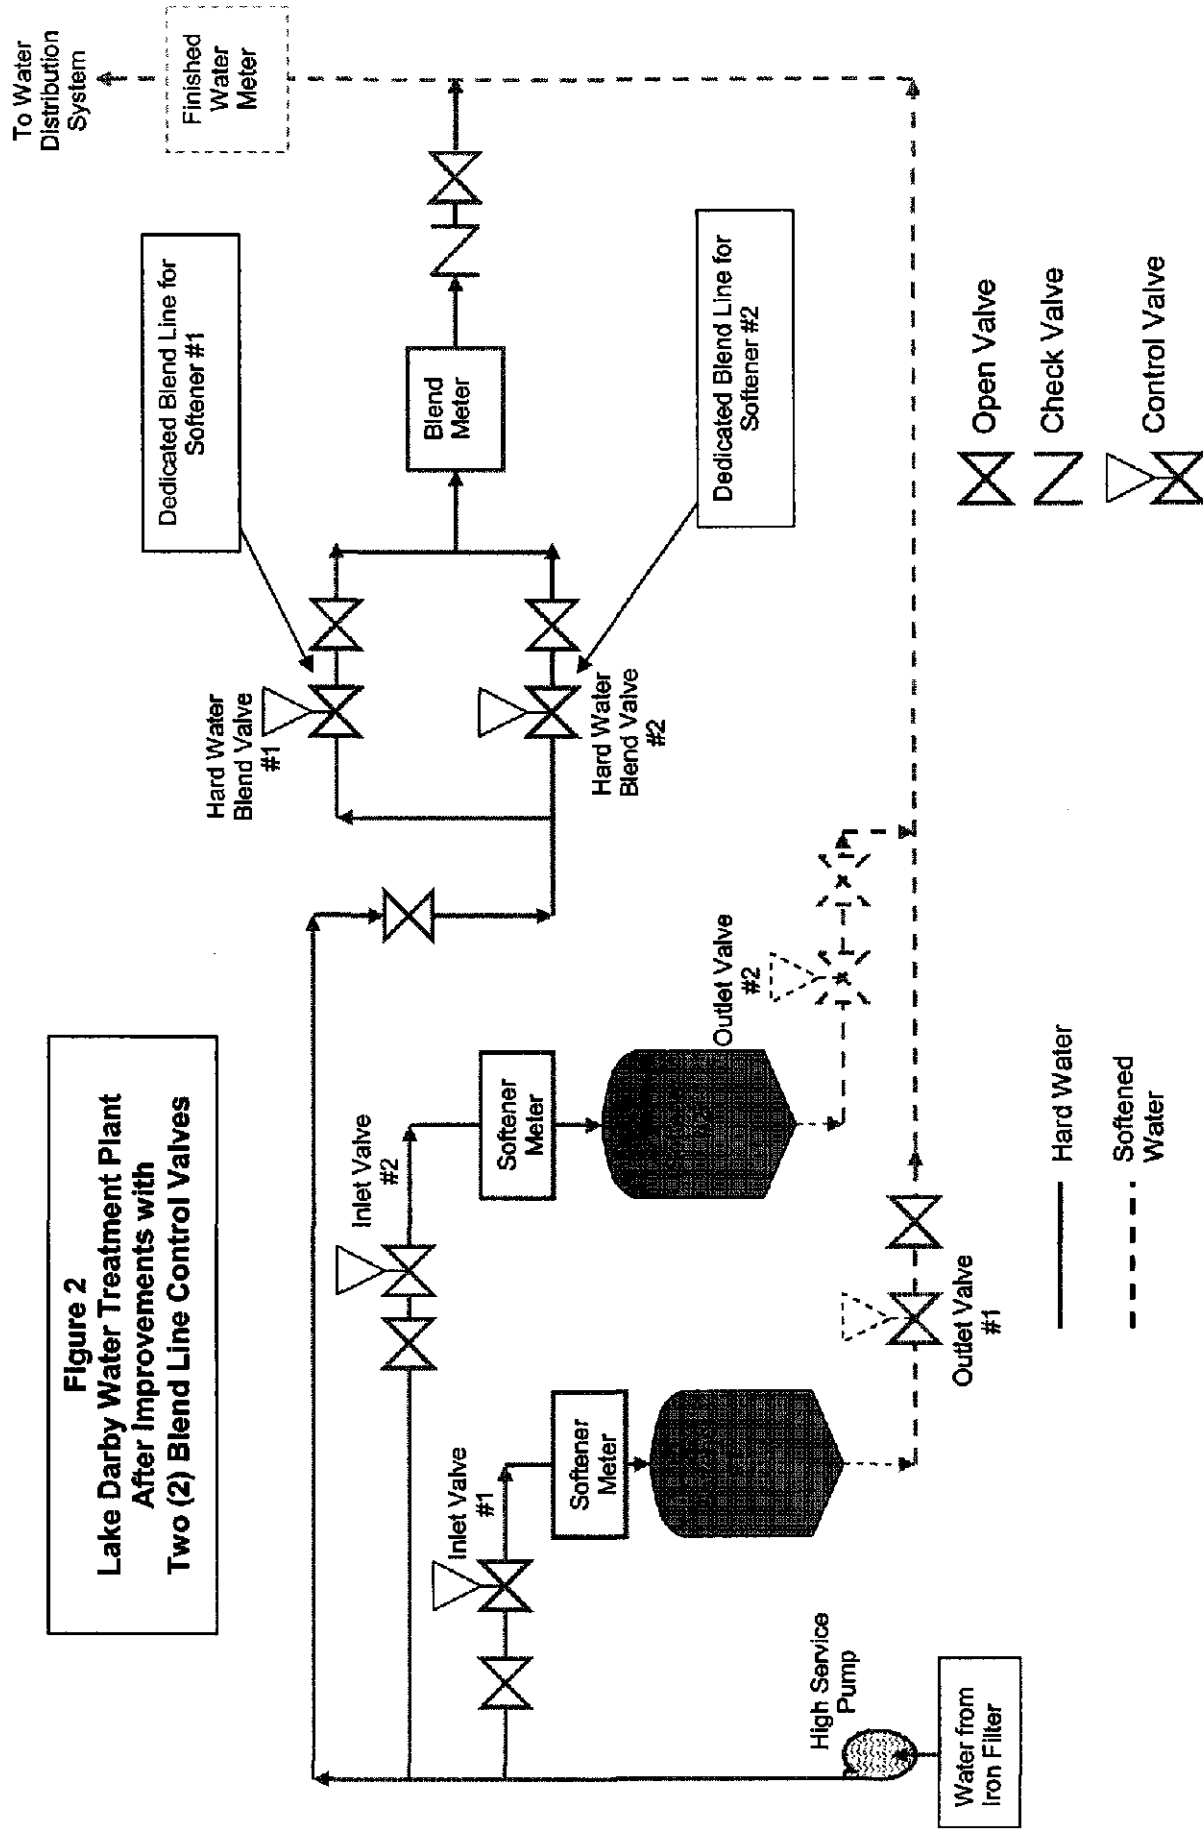
Figure 2
Lake Darby Water Treatment Plant
After Improvements with
Two (2) Blend Line Control Valves

Ohio American implemented the on/off flow control valve on a hard water blend line dedicated to a specific softener modification to address the issue. Figure 2 shows the two (2) hard water blend control valves and piping arrangement after the improvements were installed.

hard water blend lines, each with its own control valve whose operation is directly connected to its respective softener unit. The installation of these two new hard water blend lines was completed on January 24, 2008; the new lines and valves were placed into service on the next day, January 25th; and today the lines and valves are operational and are controlling the finished water hardness. Ohio American operational personnel continue to fine tune the adjustments of the control valves to hone in a stable hardness in the finished water in the 125 to 130 mg/L range.
