THE PUBLIC UTILITIES COMMISSION OF OHIO

DIRECT TESTIMONY OF

TIMOTHY J. THIEMANN

DUKE ENERGY OHIO, INC.

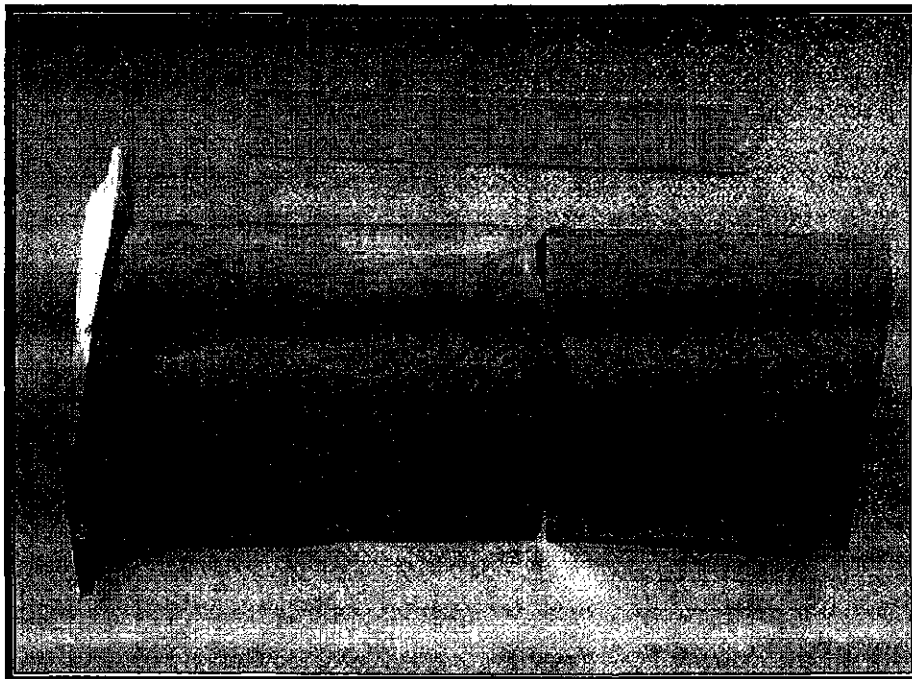
Figure 4: As received LP-A L-2 #175 blade convex side. Reddish brown deposit is seen on the convex side.

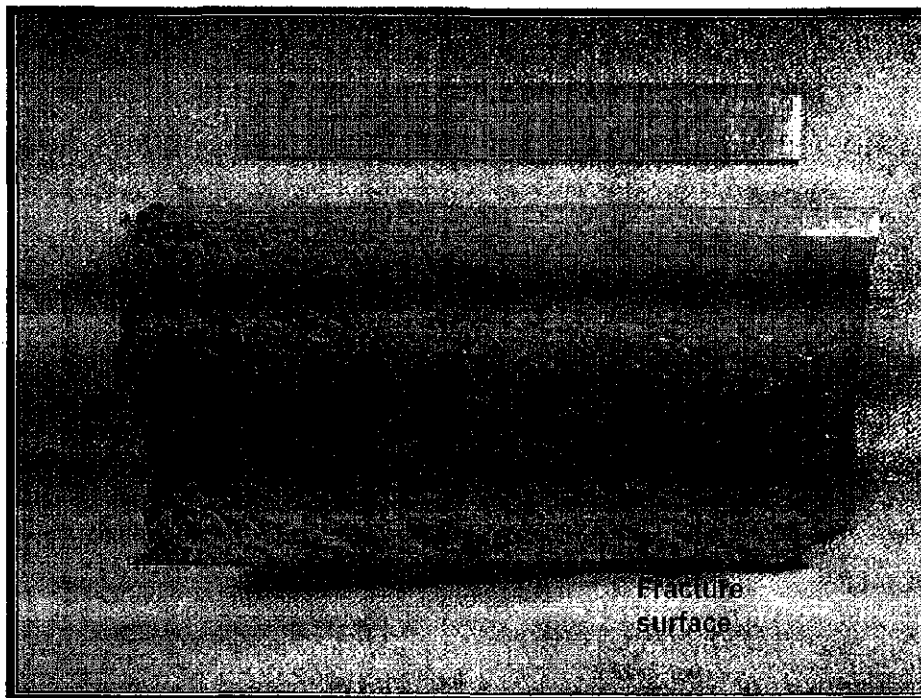
Figure 6: As received LP-B L-2 #103 blade convex side. Reddish brown deposit is seen on the convex side.

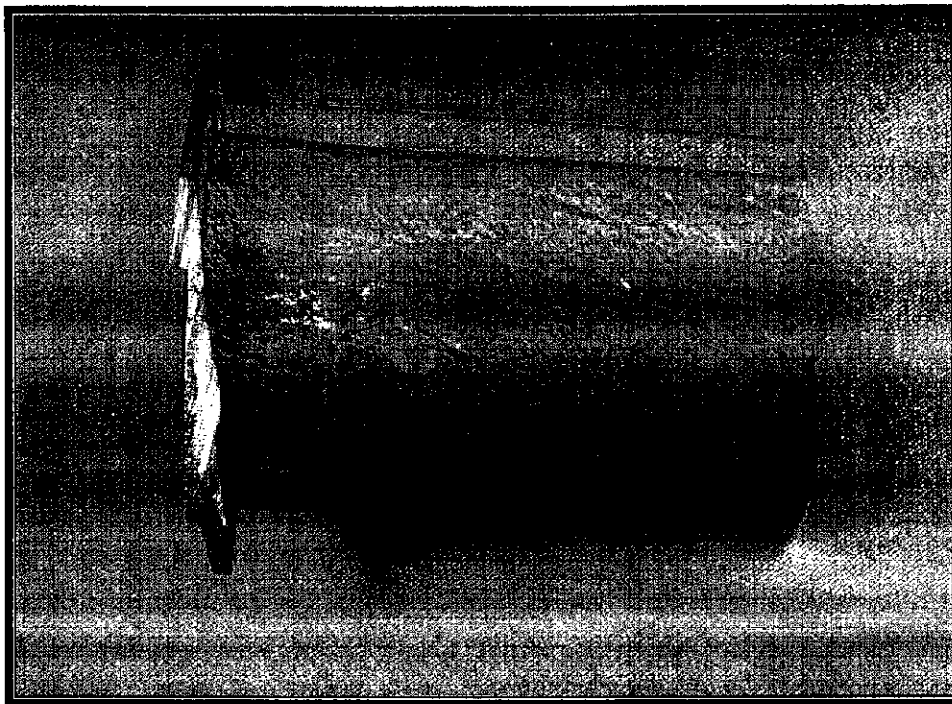
Figure 8: As received LP-B L-2 #141 blade convex side. Reddish brown deposit is seen on the convex side.

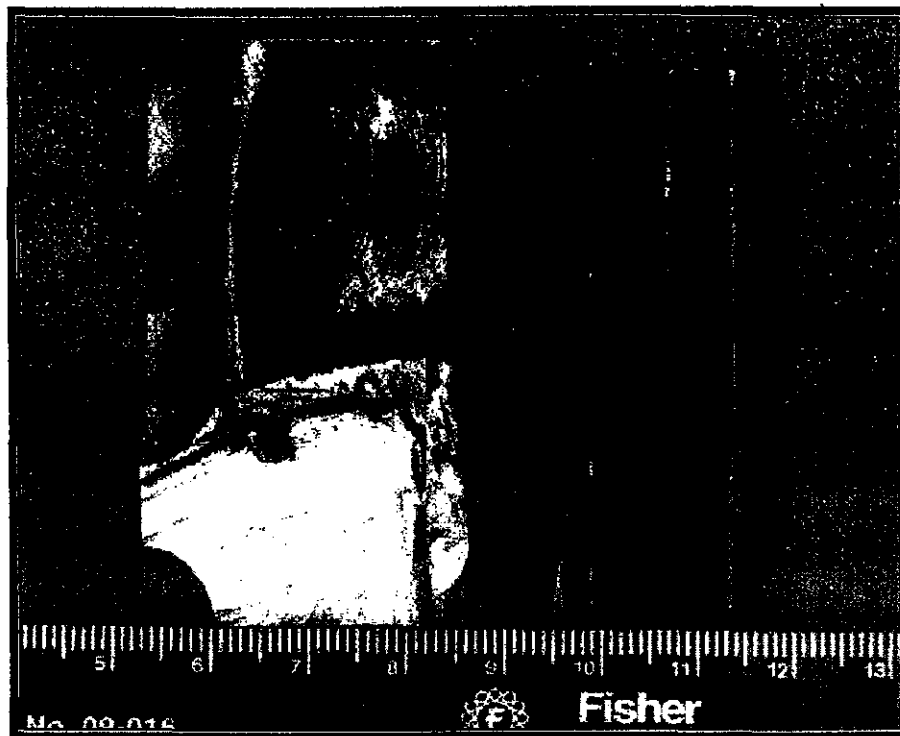
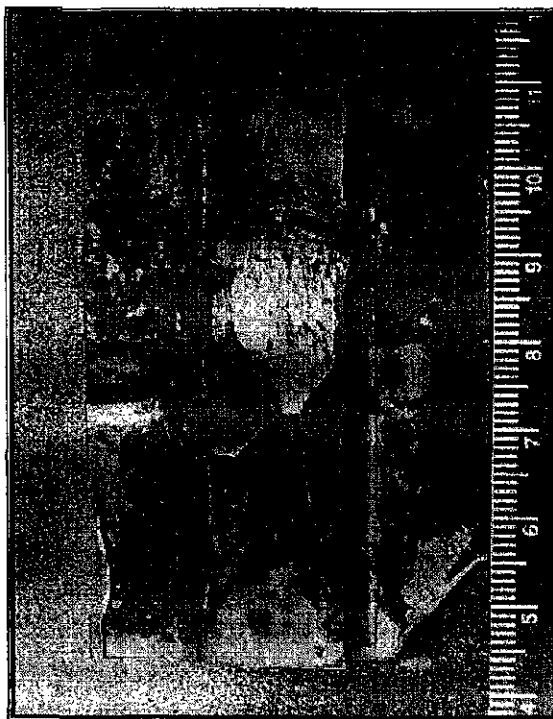
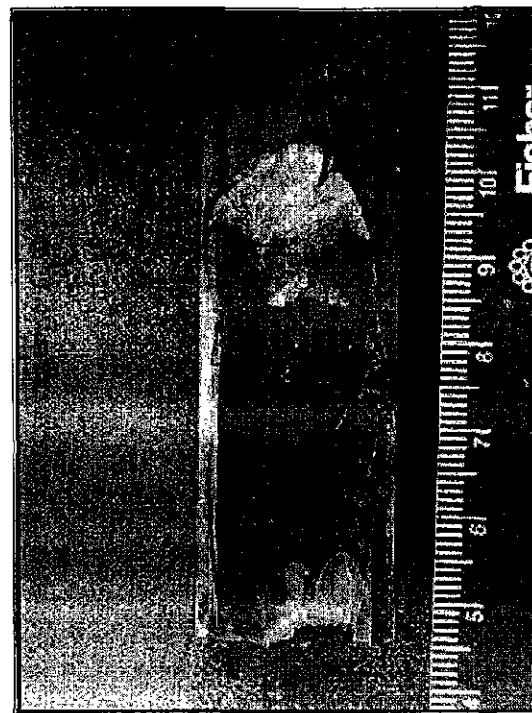
Figure 9: As received LP-A L-3 #4 blade cracked in the root. Fracture surface is covered by reddish brown oxide deposits.

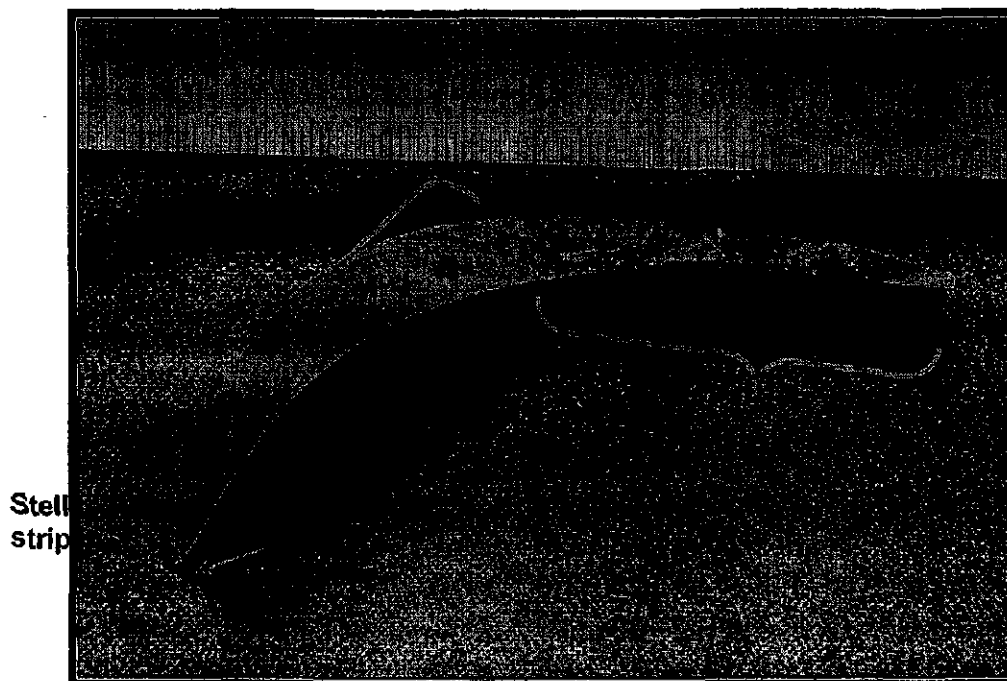
Figure 11: Macro photograph of fracture surface of LP-A L-2 #175 blade. Fracture surface was cleaned to remove thick oxide deposit. Flat fracture surface can be seen from the leading edge continuing into a fracture surface due to overload towards the trailing edge

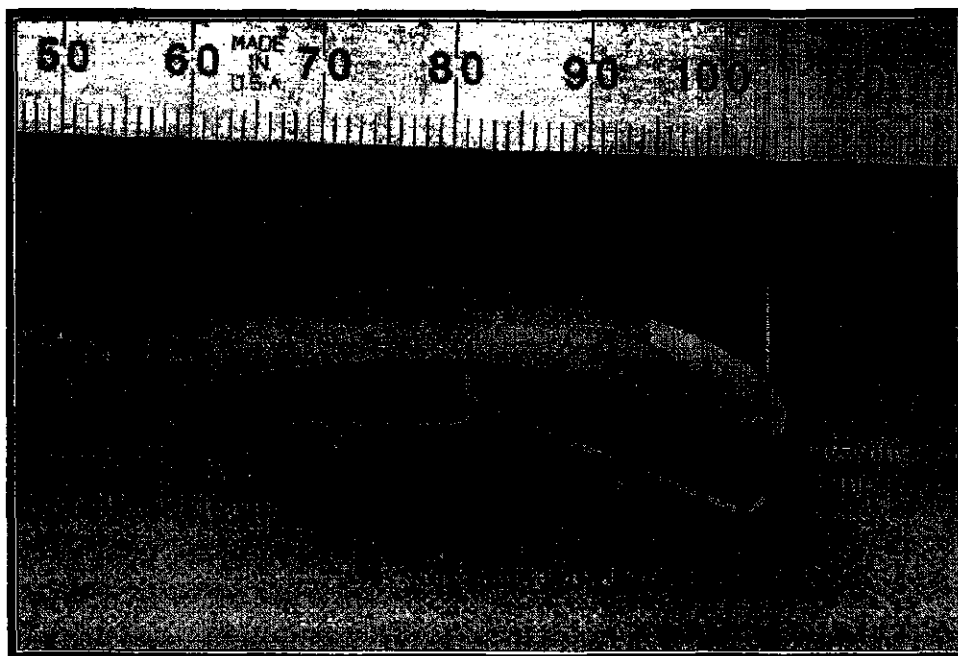
Figure 13: Macro photograph of fracture surface of LP-B L-2 #141 blade after opening the crack. Fracture surface was cleaned to remove thick oxide deposit. Flat fracture surface can be seen from the leading edge continuing into a fracture surface due to overload towards the trailing edge.

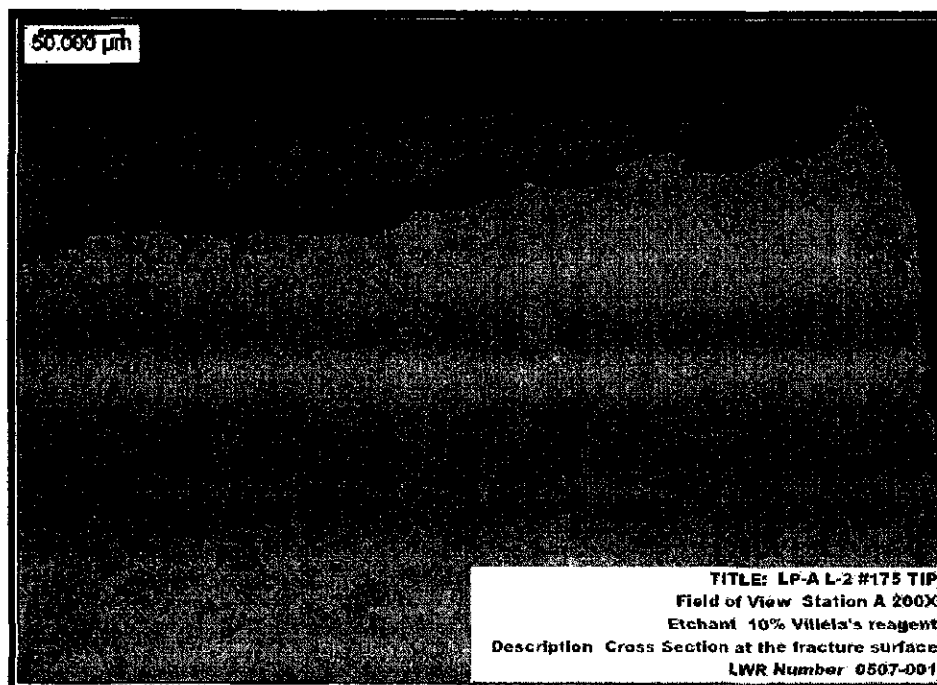
Figure 15: Photomicrograph of the cross section of the flat fracture surface of LP-A L-2 #175 blade. Microstructure indicates that the crack propagated in a transgranular fashion. The microstructure consists of tempered martensite.

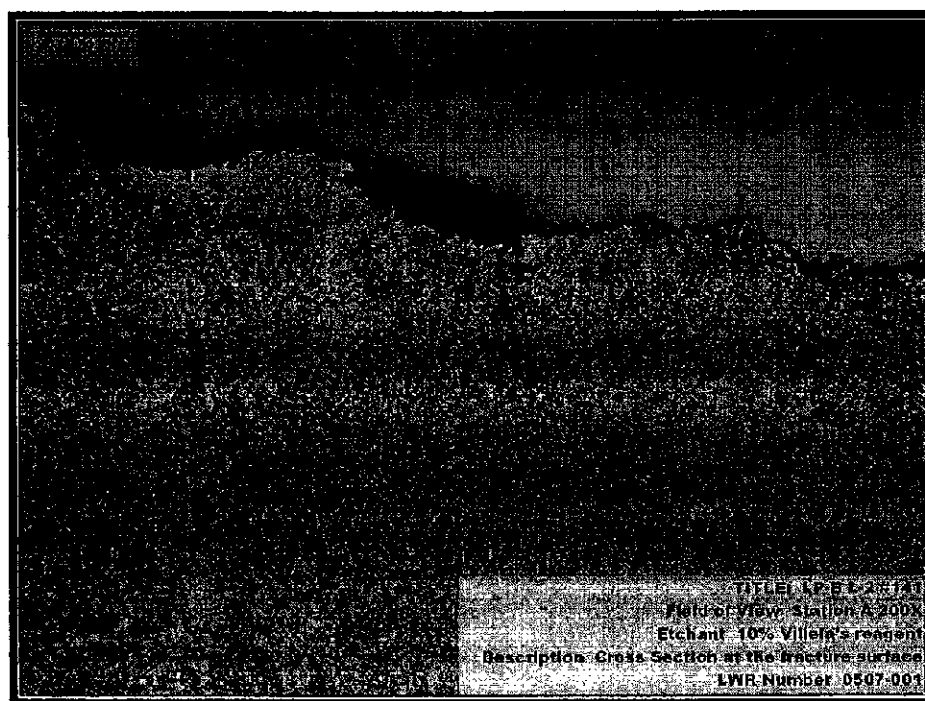
Figure 17: Photomicrograph of the cross section of the flat fracture surface of LP-B L-2 #141 blade. Microstructure indicates that the crack propagated in a transgranular fashion. The microstructure consists of tempered martensite and delta ferrite.

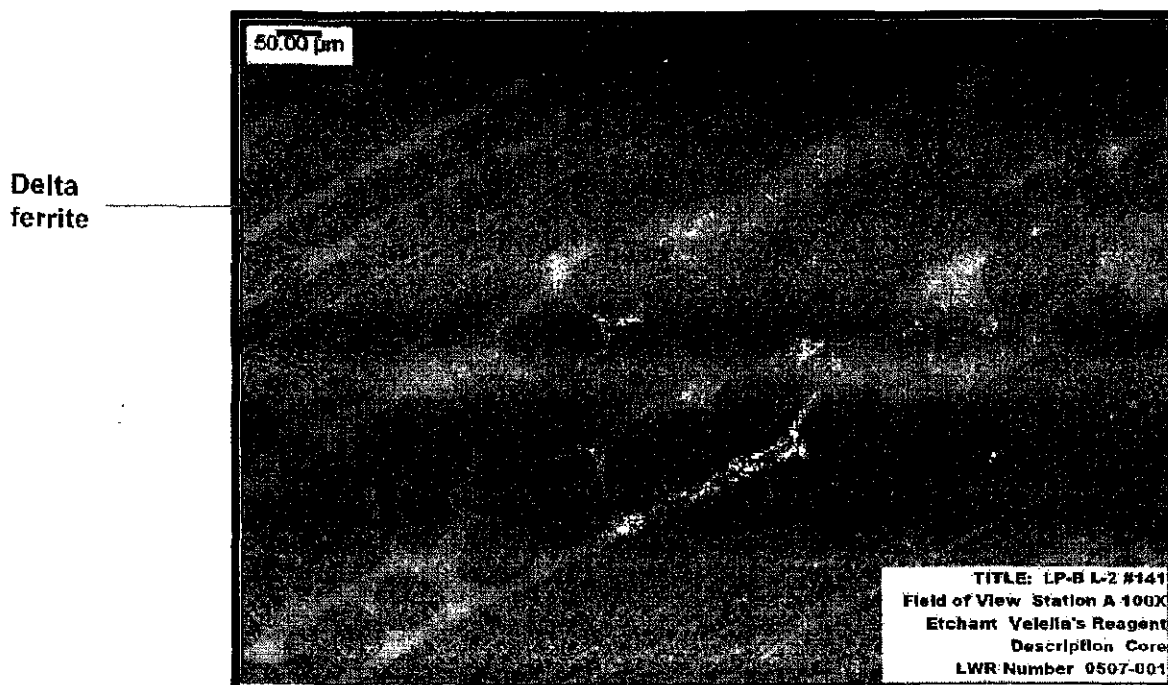
Figure 21: Photomicrograph of the core of LP-B L-2R #141 blade. The microstructure consists of tempered martensite and delta ferrite (~15%).

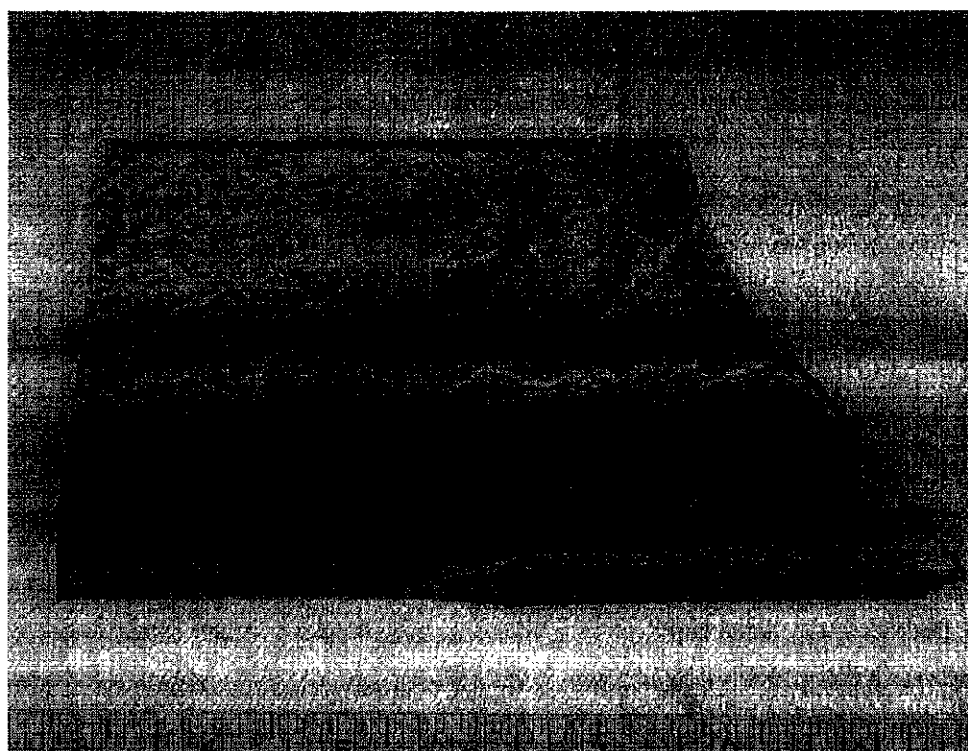
Macro-06

Figure: 2 LPA blade 58, start of group.

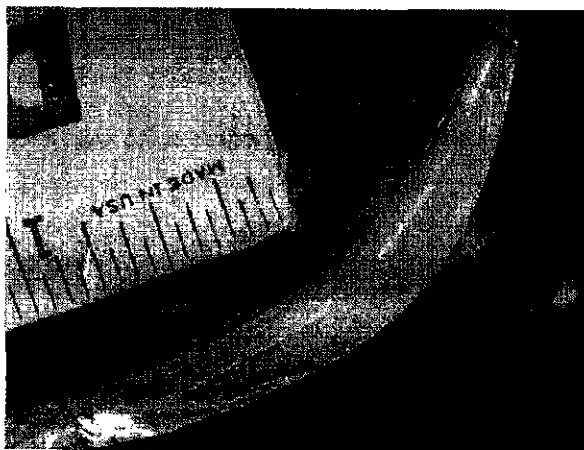
Macro-12
Macro-14

Figure: 6 Fracture surfaces from LPA-115 (left) and LPA-58 blades that were broken as received in laboratory.

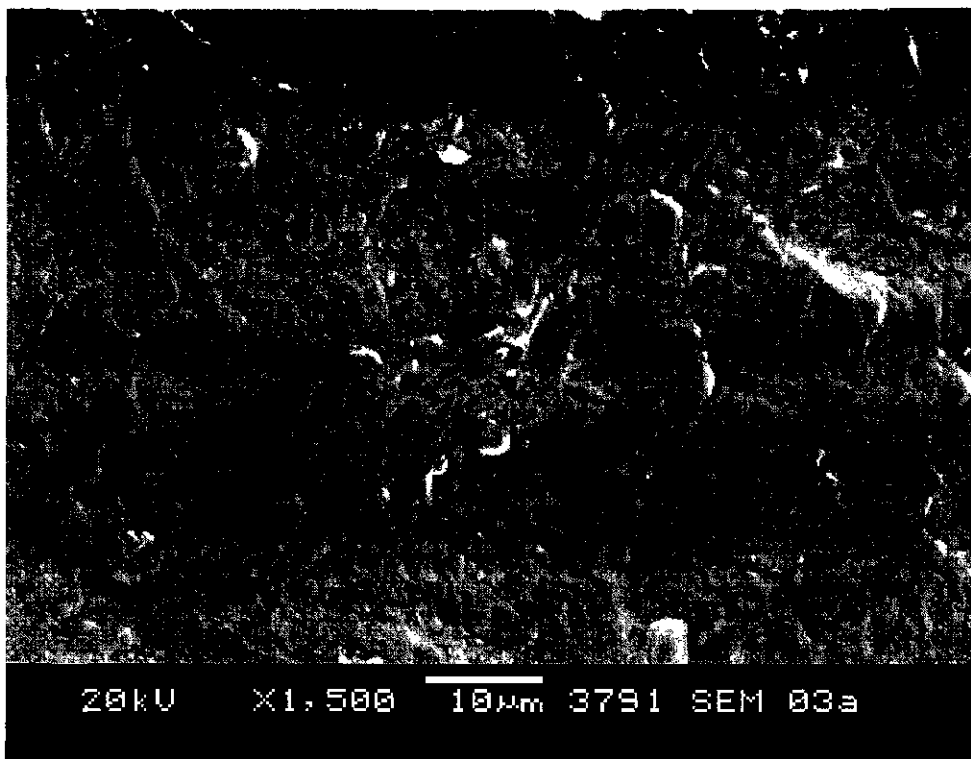
SEM-3a
SEI

Figure: 8 SEM micrograph of fracture face near leading edge of blade from LPA. Features are characteristic of striated fatigue.

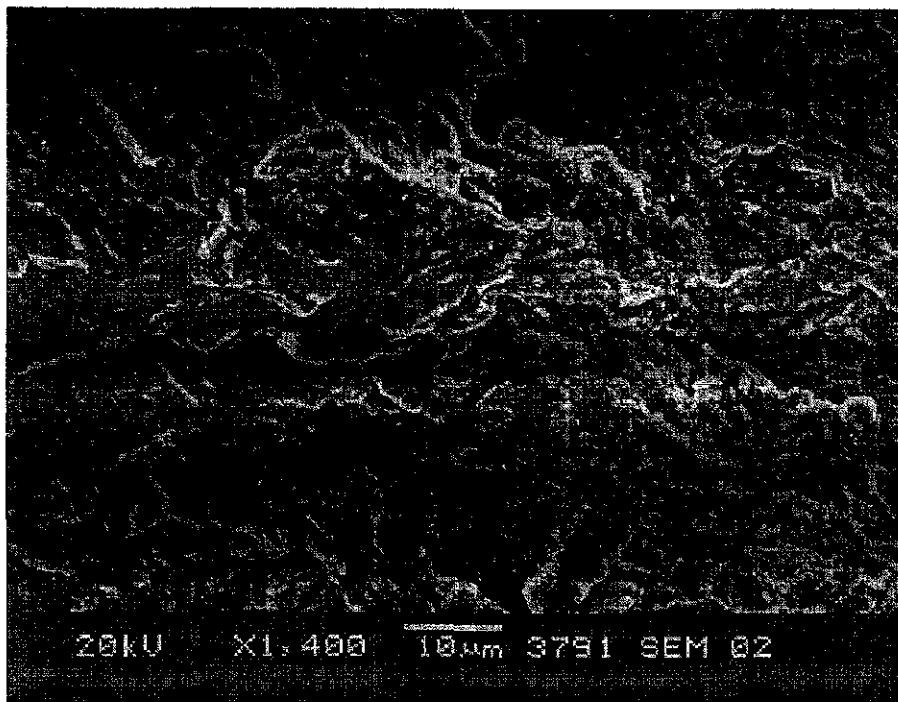
SEM-02
SEI

Figure: 10 SEM micrograph of opened crack near leading edge of blade from LPB. Features are characteristic of striated fatigue.

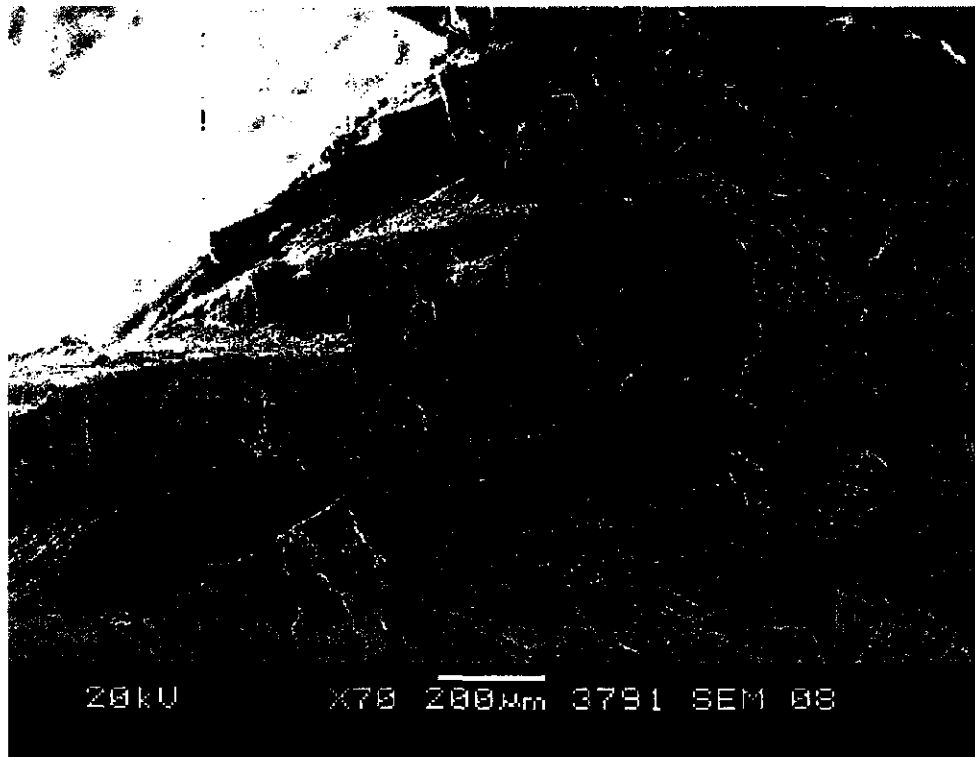
SEM-08
SEI

Figure: 11 Fracture produced in lab by opening crack in tenon. Note secondary cracking at top edge of picture

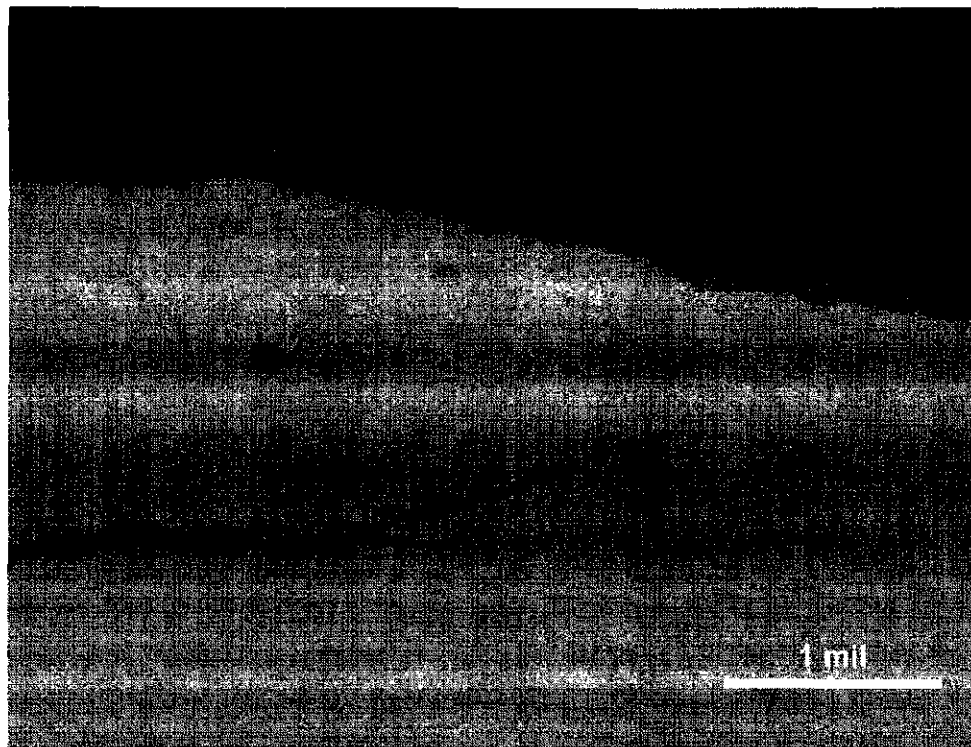
Micro-01a
Vilela's etch

Figure: 12 Transverse cross section through crack in LPB blade (axis of blade runs into paper). Cracking is mixed transgranular and intergranular.

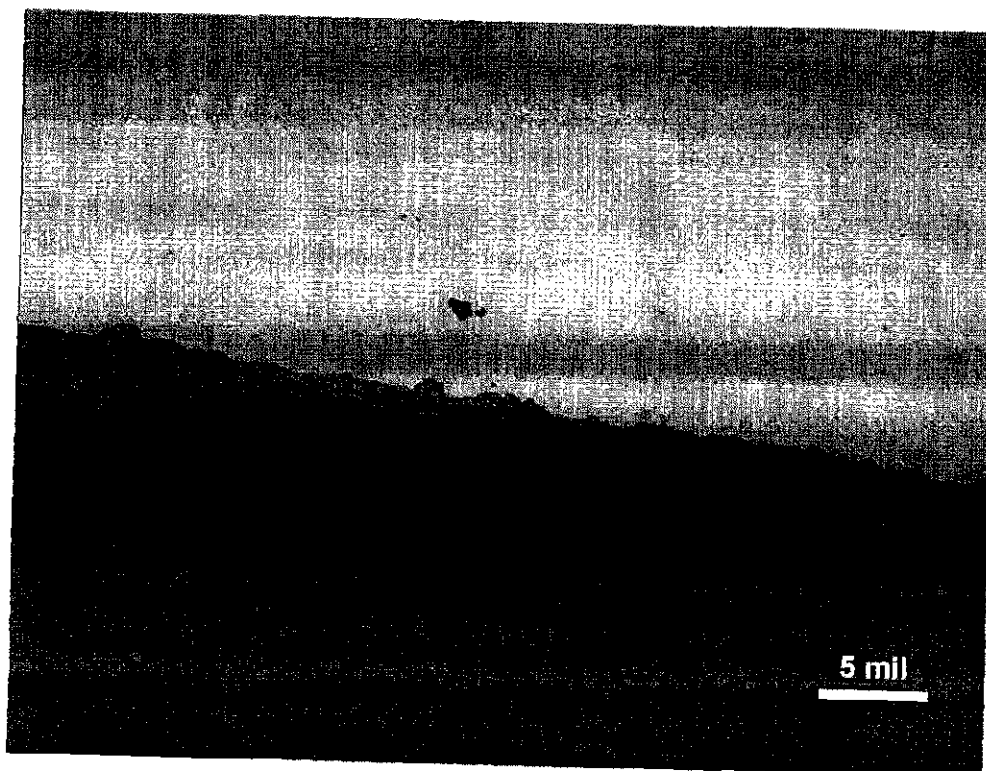
Micro-04
Unetched

Figure: 14 Cross section through typical deposit on convex face.
Note copper association with pits.

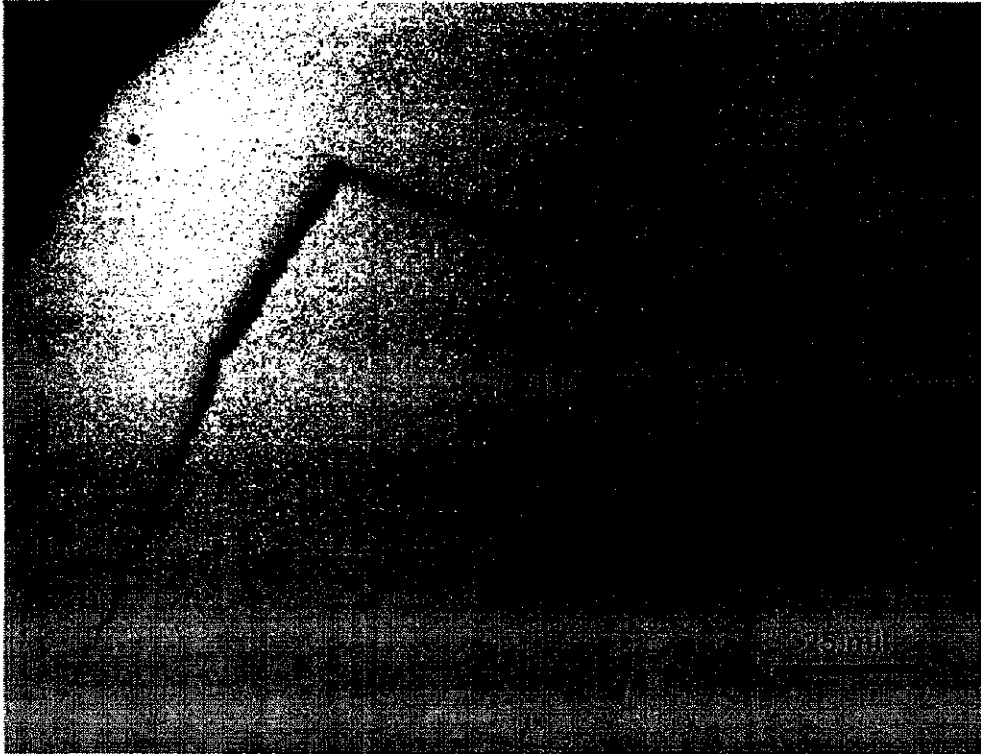
Micro-09
Unetched

Figure: 15 Section through crack in tenon. Axis of tenon is parallel to crack. Peened head is at upper left.

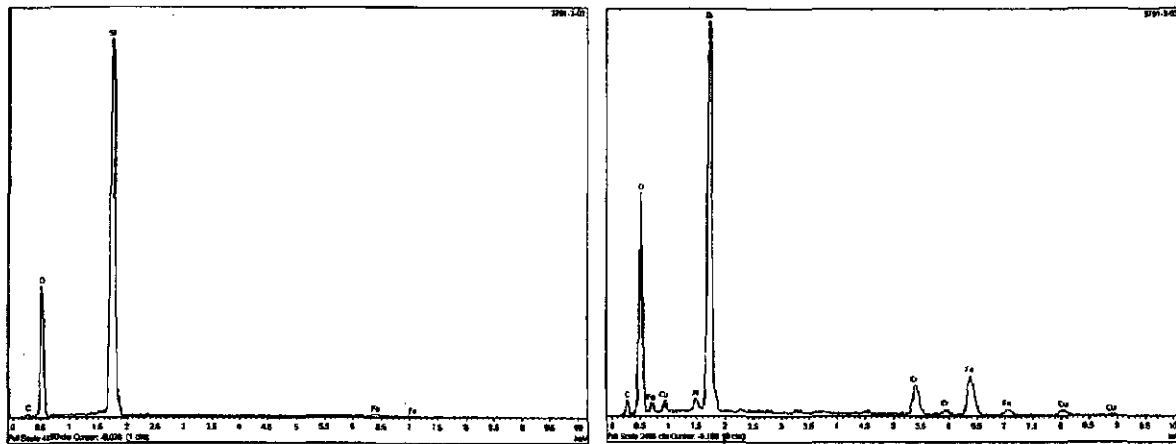
3791-3-02
3791-3-03

Figure: 18 EDS spectra of particles at left and bottom of Figure 13. Composition variation is typical from particle to particle.

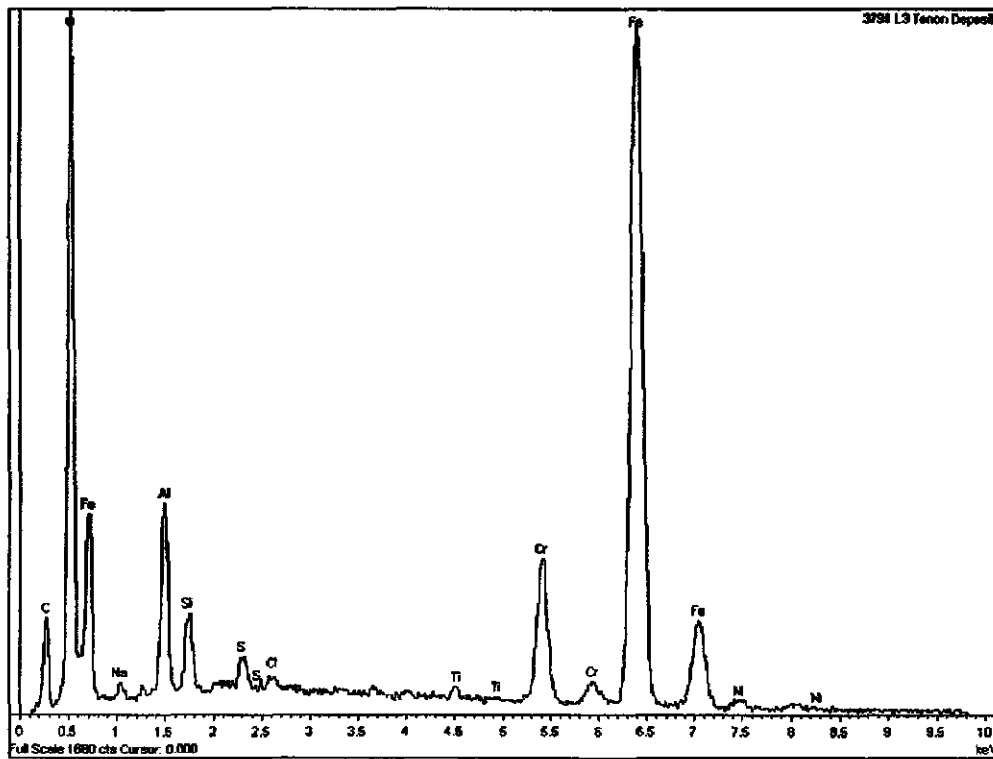
3791-L3

Figure: 19 EDS spectrum of material in L-3 tenon crevice.
