BEFORE THE OHIO POWER SITING BOARD

**In the Matter of the Application
of Champaign Wind LLC for a
Certificate to Install Electricity
Generating Wind Turbines in
Champaign County**

**MEMORANDUM OF INTERVENORS UNION NEIGHBORS UNITED, INC.,
JULIE JOHNSON, AND ROBERT AND DIANE McCONNELL IN OPPOSITION
TO THE MOTIONS OF EDP RENEWABLES NORTH AMERICA LLC,
GAMESA WIND US, LLC, INVENERGY LLC, AND CHAMPAIGN WIND
LLC TO QUASH THE BOARD’S SUBPOENAS DUCES TECUM**

RE: April 24, 2012 Turbine Failure at Timber Road II Wind Farm ("Timber Road II")

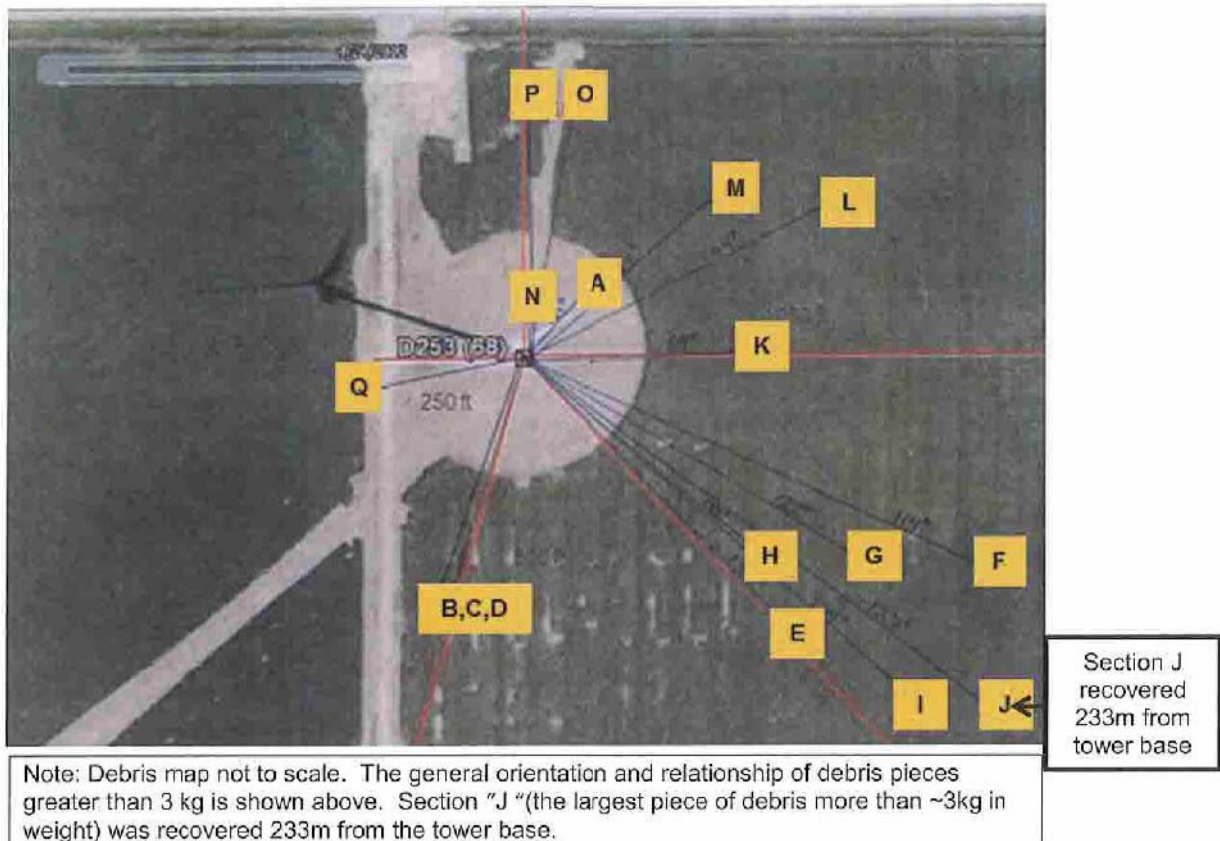
Blade Damage Summary— Turbine Serial Number 134099

Four Vestas engineers (two from Vestas American Wind Technology, Inc.'s Portland, Oregon Headquarters, and two from the Vestas Blades America, Inc. manufacturing facility) arrived on site by Thursday, April 26th, to complete and review visual inspection results. After visual inspection, the remaining, intact blade of the Turbine was determined to have incurred structural damage and require replacement. By Monday, April 30th, the Vestas engineers had visually inspected all other blades at the wind farm using high resolution spotting scopes and digital cameras, reviewed the inspection results, and formally approved 53 of the 54 remaining blade sets to return to service. Vestas found damage to one blade that is unrelated to the incident, and which has since been repaired.

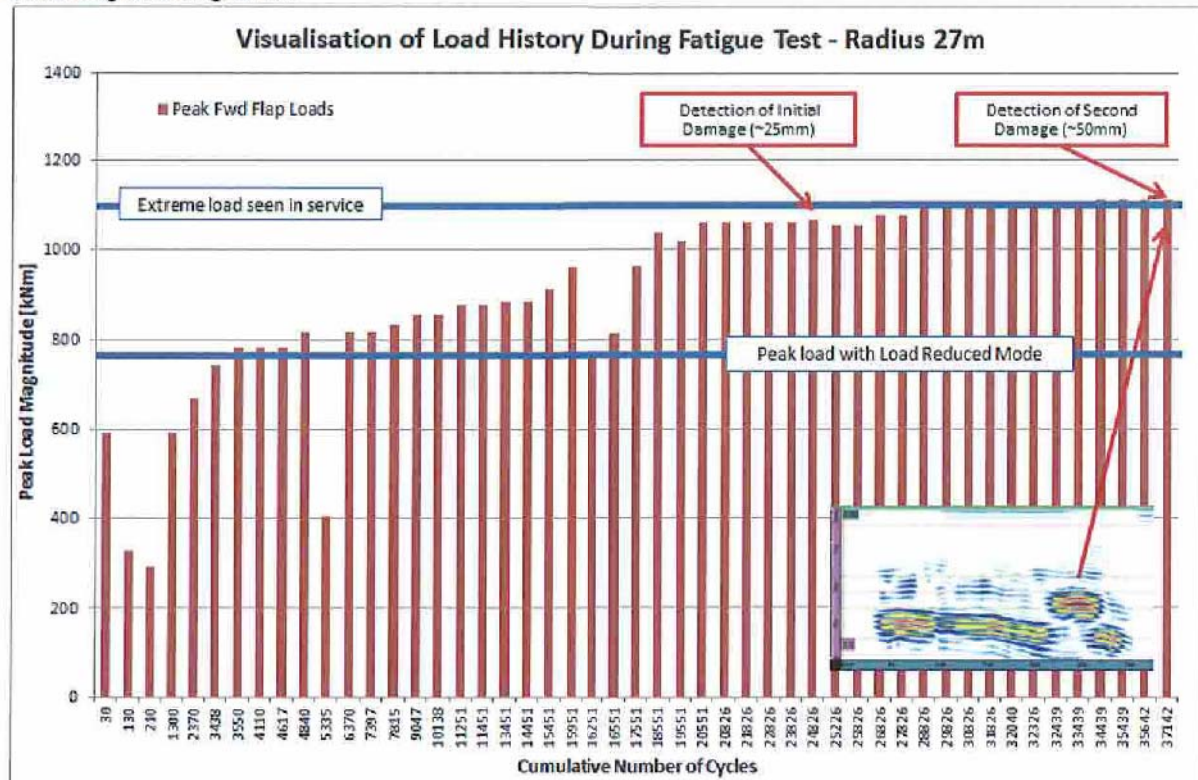
Figure 1 – Blade A, taken from blade production with no operation. Damage was introduced through increasing cyclic loading. An ultrasound scan, the inserted picture on bottom of the diagram, confirmed the damage in the blade.

Figure 1 shows the number of cycles the blade was tested at specific peak load magnitudes. The magnitude of the loading on the blade was increased over time. Damage was first detected when loading was over 95% of the extreme loading. The graph in figure 1 also shows the corresponding levels that would be experienced if load reduced mode had been applied.

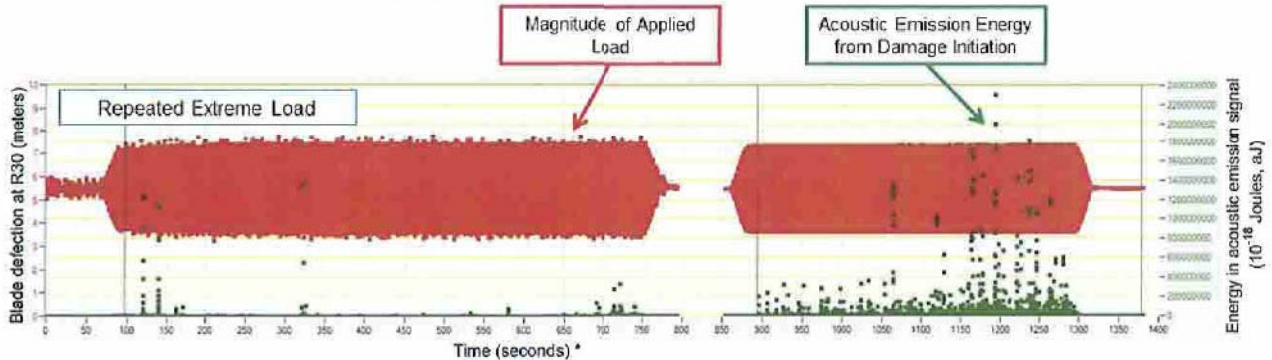
Figure 2 – Blade B was repeatedly loaded at extreme loads until damage occurred.

The blade was repeatedly loaded at extreme loads until damage occurred. The damage was detected and monitored by acoustic emission. The damage was also confirmed by ultrasound testing.

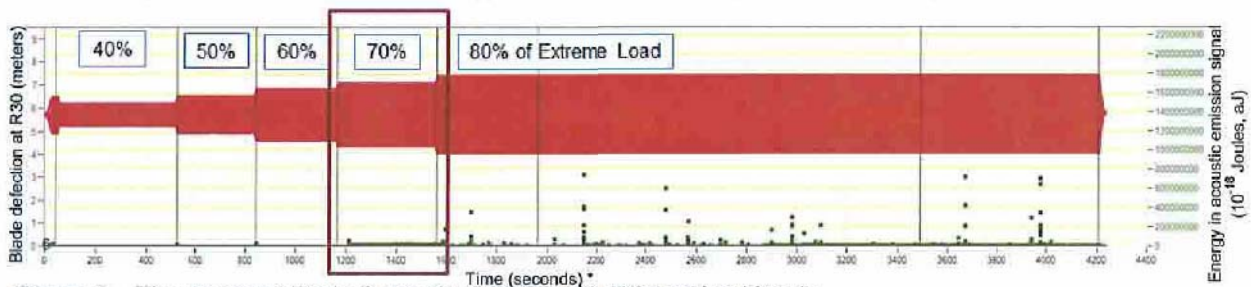
Figure 3 – The damaged Blade B was then cycled with different load levels

Blade loading was then progressively increased from the 40% to the 80% load level. Comparison of the green dots, representing the acoustic emission energy, indicates when the damage was stable and when it propagated. At 70% of the extreme load, no significant additional damage can be seen. At the 80% level, the damage increases.

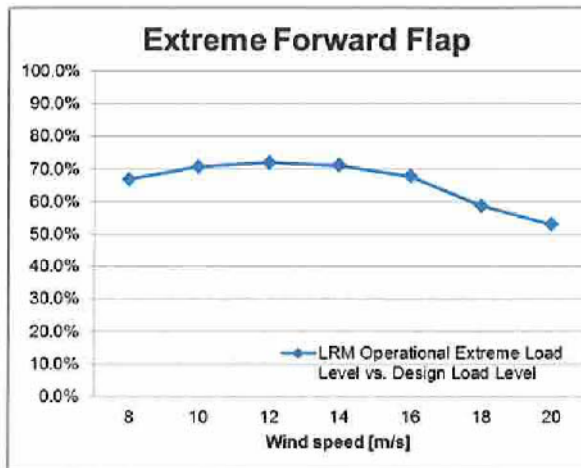
Figure 4 – Comparison of LRM operational extreme load level vs. design load level

The reduction in extreme forward flap loads compared to the wind speed is shown in figure 4. This diagram shows that the loading on the blades is reduced for all wind speeds. Similarly, the reduction in extreme forward flap loads compared to the position of the blade is shown in figure 5.

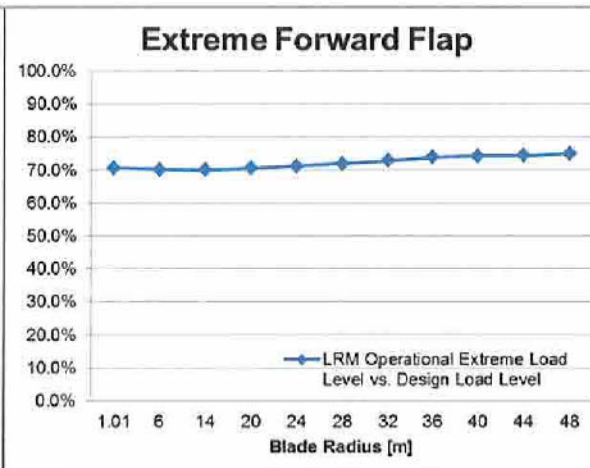
Figure 5 – Reduction in blade loading along the blade

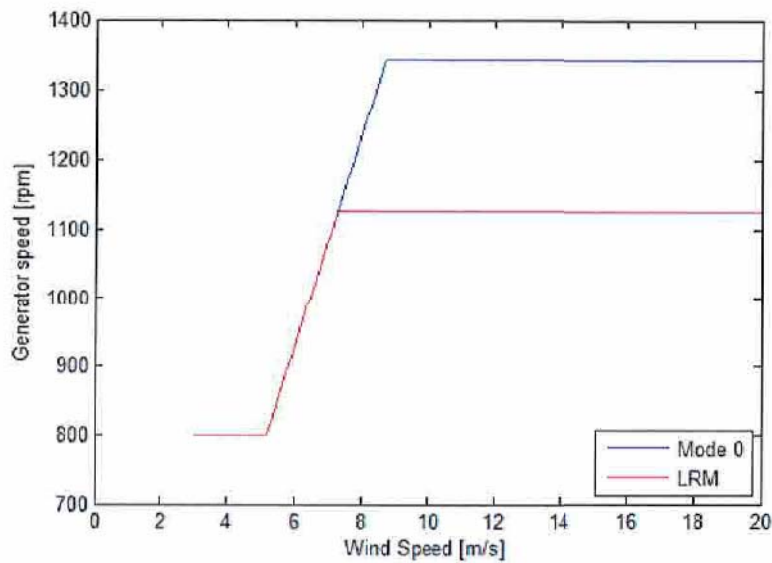
Figure 6 – Comparison of generator speed for design and LRM operation

The effect of the LRM can be seen through the characteristic change in the Generator speed for wind speeds above 10 m/s.

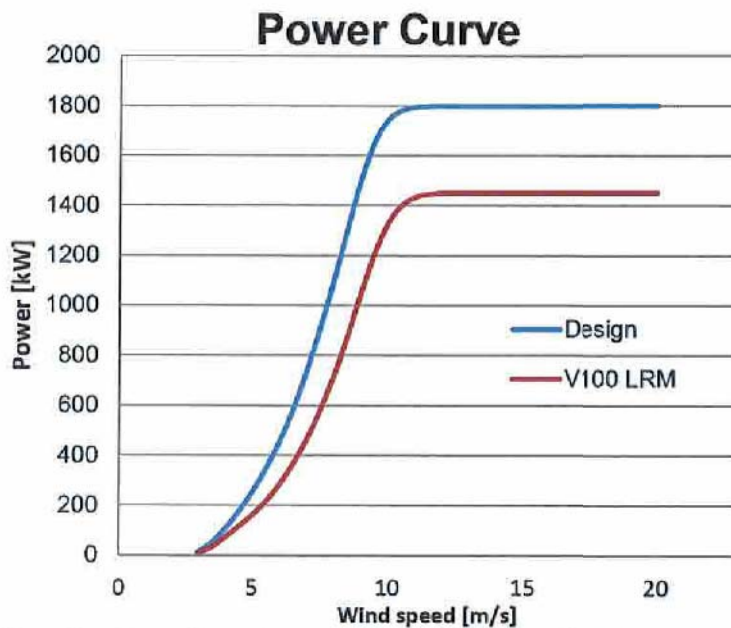
Figure 7 – Comparison of power curve for design and LRM operation

Since the LRM has an altered operational strategy, this also has an effect on the power curve as seen in Figure 7. When operating at full speed, the LRM has a reduced power output compared to the design operation.

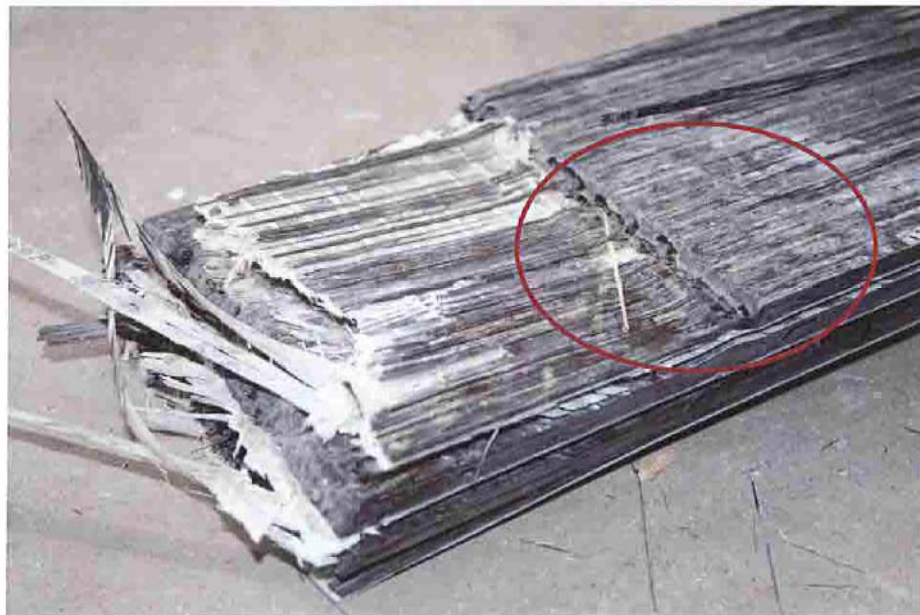
Vestas has concluded that the root cause of the failure of the initial blade was due to a wrinkle in the carbon fiber of the spar (the support structure of the blade). This wrinkle caused damage to propagate to the point of failure after the blade experienced high loads for a low number of cycles. Vestas has also concluded the second blade failure was the direct result of an overload caused by failure of the first blade. In other words, had the first blade not failed the second blade would not have failed. A more detailed description of the RCA can be found in the attached document titled "Root Cause Report".

*Image 1 – Tip section of blade A WW side. Outer slab topmost.
Red circle indicates wrinkle, see Image 2 for more
details*

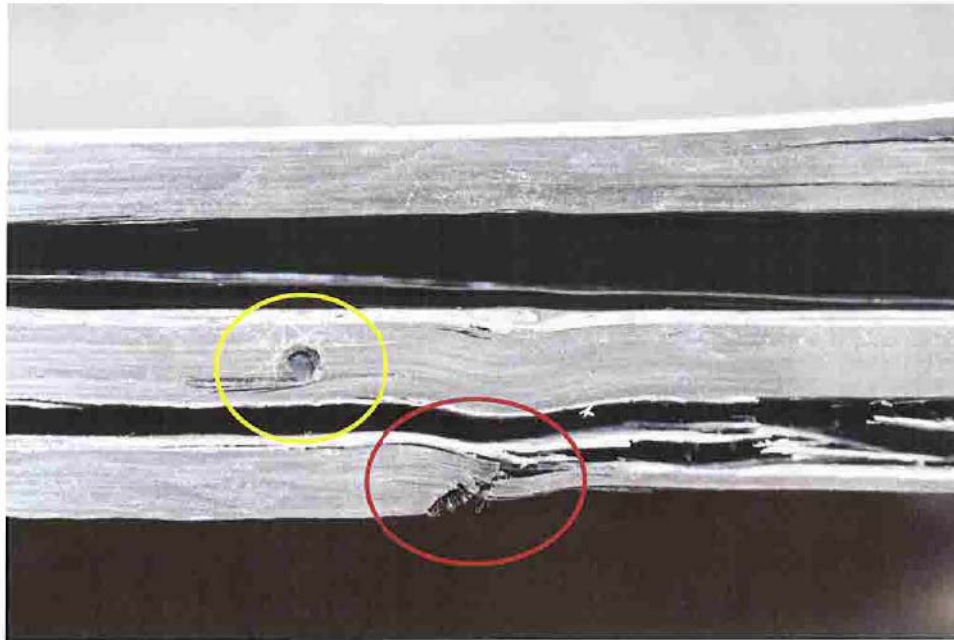
Image 2 – Close-up of red circled area in Image 1. Outer slab is bottommost in the picture. The area marked with a yellow circle is samples taken for cure analysis of the resin

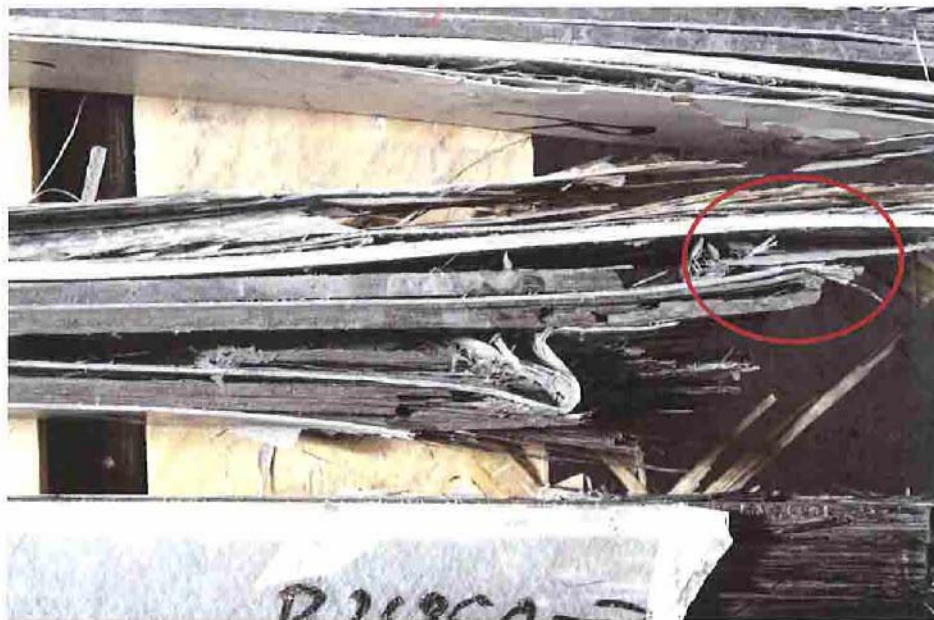
Image 3 – Root section of blade A WW side. Red circle shows wrinkle

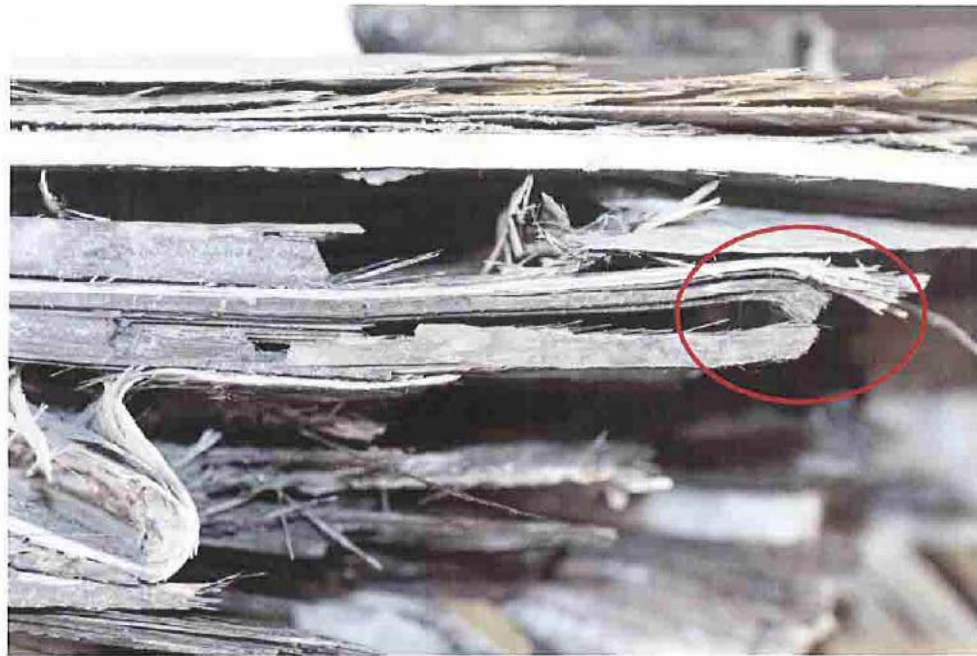
Image 4 – Close-up of red circled area in pic 3. Red circle shows a clear wrinkle
