BEFORE THE OHIO POWER SITING BOARD

In the Matter of the Application of )  
Champaign Wind LLC, for a Certificate )  
to Construct a Wind-Powered Electric ) Case No. 12-0160-EL-BGN  
Generating Facility in Champaign )  
County, Ohio )

EXHIBITS L TO Z OF THE AMENDED DIRECT WRITTEN TESTIMONY OF  
WILLIAM PALMER, FILED ON BEHALF OF INTERVENORS UNION NEIGHBORS  
UNITED, INC., DIANE AND ROBERT McCONNELL, AND JULIA F. JOHNSON

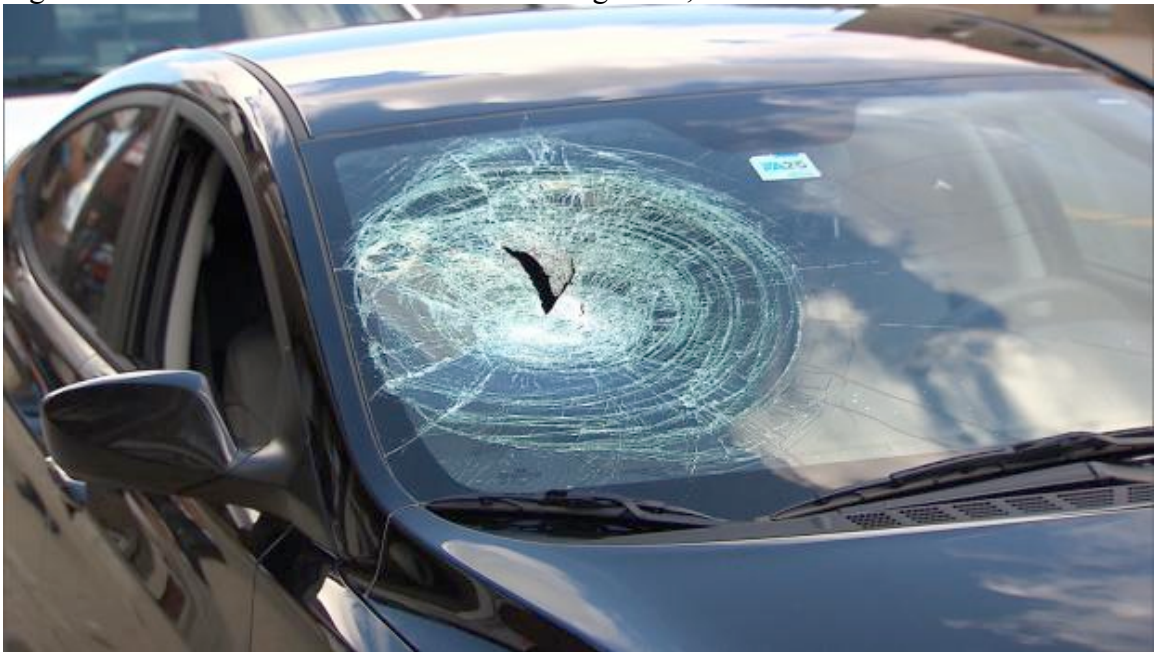
Figure 4 – From CBC Montreal Website – August 11, 2011

- The photo following (Figure 3) is the result of someone dropping a brick (approximately 1 kg) from an overpass (approximately 5 to 10 metres above the car) onto a car window in Montreal as reported in the CBC News Website for August 11, 2011. The caption under the picture on the Montreal CBC site states, *“A chunk of concrete the size of a brick smashed a car windshield on Papineau Street Thursday afternoon, injuring a passenger. (CBC)”* Since this is only a brick sized piece, and an overpass is considerably less elevation than an 8 storey window, it is fairly easy to conclude that the object falling from the turbine as has been documented to fall from a wind turbine in Ohio, might well lead to a fatality.

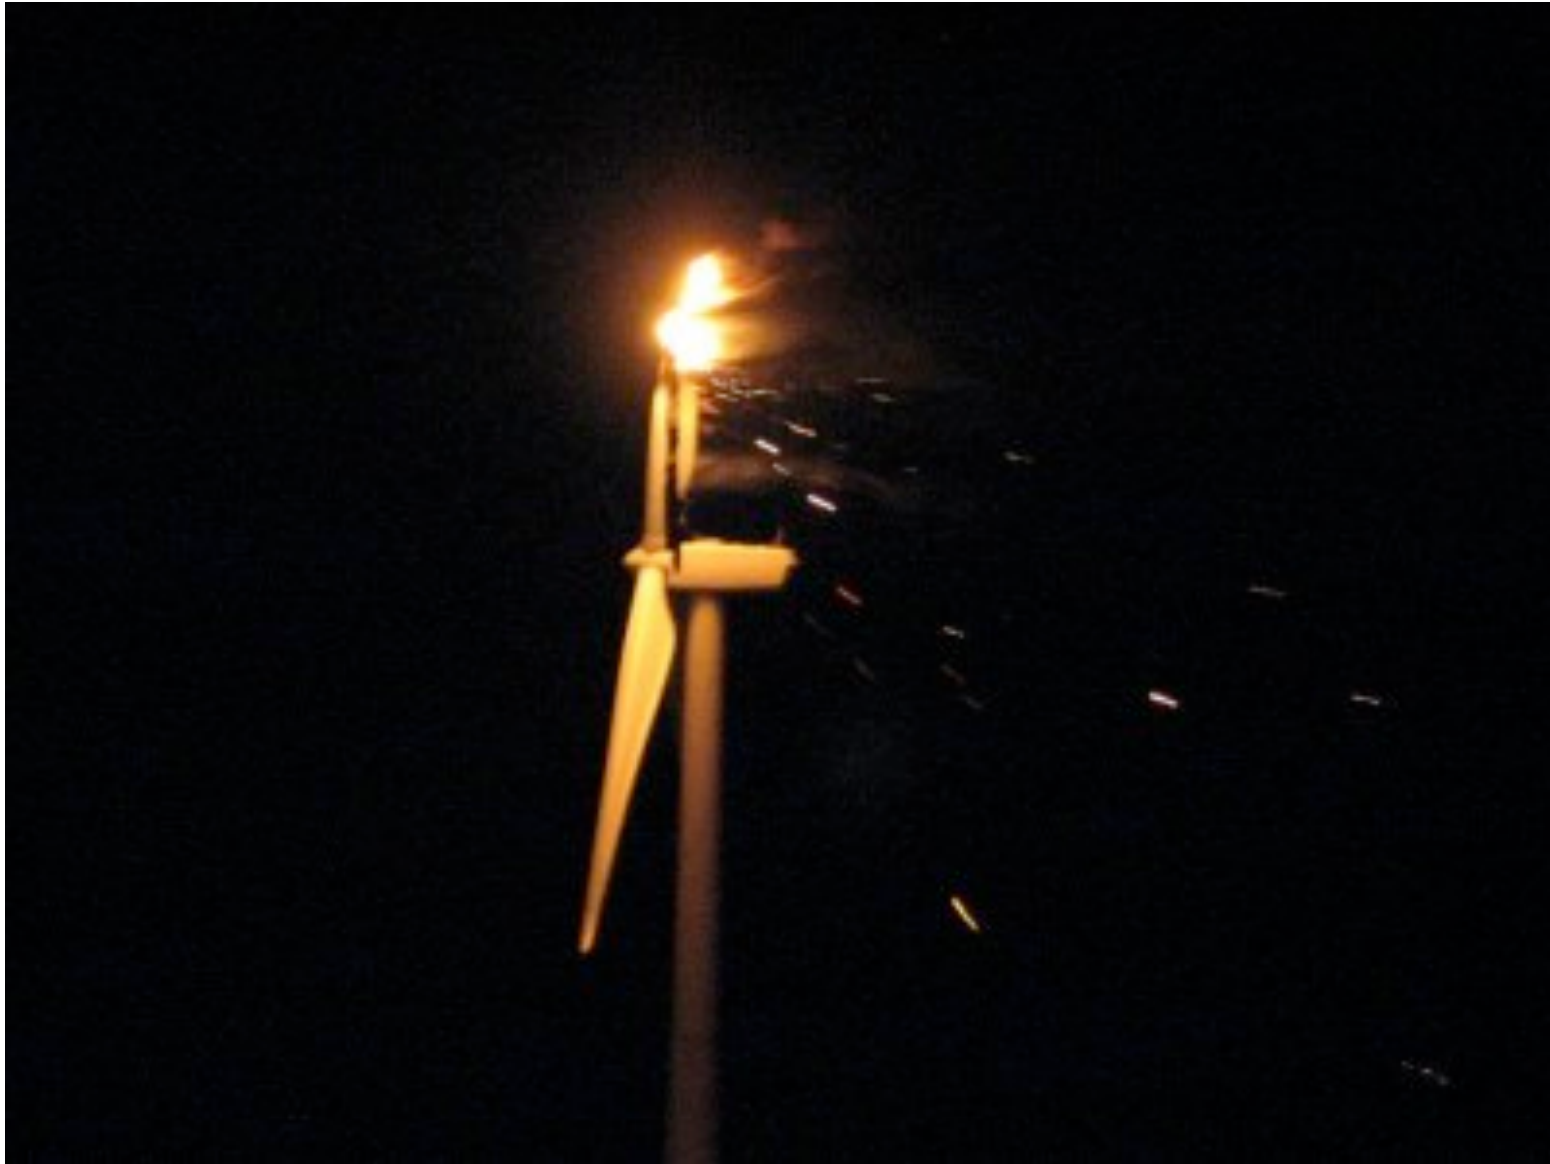
GE 1.5 MW wind turbine - Altona NY on fire Jan 29, 2012

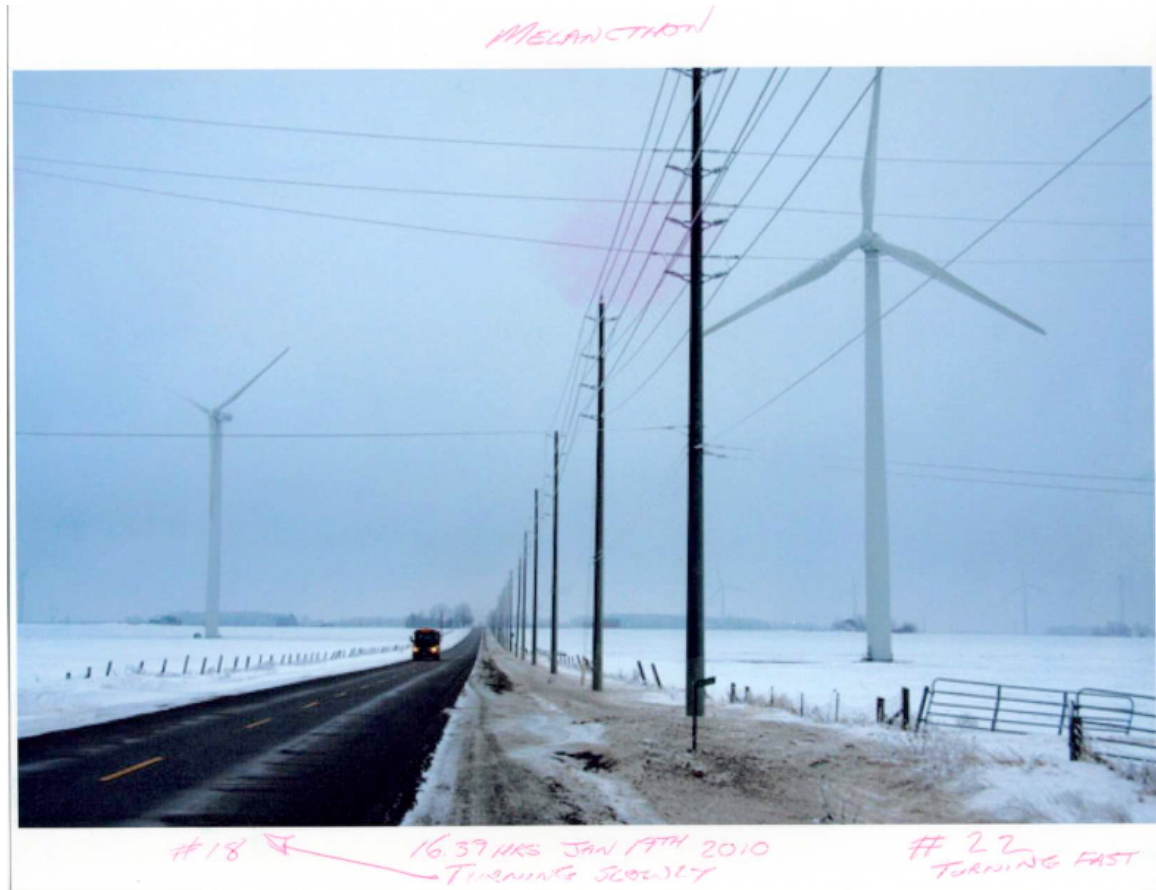
Turbine 22 – still operating, yet iced

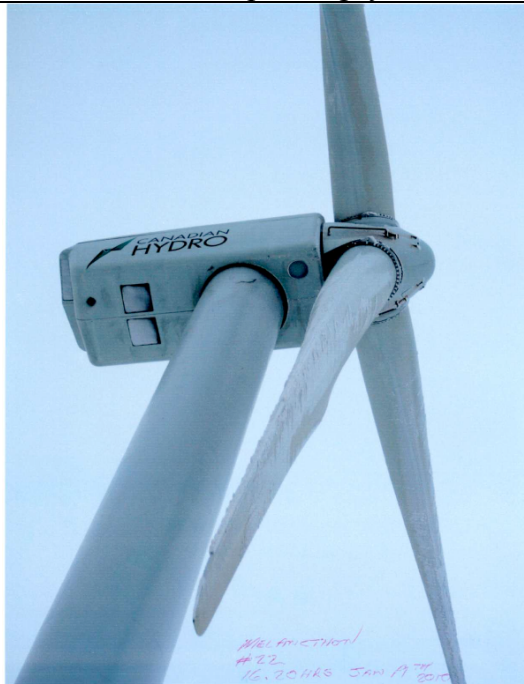
Note Some Ice Has Already Dropped

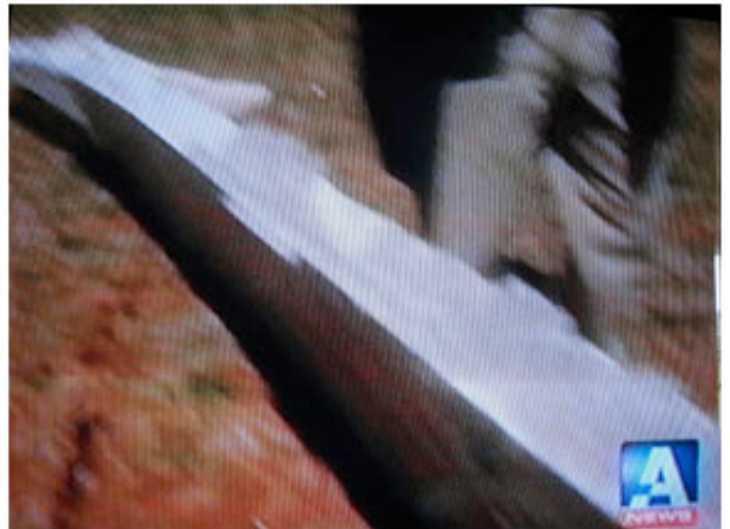
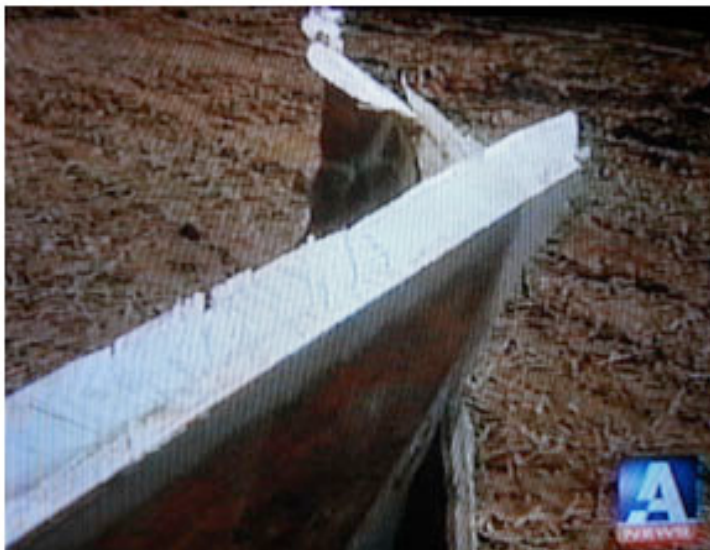
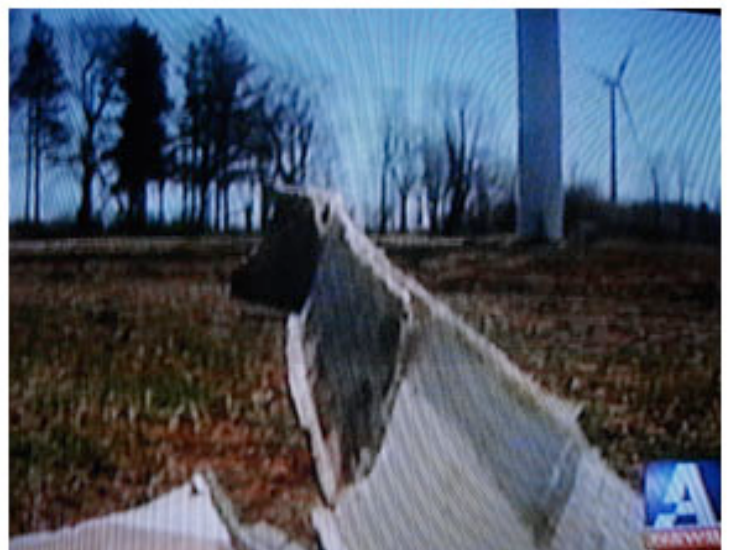
Looking at the pictures from  
A Channel News  
Monday April 30, 2007

Does "the blade" mean only the exterior coating, and not include any of the heavy structural material inside the gel-coat?
