**Vinton Solar Energy LLC  
Case No. 17-774-EL-BGN**

**Application Part 3 of 5**

- **Exhibit A Solar Modules - CONFIDENTIAL (filed under seal)**
- **Exhibit B Solar Inverters - CONFIDENTIAL (filed under seal)**
- **Exhibit C Road Survey Report May**
- **Exhibit D TRC Site Characterization Report June 2017**
- **Exhibit E TRC Vinton Raptor Nest Survey June 2017**

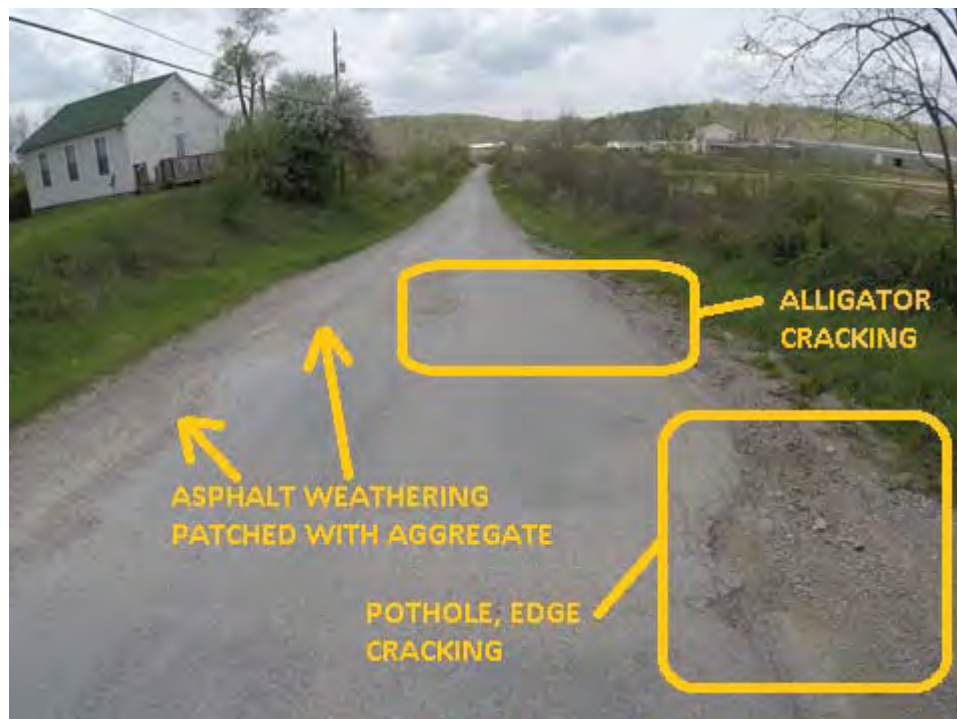
**Figure 4-1      Infirmary Rd at STA 18+00 (west)**

**Section 1** from Highway 23 to 19+00 (Morgan Rd) was observed in failed condition. The pavement presents several bumps and dips, alligator cracking, rutting, potholes and extreme asphalt weathering throughout. The ride quality for this section is very poor with the need for reduced speed due to bumps and dips.

Infirmiry Rd is in extremely poor conditions and would require reconstruction of paved sections. The gravel sections are in adequate condition and only require some maintenance to fill in washed out areas and to smooth out the surface. Since it appears that maintenance for the paved areas consists of adding gravel instead of bituminous patching, it is recommended to mill the entire road, leave millings in-place, mix with aggregate and compact. This will create a more uniform section throughout.

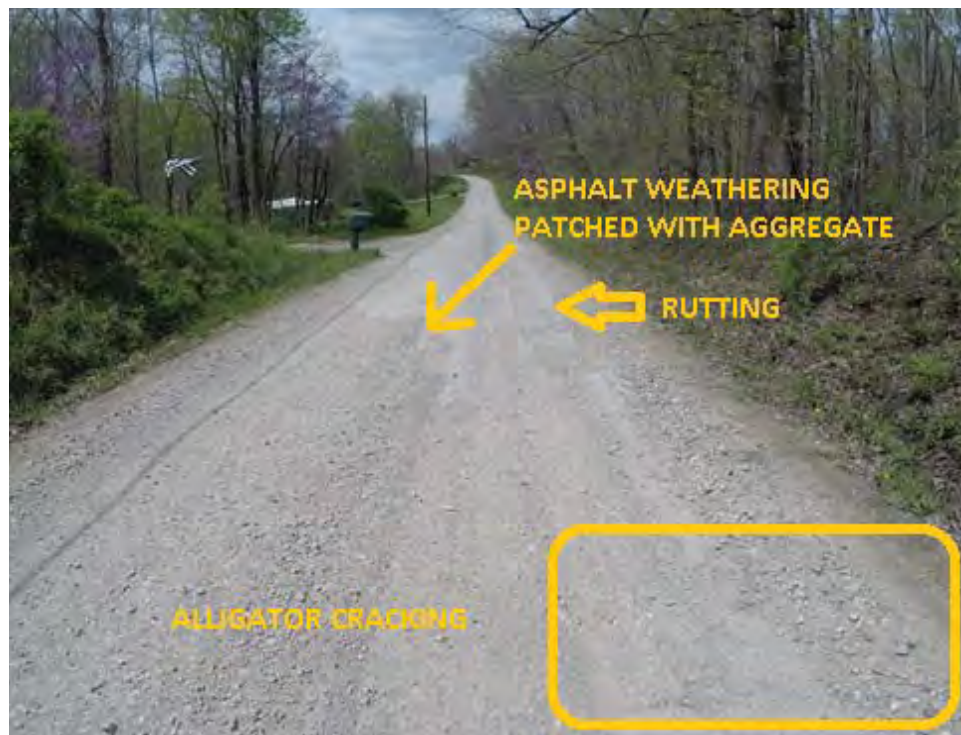
**Figure 4-2      Infirmary Rd at STA 39+00 (west)**

**Section 2** from 19+00 to 44+00 was observed in failed condition. The pavement presents several bumps and dips, alligator cracking, rutting, bleeding, potholes and extreme asphalt weathering throughout. Similar to Section 1, the ride quality for this section is very poor.

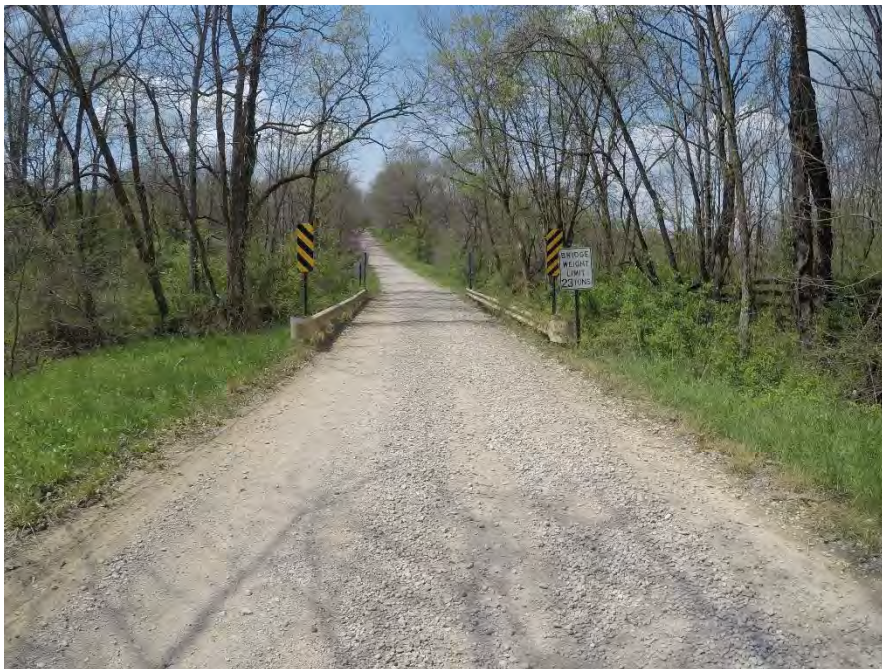
**Figure 4-4**      **Infirmary Rd at STA 146+50 (west)**

**Section 3** from 44+00 to 153+00 has no asphalt. Gravel roads are not subject to pavement assessment. Gravel section seems in good shape with some washout areas and rutting along the edges. Ride is constant without any mayor bumps. There is a weight limit of 23 Tons for a bridge located east of the project site.
