ROUTE EVALUATION STUDY

FOR THE:
**ANGELINA SOLAR PROJECT
PREBLE COUNTY, OHIO**

PREPARED FOR:
**OPEN ROAD RENEWABLES, LLC
1105 NAVASOTA STREET
AUSTIN, TEXAS 78702**

OCTOBER 2018

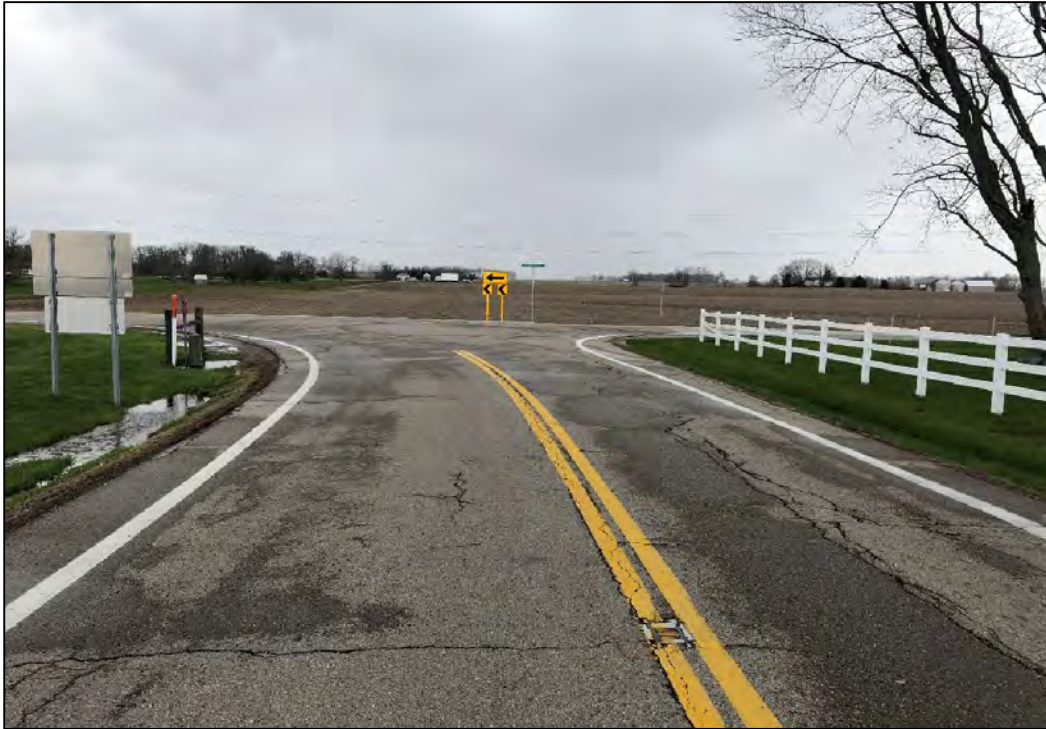
PHOTO 1: View of longitudinal cracking on SR725.

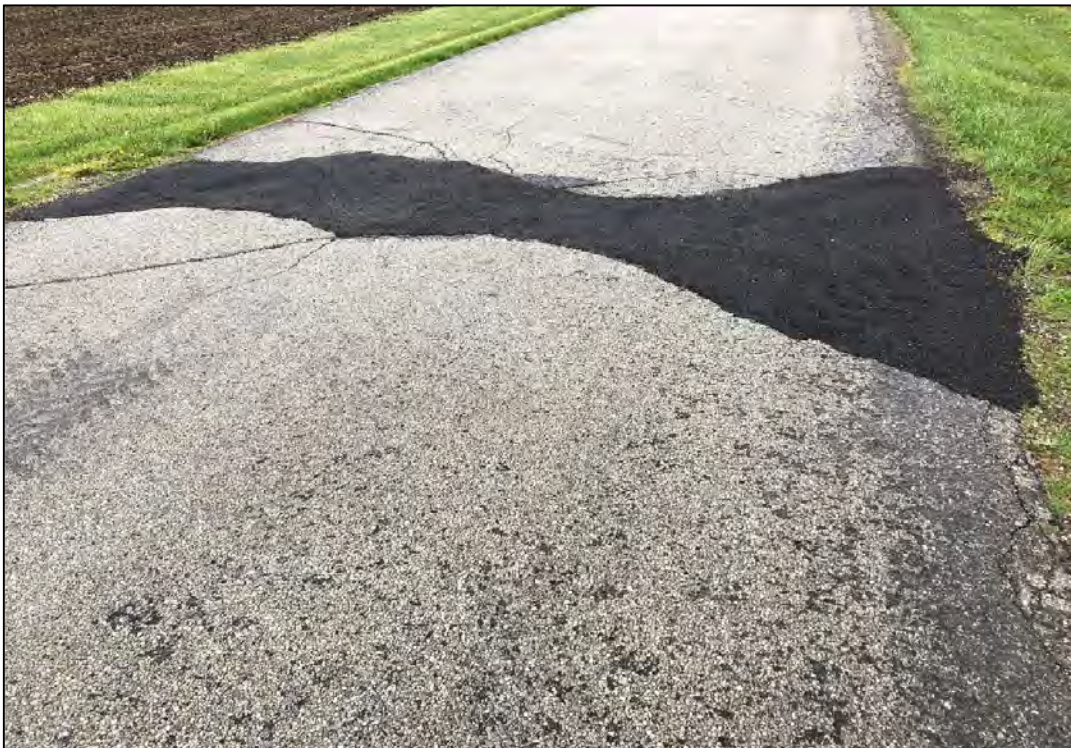
PHOTO 2: Pavement repair on State Line Road just north of State Route 725.

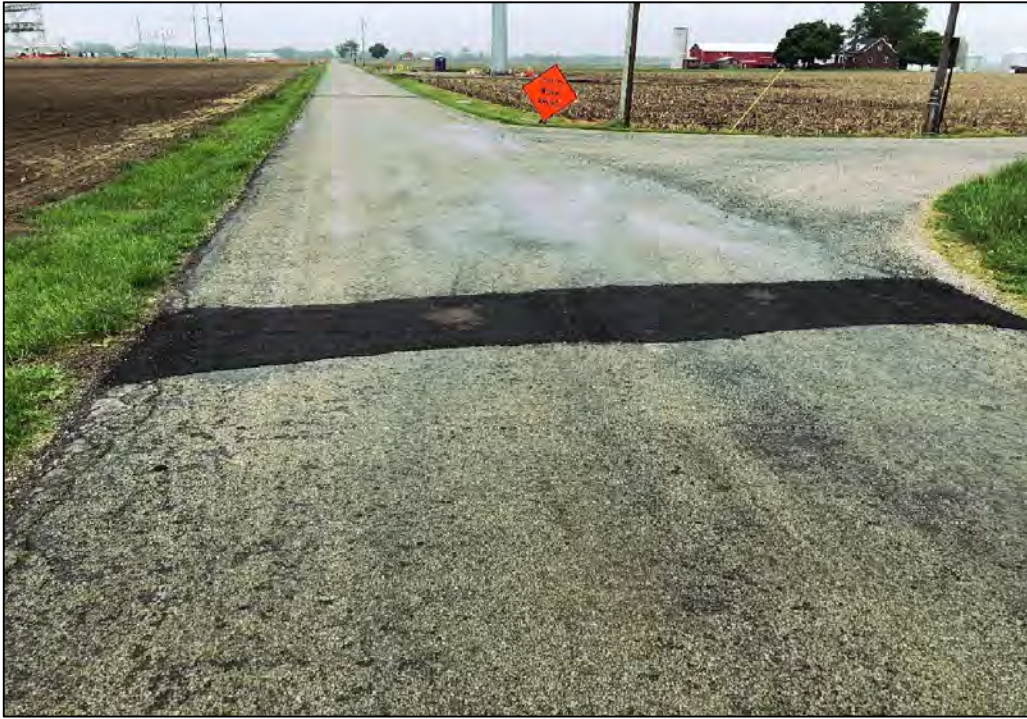
There are two corrugated metal pipe (CMP) culverts with minimal cover and have recently had pavement repair above them. There is a reinforced concrete pipe (RCP) culvert with minor pavement depression.

PHOTO 3: Pavement repair on State Line Road over CMP culvert just south of Campbell Road.

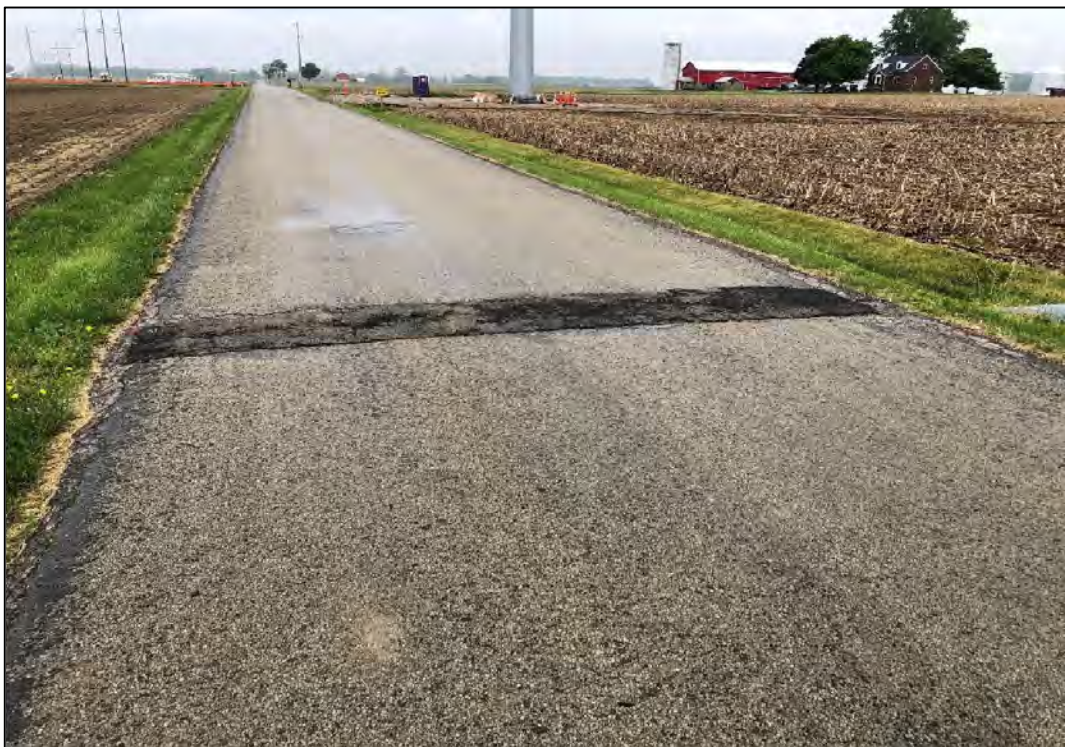
PHOTO 4: Pavement repair on State Line Road over CMP culvert just north of Campbell Road.

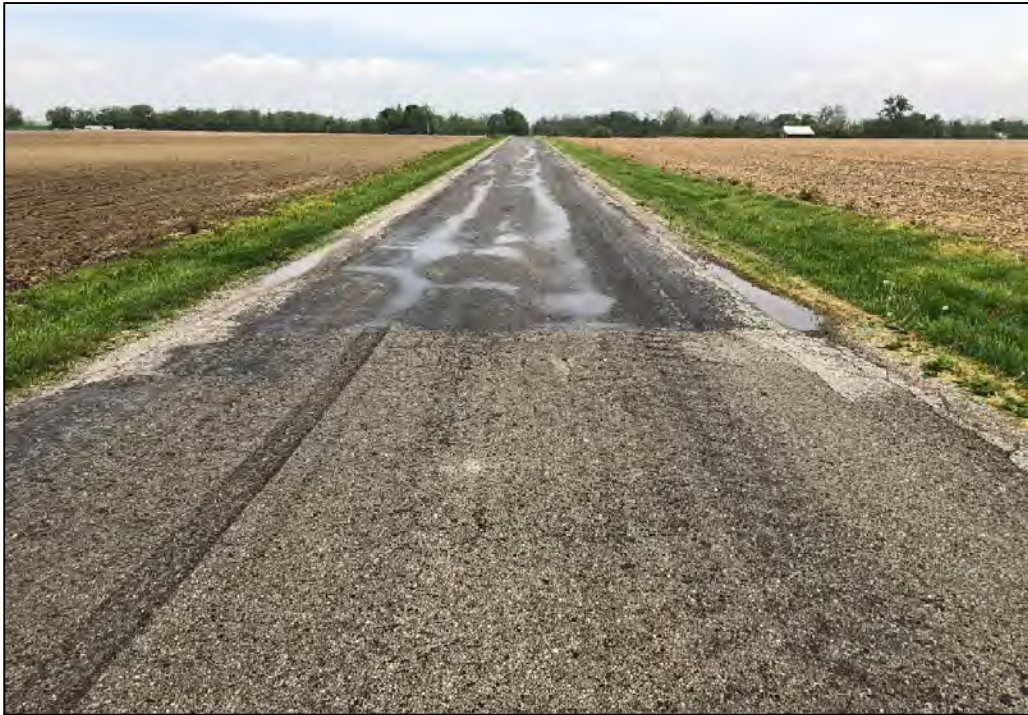
The majority of this road is in good condition and exhibits normal aging with routine maintenance with some visible pavement repairs. From Paint Creek Four Mile Road to approximately 2,800 feet south of that road, the road is in fair condition and exhibits some rutting and edge deterioration with visible pavement repairs. There is one area of pavement repair just north of State Route 725 and two areas of Pavement repair over a CMP culvert just north and south of the intersection with Campbell Road. The pavement is deteriorated at the intersection with Paint Creek Four Mile Road. There have been recent roadside ditch improvements at this intersection that would presumably improve drainage.

PHOTO 5: Pavement transition from 17 feet wide to 15 feet wide on State Line Road. Note slight rutting and edge cracking on 15-foot section.

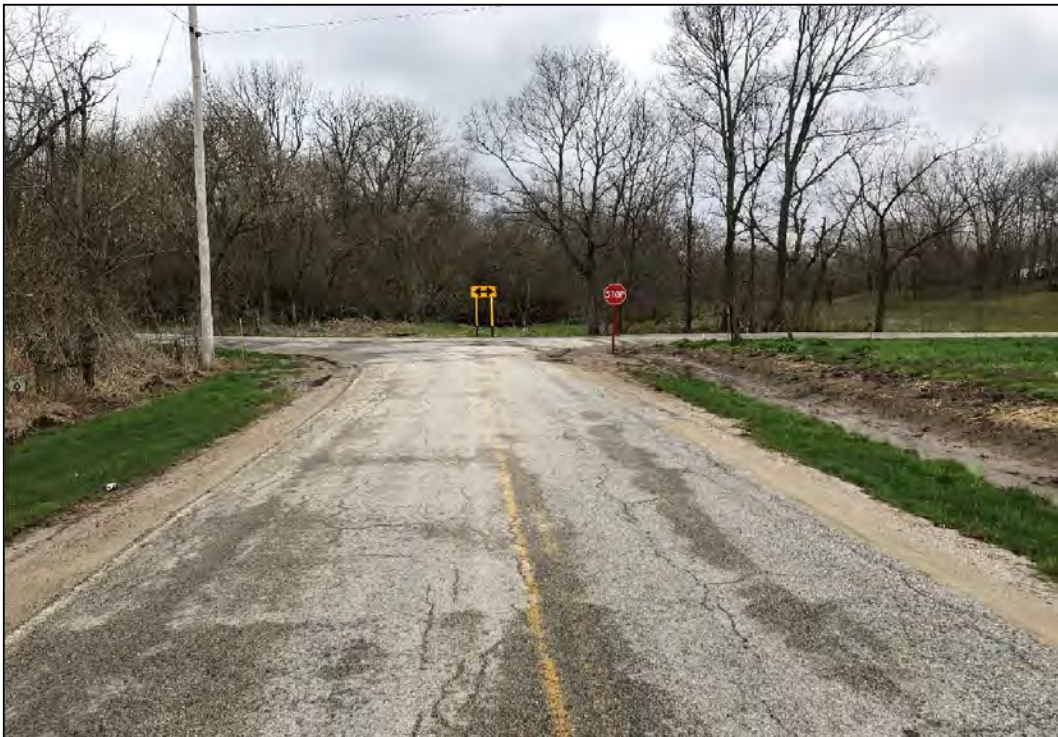
PHOTO 6: Pavement edge deterioration on Paint Creek Four Mile Road at intersection with State Line Road. Note recent drainage ditch improvements.

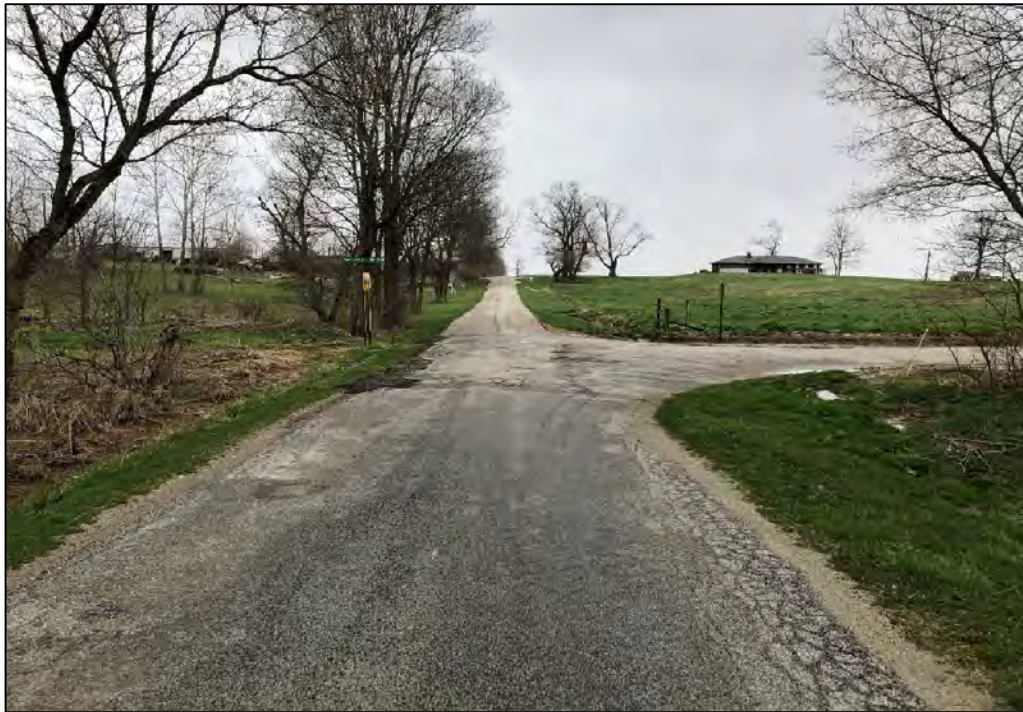
PHOTO 7: Pavement deterioration at intersection of State Line and Paint Creek Four Mile Roads.

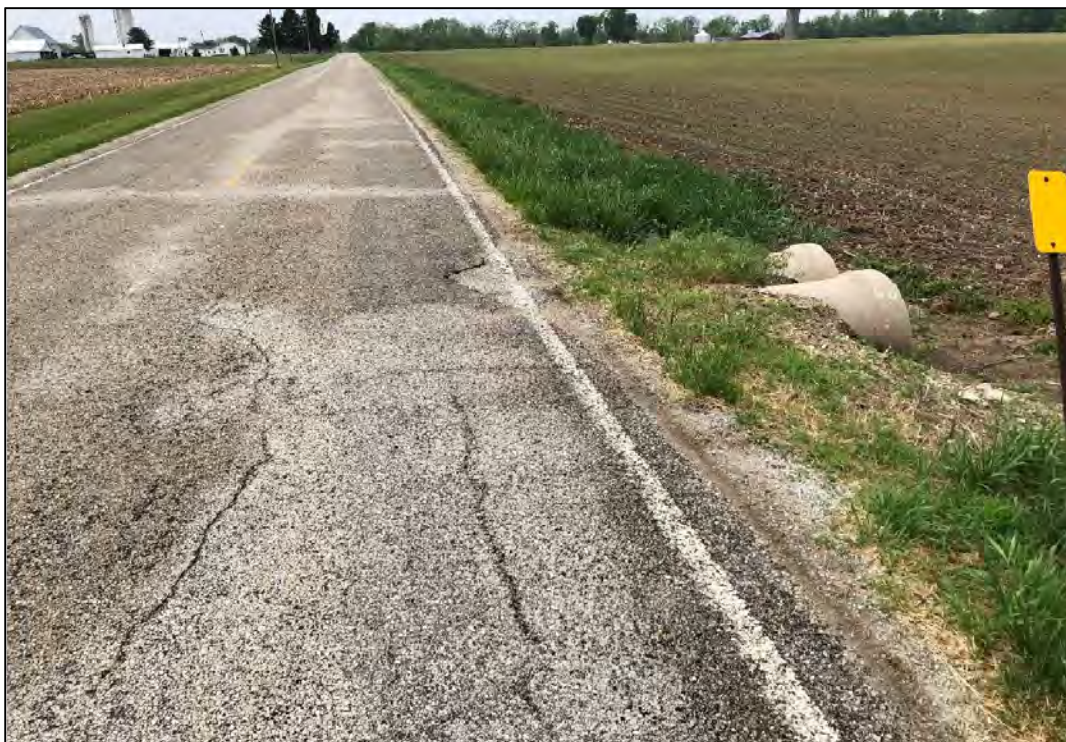
This road is in good condition and exhibits normal aging with routine maintenance with some visible pavement repairs. There is one area of pavement depression over a twin RCP culvert.

There are two locations of RCP culverts with minimal cover and minor pavement depression.

PHOTO 8: Pavement depression over twin RCP culverts on Paint Creek Four Mile Road.

- Adding temporary gravel and/or asphalt cover over structures.
- Using bridge jumpers to clear structures.
- Replacing structures during or after construction if damaged by construction traffic.
