# **ROUTE EVALUATION STUDY**

FOR THE:  
**ALAMO SOLAR PROJECT**  
**PREBLE COUNTY, OHIO**

**OCTOBER 2018**

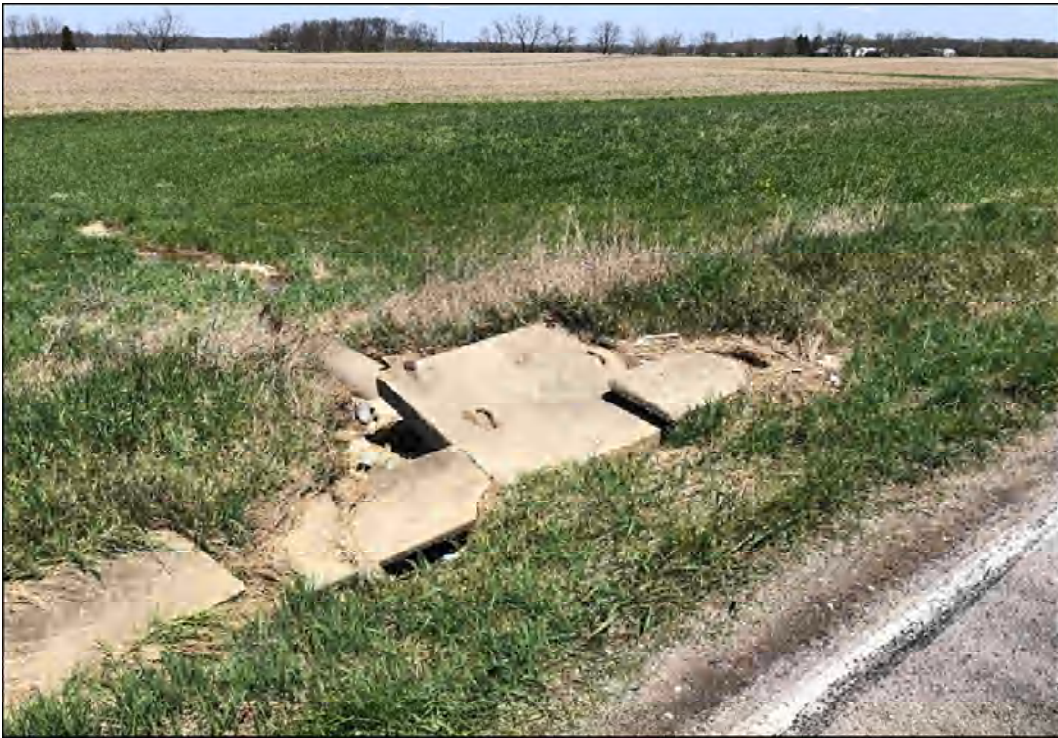
This road is in good condition exhibits normal aging with routine maintenance with some visible pavement repairs. There is one area of embankment erosion over an RCP culvert.

There is an RCP culvert with embankment erosion on the downstream end.

PHOTO 1: View of embankment erosion on downstream end of RCP culvert on Consolidated Road.

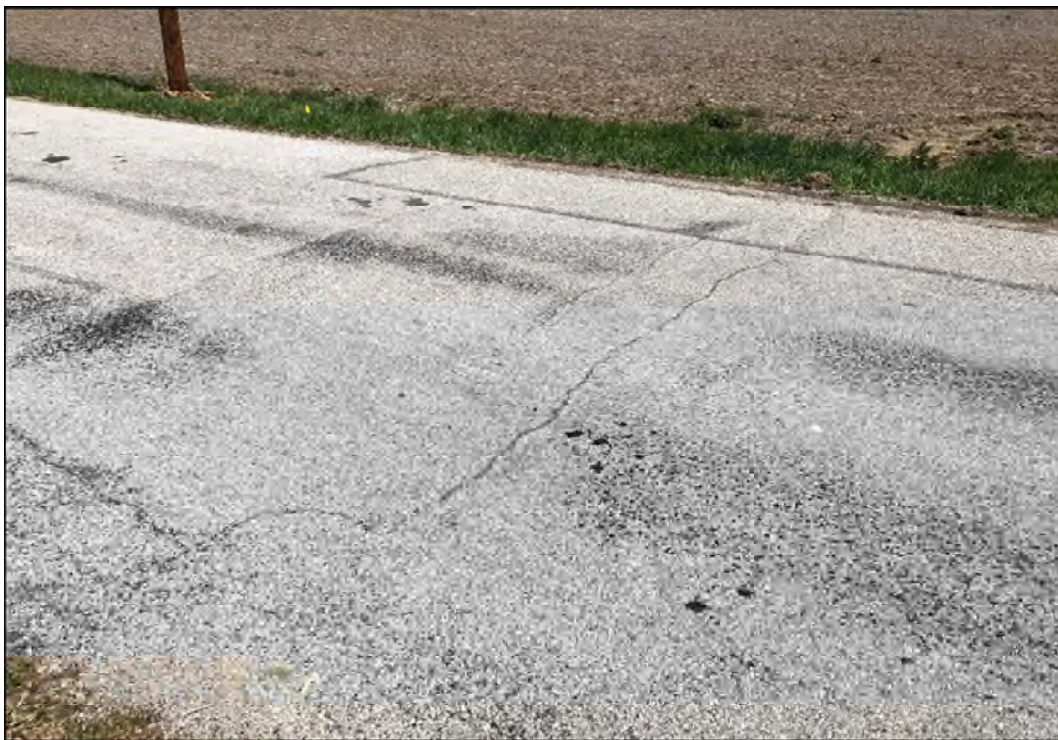
There are two CMP culverts with minimal cover and minor traverse cracking in the pavement. There is a box culvert that the County Engineer lists as in poor condition.

PHOTO 2: View of traverse cracking over CMP culvert on Camden Road.

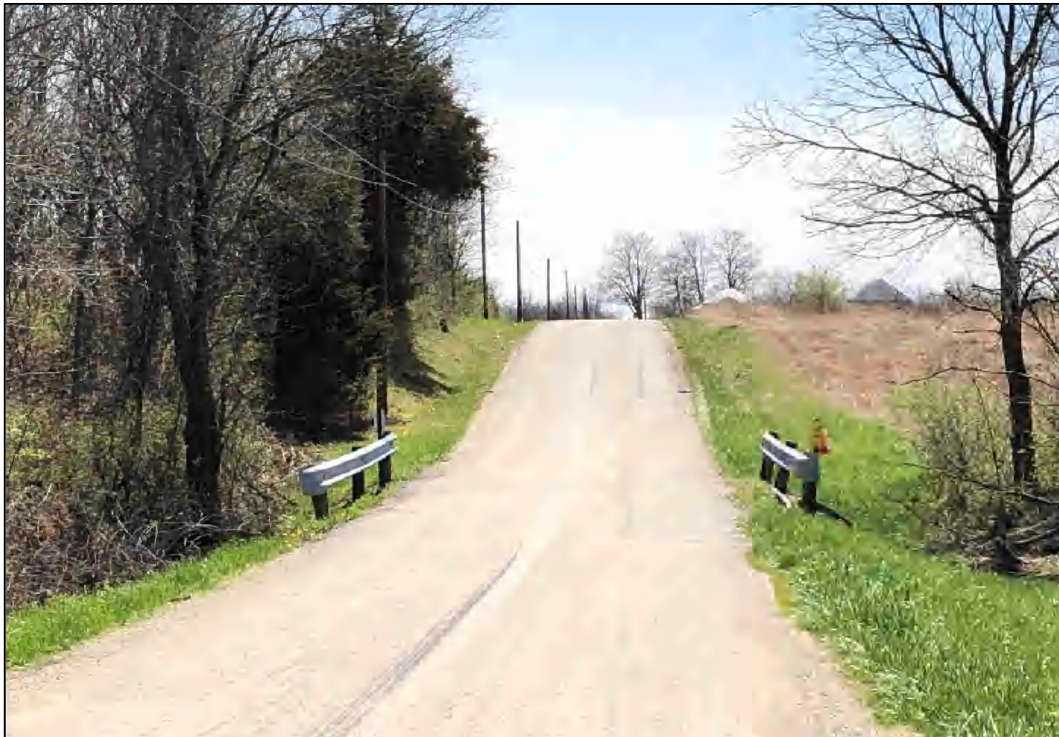
PHOTO 3: View of narrow bridge on Camden Road.

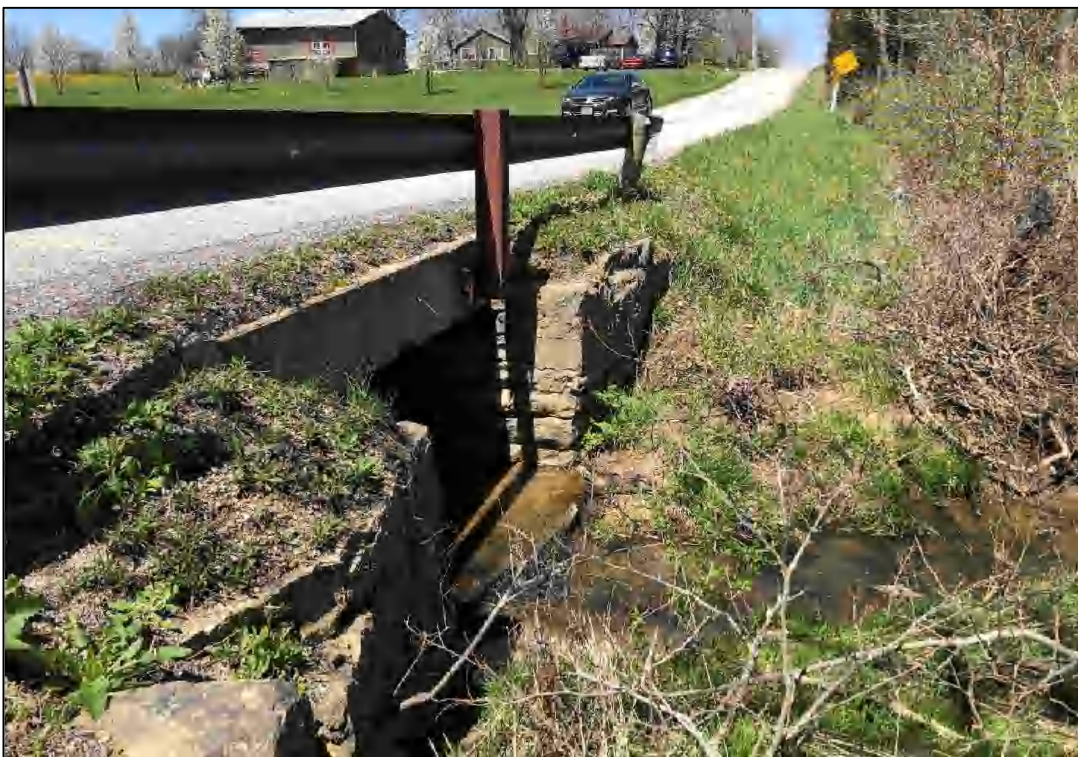
PHOTO 4: View of stone bridge abutment on Camden Road.

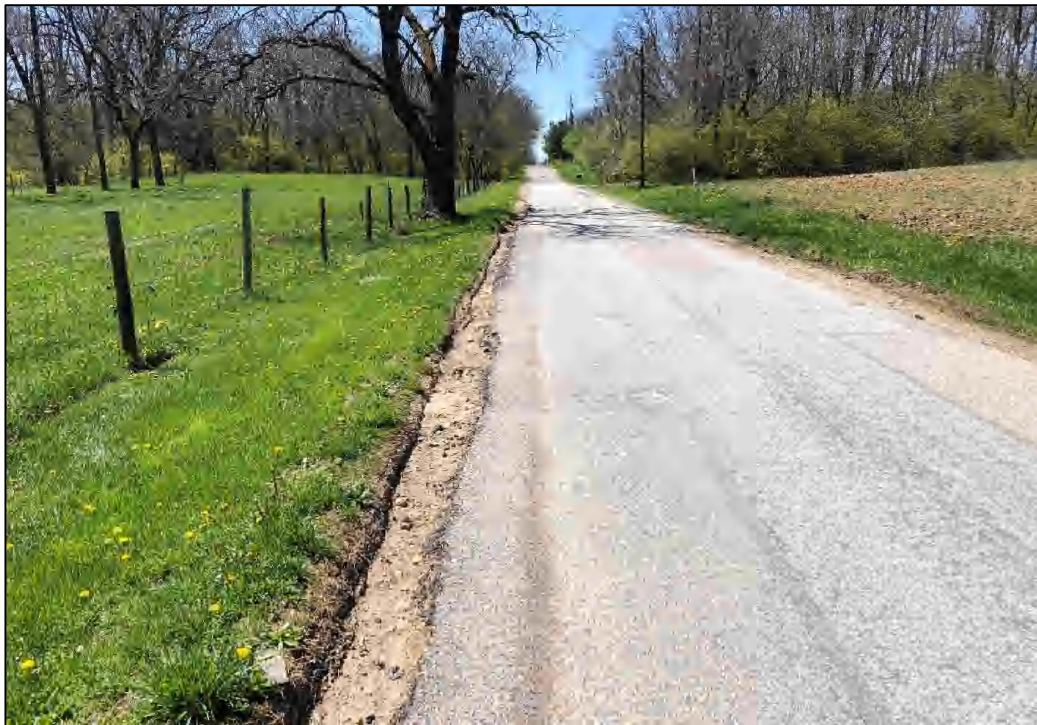
This road is in fair condition and exhibits normal aging with routine maintenance with some visible pavement repairs and recent pavement overlay. There is significant erosion and pavement edge deterioration on the road just west of US Route 127. In addition, there are two bridges between US Route 127 and Camden Road that are in poor condition. This road also has relatively steep grades between US Route 127 and just west of Camden Road.

PHOTO 5: View of significant erosion and pavement edge deterioration on Antioch Road.

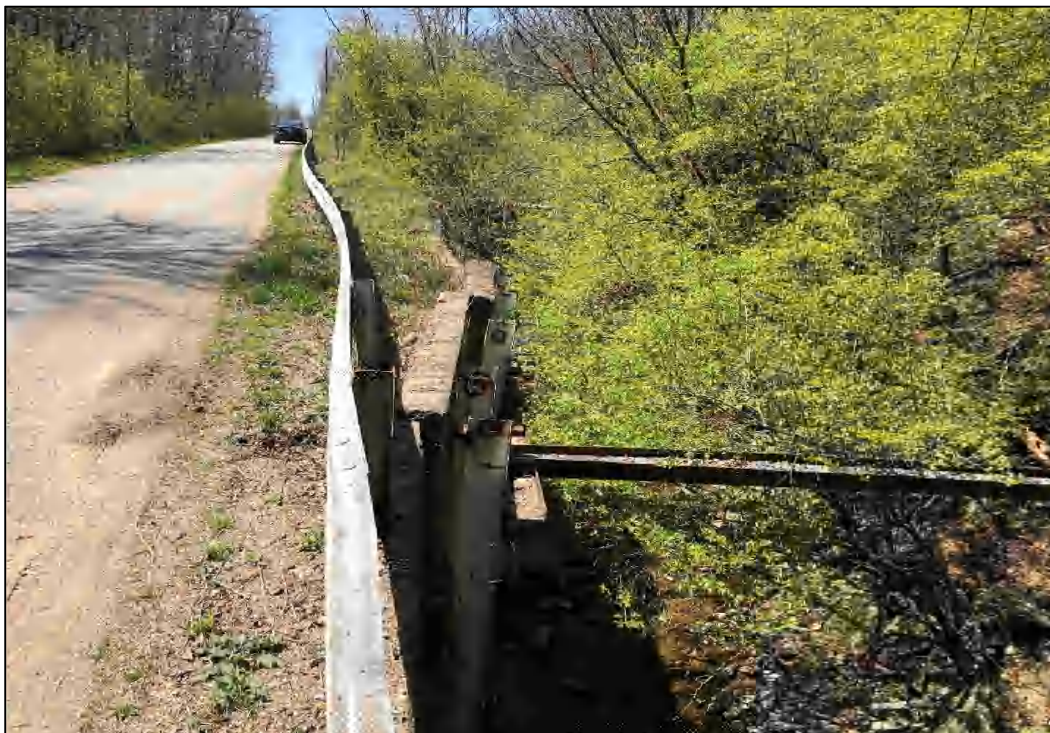
PHOTO 6: View of upstream retaining wall at bridge on Antioch Road. Note bracing and lateral panel movement.

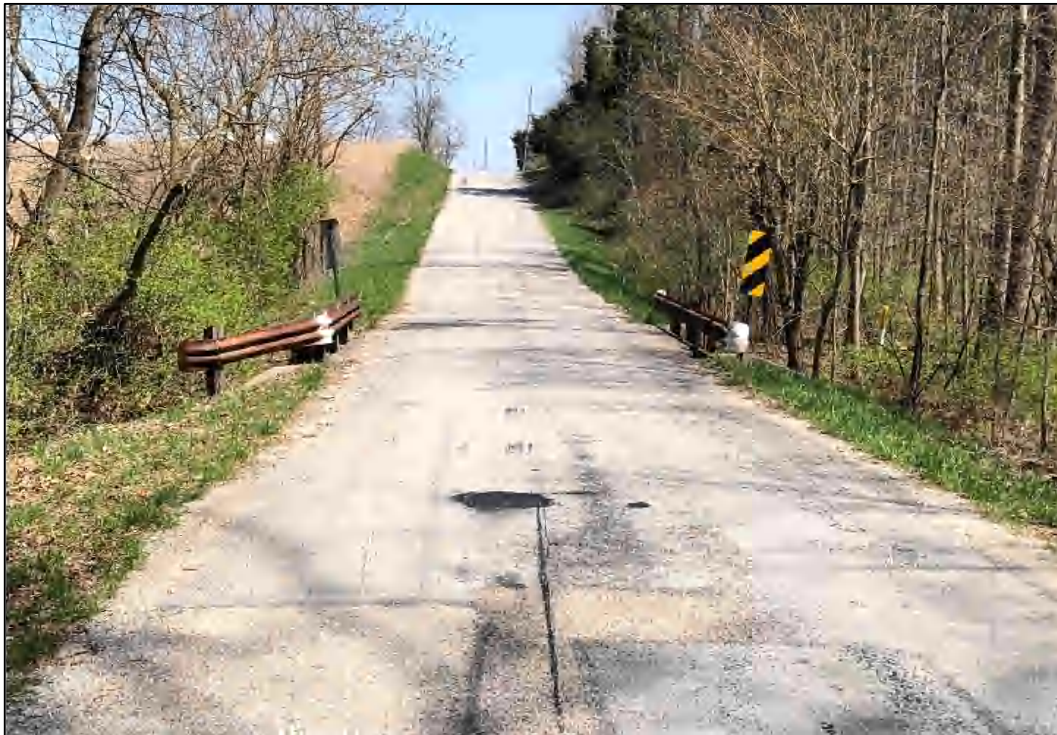
PHOTO 7: View of narrow bridge on Antioch Road.

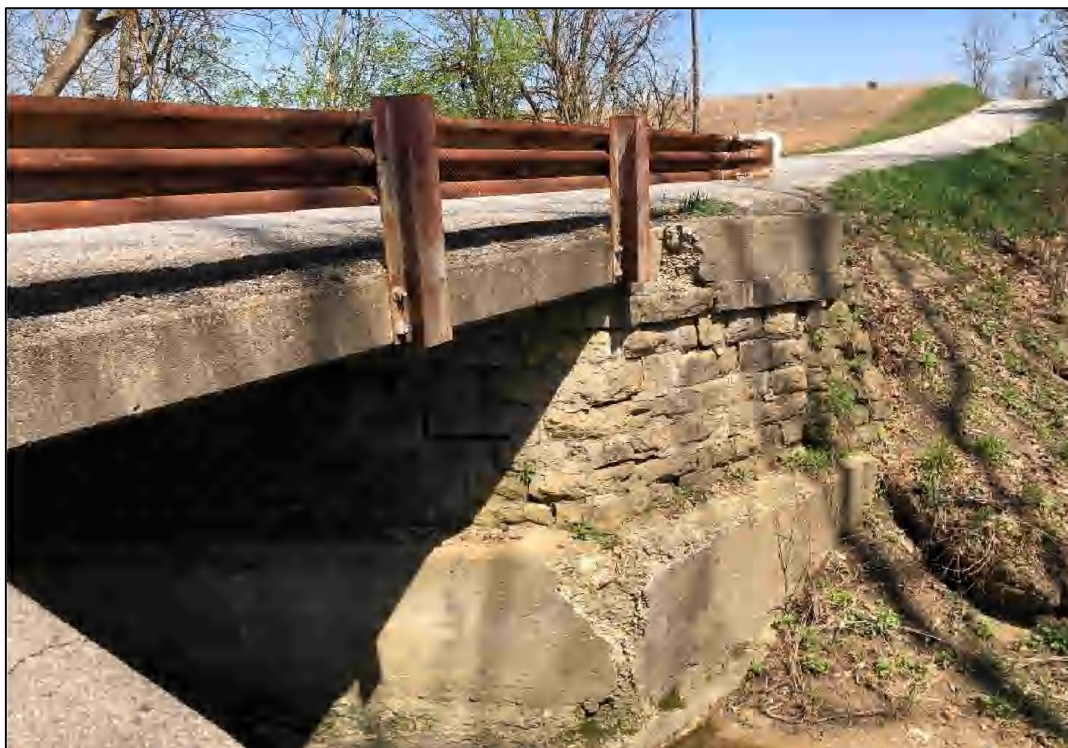
PHOTO 8: View of stone abutment on bridge on Antioch Road. Note cracks in abutment.

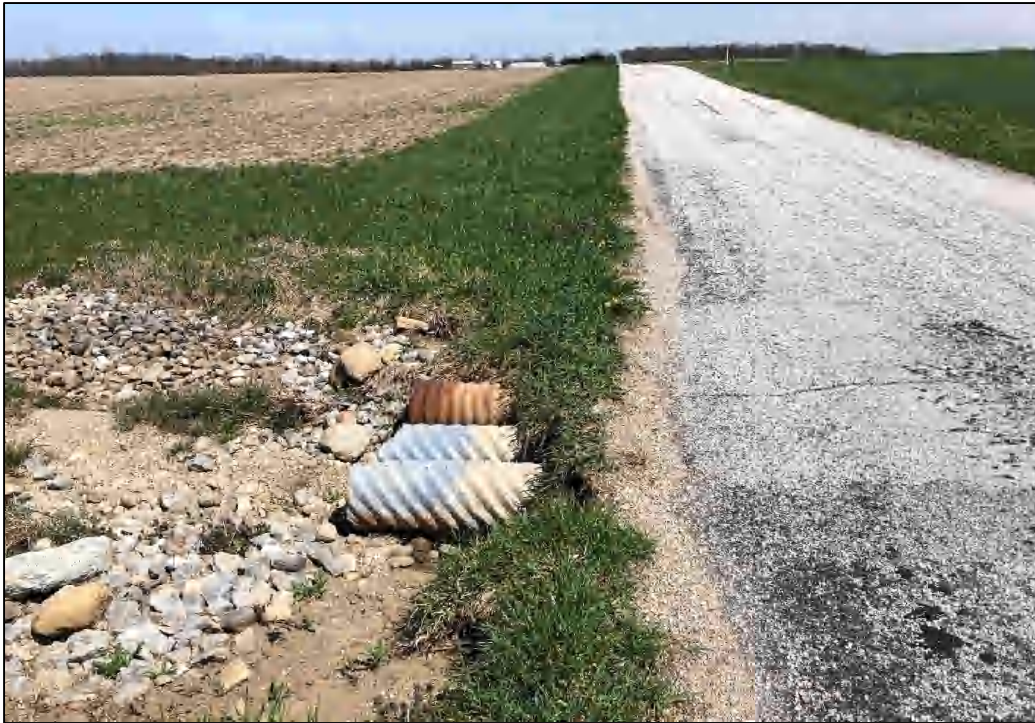
There is a triple CMP culvert with embankment erosion on the downstream end.

PHOTO 9: View of embankment erosion on downstream end of CMP culverts on Antioch Road.

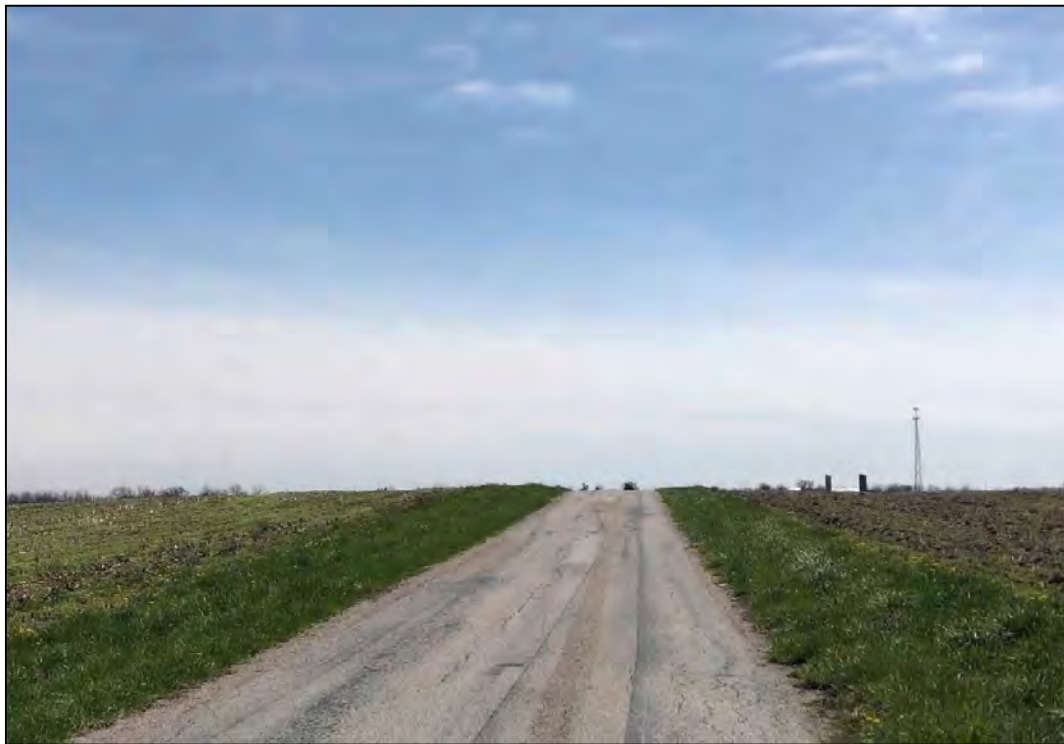
This road is in poor condition and exhibits several areas of pavement distress including edge damage, poor drainage likely contributing to poor subgrade conditions, and rutting. There is one area where the pavement is depressed over a culvert.

PHOTO 10: View of Call Road and lack of roadside drainage ditch.

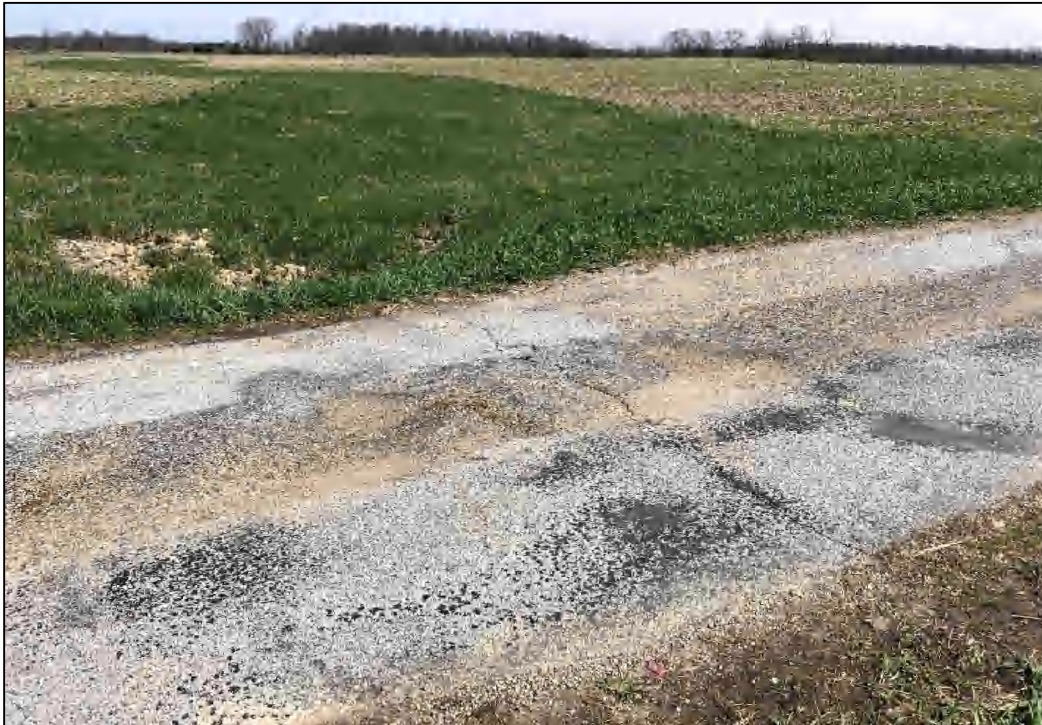
There is one CMP culvert with pavement distress above the culvert.

PHOTO 11: View of traverse crack over CMP culvert on Call Road.

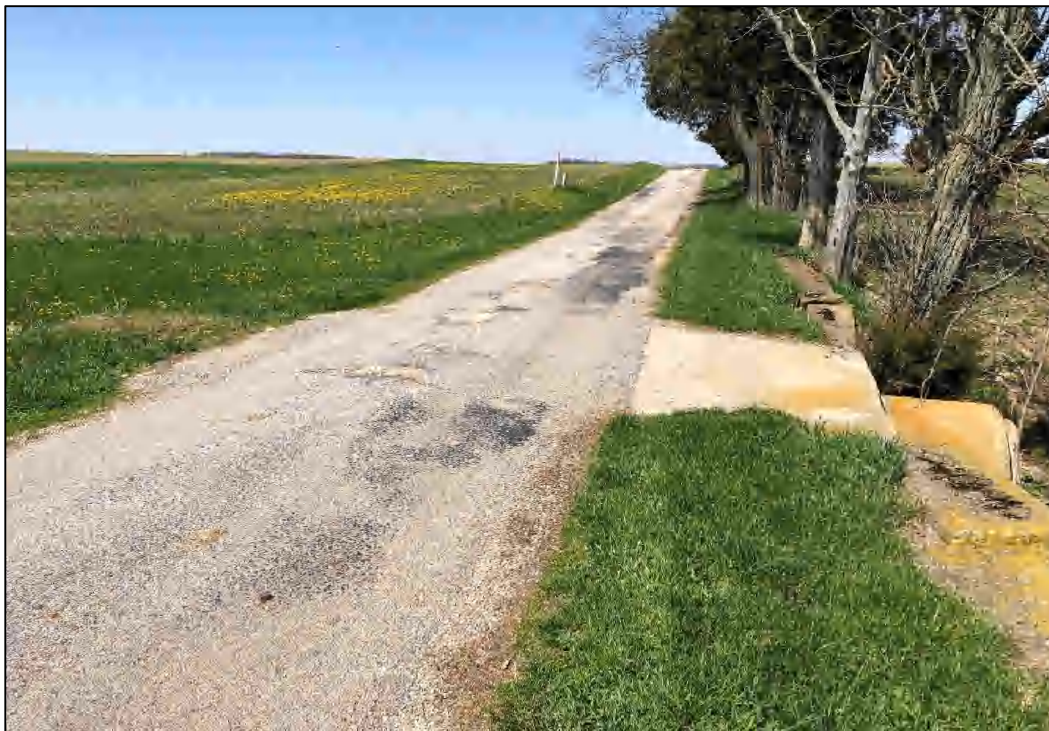
PHOTO 12: View of large RCP culvert on Call Road. Note minimal cover and concrete slab over culvert.

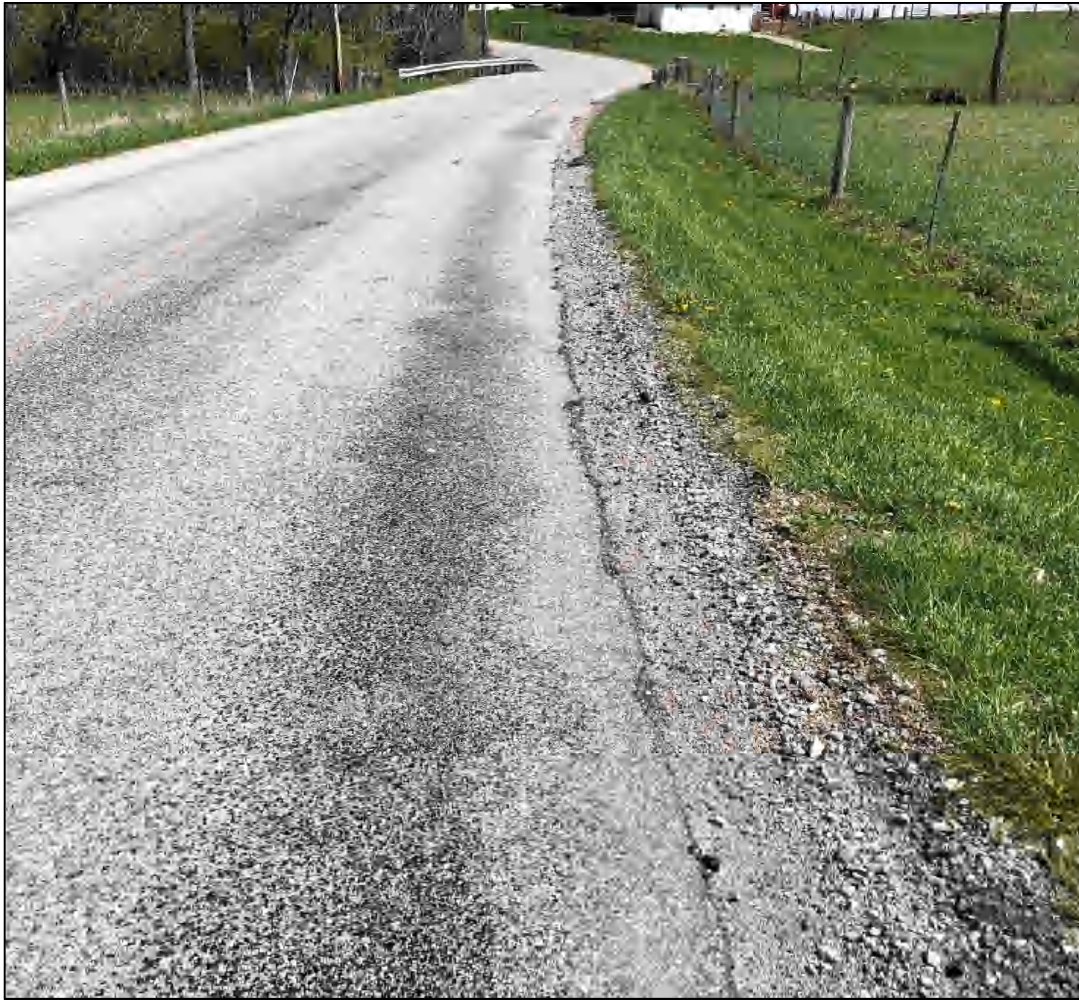
This road is in good condition exhibits normal aging with routine maintenance with some visible pavement repairs. There is one area with pavement edge deterioration likely due to poor drainage and another are with depressed pavement over an RCP culvert.

PHOTO 13: View of pavement edge deterioration on Mann Road likely due to poor drainage.

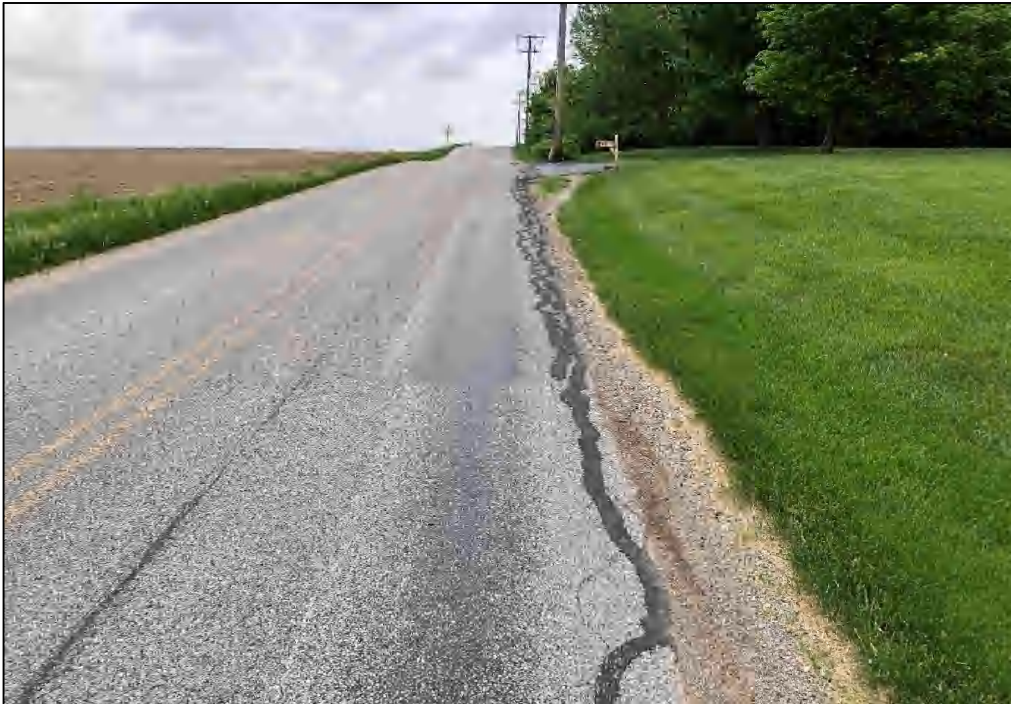
PHOTO 14: View of pavement edge deterioration on Mann Road likely due to poor drainage.

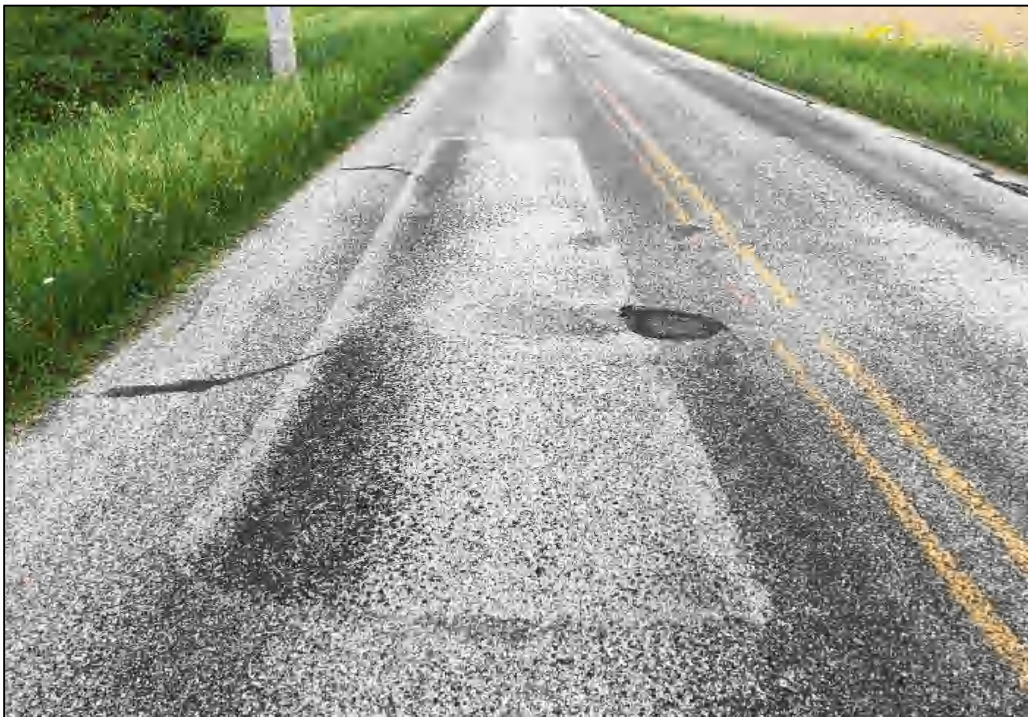
PHOTO 15: View of depressed pavement over RCP culvert on Mann Road.

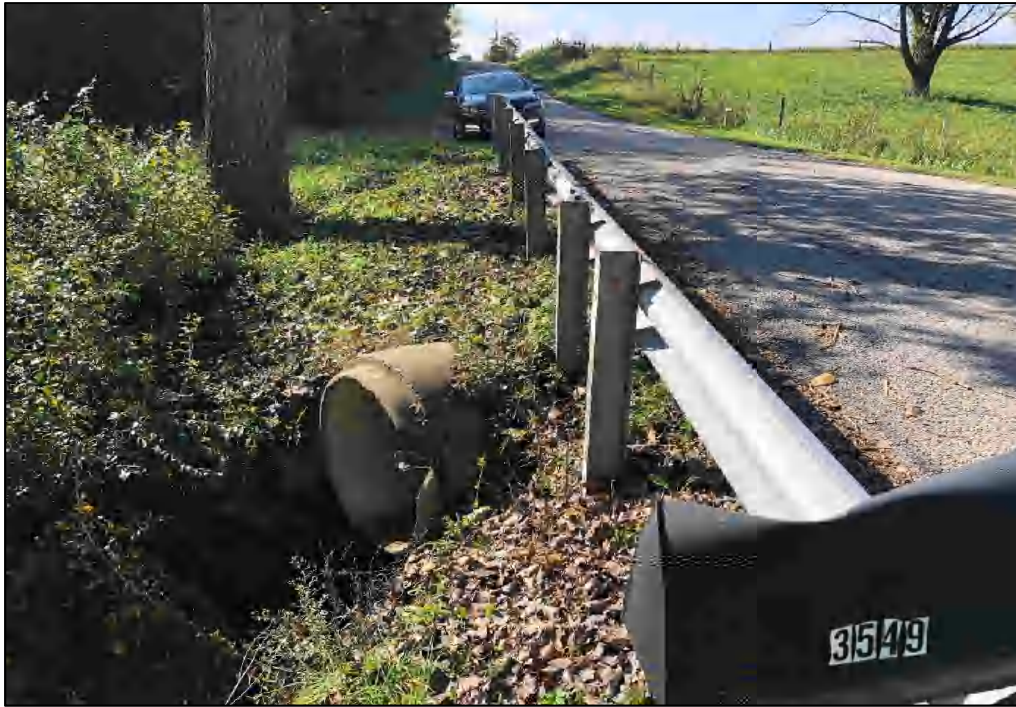
PHOTO 16: View of embankment erosion on east side of RCP culvert.

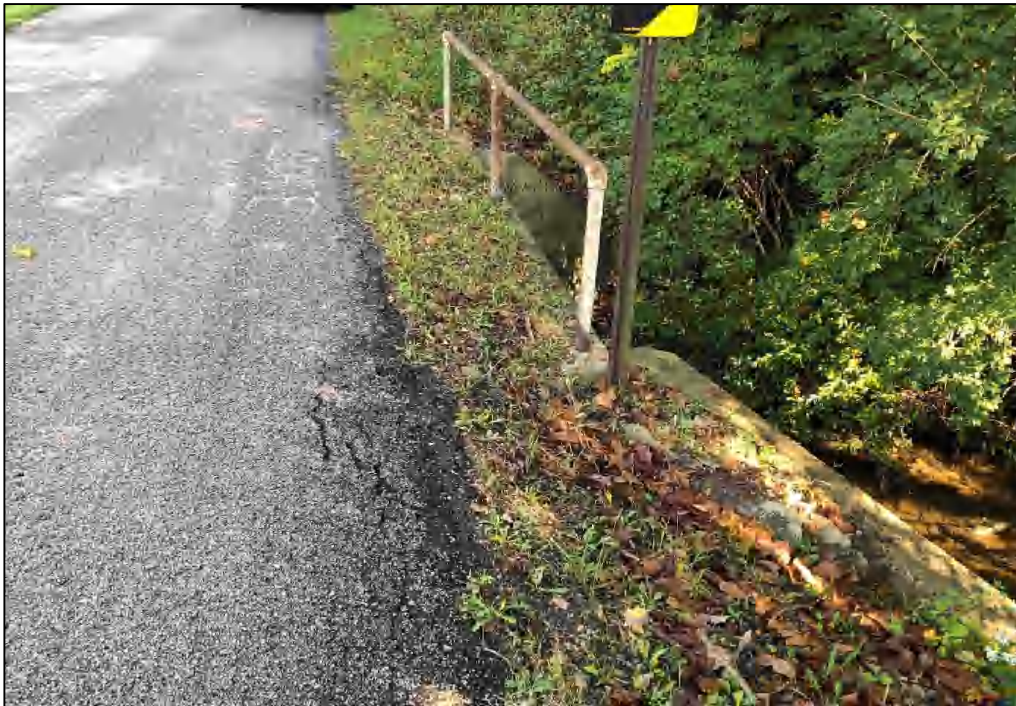
PHOTO 17: View of unstable embankment next to east side of the bridge.
