**A Report by the Staff of the
Public Utilities Commission of Ohio**

In the Matter of the Investigation of
Columbia Gas of Ohio, Inc. Relative to its
Compliance with the Natural Gas Pipeline
Safety Standards and Related Matters.

Case No. 19-0452-GA-GPS

February 22, 2019

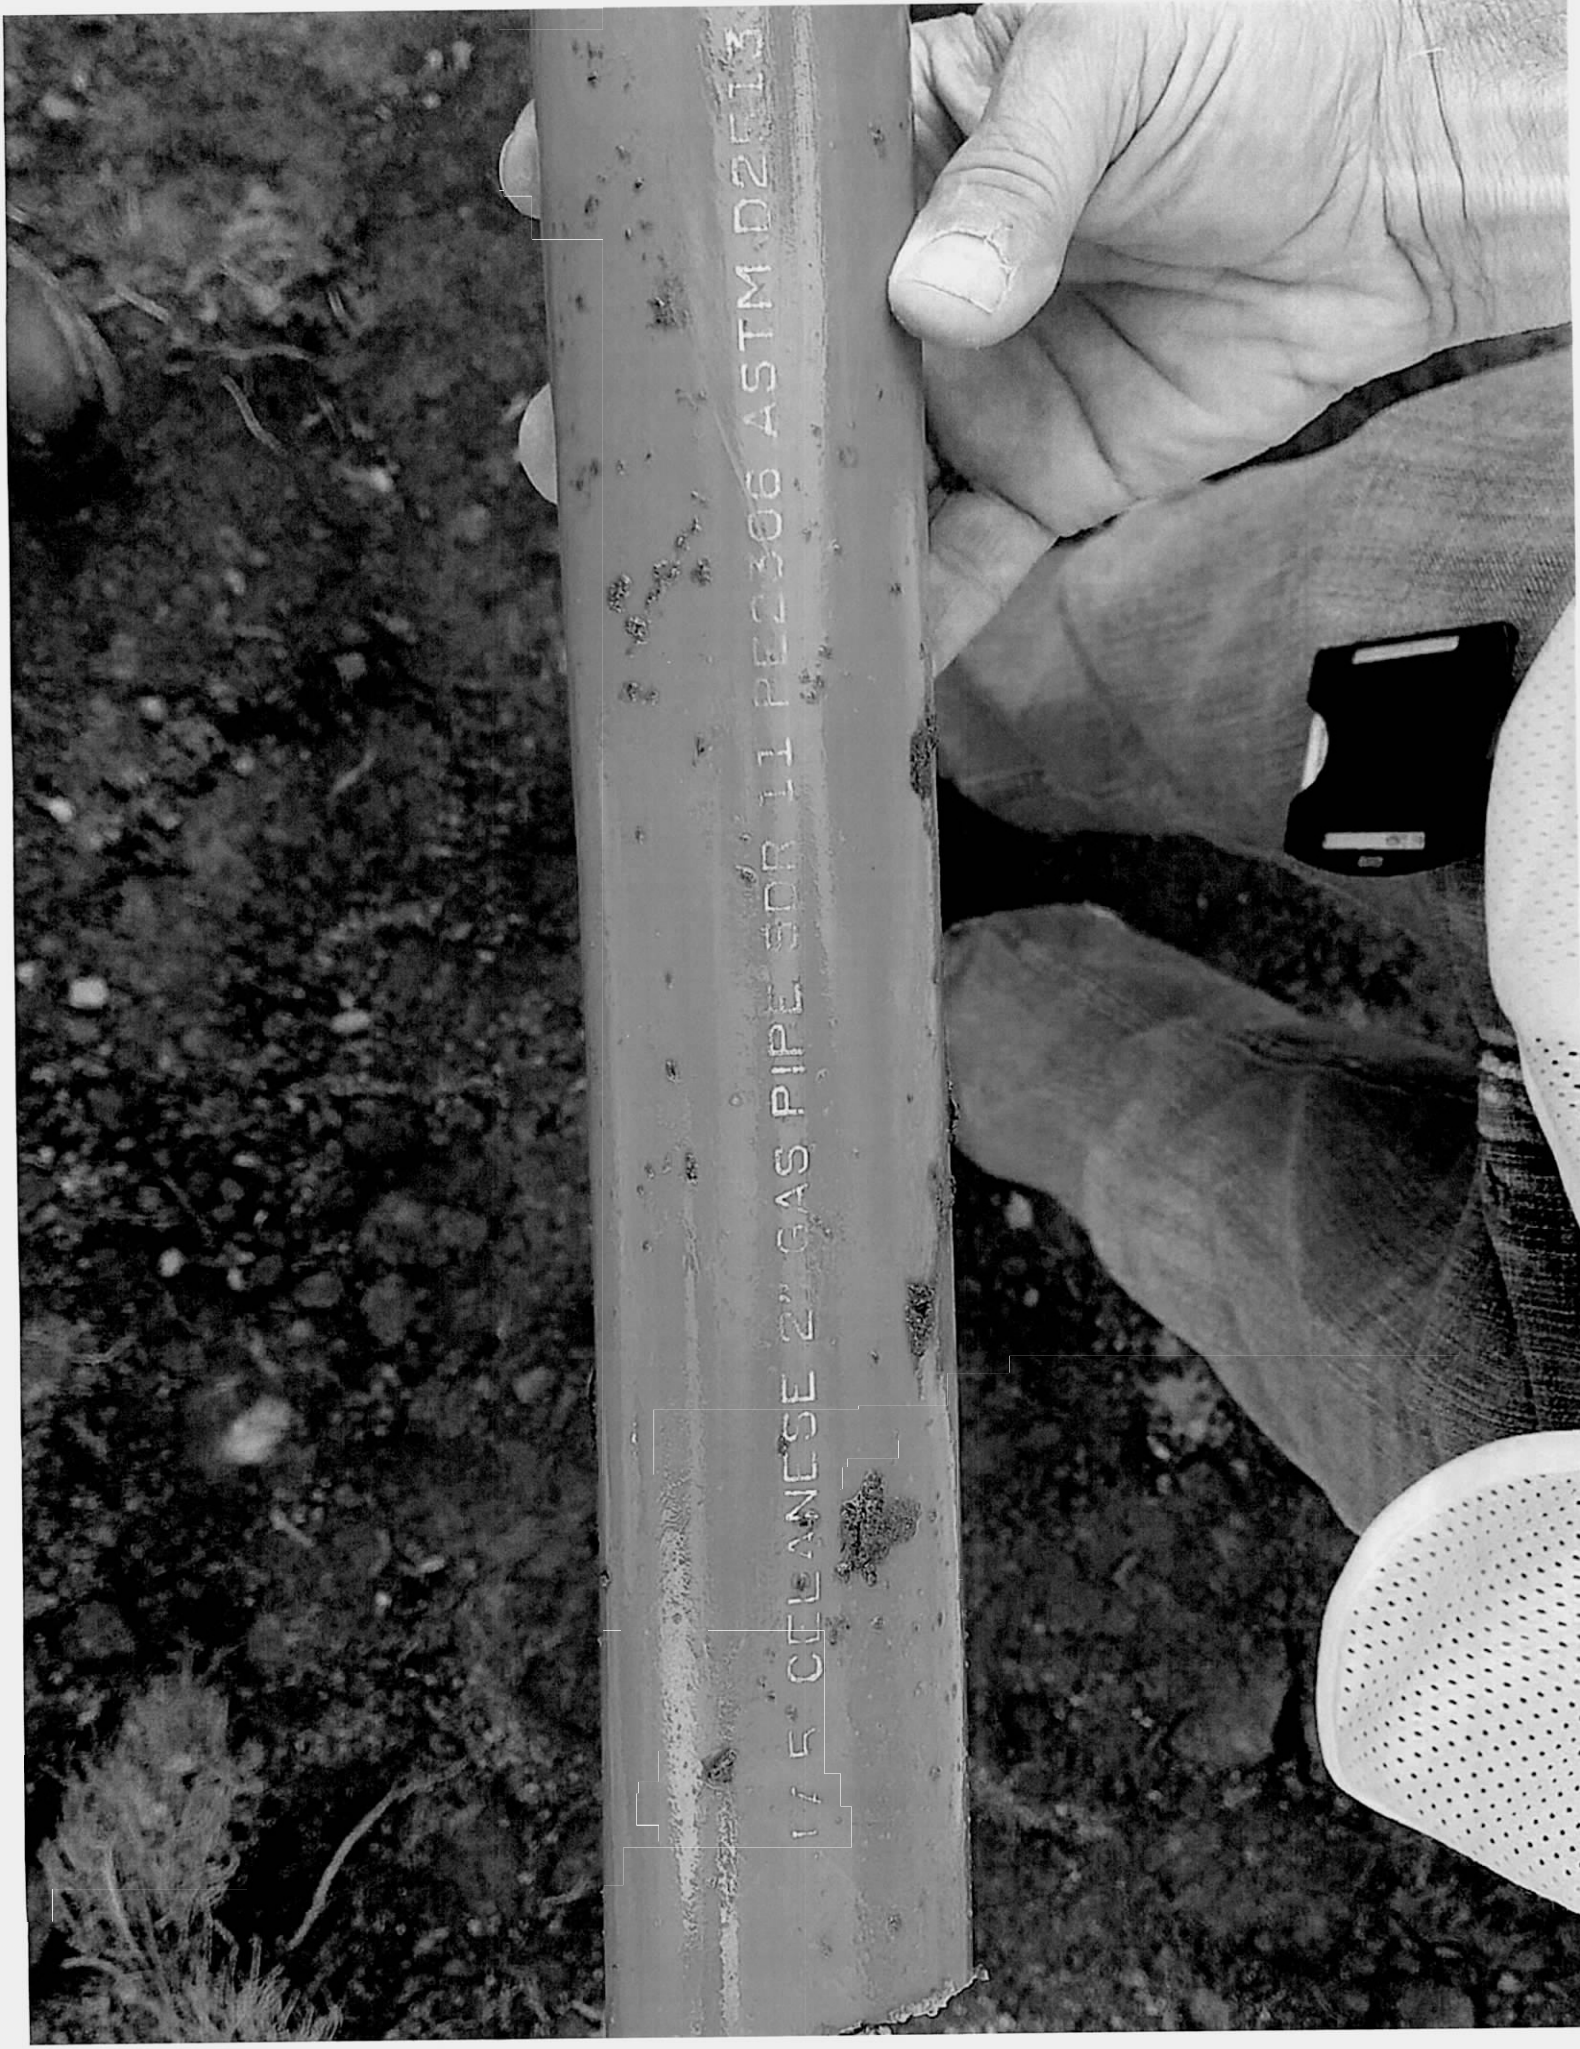
Photo of unmarked service line made of Celanese Two-Inch Gas Pipe.

175 CLEANSE 2" GAS PIPE SDR 11 PE2306 ASTM D2513
