Daily Boom Inspection Form River Bank Inspections

Incident Photos

East End MGP – Ohio Riverbank Mitigation

Summary: Testimony Shawn Fiore SSF-5 Attachment (Part 2) electronically filed by Mrs. Debbie L Gates on behalf of Duke Energy Ohio Inc. and D'Ascenzo, Rocco O. Mr. and Kingery, Jeanne W and Vaysman, Larisa

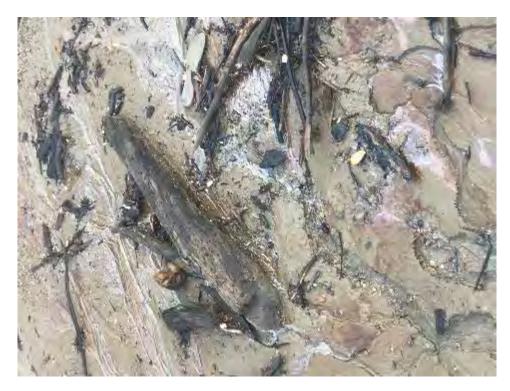
July 18, 2019 Sheen Photo

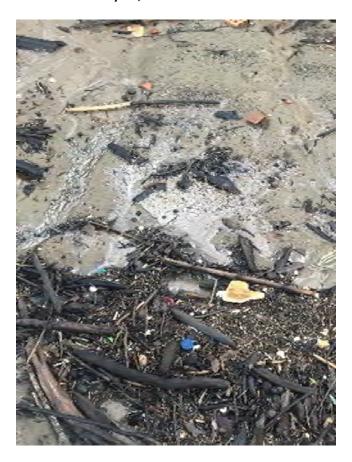
July 18, 2019 Sheen Photo
