Overpressurization of Natural Gas Distribution System,  
Explosions, and Fires in  
Merrimack Valley, Massachusetts  
September 13, 2018

NTSB/PAR-19/02  
PB2019-101365

# Pipeline Accident Report

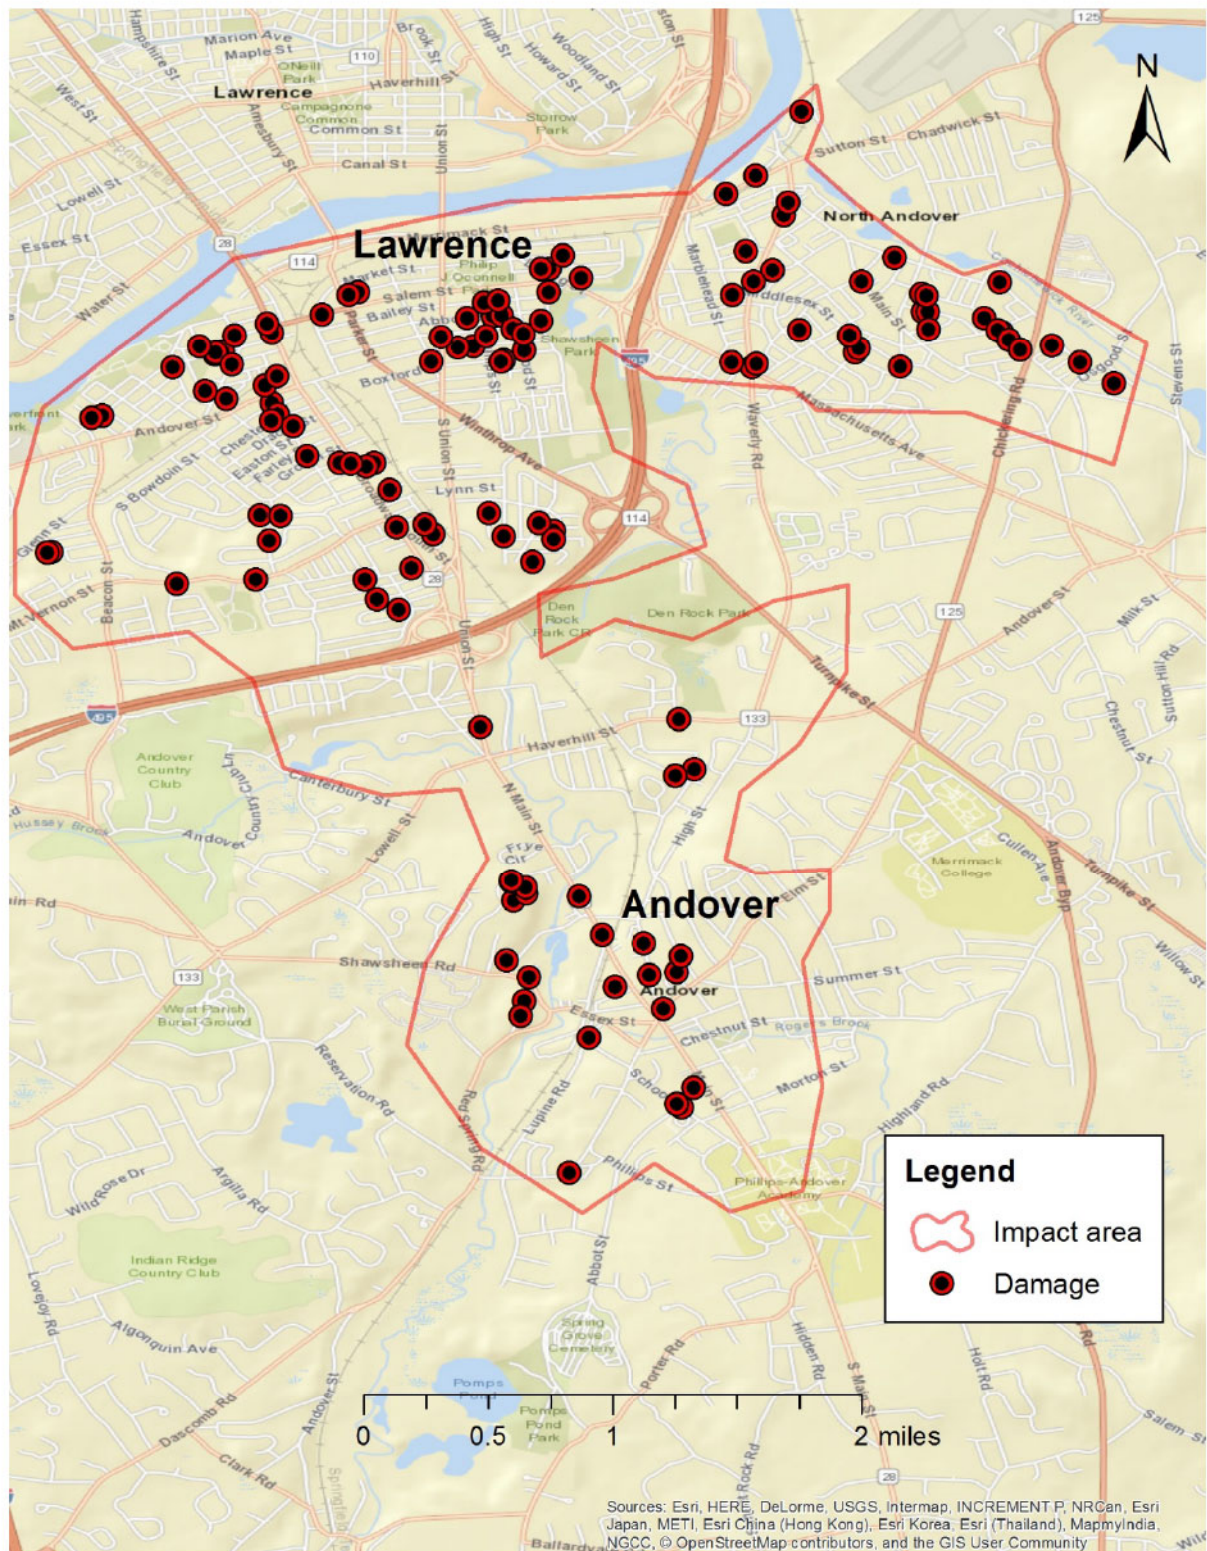
On September 13, 2018, about 4:00 p.m. local time, a series of structure fires and explosions occurred after high-pressure natural gas was released into a low-pressure natural gas distribution system in the northeast region of the Merrimack Valley in the Commonwealth of Massachusetts. The natural gas distribution system was owned and operated by Columbia Gas of Massachusetts (CMA), a subsidiary of NiSource, Inc. CMA delivers natural gas to about 325,000 customers in Massachusetts. The fires and explosions damaged 131 structures, including at least 5 homes that were destroyed in the city of Lawrence and the towns of Andover and North Andover. (See figure 1.) Most of the damage occurred from fires ignited by natural gas-fueled appliances; several of the homes were destroyed by natural gas-fueled explosions. Fire departments from the three municipalities were dispatched to the fires and explosions. First responders initiated the Massachusetts fire-mobilization plan and received mutual aid from neighboring districts in Massachusetts, New Hampshire, and Maine. Emergency management officials had National Grid United States (NG) (the electric utility) shut down electrical power in the area, the state police closed local roads, and freight and passenger railroad operations in the area were suspended. CMA shut down the low-pressure natural gas distribution system, affecting 10,894 customers, including some outside the affected area who had their service shut off as a precaution.

**Figure 1.** Map of the damaged structures in the area impacted by the overpressurization.

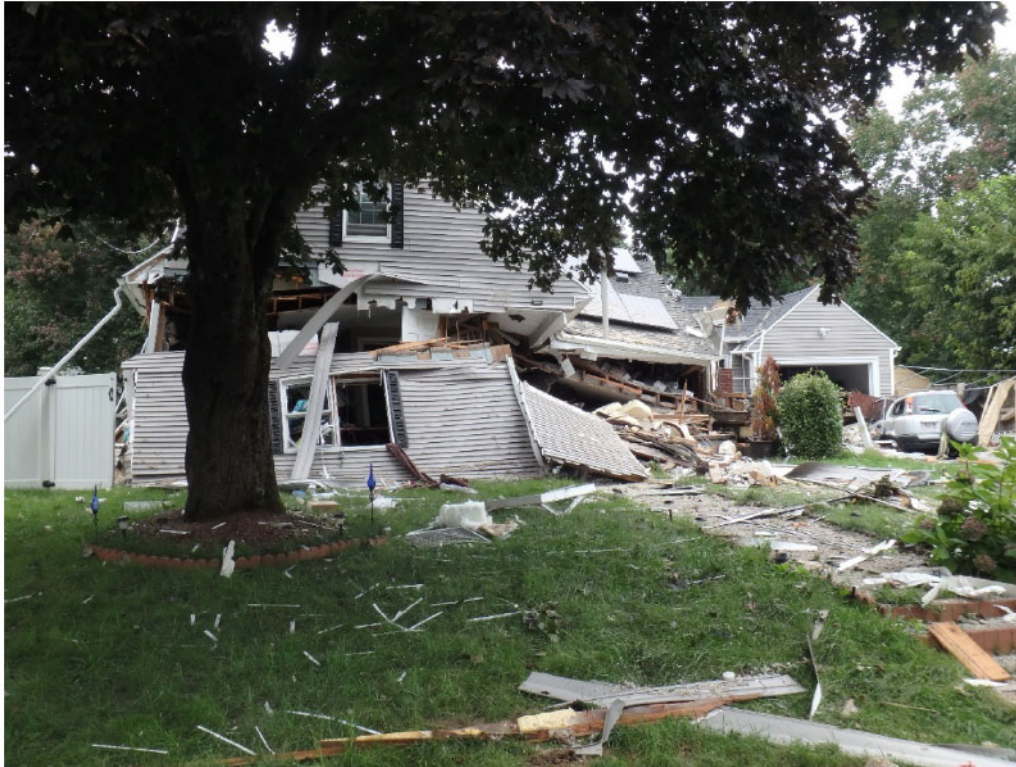
An 18-year-old male was killed when a home exploded, and the chimney fell onto the vehicle where he was sitting. (See figure 2.) Another person in the vehicle at the time of the

explosion was seriously injured, as was someone on the second floor of the house. In total, 22 people, including 3 firefighters, were transported to hospitals for treatment of their injuries. Injuries included respiratory injuries related to smoke inhalation from fires and musculoskeletal injuries from evacuating. Some people were transported to hospitals to maintain ongoing medical treatment that could not be continued in their homes because of the shutdown of natural gas and electricity and the evacuation of residents.

**Figure 2.** Remnants of house where the fatality and two severe injuries occurred.

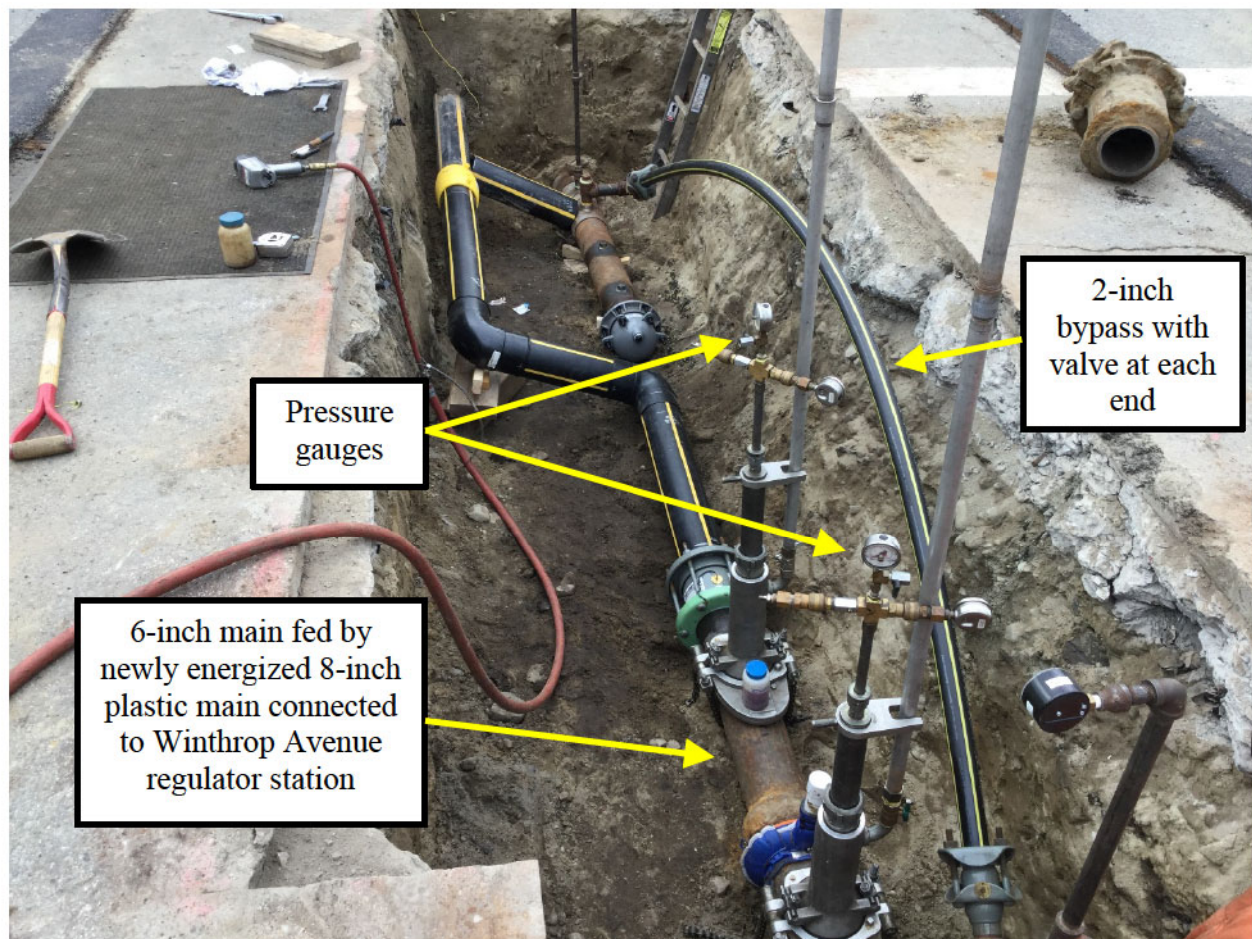
valves on a 2-inch plastic bypass pipe between the cast iron and polyethylene mains.<sup>8</sup> The crew then cut the bypass pipe to abandon the cast iron main. (See figure 5.) In postaccident interviews, crewmembers said that within minutes of closing the valves and cutting the bypass, they observed the pressure gauge on the polyethylene main exceed the expected readings.<sup>9</sup> Furthermore, a fitting on the polyethylene natural gas main blew off into the hand of one of the workers. The crewmembers said that they responded quickly to plug the blowing natural gas, and they heard emergency vehicles in the neighborhood and observed smoke plumes in multiple directions within minutes.

**Figure 5.** Salem Street tie-in for the South Union Street project (looking west). Photograph courtesy of Feeney Brothers.

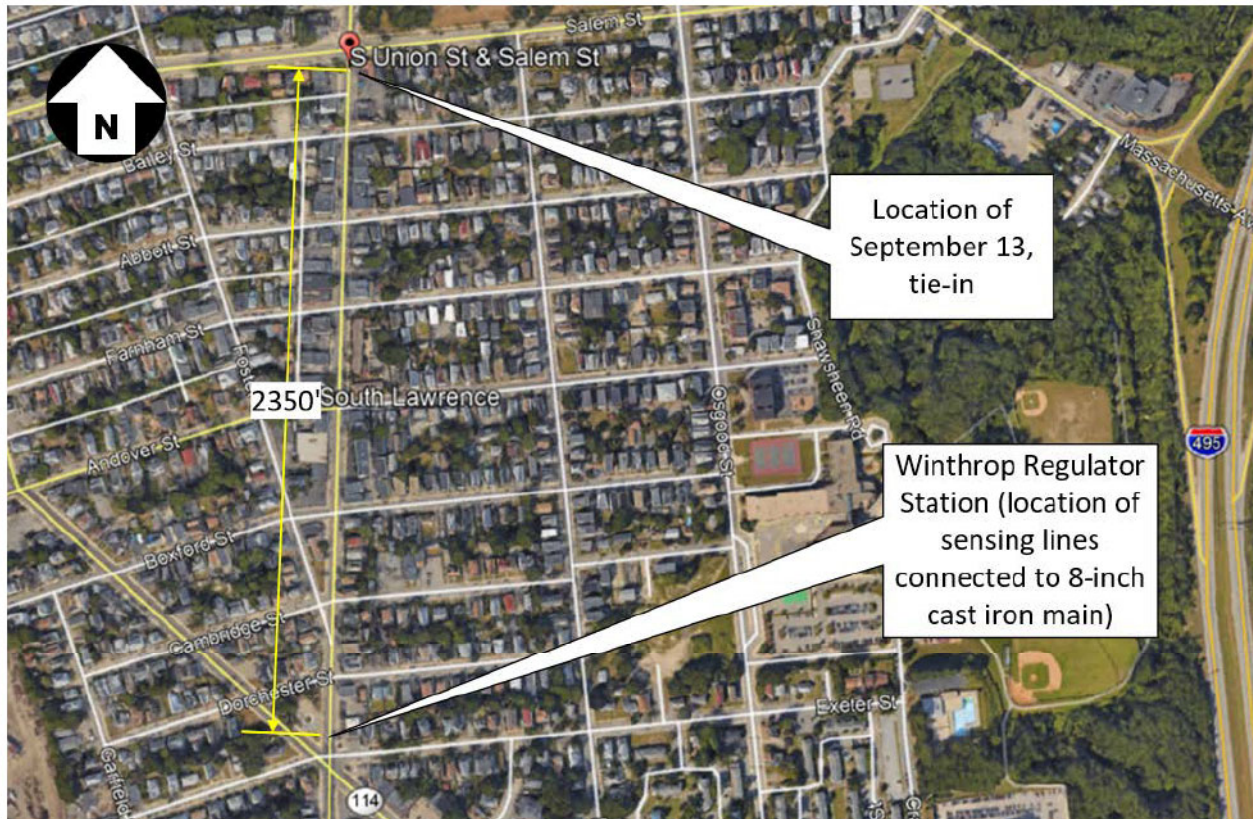
At the Winthrop Avenue regulator station, about 0.5 mile south of the work area, the abandoned cast iron main was still connected to the regulator sensing lines providing input to the two pressure regulators used to control the system pressure.<sup>10</sup> (See figure 6.) Once the contractor

crew isolated the cast iron main, the natural gas pressure began to drop in the cast iron main and in the regulator sensing lines. As the pressure dropped, the pressure regulators responded by opening further, increasing pressure in the natural gas distribution system. Since the Winthrop Avenue regulators no longer sensed system pressure, they fully opened, allowing high-pressure natural gas to be released into the low-pressure natural gas distribution system.

**Figure 6.** Location of September 13, 2018, tie-in and the Winthrop Avenue regulator station.

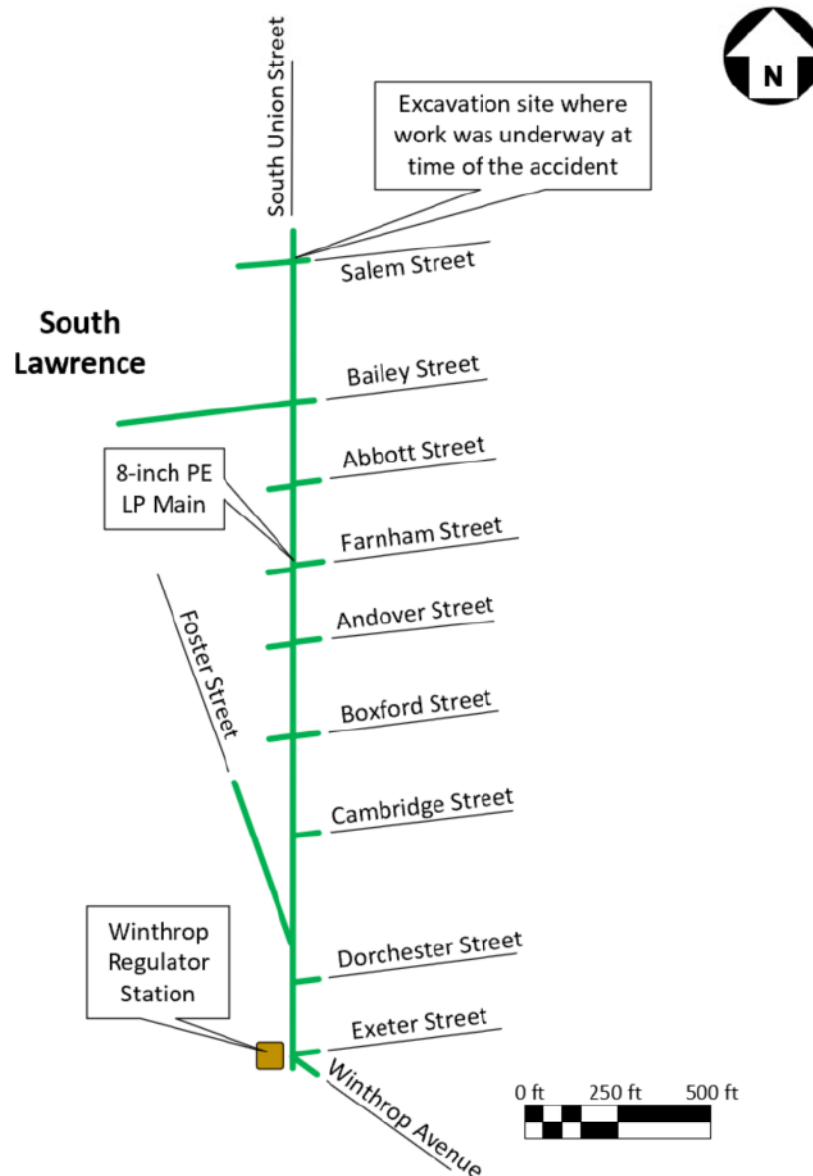
Figure 7 shows the area of the replacement of the natural gas main in South Lawrence along South Union Street with the cross-street tie-ins. The work on the day of the accident was at the north end of the project at Salem Street. The Winthrop Avenue regulator station is at the south end of the project.

**Figure 7.** Areas along South Union Street with tie-ins impacted by the project.

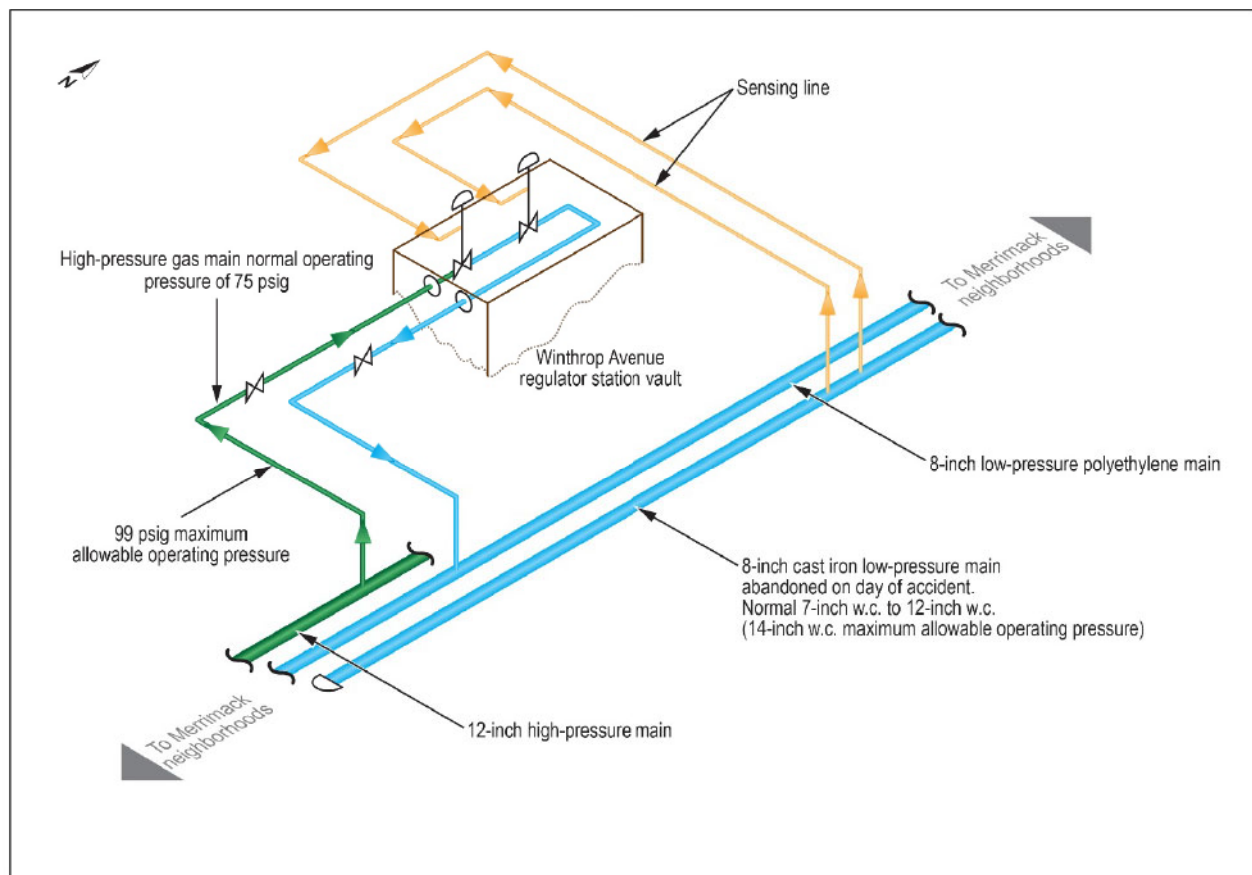
The first stage of the project involved the installation of the polyethylene main, which was completed in late 2016. The regulator sensing lines at the Winthrop Avenue regulator station remained attached to the cast iron main, where they controlled natural gas flow through the

Winthrop Avenue regulator station into both the cast iron and polyethylene mains, which were connected in the low-pressure natural gas distribution system. (See figure 8.)

The city restrictions, due to paving in the area, delayed the South Union Street project for more than a year. Prior to the delay, CMA connected the polyethylene pipe to the distribution system, which allowed it to be monitored for pressure changes. The second stage of the project began in 2018 and involved installing the tie-ins to the polyethylene main and abandonment of the cast iron main. On the day of the accident, the sensing lines were still connected to the cast iron main and were functionally disconnected from the distribution system when the cast iron main was abandoned.

**Figure 8.** The Winthrop Avenue regulator station.
