# **Columbia Gas of Ohio - Zanesville Regulator Failure**

## **Low Pressure MAOP Excursion – May 9, 2019**

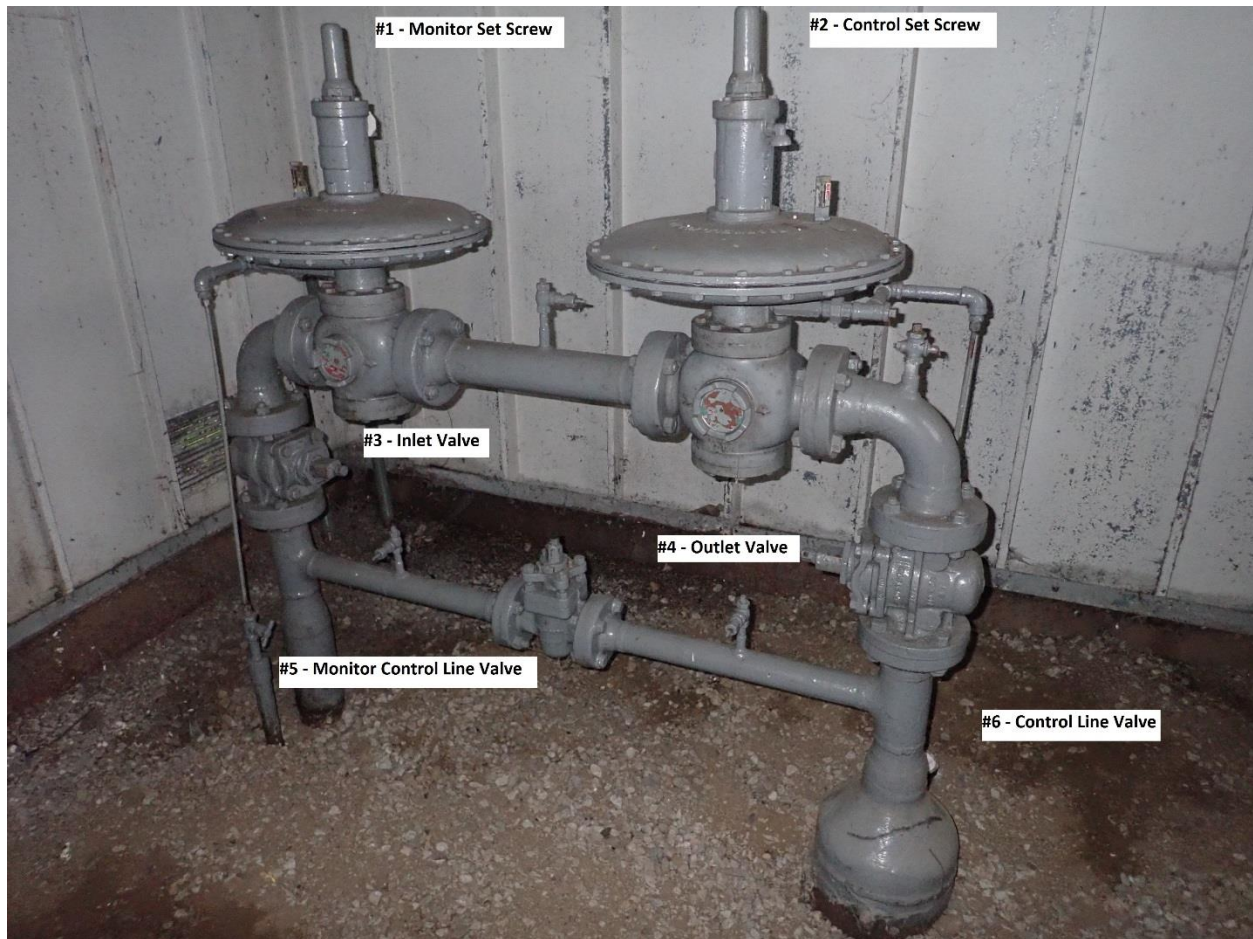
This low pressure regulator is located in Zanesville, Ohio and is one of the two regulator stations feeding into the system, where the operator had a maximum allowable operating pressure ("MAOP") excursion. This station is called the Muskingum Station (DR-14/Premise #401708). The Indiana Station (DR-35/Premise #401715) was operated and the location where the control line valves were shut, but this Muskingum Station photo is a clone to the Indiana Station. The parts of the regulator station are numbered to help explain what actions the Measurement and Regulations ("M&R Tech") performed to cause the MAOP excursion.

The M&R tech forgot to open the monitor control line valve (#5) and the control line valve (#6), which trapped the natural gas between the closed control line valves and the bottom part of the diaphragm of the regulators. This trapped downstream pressure is what causes the diaphragm not to move from the existing spring tension and applied a constant gas flow and pressure. This created a false sensing pressure for the monitor and control regulators, which caused the MAOP Excursion (refer to VIII – Written Statements).

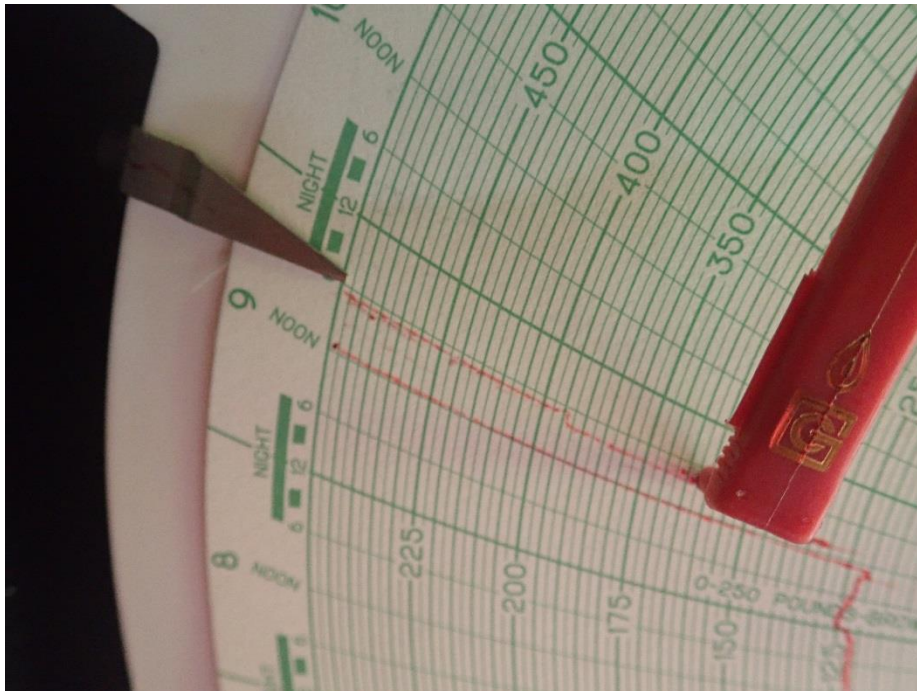
Pressure exceeded chart recorder element pressure (0-25"wc) at Indiana Station

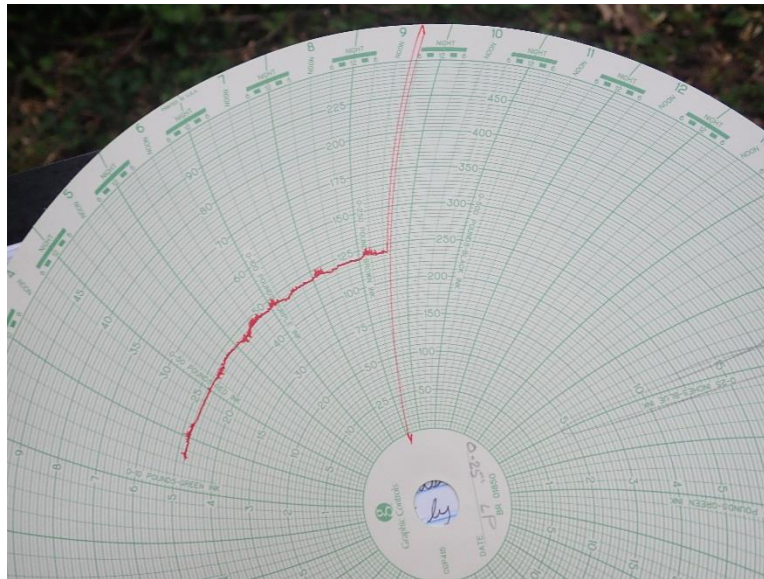
Pressure exceeded chart recorder element at Muskingum station

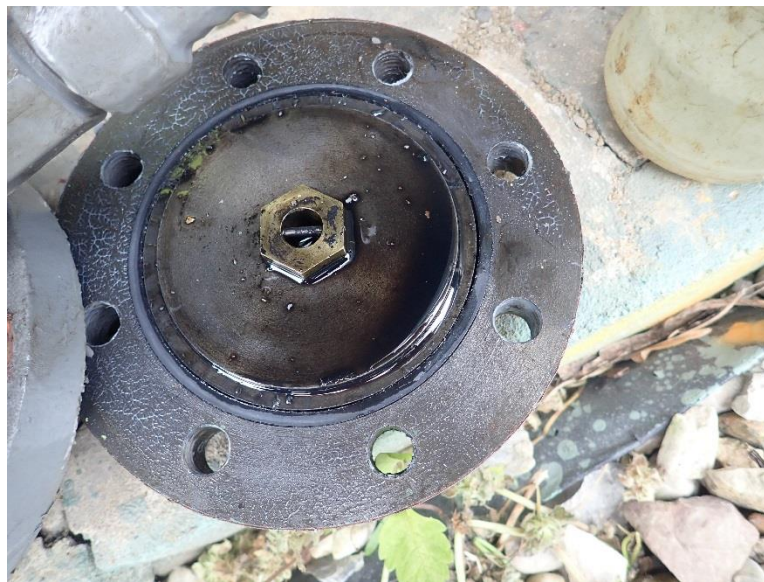
The area manager for COH Three Rivers was on scene and mentioned this system did receive production gas at one time and was known to have water and fluids in the system from time to time.

The operator installed at drip near the piping at the Indiana Low Pressure Regulator Station and found 14 gallons of production fluid. The operator also has producers feeding into the Zanesville systems.

Production Oil – Bottom of Inspection Plate at Indiana Station

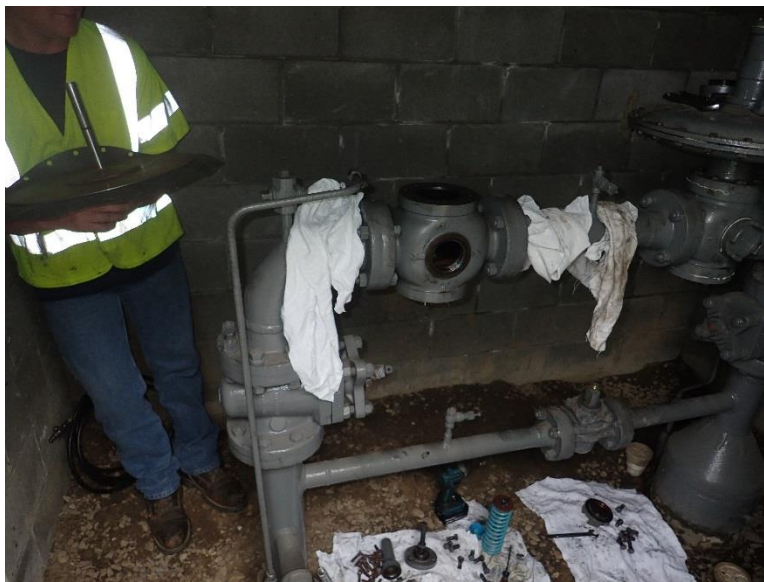
Complete Tear-down Indiana Monitor Regulator

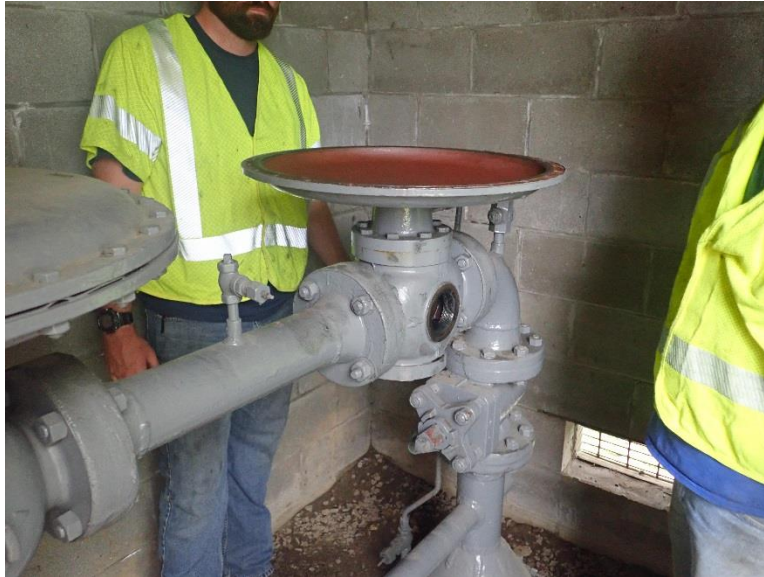
Performing Complete Tear Down of Control Regulator at Indiana Station

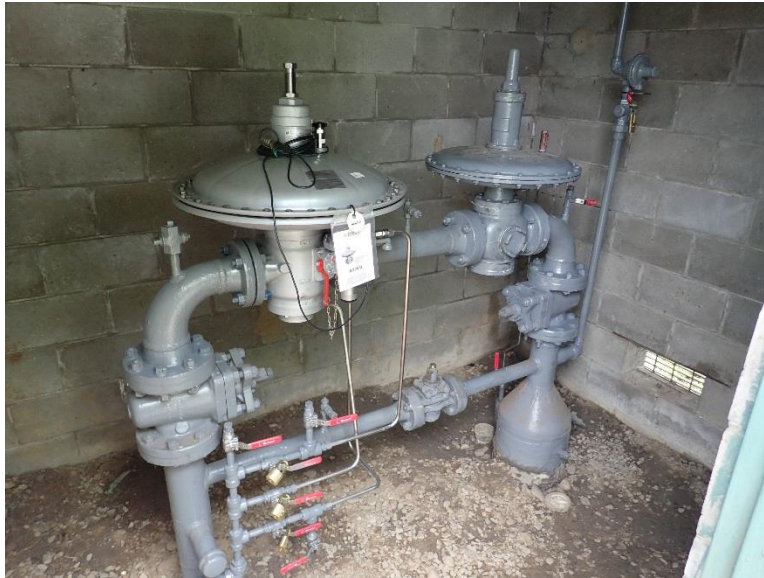
Modified Indiana Station – New PF Monitor Regulator and Token RV

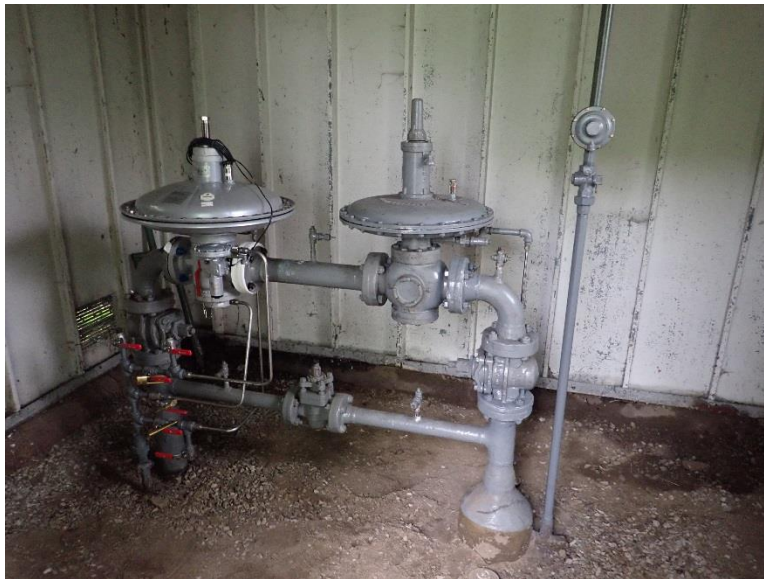
Modified Muskingum Regulator Station – New Monitor PF regulator and Token RV
