Ohio Power Siting Board  
180 E. Broad St.  
Columbus, OH 43215  
Case No. 18-91-EL-BGN

# Incident report

## **Timber Road IV, Ohio, USA Blade Incident on September 3, 2020 V150-4.2 MW Mk 3E**

Date of report: February 5, 2021  
Vestas ref.: 4995  
Document no.: 0104-6124 V00

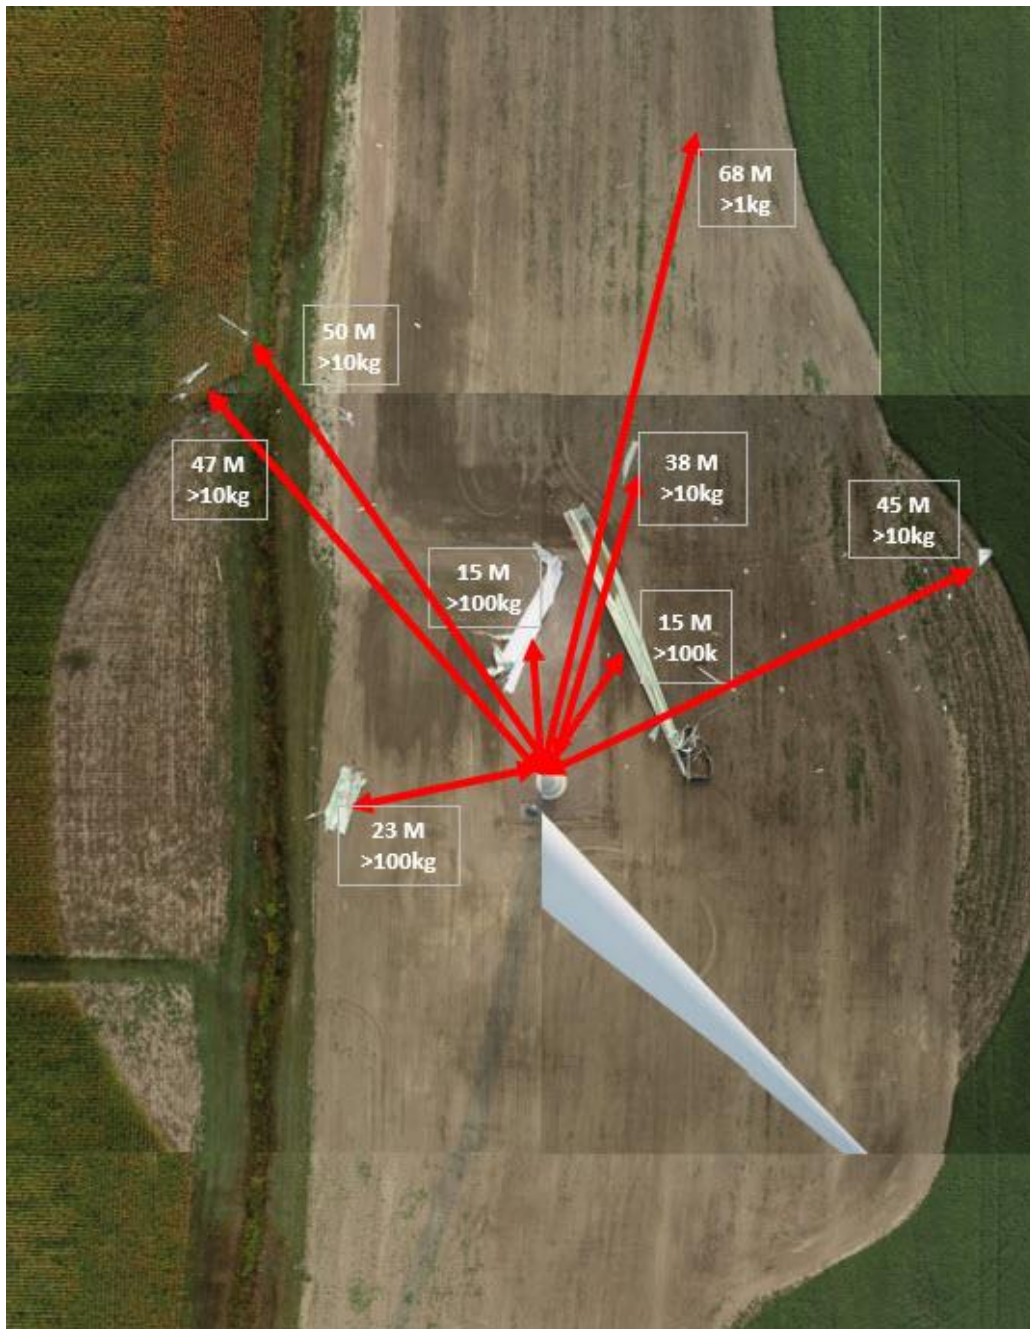
Figure 1 Debris map

A drone inspection performed after the incident provided an immediate overview of the damage incurred. A piece of the broken blade was resting on top of the nacelle and the rest of the broken part had fallen to the ground. In the up-tower inspection, the failed blade was confirmed to be blade C. The debris map in Figure 1 shows the location and estimated weights of all significant debris around the turbine after the incident.

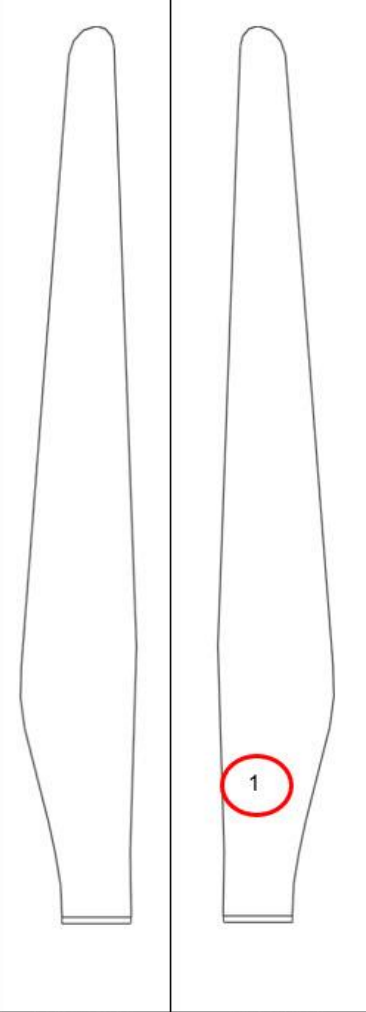
Figure 2 Summary of inspection

After the root section of the damaged blade had been lowered safely and secured below the turbine, an on-site inspection was carried out on October 13-14, 2020 by Vestas specialists. The blade had broken into three sections. The leeward and windward shells of the broken tip section had separated.

Dry laminates were observed in the structural shell interlayer laminate sections in the shell laminate section of the trailing edge panel, and in the laminate panel adjacent to the main web in the leeward shell.

Project no./name:	Timber Road IV	
	Pad no.:	TMR428	
	Comments to the damage shown in the drawing:	1) R7-8 – Break location Dry laminates found Large folded ply/wrinkle found	
Windward	Leeward

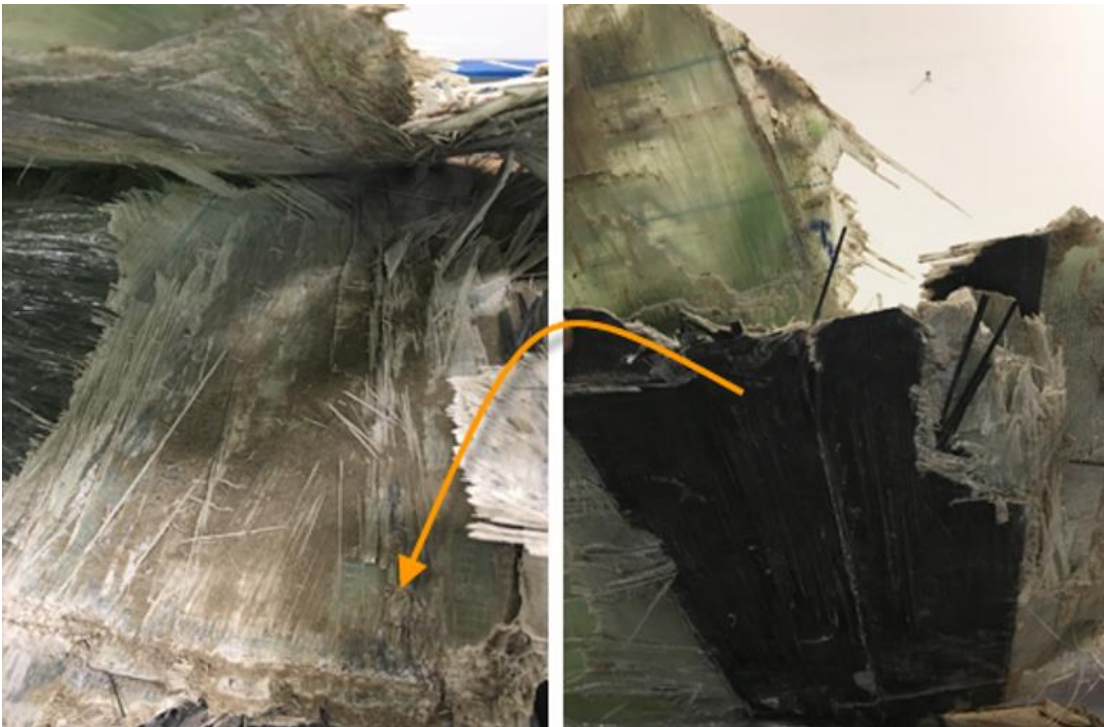
- Dry laminates were observed throughout the thickness of the shell laminate.
- Under-core laminates exhibited poor bonding with the core and the carbon pultrusion indicating poor interlaminar bonding as shown in Figure 3.
- A hole saw cut was made in the laminate section of the leeward shell exposing the dry laminate between the over and under core laminate as shown in Figure 5.

Figure 3 Individual fibers can be pulled from the laminate showing poor consolidation

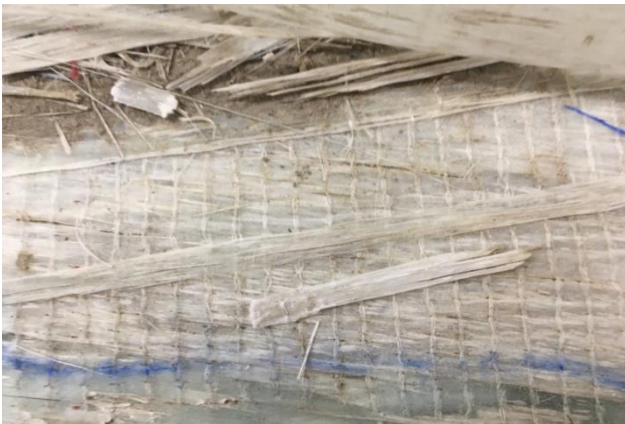
Figure 4 Dry fibers

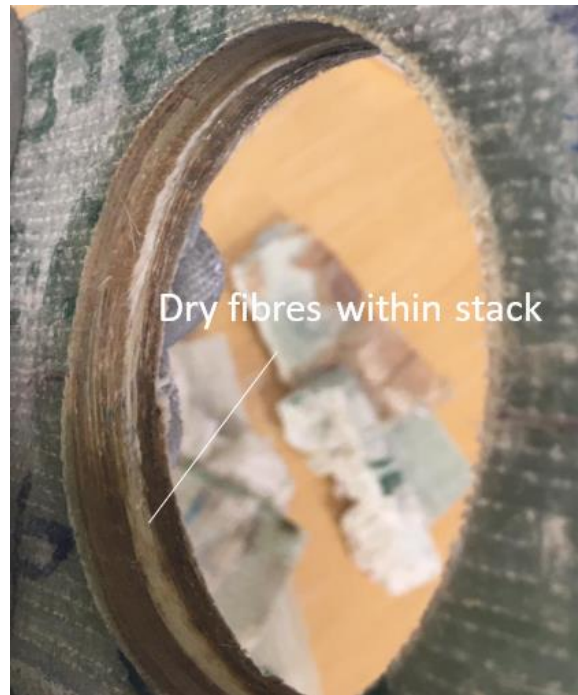
Figure 5 Hole cut through shell - dry laminate layer in the middle of the shell
