Case number: 18-0091-EL-BGN

Document Description: Incident Report - pages 2, 5, 6, 8, and 9

On September 3, 2020 at approximately 22:36 hours local time, a Vestas V150 4.2MW wind turbine at Paulding Wind Farm IV ("Timber Road IV") in Paulding County experienced a blade failure. Damaged blade debris has fallen to the crane pad and within an approximate 90-meter radius around the turbine.

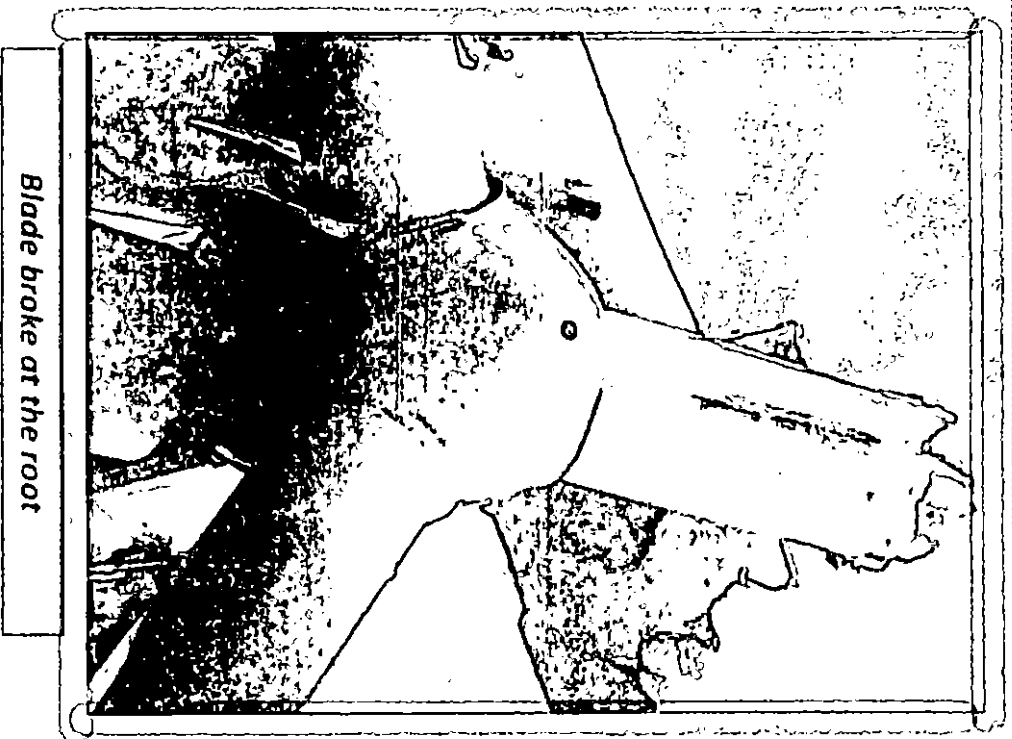
*Blade broke at the root*

Preparations are underway to ready a crane and necessary equipment to remove the damaged root section of the failed blade. This work is currently scheduled during the week of October 5. Once the remaining blade section is safely removed, Vestas and Timber Road IV Engineering will be on site to perform the field investigation. This material will be incorporated into Vestas' root cause analysis. This root cause analysis and final incident report is expected to take several weeks after the field investigation. Timber Road IV intends to submit the same to OPSB once the full root cause analysis is completed and the report becomes available.
