From: [Puco ContactOPSB](#)
To: [Puco Docketing](#)
Subject: public comment: 16-2443-EL-BGN, 18-0090-EL-BGA, 20-0033-EL-BGA, 21-0182-EL-BGA
Date: Monday, July 18, 2022 8:59:43 AM
Attachments: [GPS report 6-29-2022-Draft.docx](#)

Guernsey Power Station: Environmental Impacts Status Report

June 29, 2022

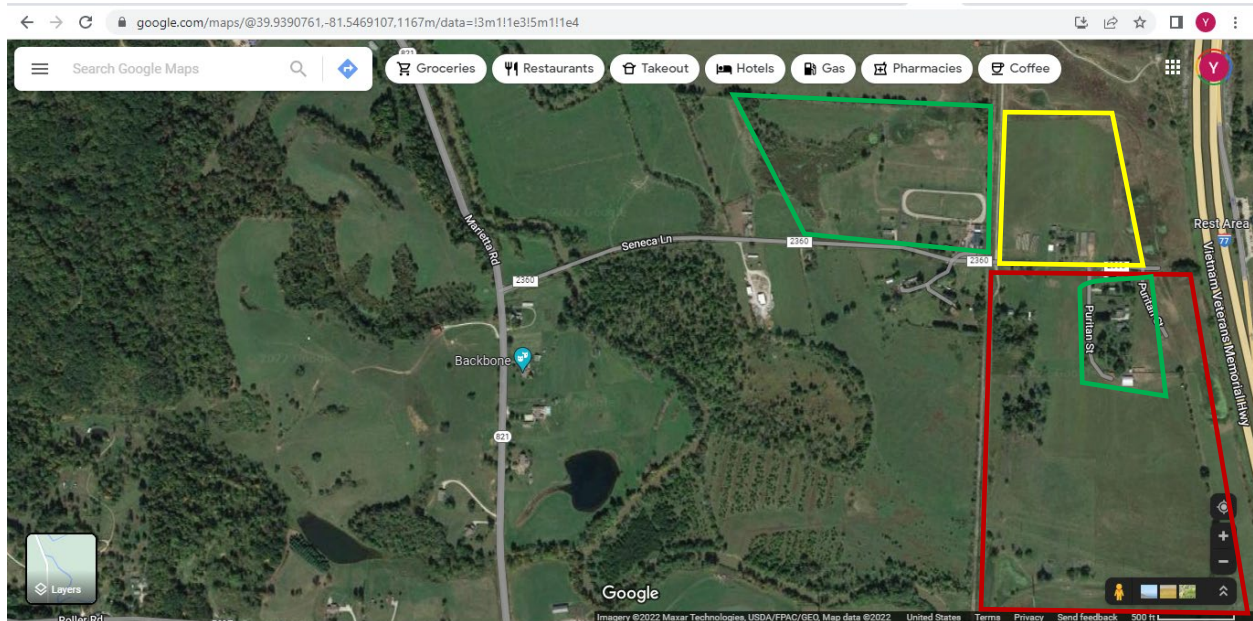
Figure 1. Location of GPS before preparation and construction. The location of the industrial site (approximately 150 acres) is outlined in red. The location of the laydown yard (approximately 100 acres) is outlined in yellow. Resident properties and homes directly impacted by site preparation and construction are outlined in green. Please note the oval horse track located on property owned by Kevin Young.

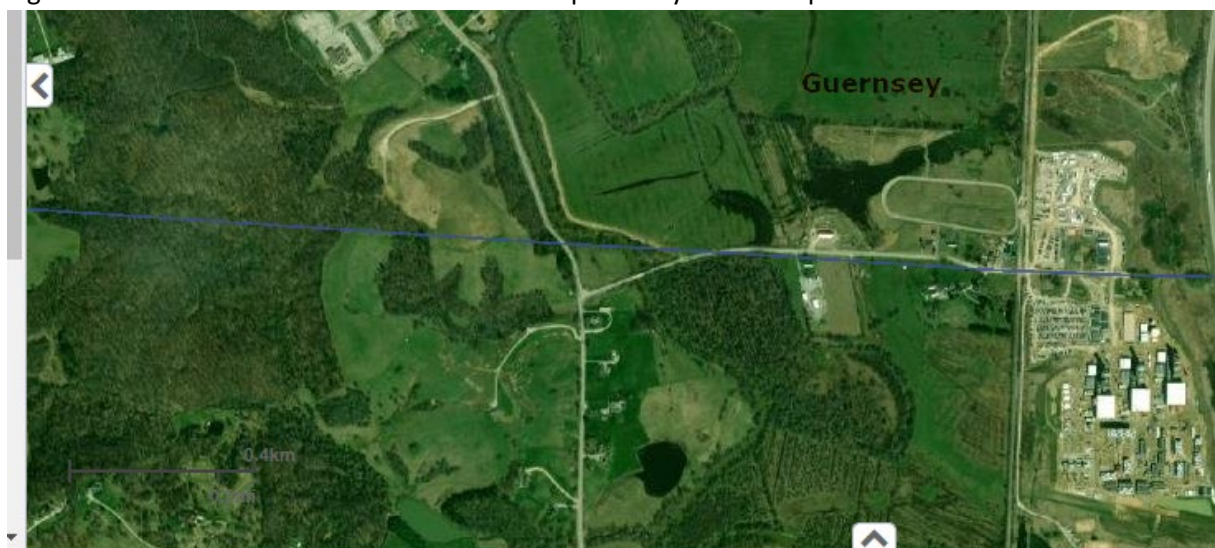
Figure 2. Aerial view of GPS and surrounding area during construction.

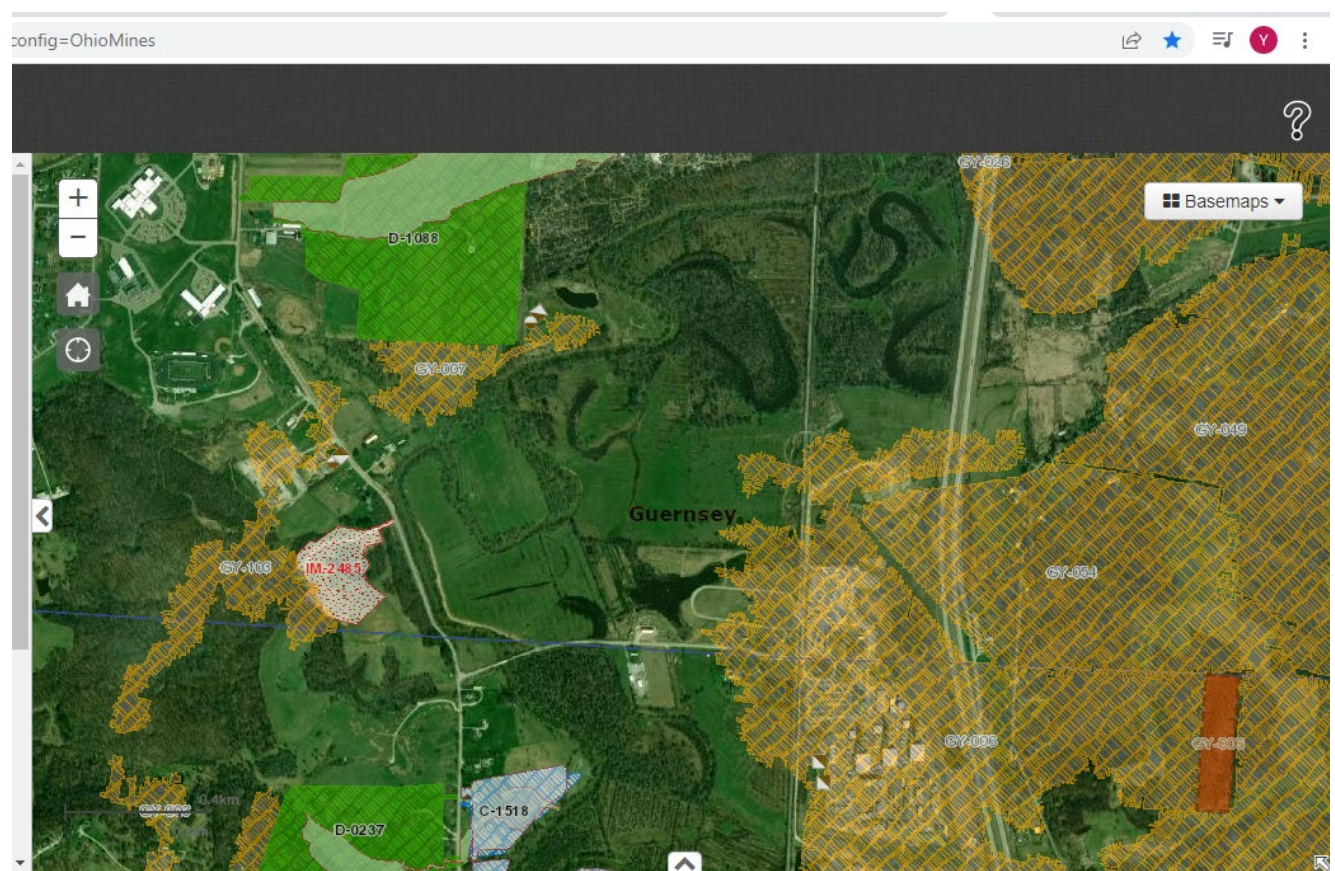
The entire GPS construction site and much of the private property sits above an abandoned coal mine. Figure 3 shows the network of tunnels located about 150' below the surface (ODNR Mine Map Viewer). Tunnels located below GPS were filled with coal ash prior to construction to stabilize the subsurface and support the weight of the facility. Coal ash was blended with fluids of unknown composition and the slurries were injected using hundreds of injection wells that were drilled every 25'. Residents endured extremely poor air quality during the injection period, which lasted for several months. One family living next to the site, which included a 4-year-old girl and her mother and grandfather, were relocated after being forced to find a lawyer and endure a lawsuit to be compensated for property values that became worthless after air and drinking water well contamination that caused serious health problems.

Figure 3. This map illustrates the extent of abandoned coal mines (yellow grids). Note that the fringe of the mines is located directly under the oval horse track and continues northward. An open airshaft located north of the track previously contained water and formed a small pond measuring about 5' in diameter. Following subsurface stabilization (coal ash injection) and addition of compacted fill material that increased the elevation of the construction site and laydown yard by approximately 30', this small pond developed into a 2-acre lake.
