**BEFORE
THE PUBLIC UTILITIES COMMISSION OF OHIO**

Citizens Against Clear Cutting, et al.)	
)	
Complainants,)	
)	
v.)	Case No. 17-2344-EL-CSS
)	
Duke Energy Ohio, Inc.,)	
)	
Respondent)

**DIRECT TESTIMONY OF TIM BACK
ON BEHALF OF
COMPLAINANTS**

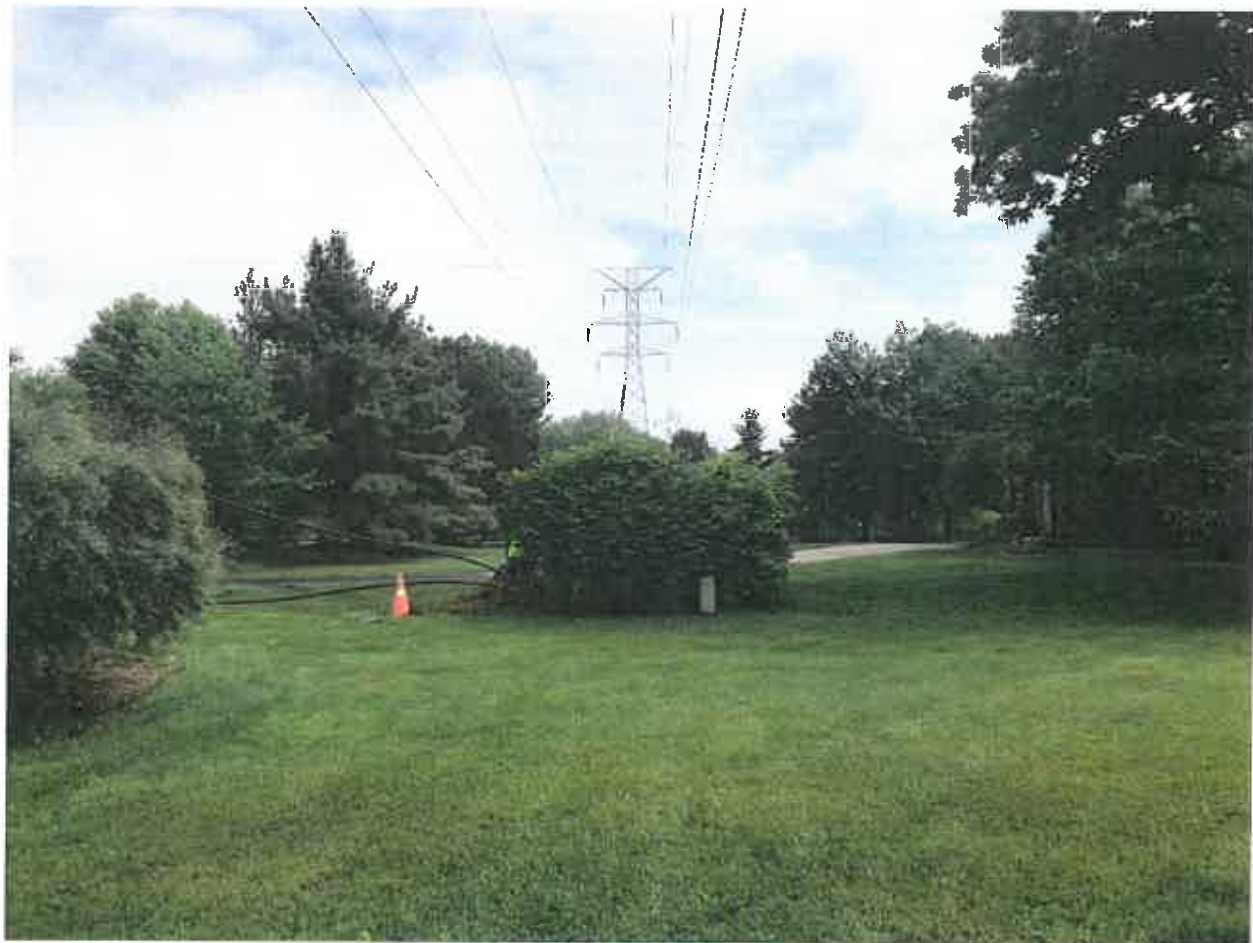
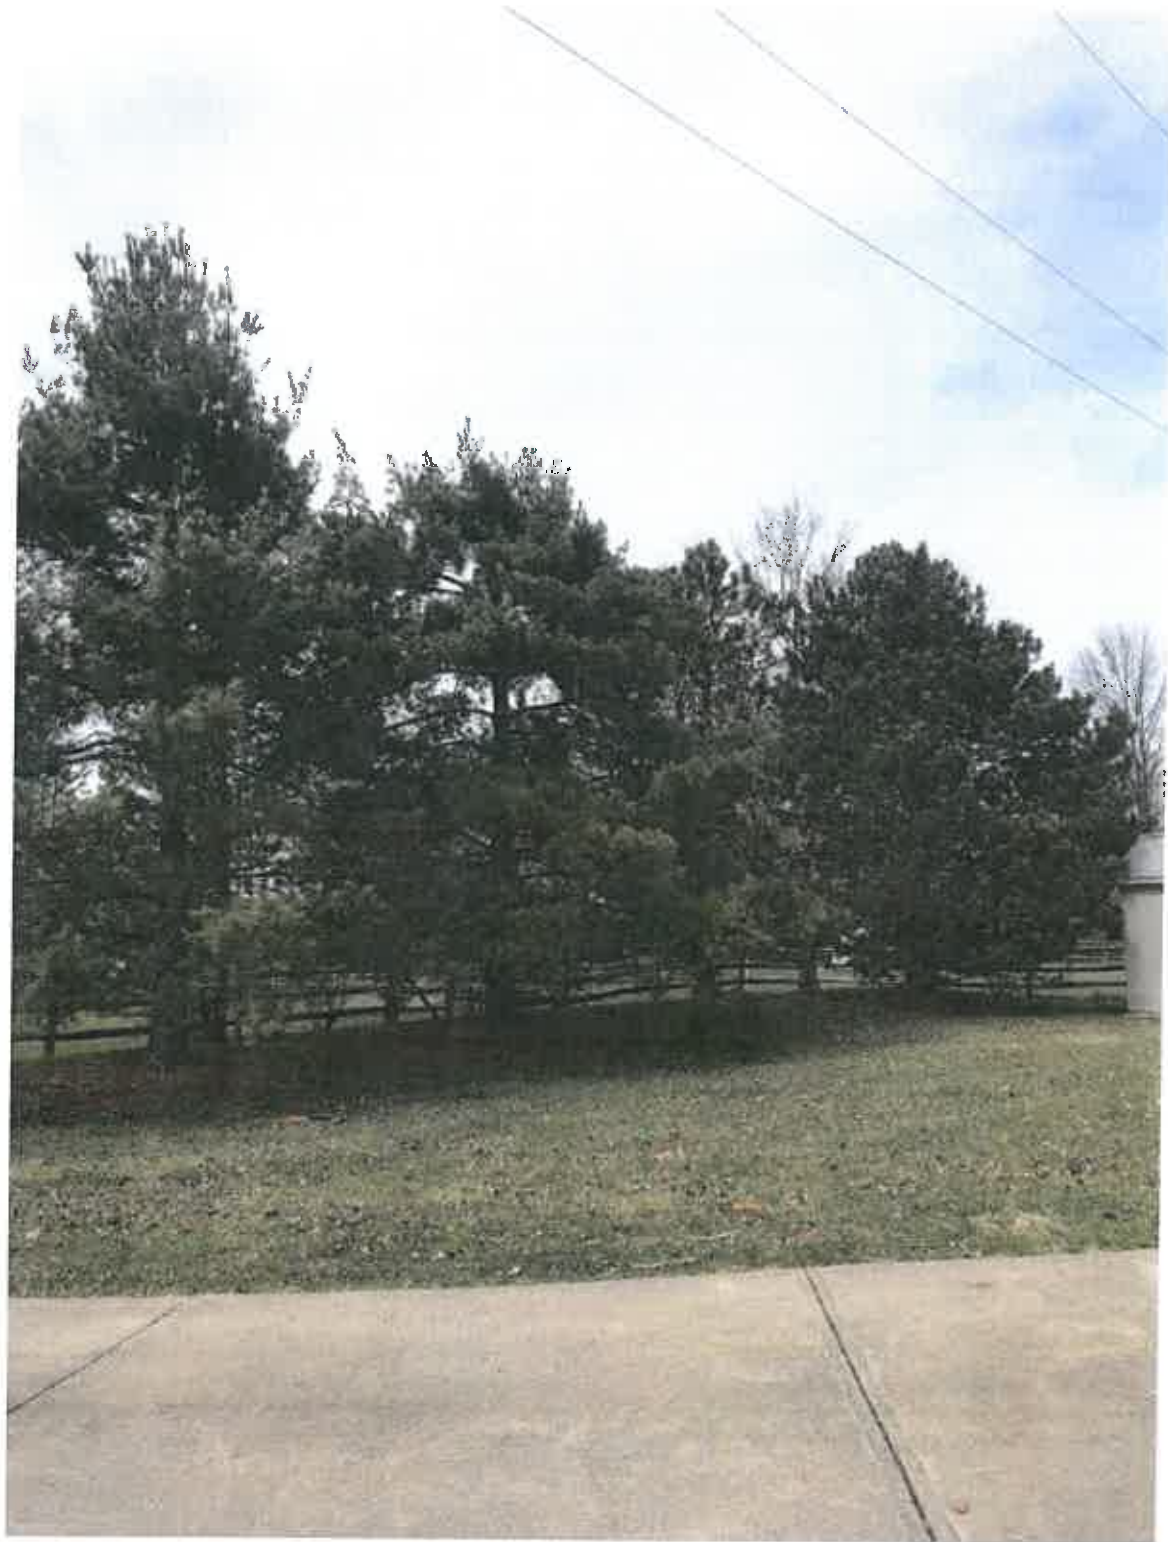
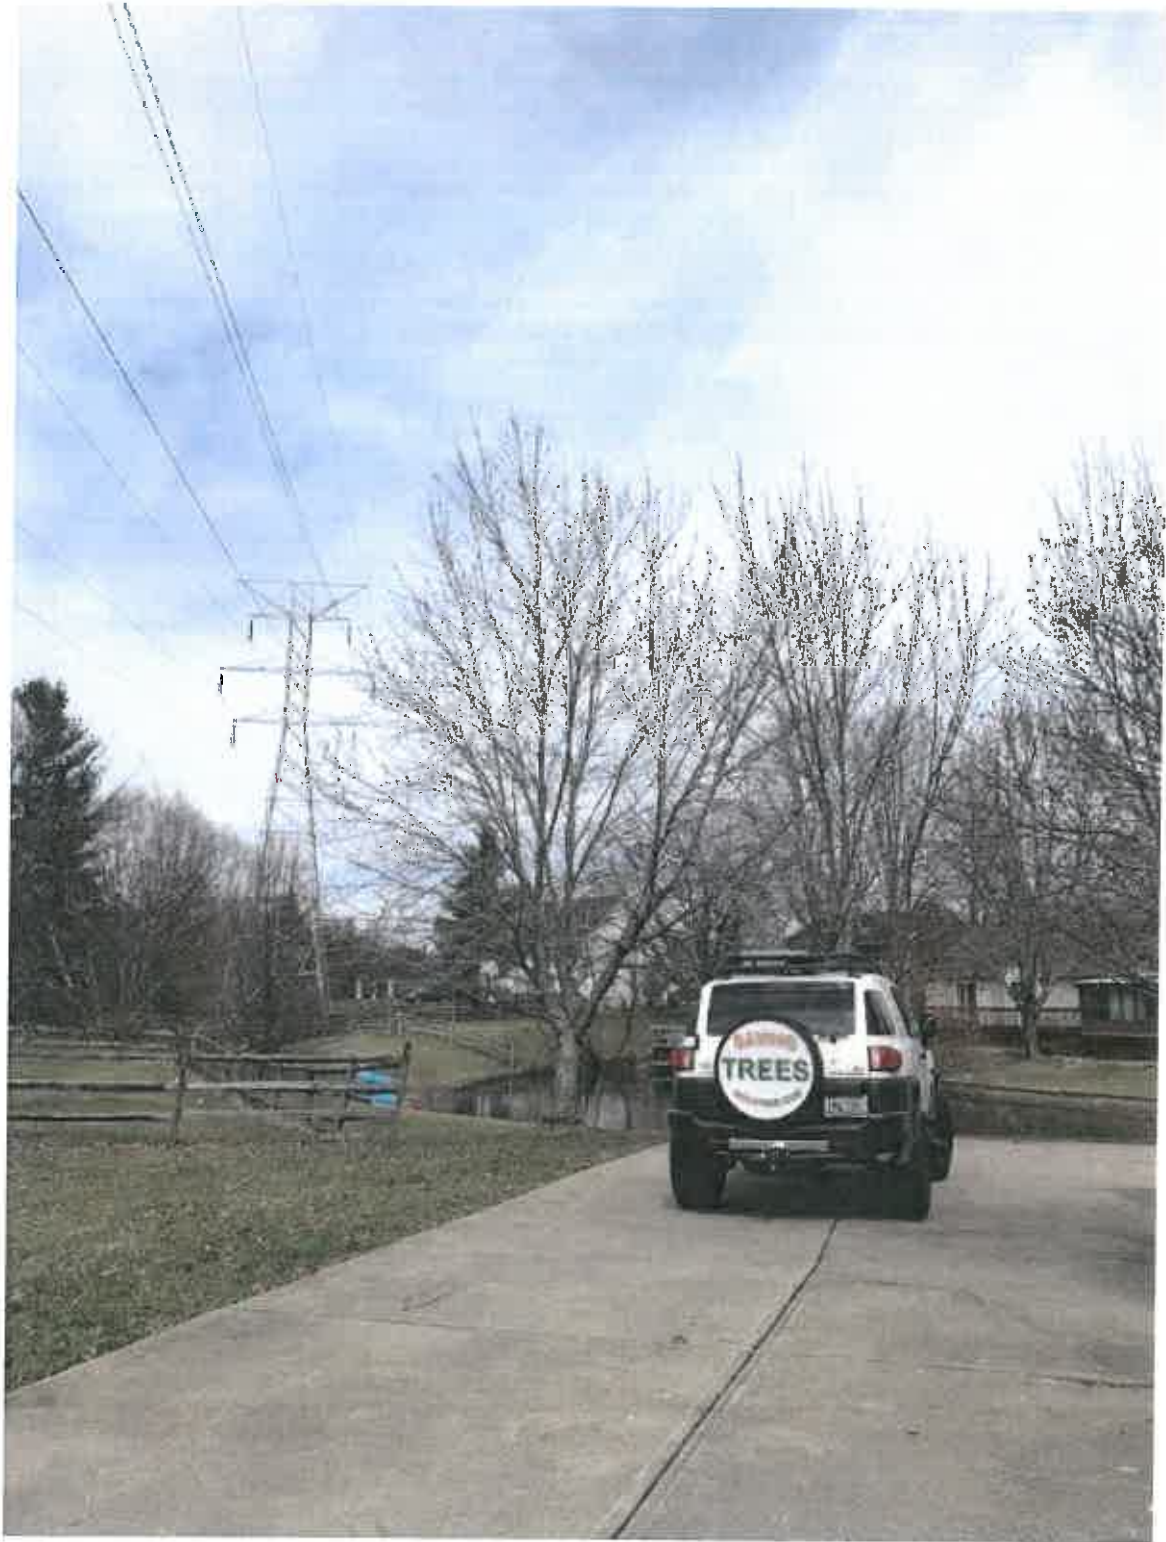
APPENDIX B – PHOTOGRAPHS

TREE SPECIES	HEIGHT	GROWTH RATE/ MATURE HEIGHT	LOCATION RELATIVE TO OUTERMOST CONDUCTOR	CLEARANCE OF TREE TO NEAREST CONDUCTOR	SUGGESTIONS
Shagbark Hickory	73 feet	12 inches per year/ 100 feet	26 feet 3 feet periperial zone	12 feet	Side trimming will create a hazard due to extreme imbalance. Do not remove. Suggest crown reduce entire canopy by near 30 percent for balance.
Red Sunset Maple	38 feet	13 inches to more than 24 inches per year/ 45-50 feet	20 feet	24 feet	Crown reduce entire canopy by near 25 percent and treat with growth regulator
Austrian Pine	33 feet	13-24 inches per year/ 50-60 feet	16 feet	20 feet	Crown reduce to near 25 feet and treat with growth regulator. In this region this species is about half of growth rate
Austrian Pine	25 feet	13-24 inches per year/ 50-60 feet	7 feet	15 feet	Treat with growth regulator. In this region this species is about half of growth rate.
White Pine	23 feet	13-24 inches per year/ 50-60 feet	11 feet	14 feet	Treat with growth regulator

Mulberry	16 feet	Fast/ 50-60 feet	7 feet	24 feet	Suggest growth regulator, no reduction needed
Burning Bush	10 feet	8-10 feet	8 feet	30 feet	Do not remove. Maturity height has no concerns.
Burning Bush	10 feet	8-10 feet	8 feet	30 feet	Do not remove. Maturity height has no concerns.
Lilac	10 feet	8-10 feet	1 foot	30 feet	Do not remove. Maturity height has no concerns.

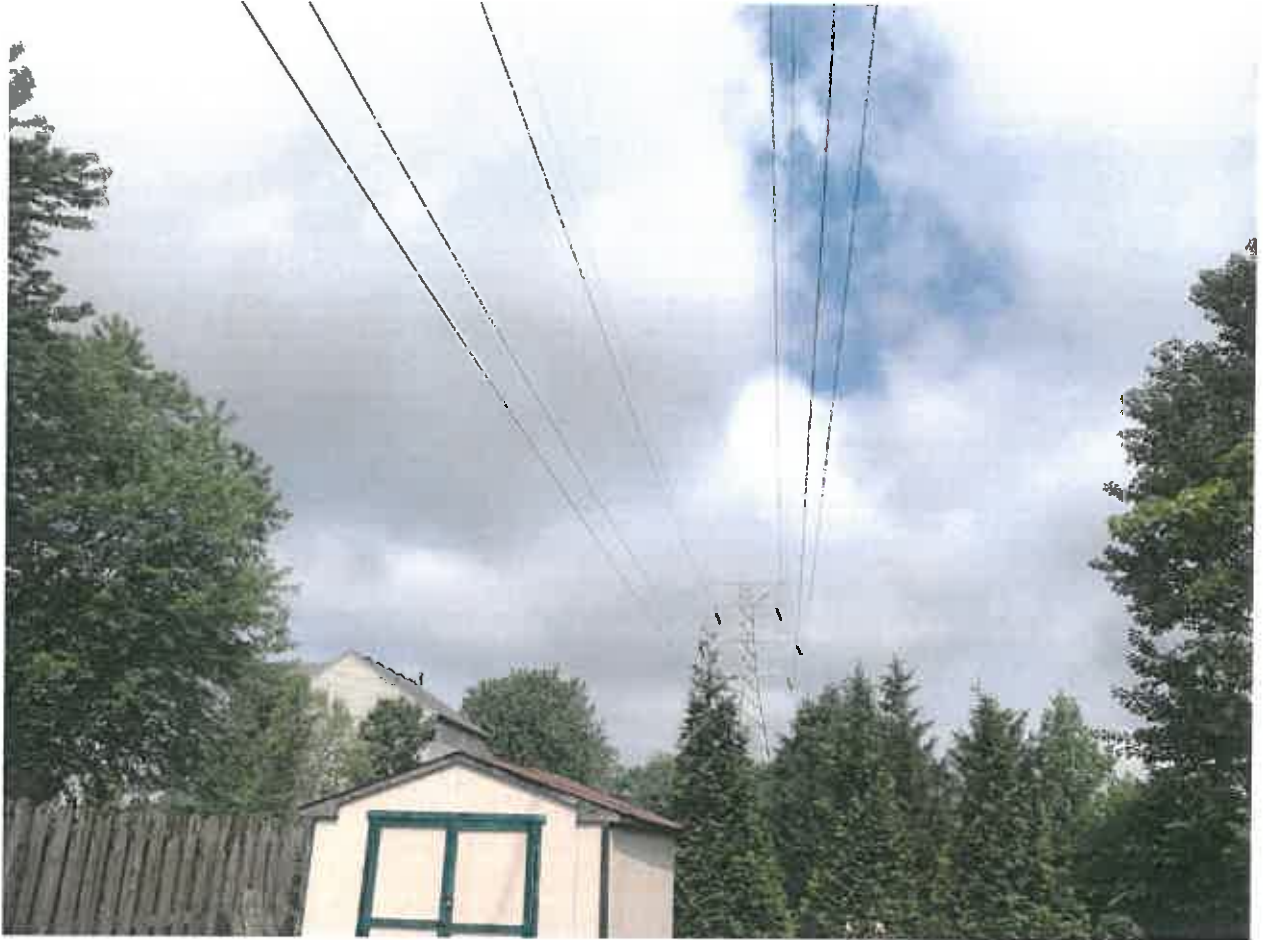
APPENDIX B – PHOTOGRAPHS

Maintain proper height by trimming every 3-5 years.
Red Bud	12	Medium/ 20-30 feet	31 feet	48 feet	Do not remove due to water retention. Maintain proper height by trimming every 3-5 years.
Silver Maple	50	More than 24 inches per year/ 50-80 feet	38 feet 3 feet peripheral	15 feet	Do not remove due to water retention. Maintain proper height by trimming every 3-5 years.

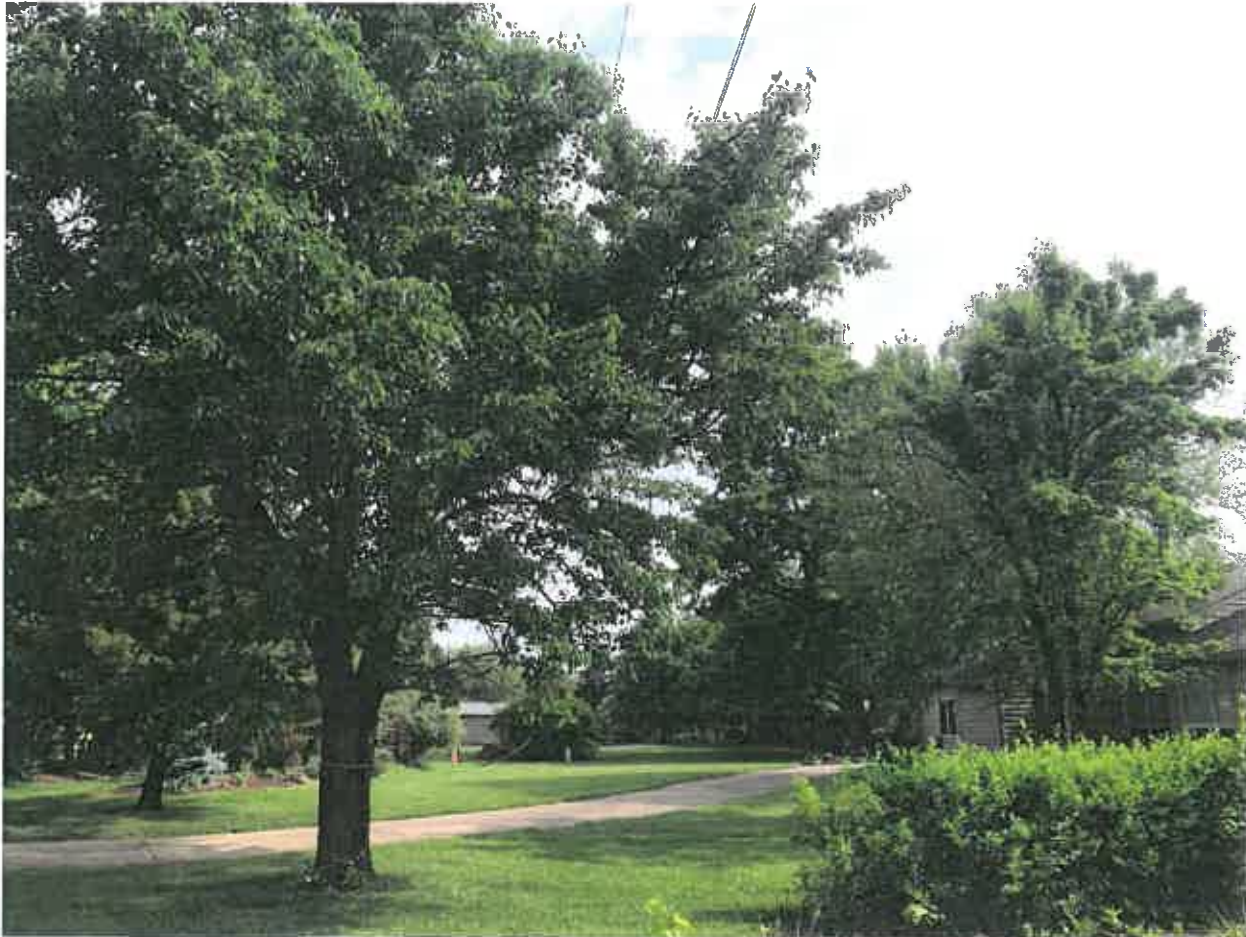
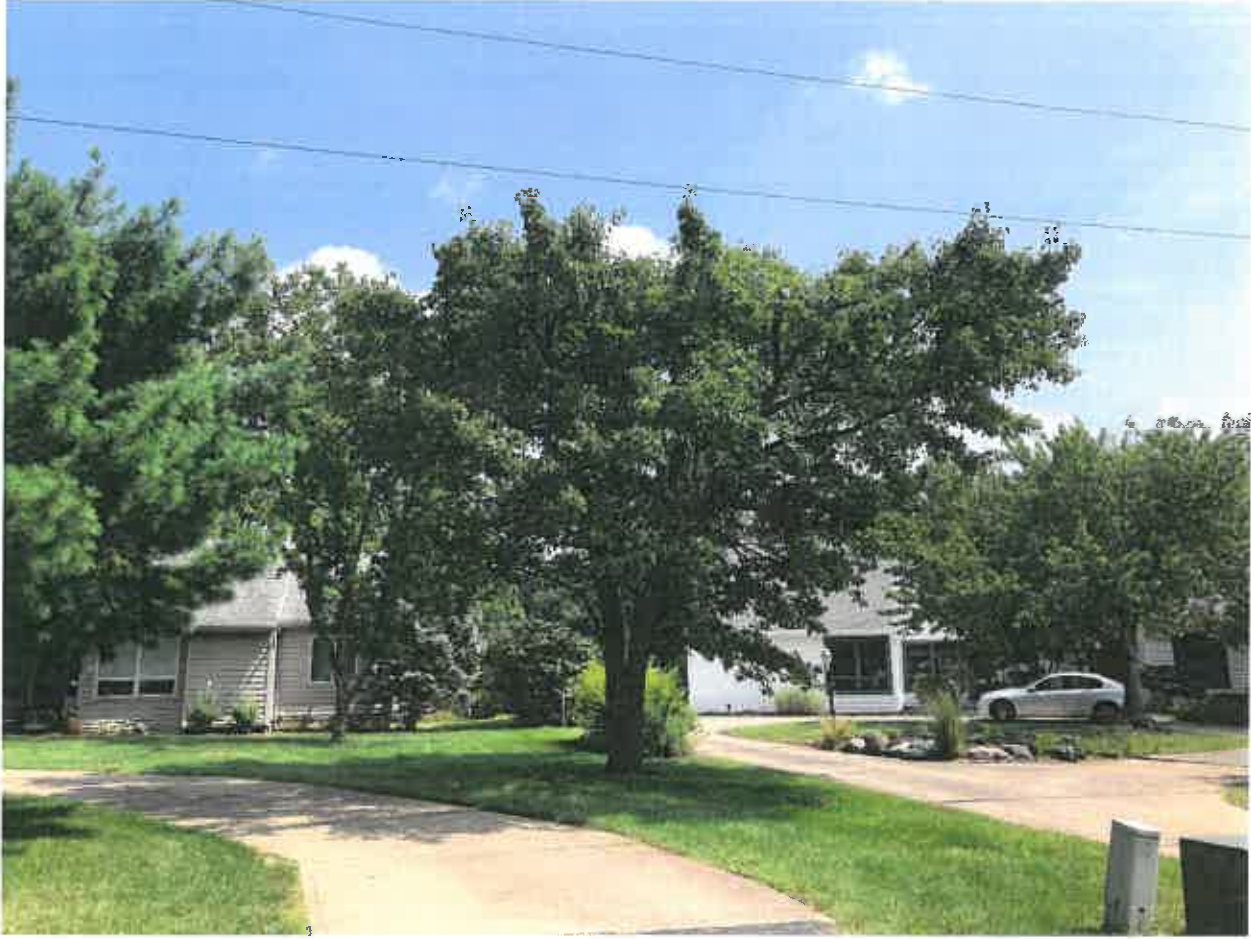
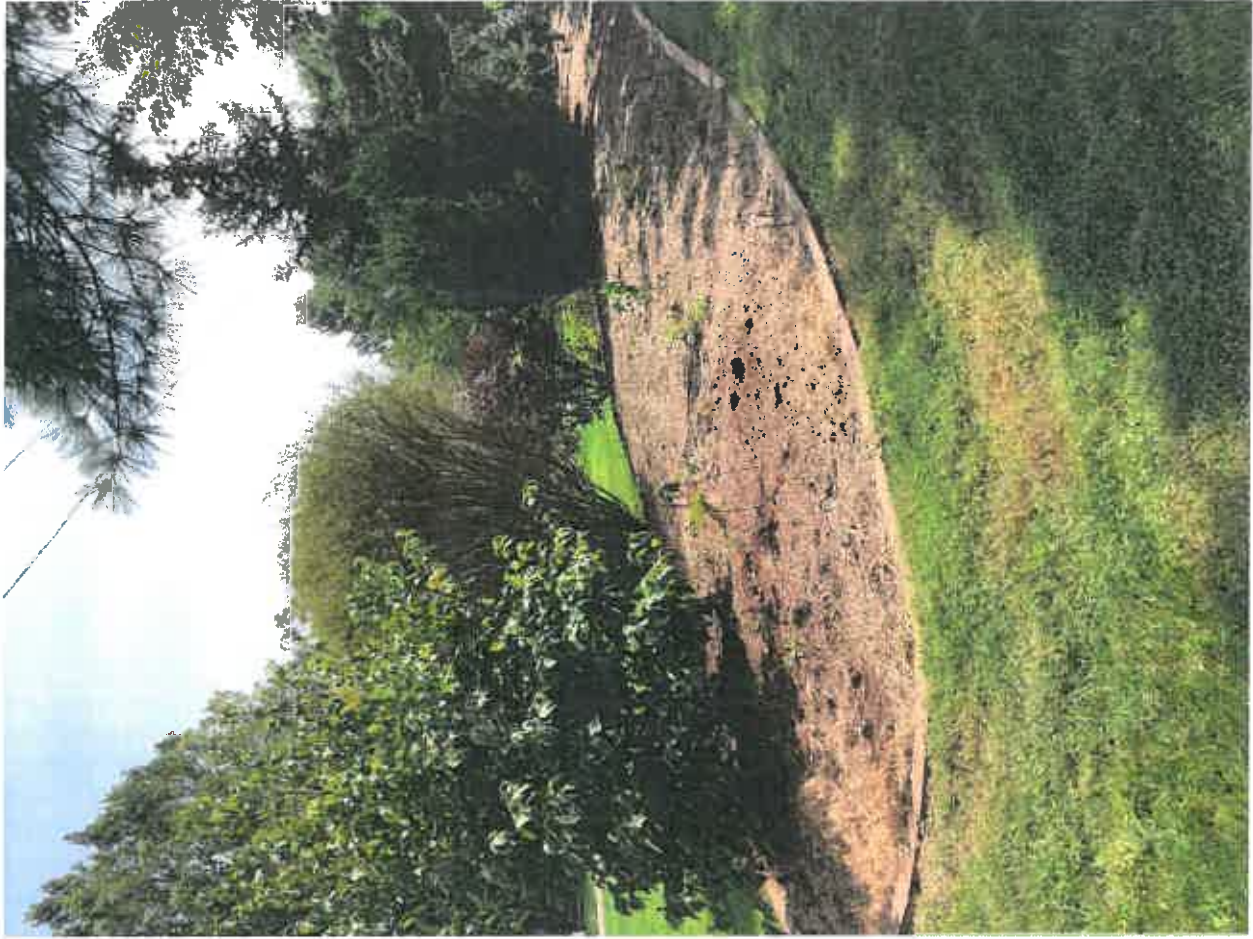
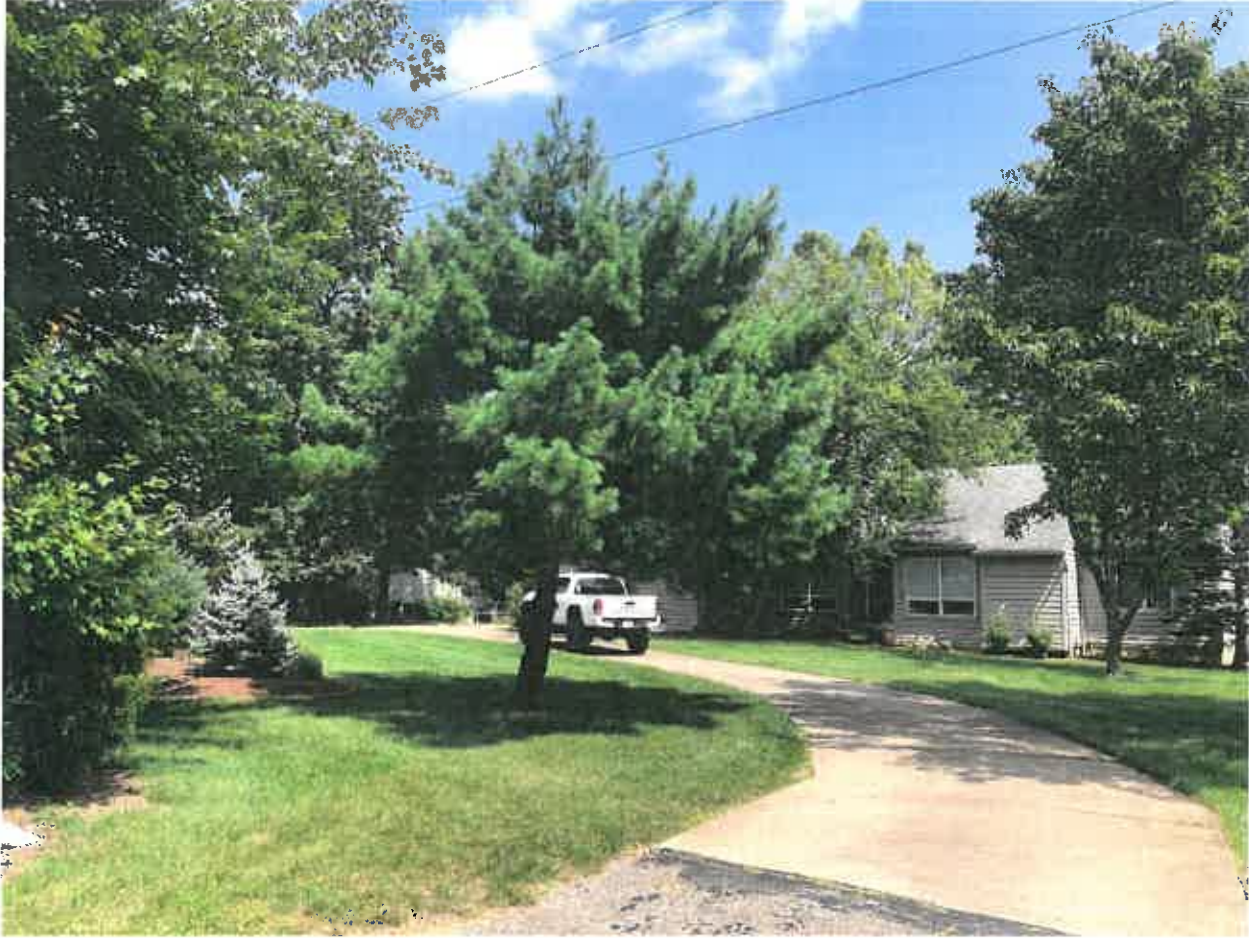
APPENDIX B – PHOTOGRAPHS

Sand Cherry	6 feet	6 inches per year	3 feet inside west wire zone	34 feet	Do not remove. Height of maturity does not mature to concerned heights
White Pine	17 feet	Up to 24 inches per year/ 50-80 feet	2 feet inside west wire zone	23 feet	Do not remove. Trim every 3-5 years

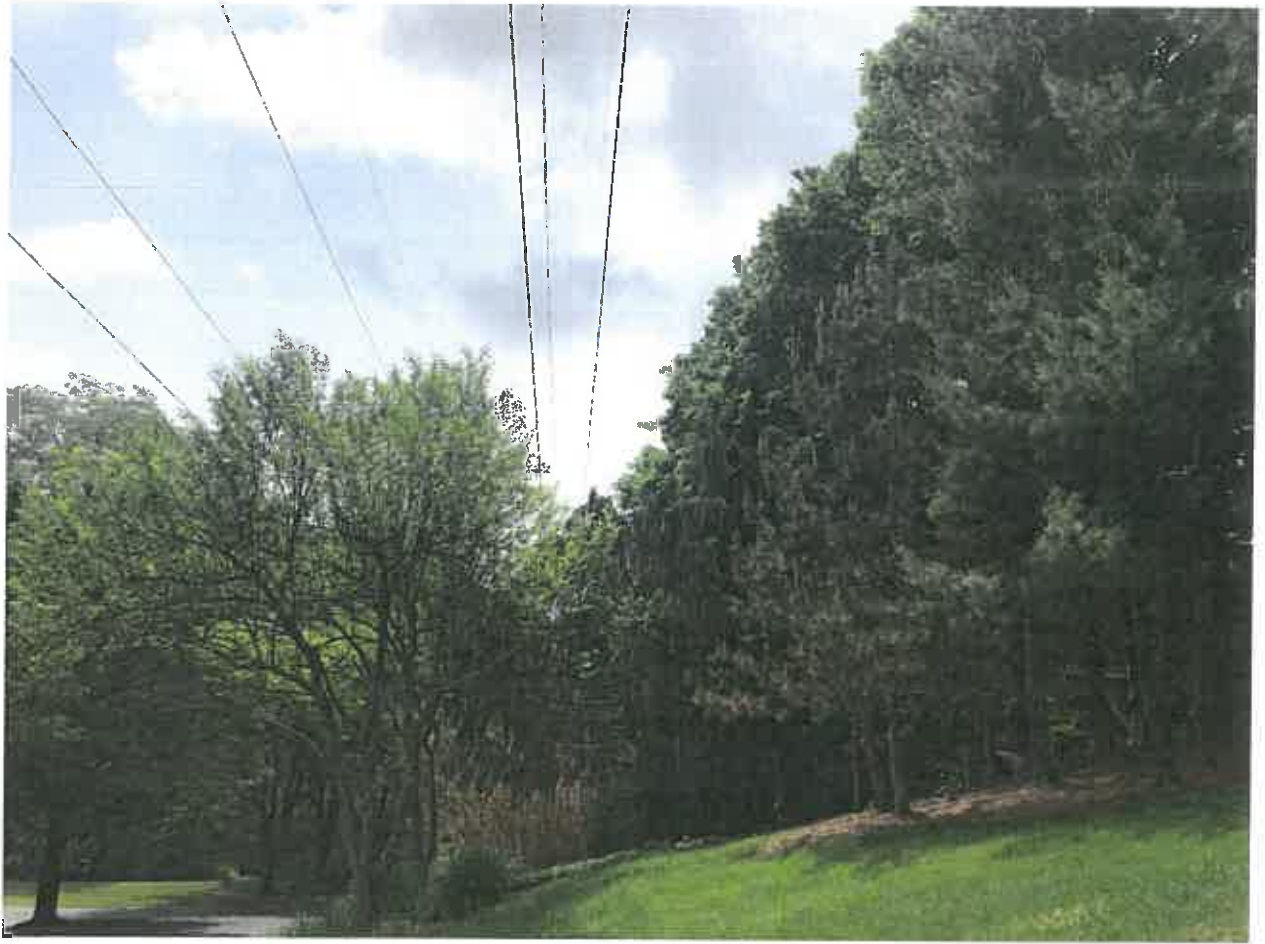
APPENDIX B – PHOTOGRAPHS

TREE SPECIES	HEIGHT	GROWTH RATE/MATURE HEIGHT	LOCATION RELATIVE TO OUTERMOST CONDUTOR	CLEARANCE OF TREE TO NEAREST CONDUTOR	SUGGESTIONS
Austrian Pine		Medium/ 50-60 feet	2 feet in border zone	18	See Recommendations on Page 2
Crabapple	25 feet	Slow – Medium/ 35 feet	10 feet inside wire zone	10	See Recommendations on Page 2
Norway Spruce	30 feet	Medium/ 80 feet	18 feet in border zone	18	See Recommendations on Page 2
White Pine	38 feet	More than 24 inches per year/ 50-80 feet	21 feet in border zone	21	See Recommendations on Page 2
White Pine	20 feet	More than 24 inches per year/ 50-80 feet	21 feet in border zone	21	See Recommendations on Page 2
White Pine	38 feet	More than 24 inches per year/ 50-80 feet	2 feet in peripheral zone	29	See Recommendations on Page 2
Austrian Pine	20 feet	Medium/ 50-80 feet	15 feet in border zone	20	See Recommendations on Page 2
Austrian Pine	14 feet	Medium/ 50-80 feet	15' in border zone	25	See Recommendations on Page 2

Austrian Pine	16 feet	Medium/ 50-80 feet	22 feet in border zone	32	See Recommendations on Page 2
Austrian Pine	17	Medium/ 50-80 feet	19 feet in border zone	30	See Recommendations on Page 2
American Elm	58 feet	Medium to fast/ 60 feet	8 feet in peripheral zone	35	See Recommendations on Page 2
Hackberry	55 feet	Medium to fast/ 40-60 feet	26 feet in border zone	26	See Recommendations on Page 2
Hackberry	40 feet	Medium to fast/ 40-60 feet	15 feet in border zone	10	See Recommendations on Page 2
Hackberry	48 feet	Medium to fast/ 40-60 feet	26 feet in border zone	20	See Recommendations on Page 2
Hackberry	45 feet	Medium to fast/ 40-60 feet	1 foot in peripheral zone	25	See Recommendations on Page 2

Note: These trees are on a 25 degree slope from house down to rear of property.

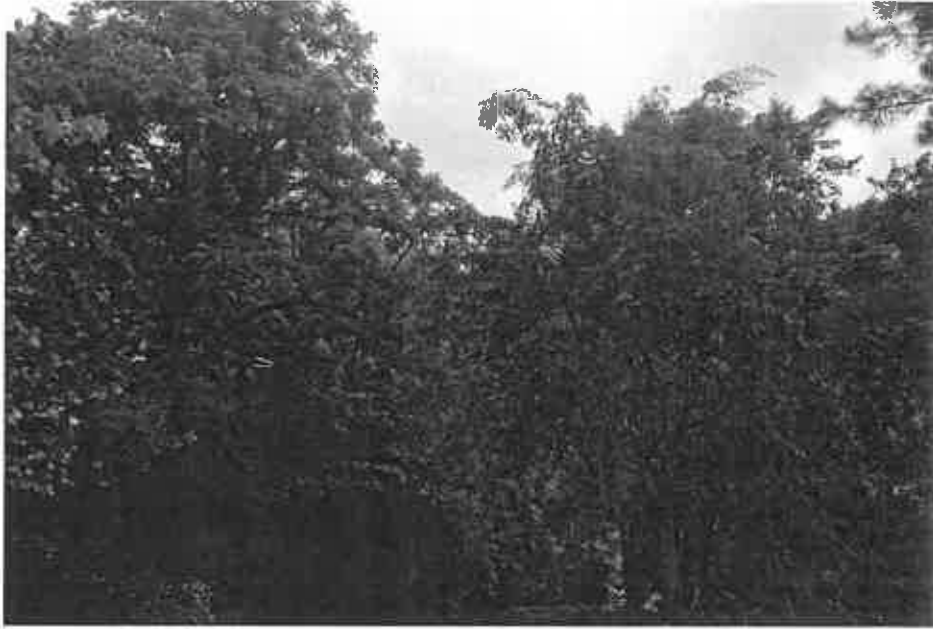
APPENDIX B – PHOTOGRAPHS

TREE SPECIES	HEIGHT	GROWTH RATE/ MATURE HEIGHT	LOCATION RELATIVE TO OUTERMOST CONDUTOR	CLEARANCE OF TREE TO NEAREST CONDUTOR	SUGGESTIONS
Bitternut Hickory	74 feet	less than 12 incher per year/ 60-80 feet	37 feet 12 feet peripheral	11 feet	Suggest Crown reduce by near 25 percent and treat with growth regulator
White Pine	20 feet	More than 24 incher per year/ 50-80 feet	10 feet	60 feet	Crown Reduce by near 20%
Weeping Cherry	18 feet	12-24 inches per year/ 20-30 feet	9 feet	58 feet	Suggest reduce by near 25 percent and owner maintain
Trees in natural area: Sycamore, Walnut, Box Elder, Hackberry and other native trees	50 feet 45 feet 40 feet 50 feet	20-24 inches 18-24 inches 16-20 inches 18-24 inches	30-40 feet average 30-40 feet average 30-40 feet average 30-40 feet average	20-25 feet average 20-25 feet average 20-25 feet average 20-25 feet average	Suggest reduce by near 25 percent and use growth regulator. If removed excessive erosion

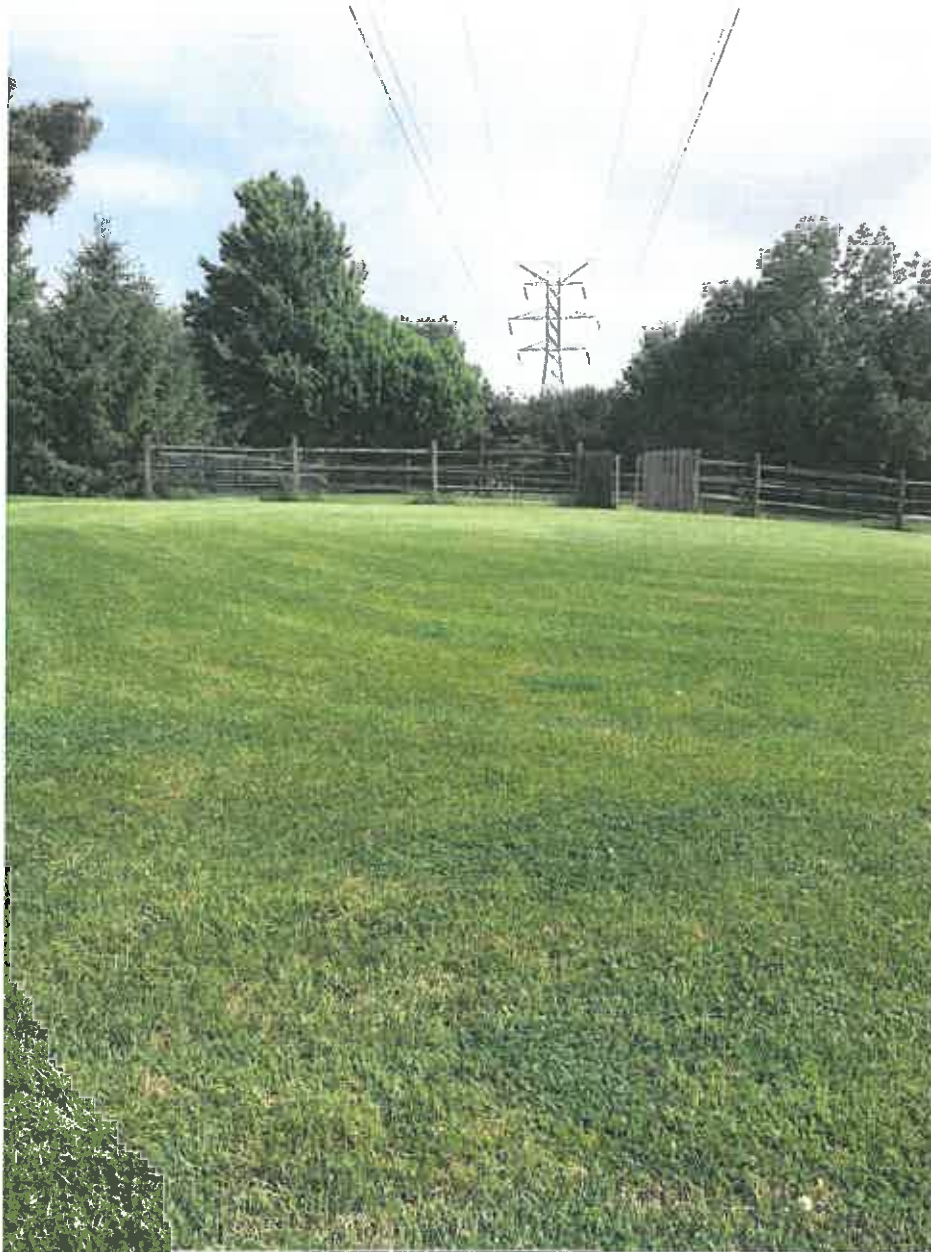
APPENDIX B – PHOTOGRAPHS

Arborvitae	15 feet	6-10 inches per year/ 30-35 feet	32 feet (Border Zone)	51 feet	Owner maintains height
Arborvitae	16 feet	6-10 inches per year/ 30-35 feet	25 feet (Border Zone)	48 feet	Owner maintains height
Arborvitae	17 feet	6-10 inches per year/ 30-35 feet	23 feet (Border Zone)	48 feet	Owner maintains height
Rose of Sharon (10)	5 feet	12-24 inches per year/ 8-12 feet	24 feet (Border Zone)	56 feet	Maintain to near 7-8 height
Rose of Sharon (8)	9 feet	12-24 inches per year/ 8-12 feet	24 feet (Border Zone)	56 feet	Maintain to near 7-8 height

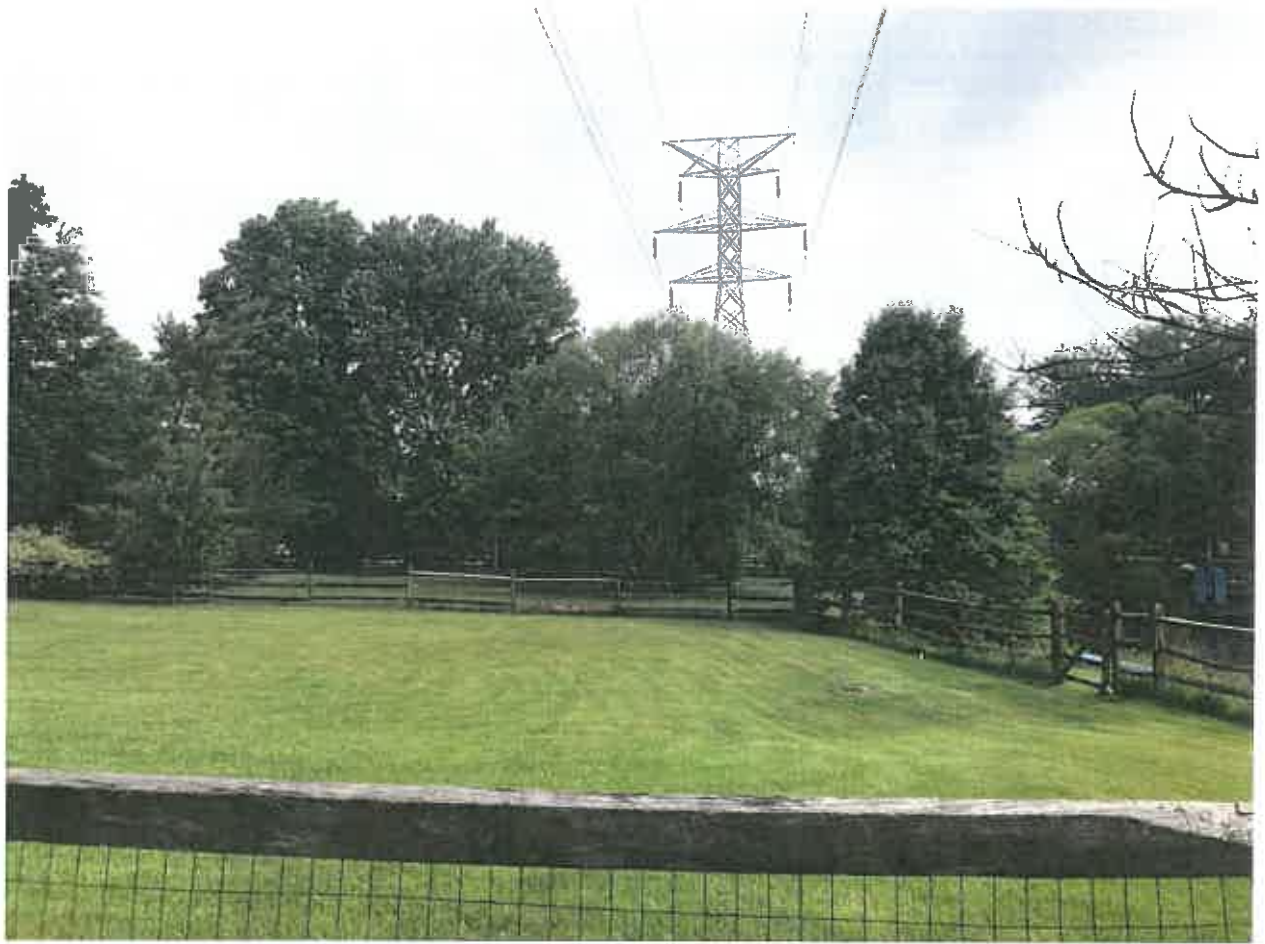
APPENDIX B – PHOTOGRAPHS

TREE SPECIES	HEIGHT	GROWTH RATE/ MATURE HEIGHT	LOCATION RELATIVE TO OUTERMOST CONDUCTOR	CLEARANCE OF TREE TO NEAREST CONDUCTOR	SUGGESTIONS
Silver Maple	50 feet	More than 24 inches per year/ 50-80 feet	23 feet	27 feet	Treat with growth regulator
Silver Maple	76 feet	More than 24 inches per year/ 50-80 feet	34 feet	28 feet	Duke proposes to side trim near half of the tree this creates hazard due to imbalance. Suggest crown reduce entire canopy by 25 percent and treat with growth regulator.
White Pine	75 feet	More than 24 inches per year/ 50-80 feet	24 feet	20 feet	High risk propose crown reduce to 30 feet
Crabapple	18 feet	13-24 inches per year/ 15-20 feet	7 feet	42 feet	Suggest crown reduce to 12 feet
Mulberry	47 feet	Fast/ 60 feet	1 foot	13 feet	Suggest remove
Multi trunk River Birch	39 feet	13-24 inches per year/ 40-70 feet	5 feet inside west wire zone	23 feet	Suggest crown reduce to near 30 feet and treat with growth regulator

with growth regulator
Rose of Sharon	12 feet	12-24 inches per year/ 8-12 feet	7 feet inside of west wire zone	48 feet	Suggest do not remove
Burning Bush	10 feet	12 feet	7 feet inside of west wire zone	50 feet	Maintain 7-8 foot
Wisteria Vine	5x12 feet	10-14 foot per year	5 feet inside of west wire zone	55 feet	Maintain 8 foot

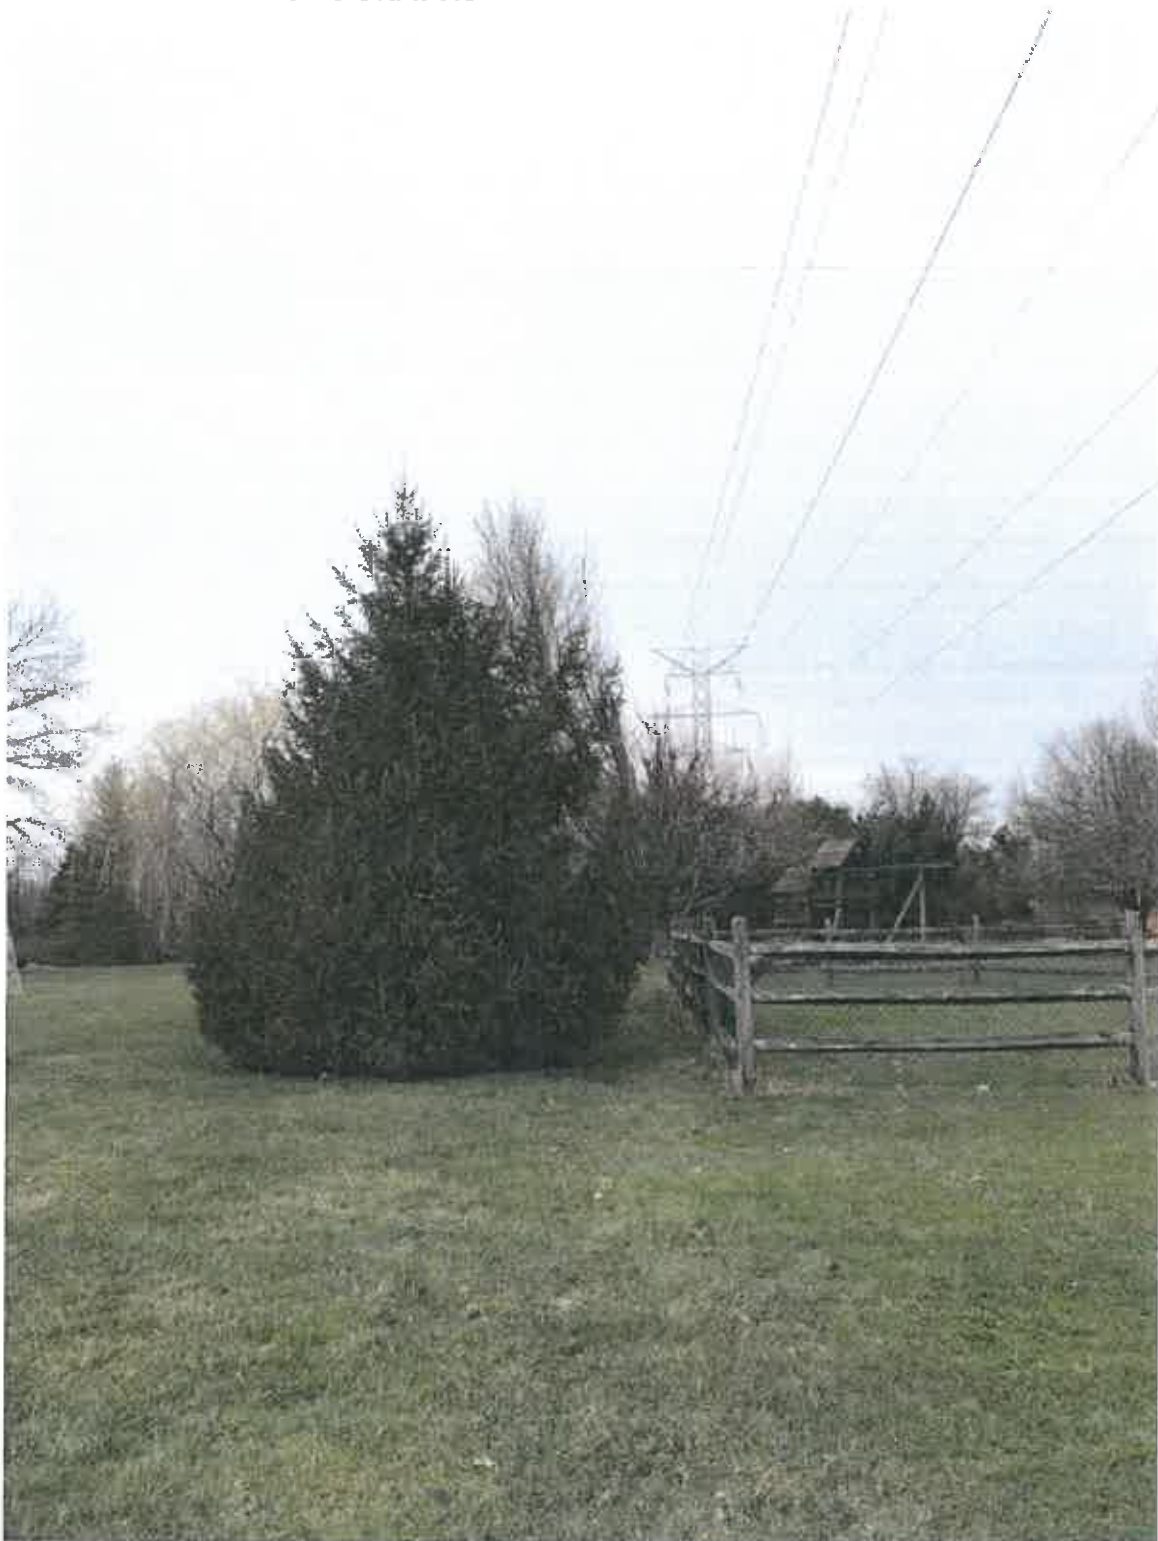
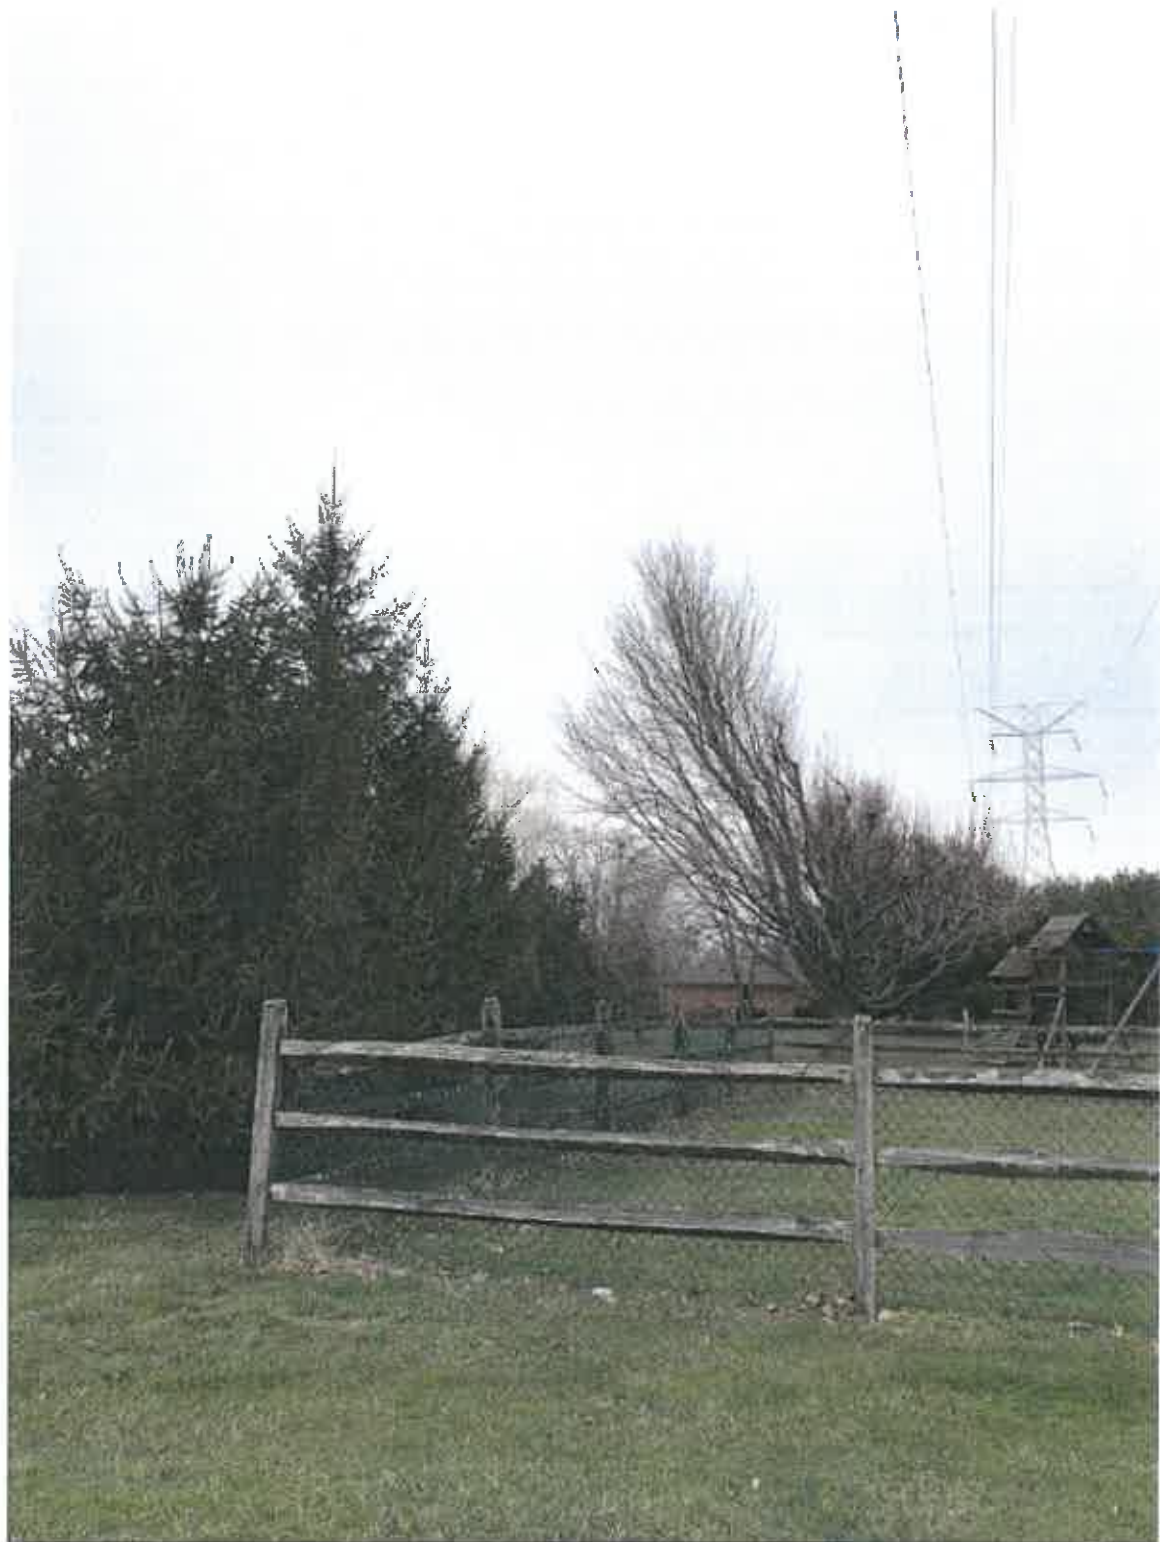
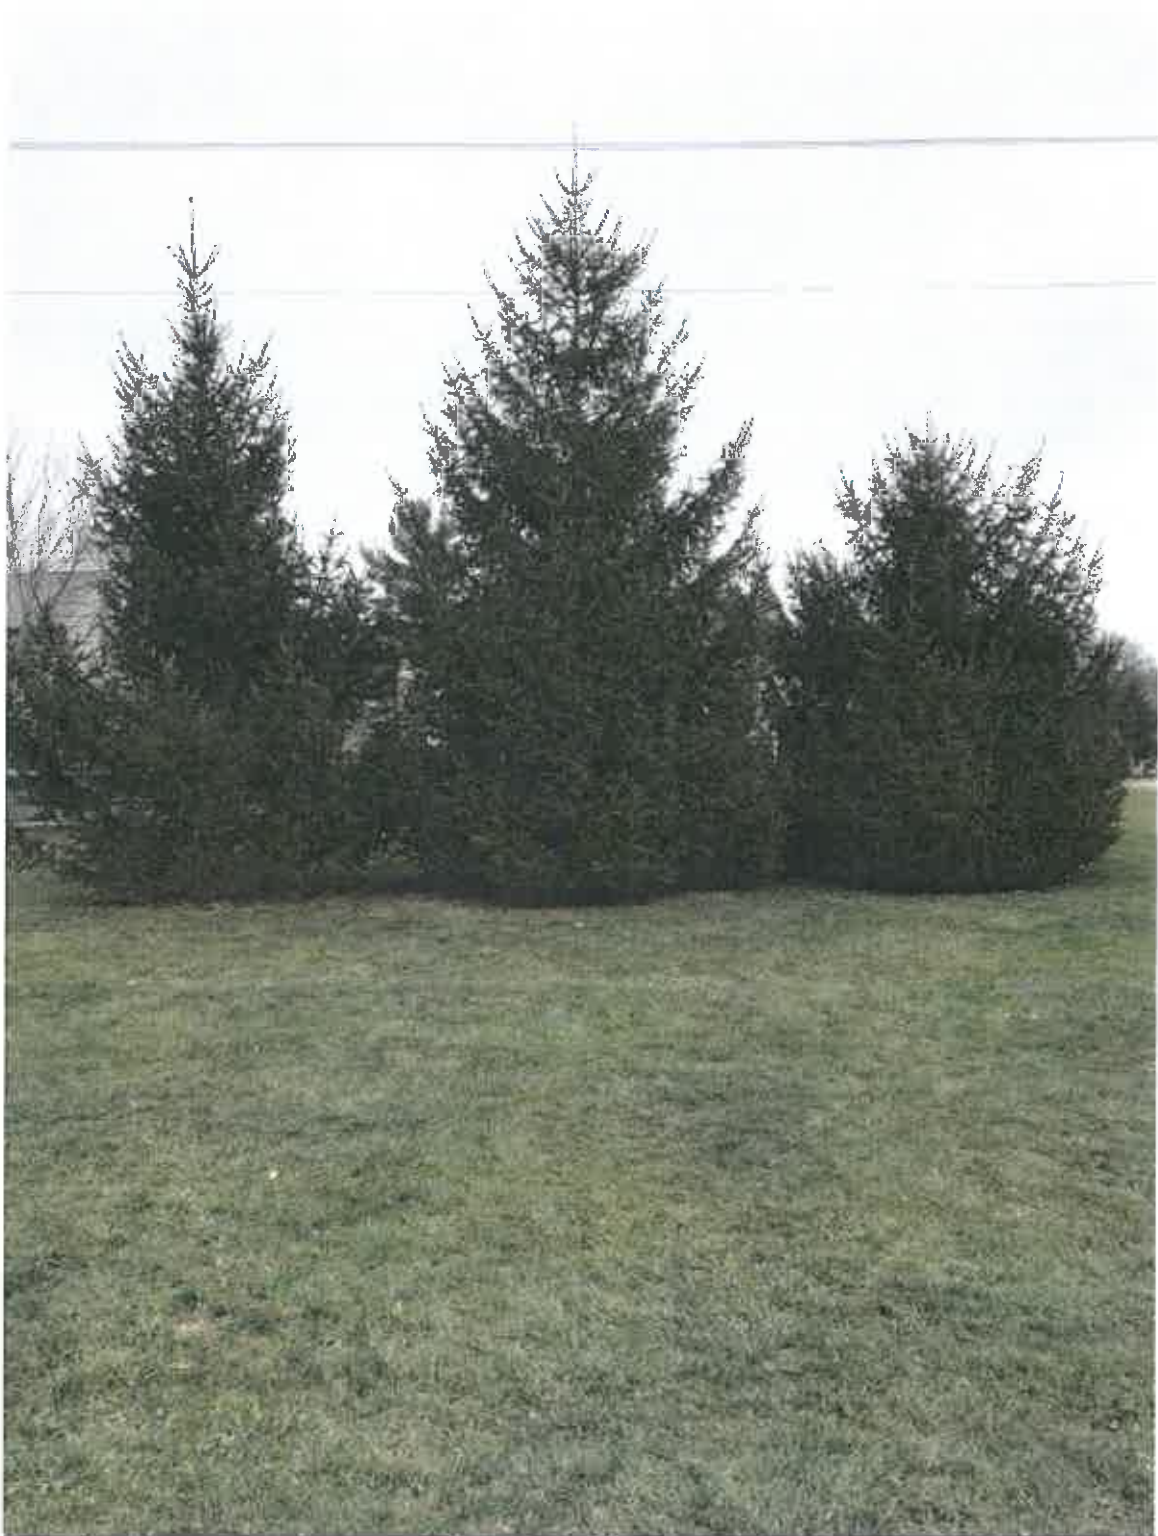
APPENDIX B – PHOTOGRAPHS

TREE SPECIES	HEIGHT	GROWTH RATE/ MATURE HEIGHT	LOCATION RELATIVE TO OUTERMOST CONDUCTOR	CLEARANCE OF TREE TO NEAREST CONDUCTOR	SUGGESTIONS
Norway Spruce	18 feet	13-24 inches per year/ 40-60 feet	9 feet in west border zone	36 feet	Do not remove due to need of water retention.
Norway Spruce	22 feet	13-24 inches per year/ 40-60 feet	9 feet in west border zone	32 feet	Do not remove due to need of water retention.
Norway Spruce	25 feet	13-24 inches per year/ 40-60 feet	9 feet in west border zone	29 feet	Do not remove due to need of water retention.
