**BEFORE
THE PUBLIC UTILITIES COMMISSION OF OHIO**

Citizens Against Clear Cutting, et al.)	
)	
Complainants,)	
)	
v.)	Case No. 17-2344-EL-CSS
)	
Duke Energy Ohio, Inc.,)	
)	
Respondent)

**DIRECT TESTIMONY OF TIM BACK
ON BEHALF OF
COMPLAINANTS**

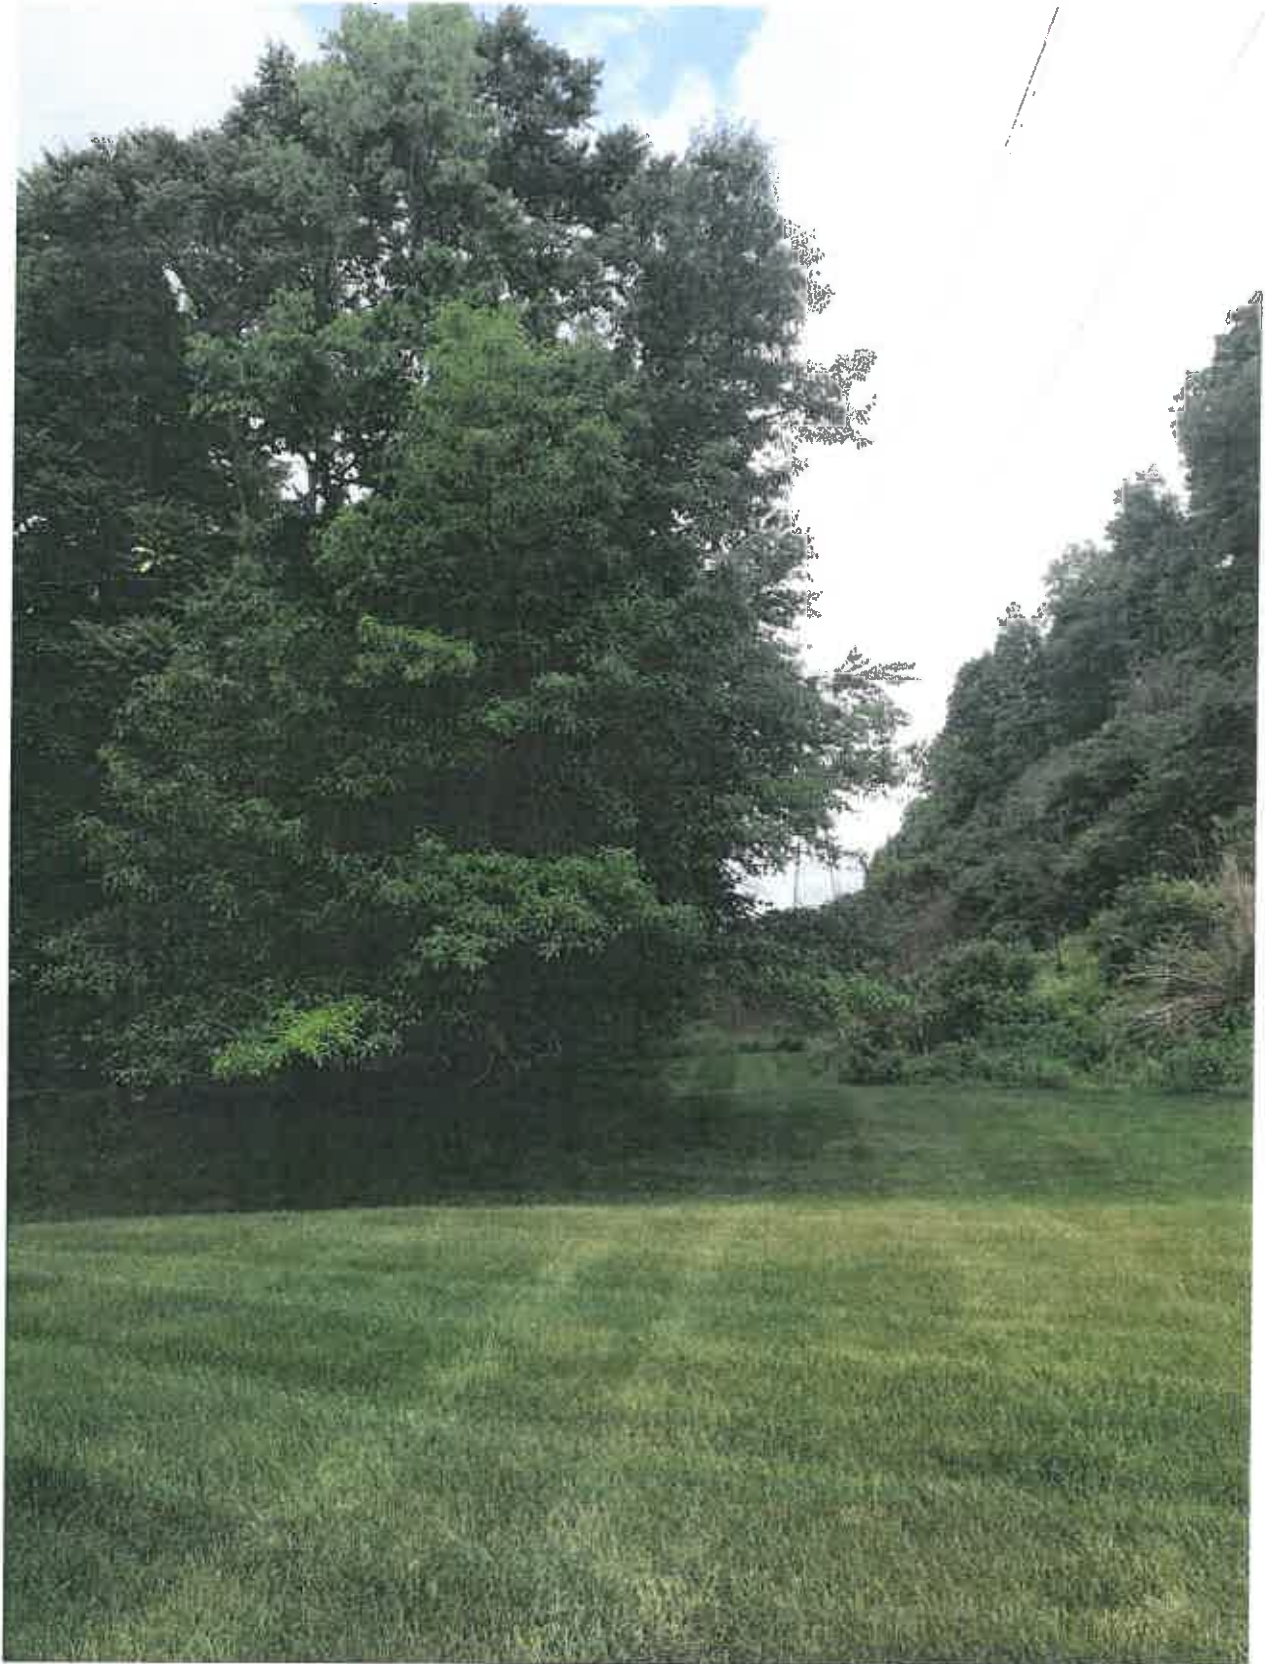
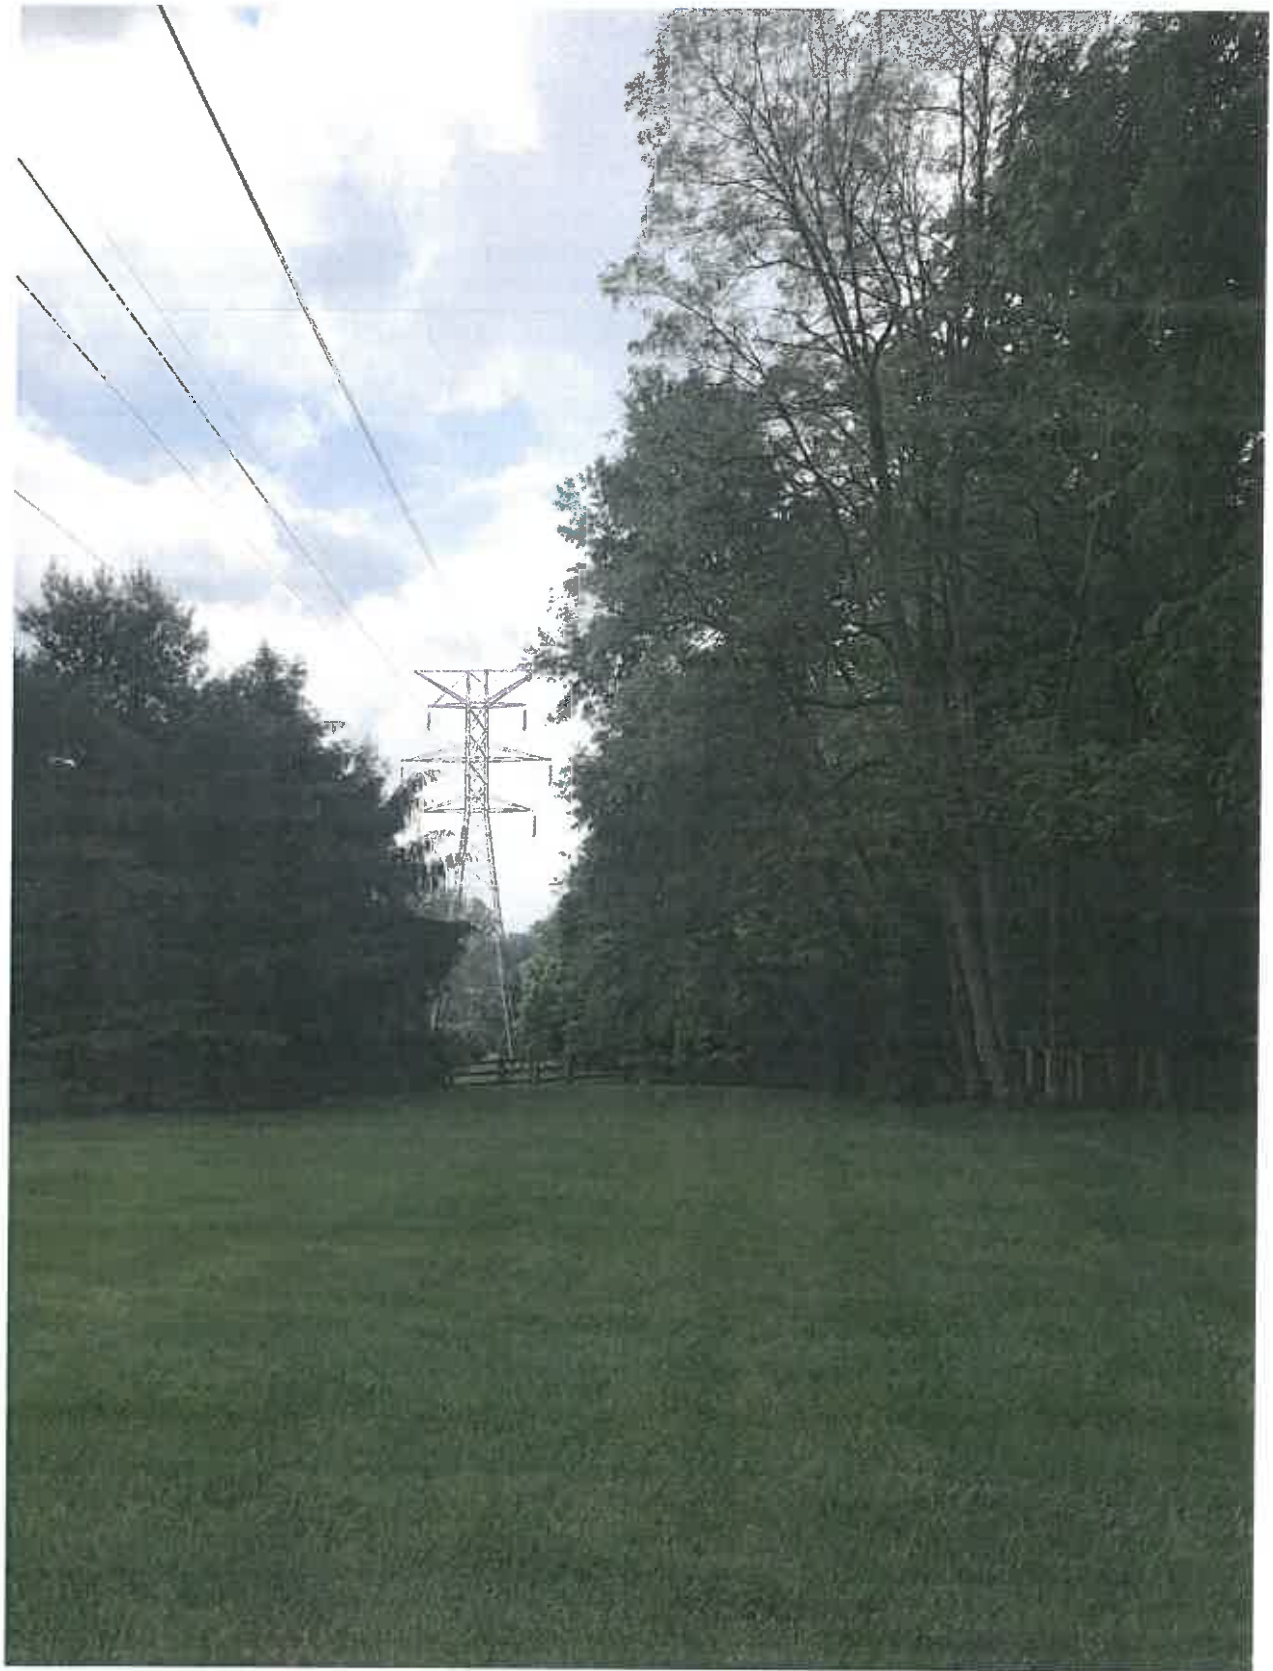
APPENDIX B – PHOTOGRAPHS

pruning (reduction) every 3-5 years.
White Pine	45 feet	More than 24 inches per year/ 50-80 feet	2 feet inside west wire zone	2 feet	Maintain proper clearances. Suggest pruning (reduction) every 3-5 years.
White Pine	60 feet	More than 24 inches per year/ 50-80 feet	1 foot in border zone	29 feet	Maintain proper clearances. Suggest pruning (reduction) every 3-5 years.
Locust	16 inch x 105 feet	2-3 feet per year	13 feet in peripheral zone	43 feet	Maintain proper clearances. Suggest pruning (reduction) every 3-5 years.
Cherry	15 inch x 90 feet	2-3 feet per year	13 feet in peripheral zone	43 feet	Maintain proper clearances. Suggest pruning (reduction) every 3-5 years.
