Re: Supplement to Application

Case No. 18-1360-EL-BGN In the Matter of the Application of Hardin Solar Energy II LLC for a Certificate of Environmental Compatibility and Public Need to Construct a Solar-Powered Electric Generation Facility in Hardin County, Ohio.

- <u>Attachment 1</u>: In response to O.A.C. Rules 4906-4-03(B)(2)(i) and 4906-4-06(F)(3) (pages 16 and 35 of the Application, respectively), the Applicant stated that the Road Survey Report would be provided shortly following the filing of the Application. At this time, the Applicant is providing, as Attachment 1, the Road Survey Report completed by Barr dated October 2018.

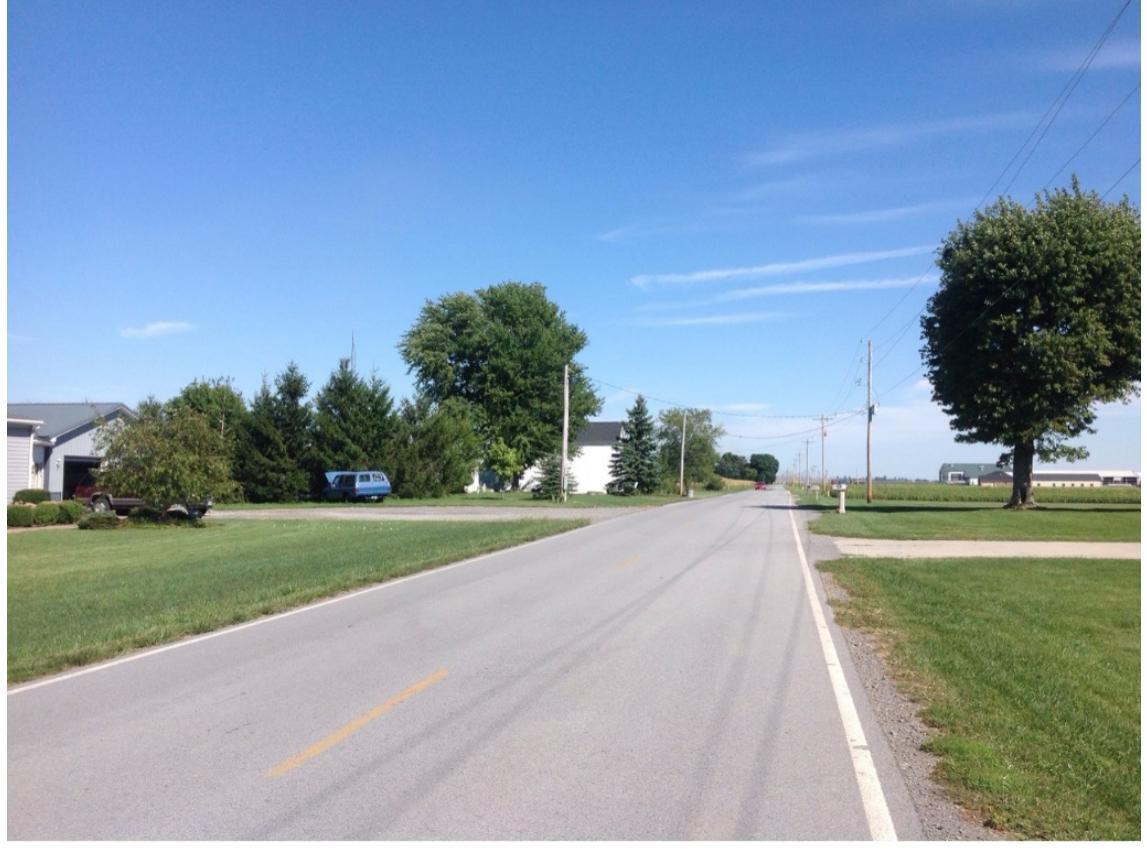
Figure 4-1 CR-110 Section 1

Section 1 from OH-235 to 114+00 was generally in good condition. Minimal distresses such as shoulder drop-off, sags and bumps were observed, specifically on the bridge at the intersection with CR-35 and at the irrigation ditch crossings by the Van Deurzen Dairy site. Heavy traffic from harvesting activities was observed coming in and out of the Van Deurzen Dairy site, and travelling east on CR-110 to the adjacent fields. During the site visit no significant distresses were observed in this section of road product of the heavy traffic. Two sample units were selected within the section.

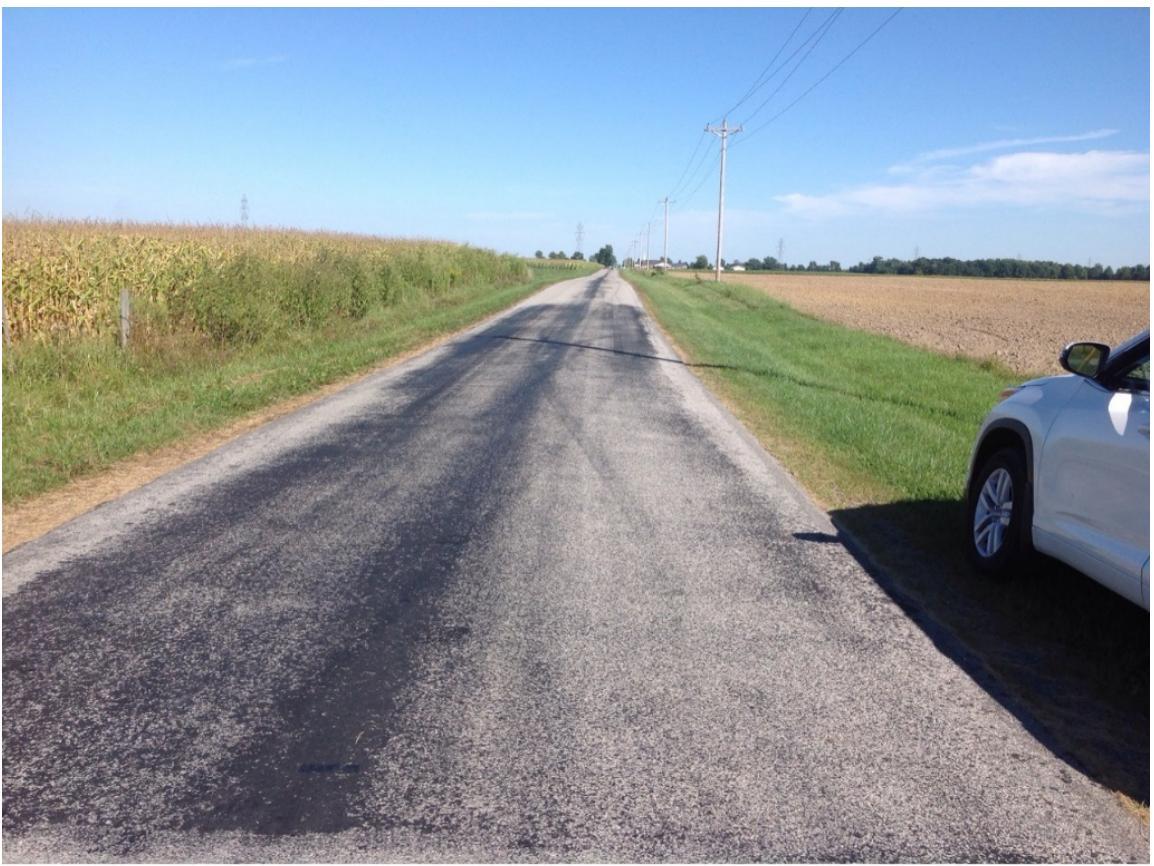
Figure 4-3 TR-120 Section 1

Section 1 from OH-235 to 25+00 was observed generally in good condition. The pavement has minimal distresses such as bleeding.

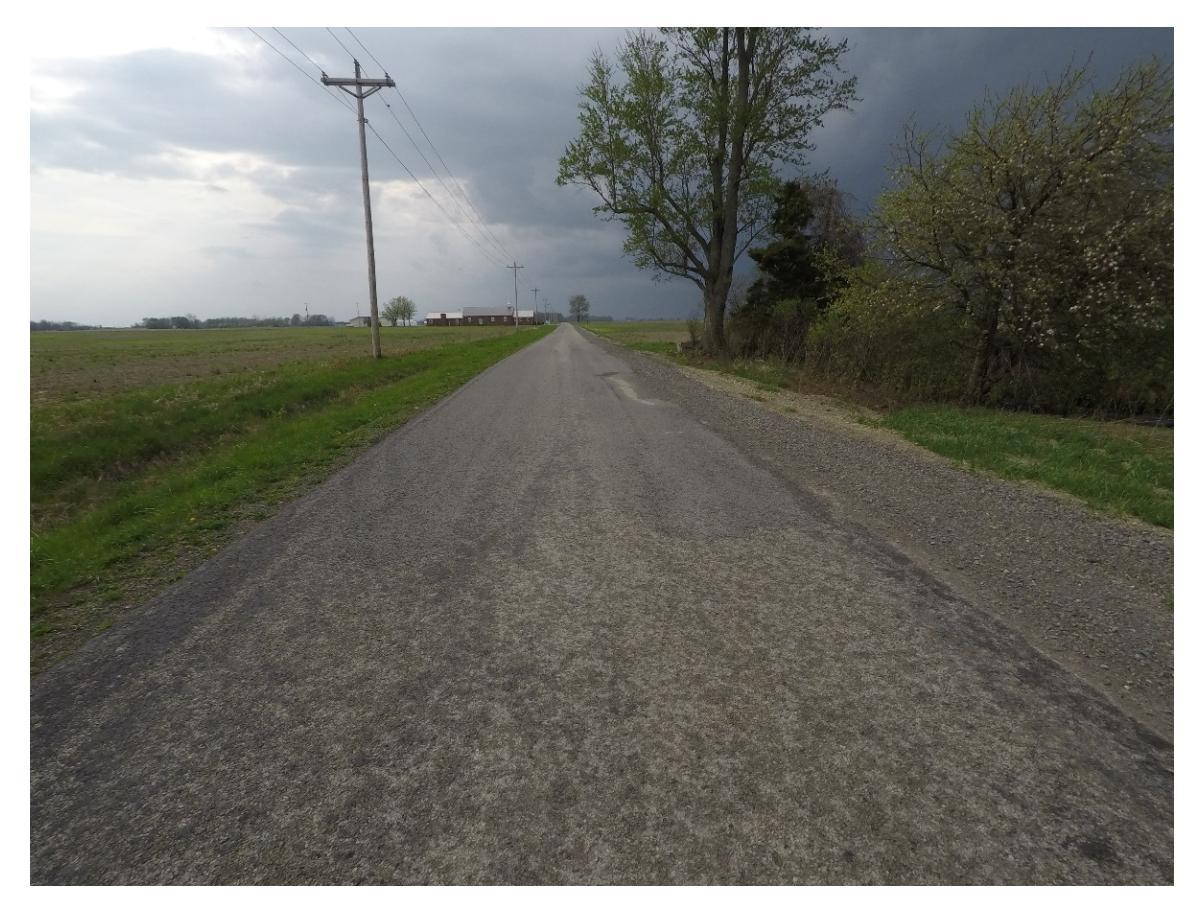
Figure 4-4 TR-120 Section 2

Section 2 from 25+00 to 51+50 was observed generally in good condition. The pavement has minimal distresses such as bleeding and edge cracking. One small area had patching and a slight depression.

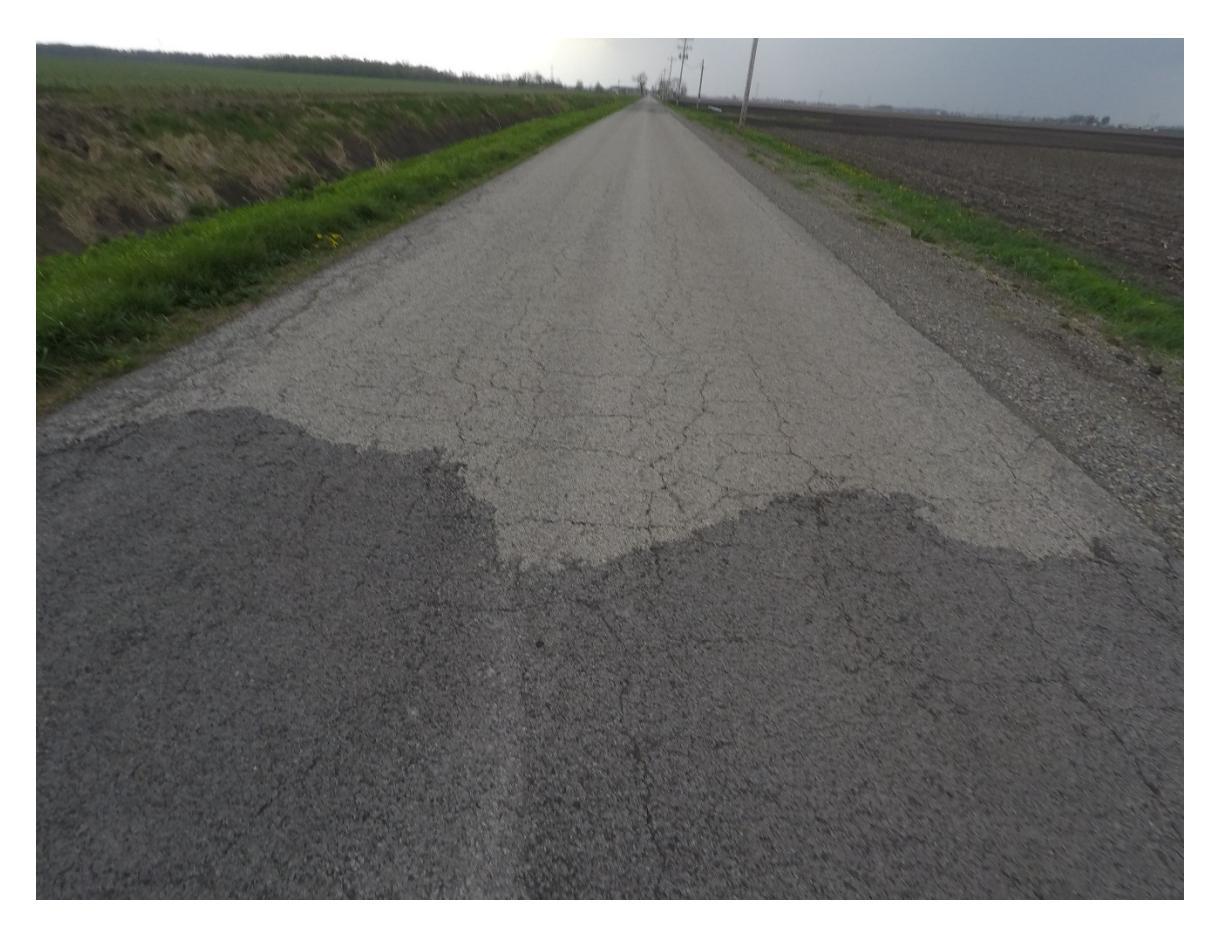
Table 4-7

Section 4 from 78+00 to 104+00 was observed generally in poor condition. The pavement has several patches, bumps and dips, and block cracking throughout the section. The ride quality for this section is poor. Driving at posted speeds presents vehicle vibration. Some areas require slight reduction in speed due to the size of the bumps and dips.

Access to the project site from TR-120 is adequate only up to the western edge of the project boundary. The section of road within the project boundary is in poor condition with extensive block cracking and pavement weathering. Due to the extents of the damage, localized corrections cannot be implemented. It is recommended to avoid these areas.

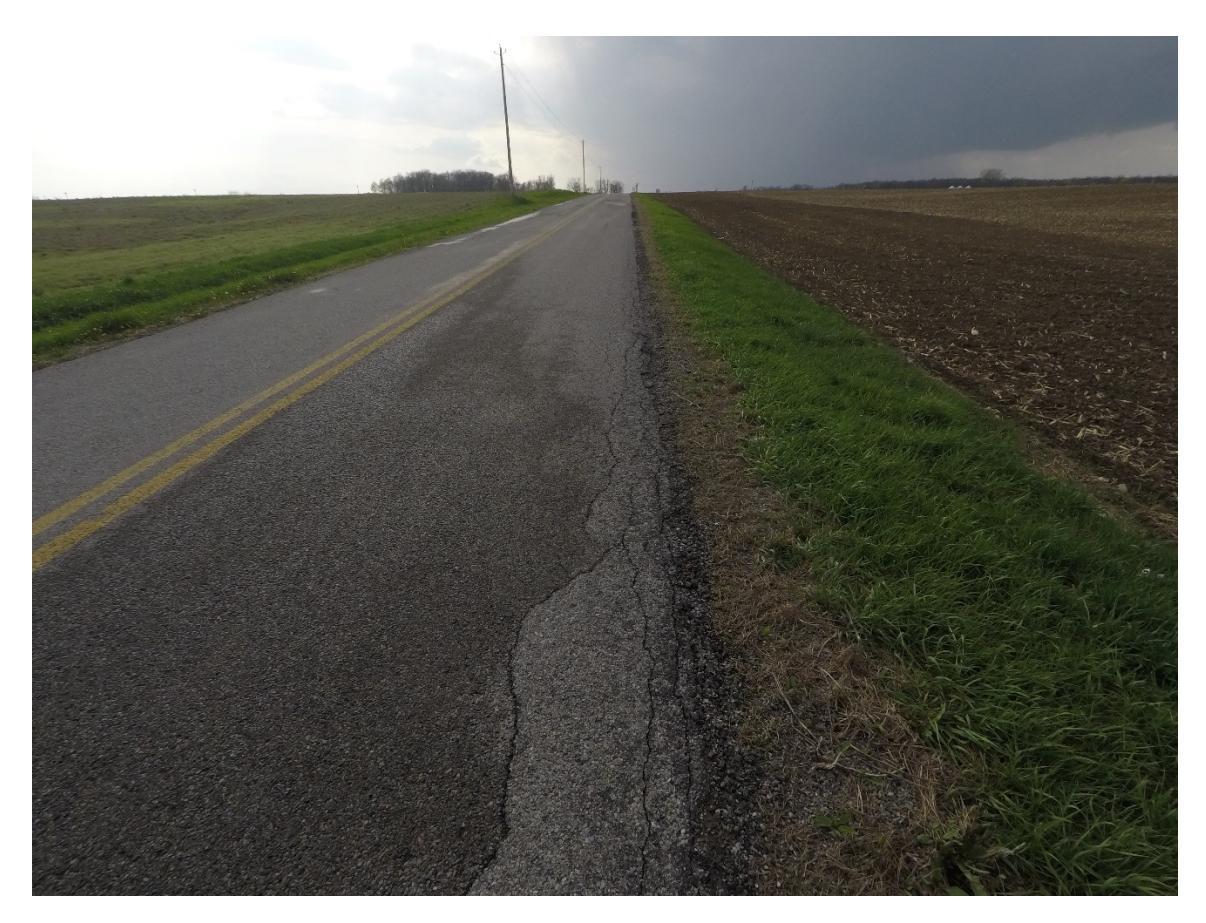
Table 4-9CR-130 Section 1 – PCI Summary

Section 1 from OH-235 to 29+00 was observed generally in good condition. The pavement has minimal distresses such as bleeding, edge cracking and some small bumps.

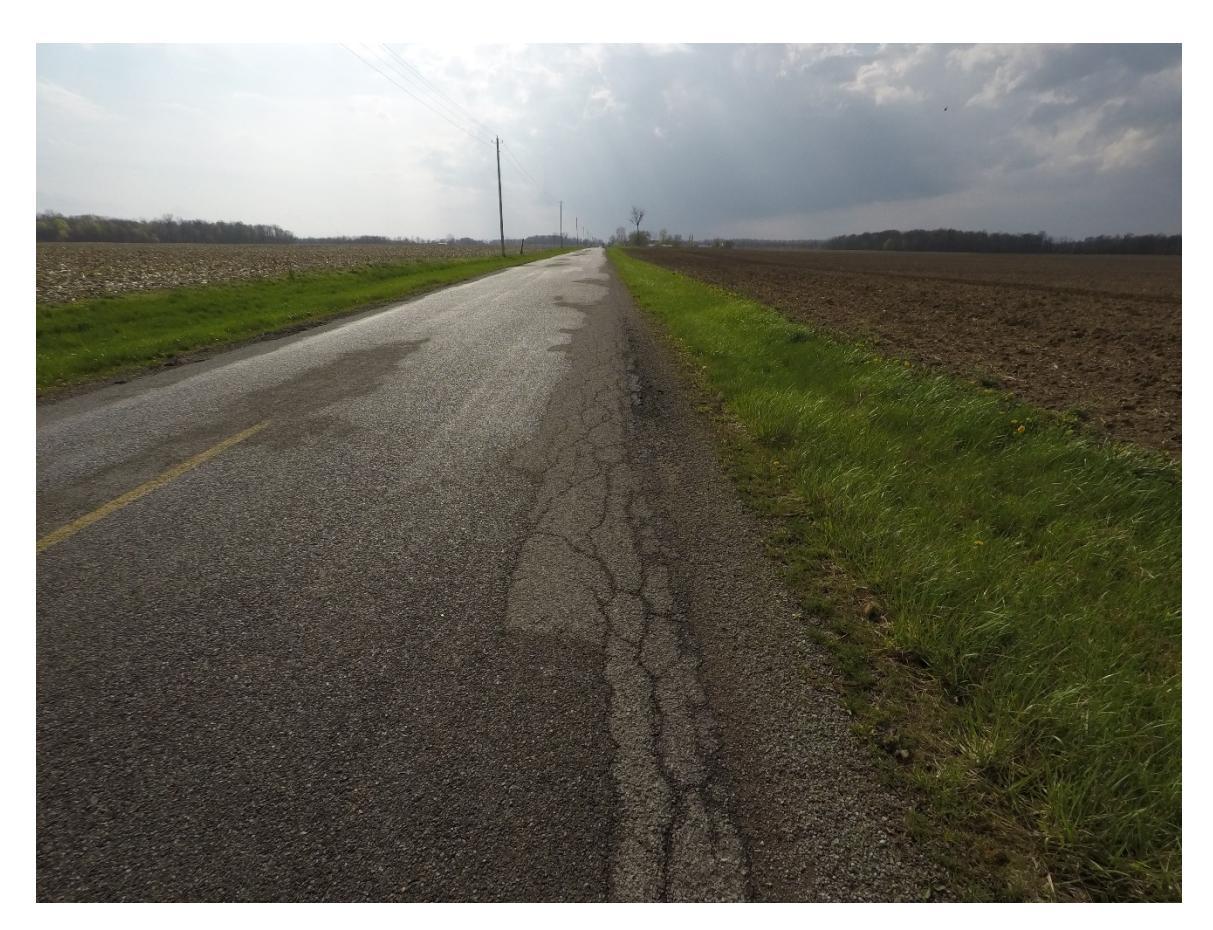
Table 4-10CR-130 Section 2 – PCI Summary

Section 2 from 29+00 to 56+00 was observed generally in good condition. The pavement has minimal distresses such as edge cracking, transverse cracking and shoulder drop-off.

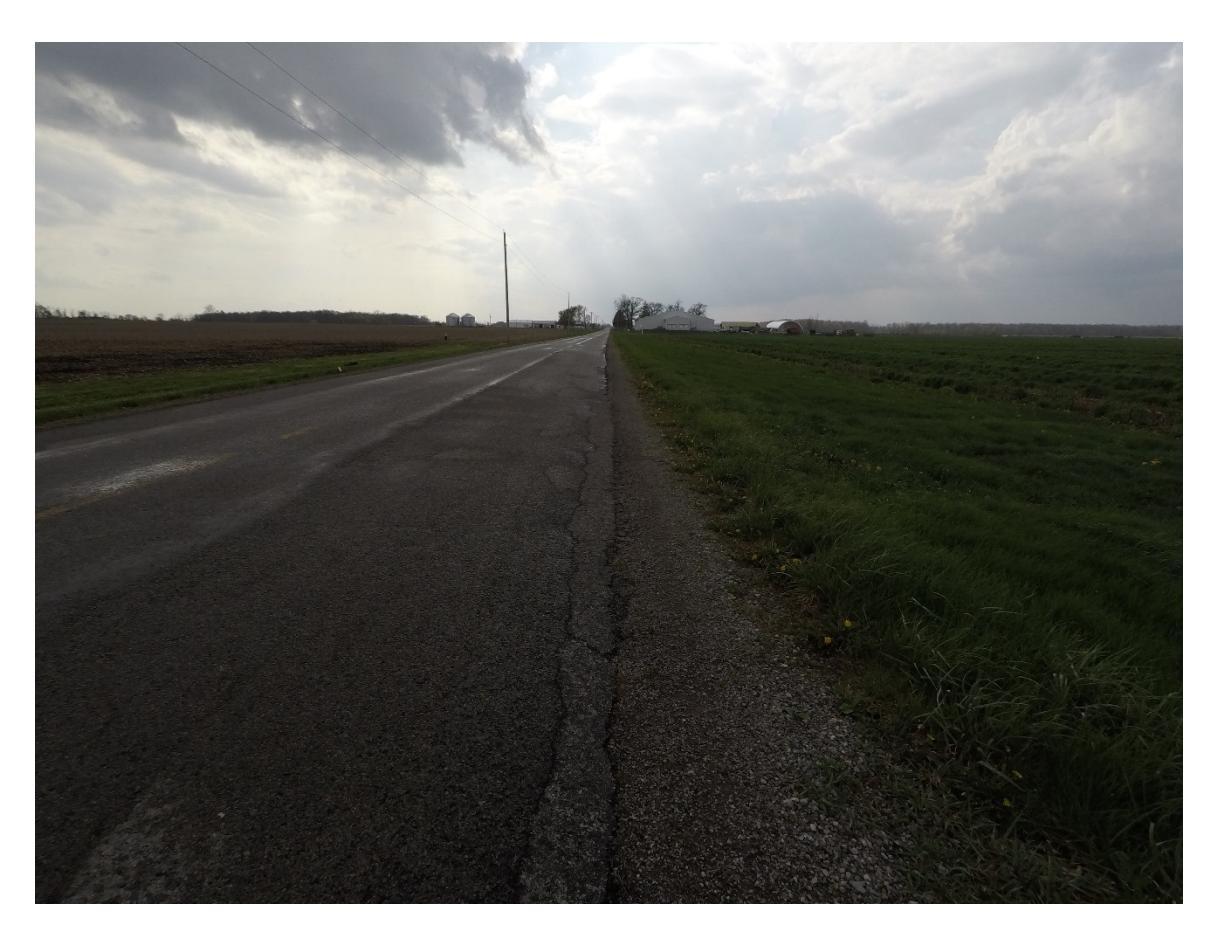
Table 4-11CR-130 Section 3 – PCI Summary

Section 3 from 56+00 to 82+00 was observed generally in satisfactory condition. The pavement has some distress such as edge cracking, shoulder drop-off and small area of raveling.

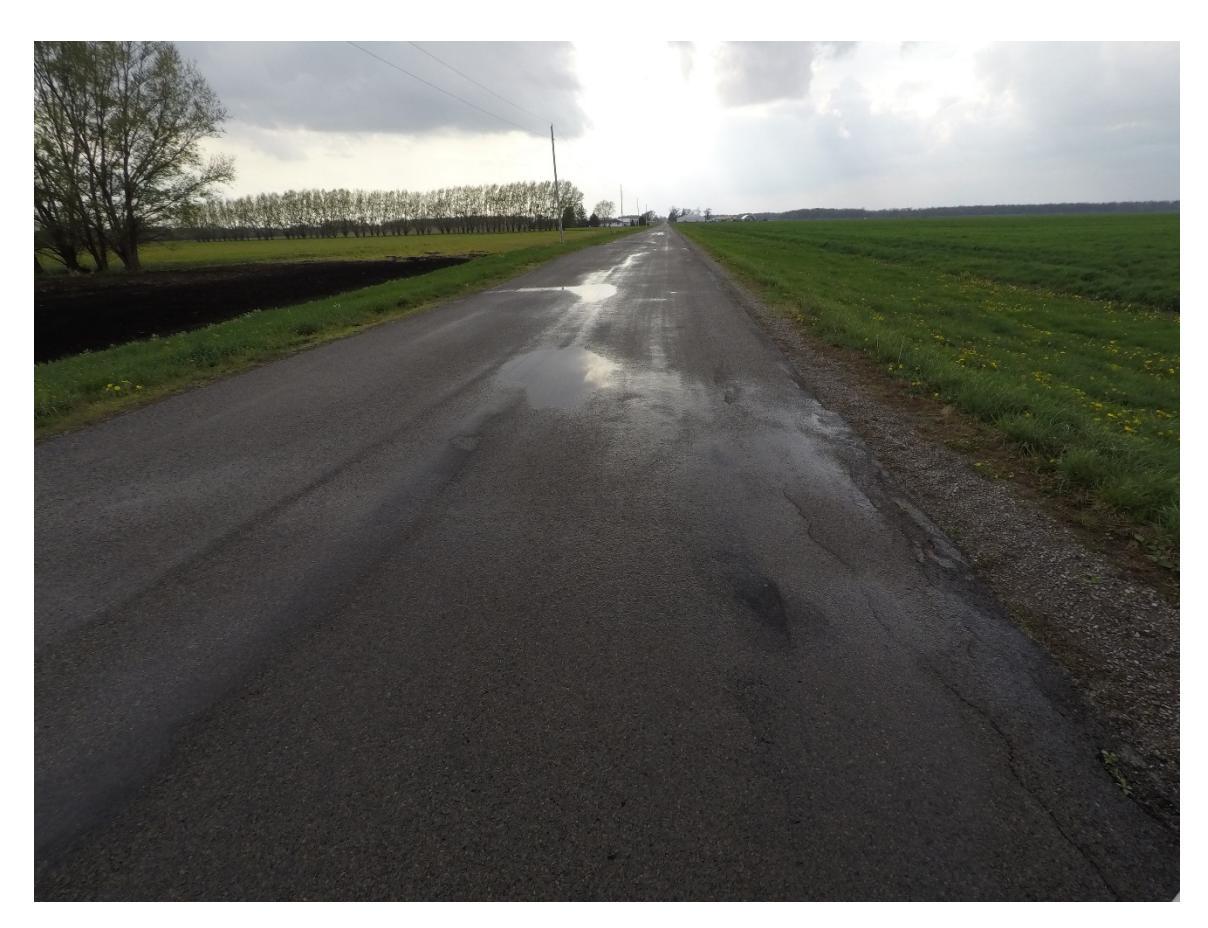
Figure 4-12 CR-130 Section 4

Section 4 from 82+00 to OH-195 was observed generally in good condition. The pavement has minimal distresses such as edge cracking, transverse cracking, shoulder drop-off and raveling.

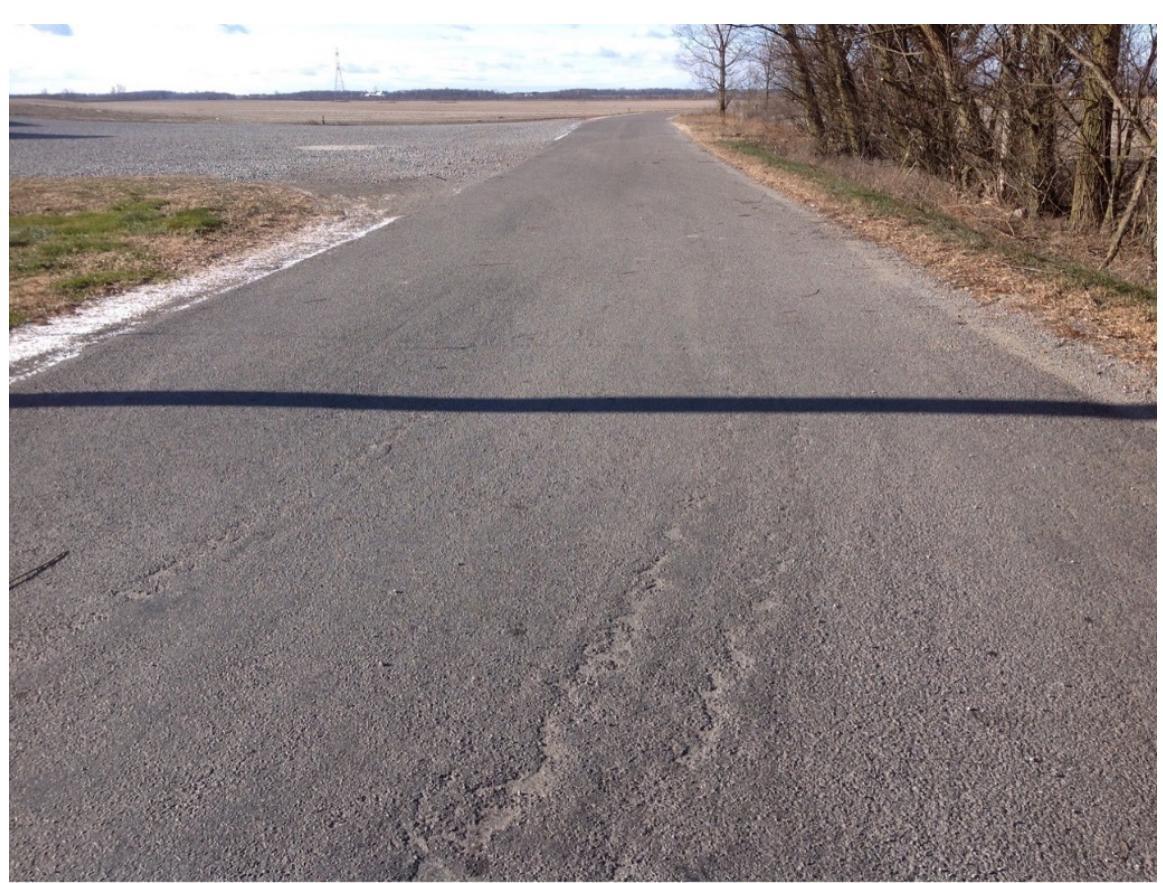
Figure 4-13 CR-130 Section 5

Section 5 from OH-195 to CR-65 road conditions varied along its length from fair to good with the majority of the distresses at the intersections with other roads, bridges or at farm entrances. Such distresses were mainly classified as low, with few areas where the severity was deemed as medium.

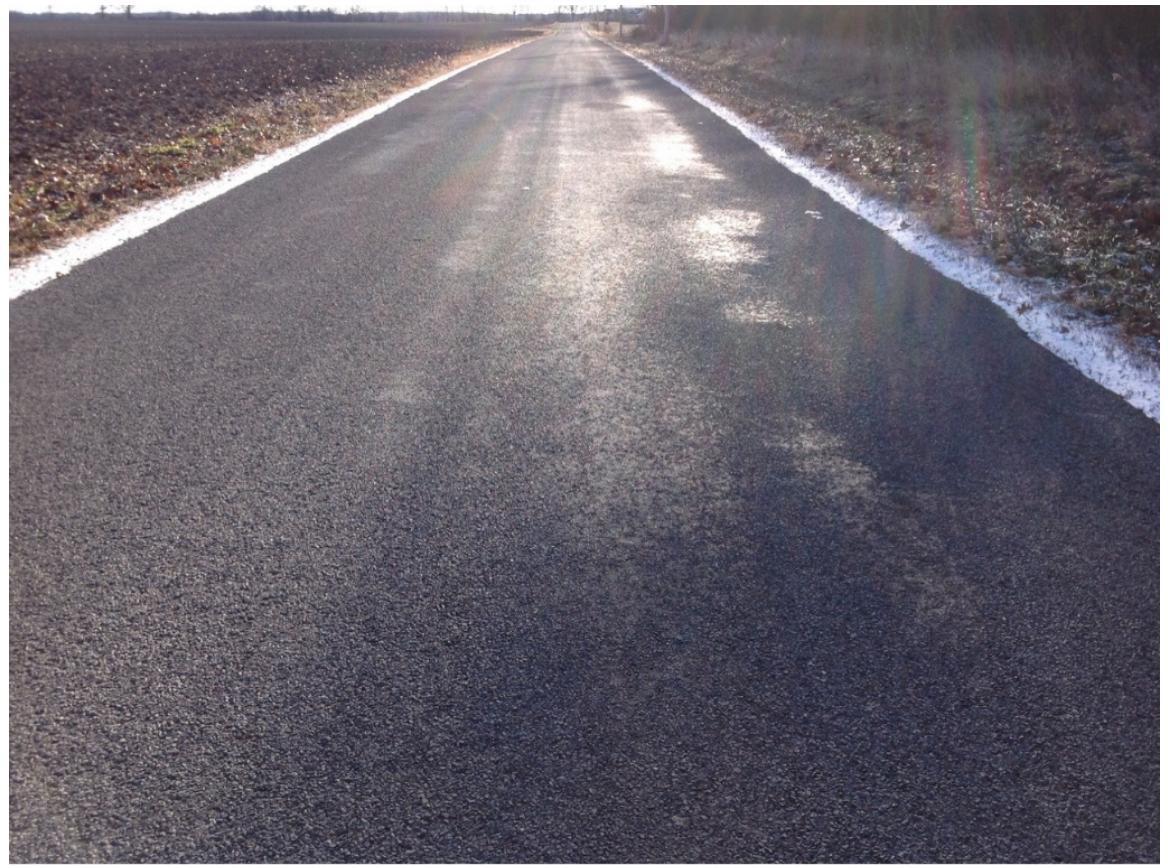
Figure 4-14 CR-130 Section 6

Section 6 from CR-65 to TR-65 was observed generally in good condition. The pavement has minimal distresses such as bleeding. The road differs from previous sections with a width of 17 feet compared to 20 feet.

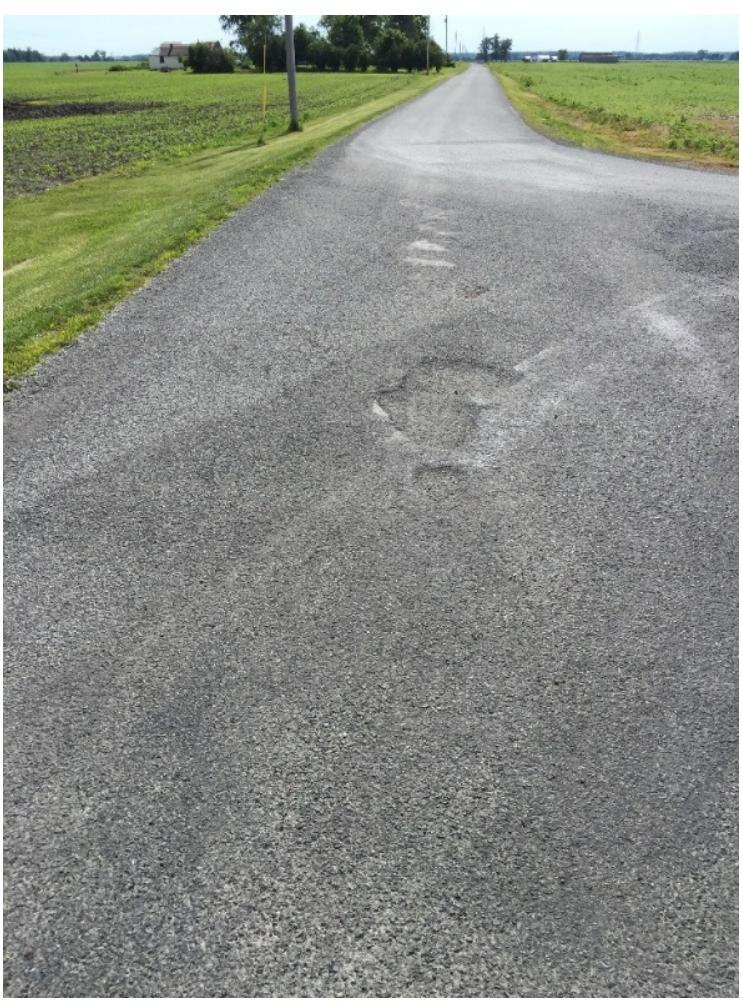
Figure 4-16 TR-65 Section 1

Section 1 from CR-130 to the road's 90° bend was observed generally in satisfactory condition. The pavement has minimal distresses such as bleeding and edge cracking. Some areas had small potholes and corrugation resulting in lower rating. Five sample units were selected within the section.

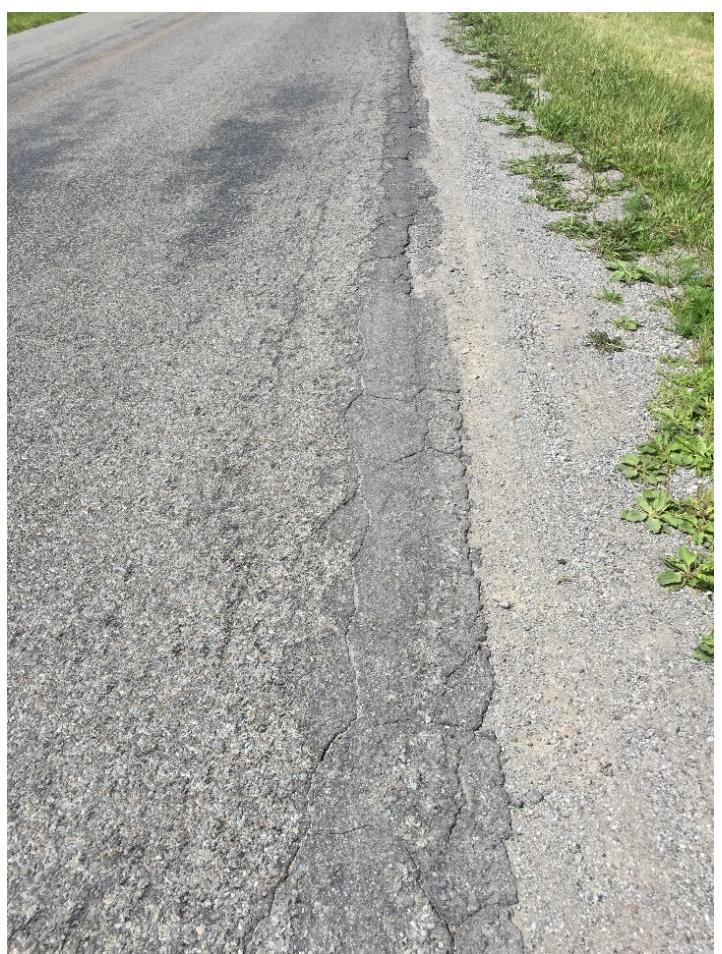
Figure 4-19 CR-75 Section 1

Section 1 from OH-67 to 33+50 was observed generally in satisfactory condition. The pavement has minimal distresses such as edge cracking. Six sample units were selected within the section.

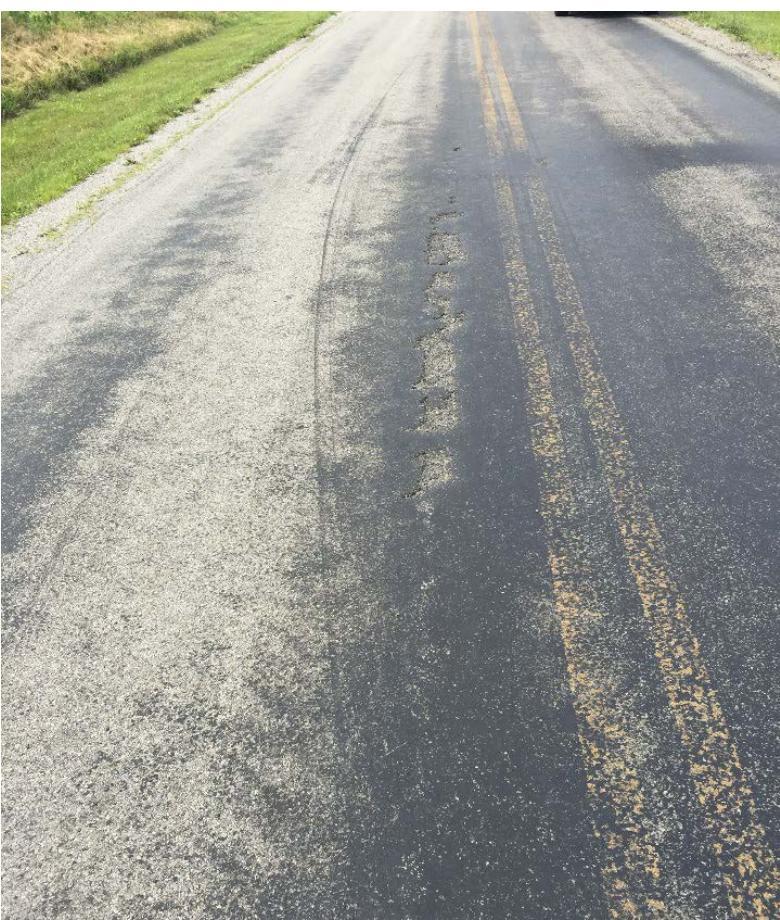
Figure 4-21 CR-75 Section 3

Section 3 from TR-154 to the north intersection with CR-150 was observed generally in satisfactory condition. The pavement has minimal distresses such as bleeding and edge cracking. One sample unit had potholes, bleeding and edge cracking and seemed only in "fair" condition.
