Waters of the U.S. Investigation Memorandum

Subject: State Route 13 (Line 3-C) Replacement Project

Thorn Township, Perry County, Ohio

Waters of the U.S. Review

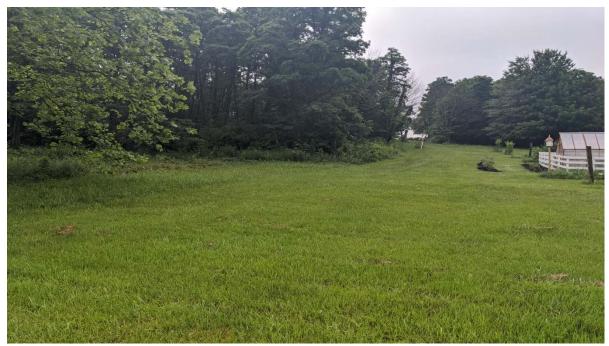
Photo 1: View of the existing pipeline corridor located east of SR 13, facing east.

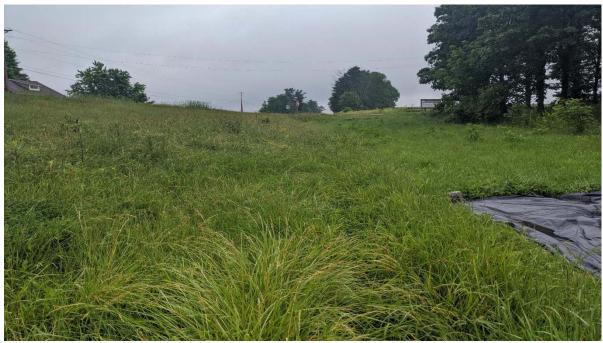
Photo 2: View of vegetated drainage swale looking north towards the SR 13 & High Point Road Intersection.

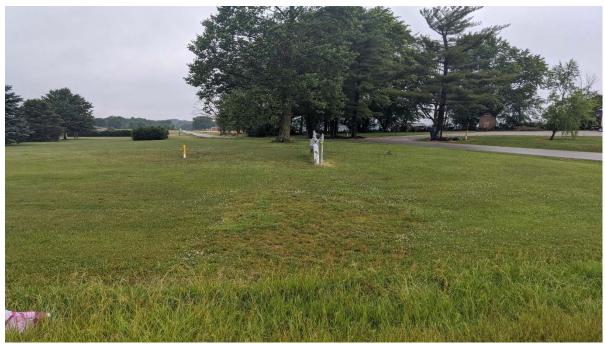
Photo 3: Looking west along the existing pipeline corridor, from the southbound SR 13 edge of pavement.

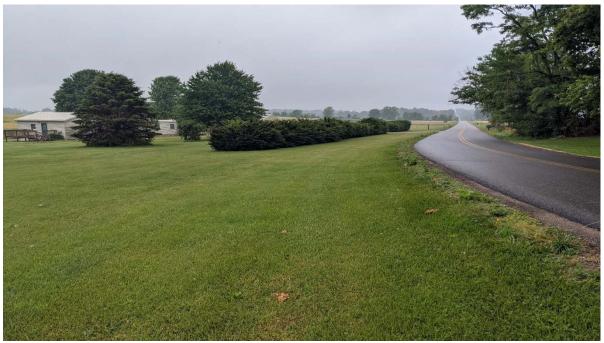
Photo 4: Looking west along the proposed pipeline corridor, south of High Point Road.

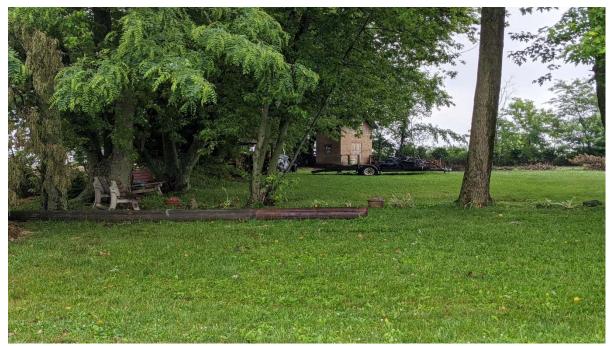
Photo 5: Looking north along the proposed pipeline corridor, north of High Point Road.

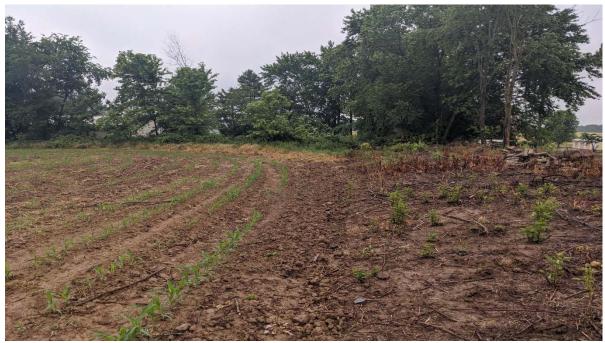
Photo 6: Looking south along the proposed pipeline corridor, from the proposed relocation tie-in.
