Re: Case No. 07-252-WS-UNC  
Ohio American Water Company  
Stipulation Page No. 16, ¶13D

Ohio American Water Co.  
Franklin County Operations  
Lake Darby Water Treatment Plant  
PWSID#2502612

Reporting Period                      October                      2008

**Hardness Concentration Exception Event – October 29, 2008**

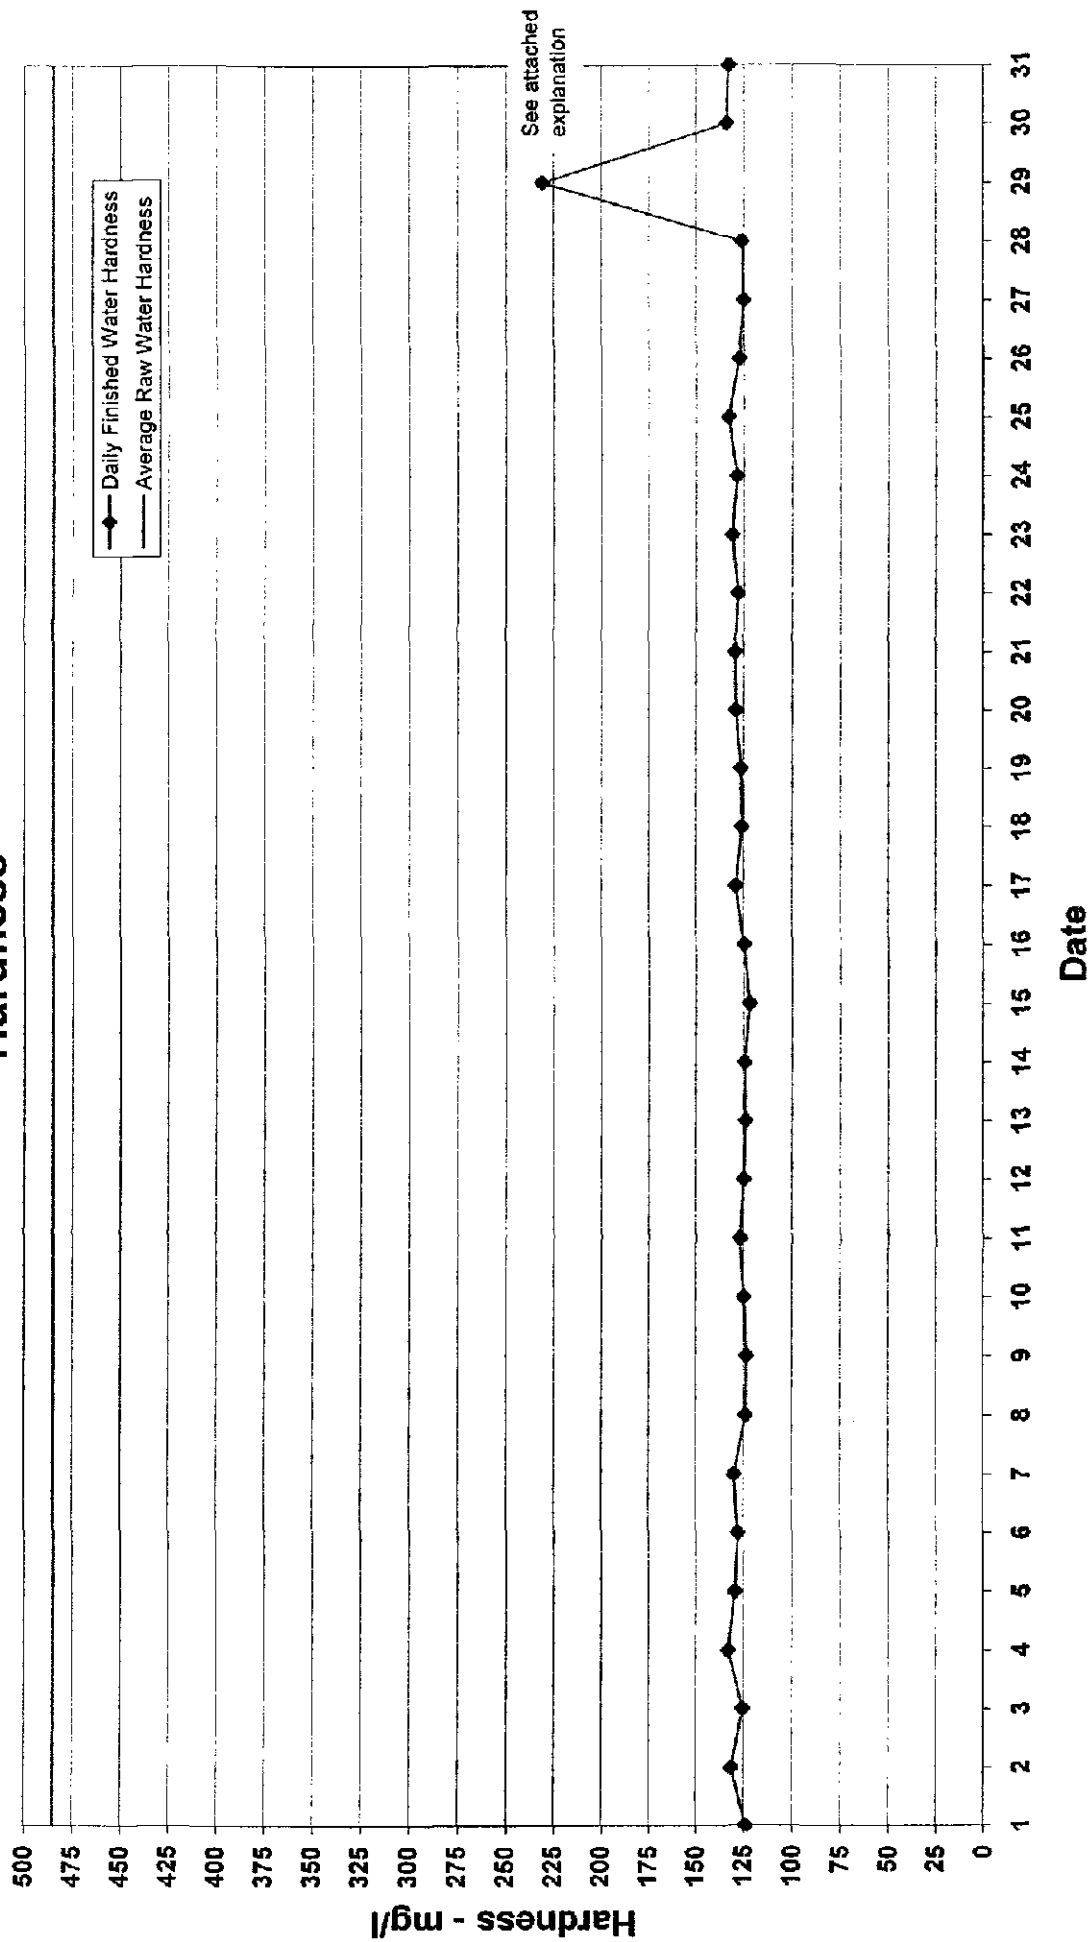
# October 2008 - Lake Darby Daily Finished Water Hardness

On October 29, 2008 an elevated hardness concentration was measured at the Lake Darby Water Treatment Plant (LDWTP) by the on line hardness analyzer and confirmed by the operator bench test. As a result of the elevated value measured, Ohio American Water Company (OAWC) immediately began reviewing operating data and investigating possible causes.

Upon reviewing the data, it was determined that LDWTP's two (2) water softeners were both in regeneration operating mode at the same time. This is an unacceptable operating condition. This condition is supposed to be prevented from occurring by each water softener's respective controller monitoring the operating condition of the other controller.

The above issues are being addressed and a fix should be implemented by mid-November. In the meantime the on-line hardness analyzer is being programmed to shut the LDWTP down if the hardness concentration exceeds 150 mg/L.
