Re: *Testimony of Alan P. Rehbein
Dane L. Mazzitti v. Ohio Edison Company
Case No. 08-1146-EL-CSS*

BEFORE THE
PUBLIC UTILITIES COMMISSION OF OHIO

TESTIMONY OF ALAN P. REHBEIN

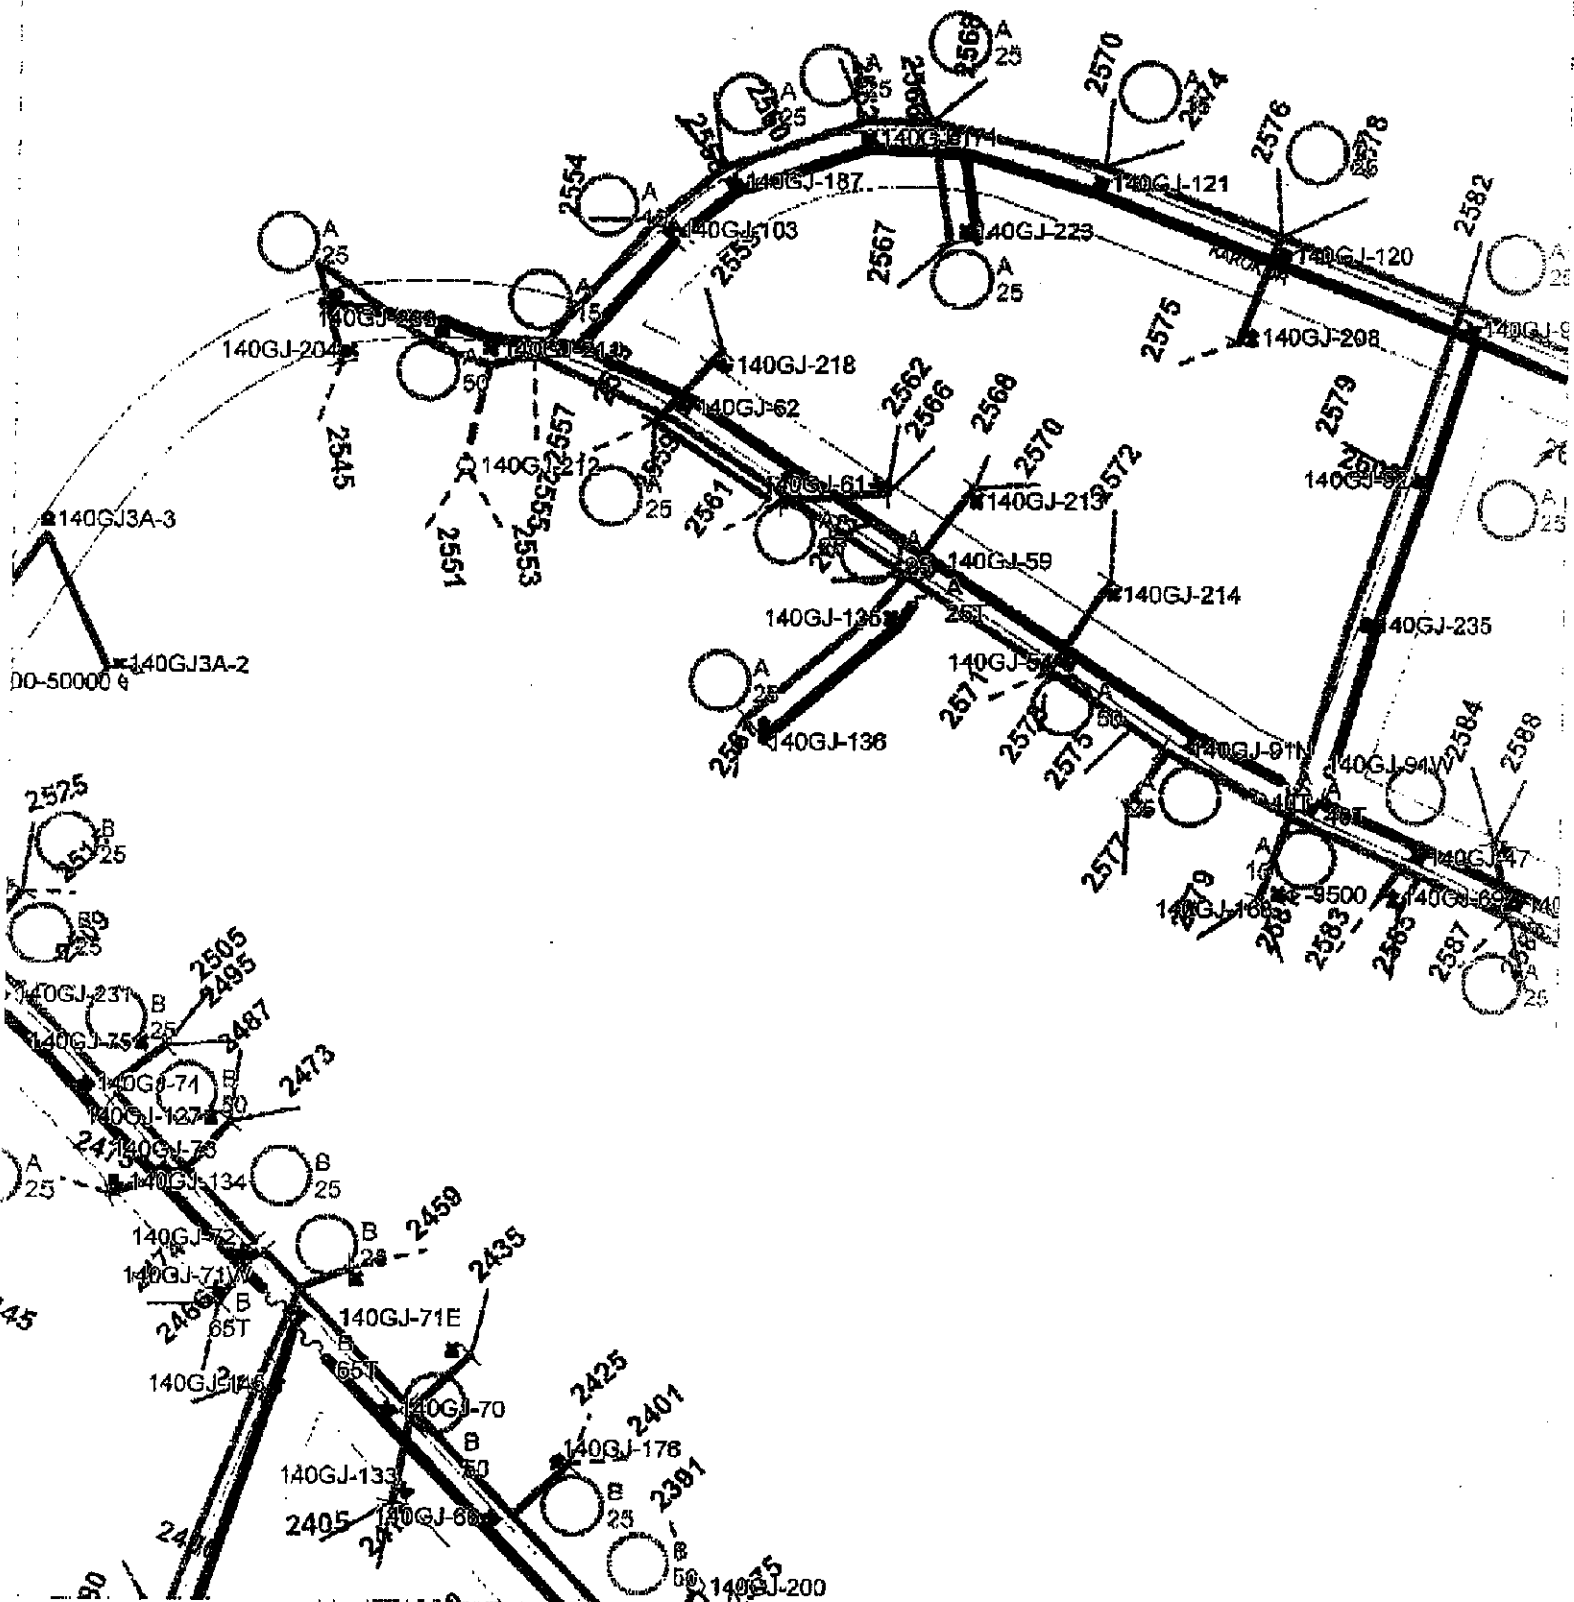
9 **A.** As indicated on attached Exhibit APR-3, which is a drawing of the distribution
10 system around Mr. Mazzitti's property, the main distribution line runs along
11 Choctaw Drive. That line is the middle line on APR-3. A tap line extends
12 between 2563 and 2567, which is the line at issue in this proceeding. This line
13 serves Mr. and Mrs. Anthony Piecenski, Mr. Mazzitti's neighbors, at
14 2567 Choctaw Drive.

3 **A. If you are referring to a feeder line or drop line as meaning one that brings the**
4 **electricity into the home, no, it is not. As I indicated before, it is a 12.5 kV**
5 **primary distribution line. At the end of this line is a drop line that delivers**
6 **electricity to the Piecenski's home. The voltage is stepped down at the**
7 **transformer indicated on Exhibit APR-3 as 140GJ-136.**
