<p>6397 Emerald Parkway Suite 200 Dublin, Ohio 43017 © 2011, Hull & Associates, Inc.</p> <p>Phone: (614) 793-8777 Fax: (614) 793-9070 www.hullinc.com</p>	<p>Buckeye Wind Project Surface Water Delineation</p> <p>Site Photographs</p> <p>Champaign County, Ohio</p>	<p>Date: MARCH 2013</p> <p>Project Number: EVP010 File Name: EVP010.300.0012</p>
---	---	---

Summary: Application Appendix C - Surface Water Report (86-98) electronically filed by Mr. Michael J. Settineri on behalf of Buckeye Wind LLC

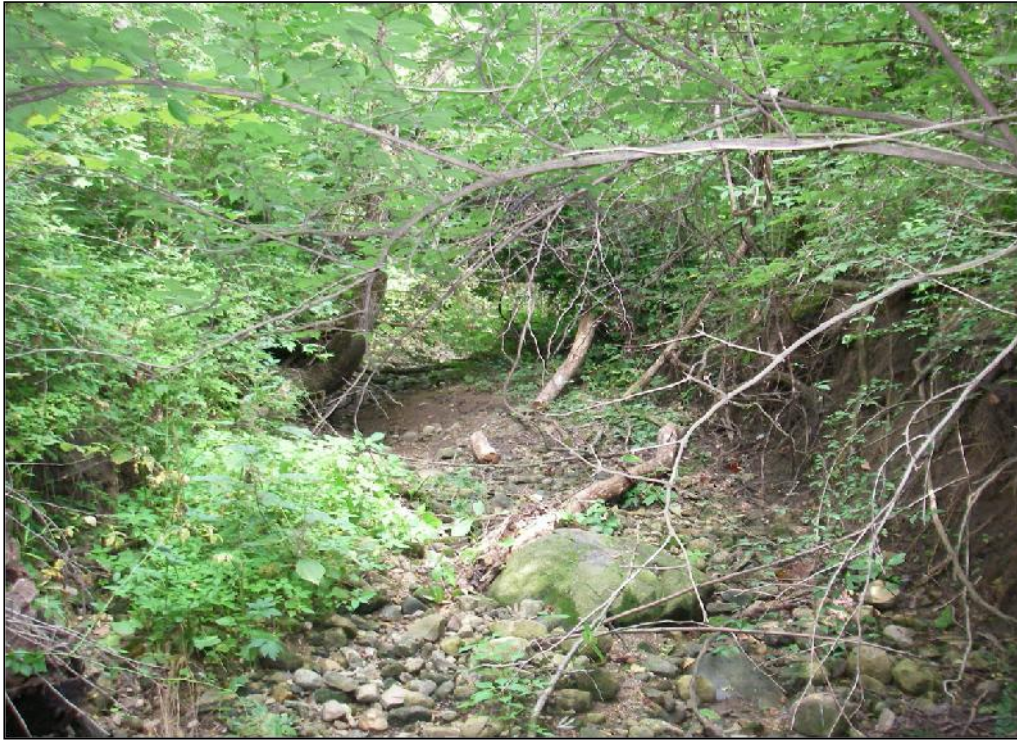
Photo 25. View of Stream R located between Turbines 37 and 43; facing upstream.

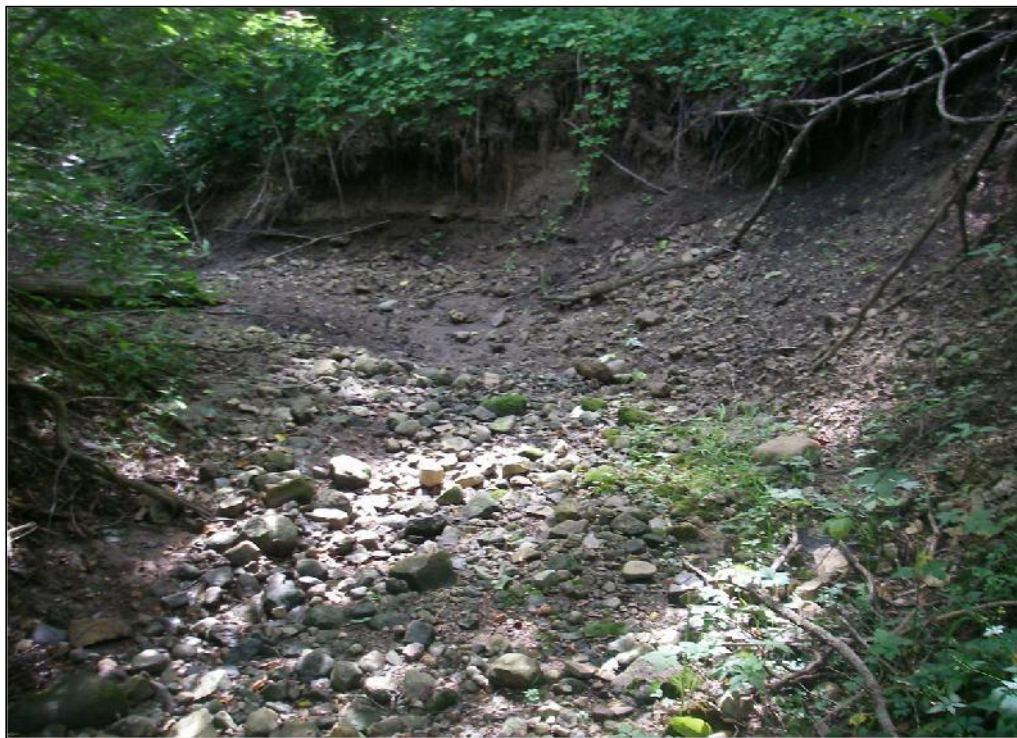
Photo 26. View of Stream R near Turbine 37; facing downstream.

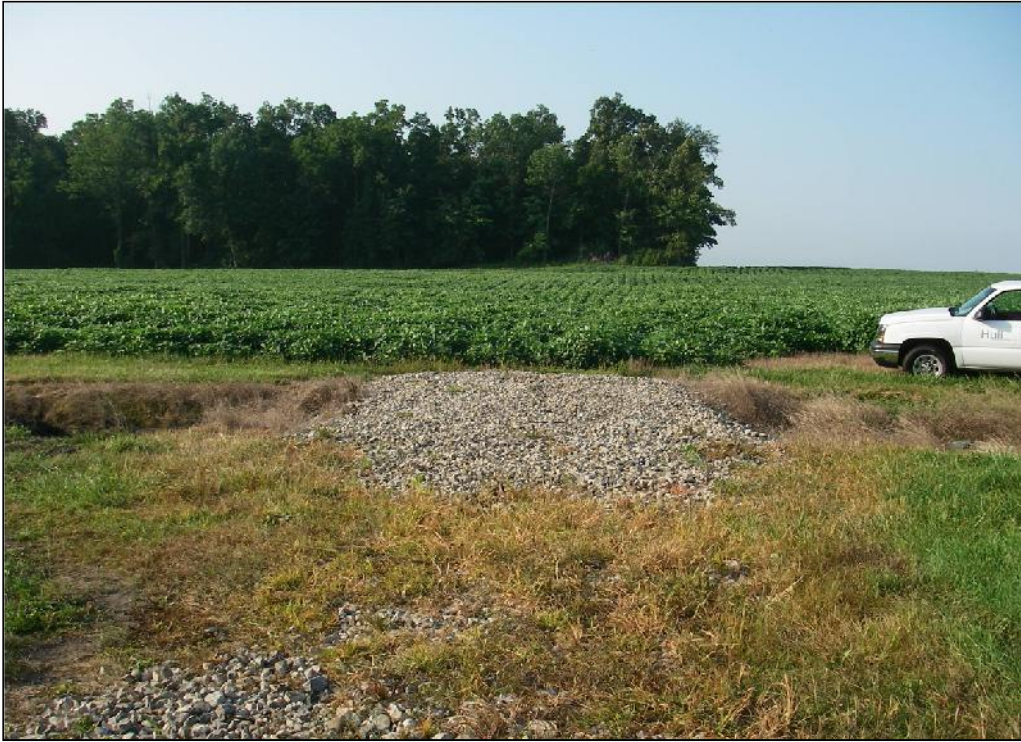
Photo 27. Stream S gravel crossing in foreground.

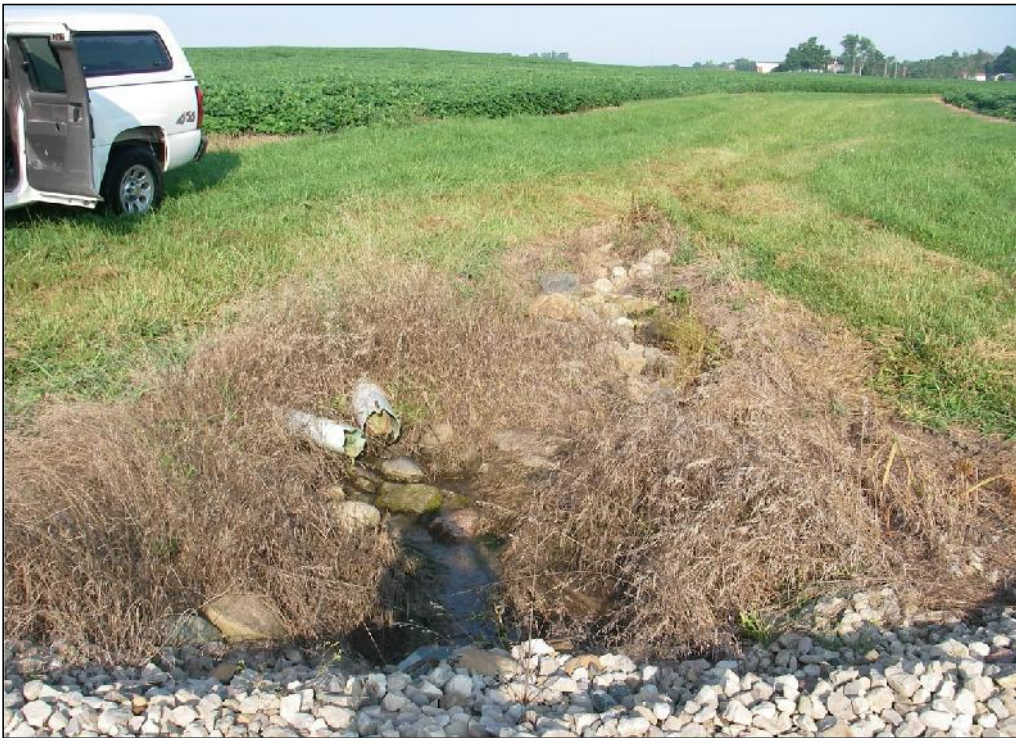
Photo 28. View of Stream S near Turbine 18; facing upstream.

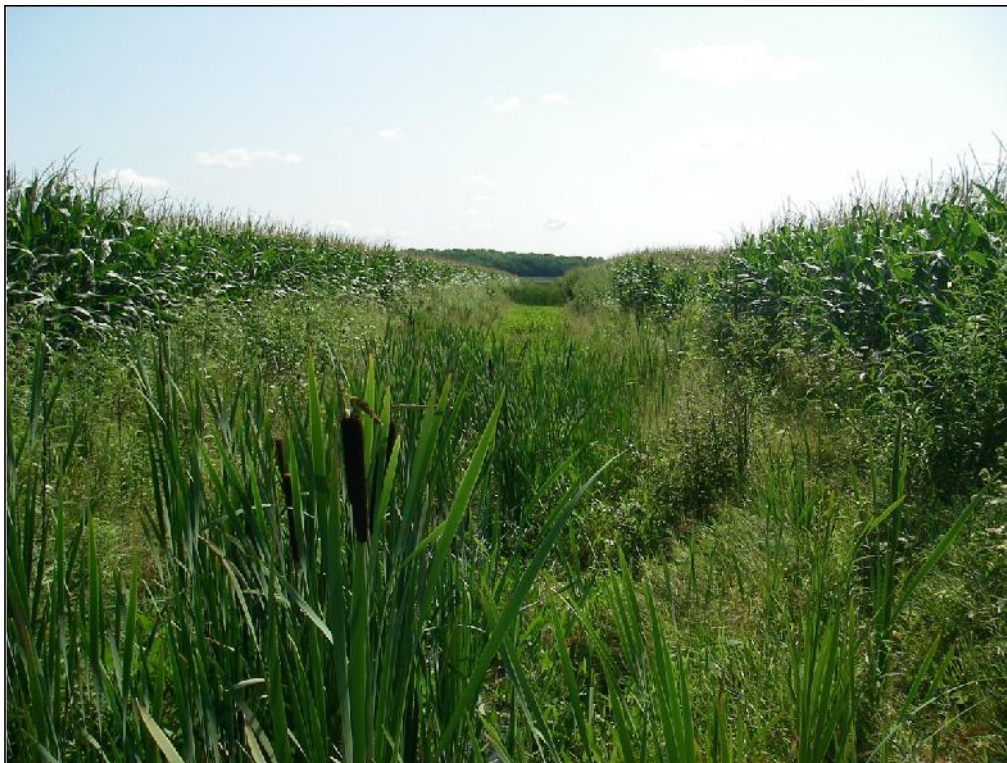
Photo 29. View of Stream V between Turbines 42 and 43 facing downstream looking east.

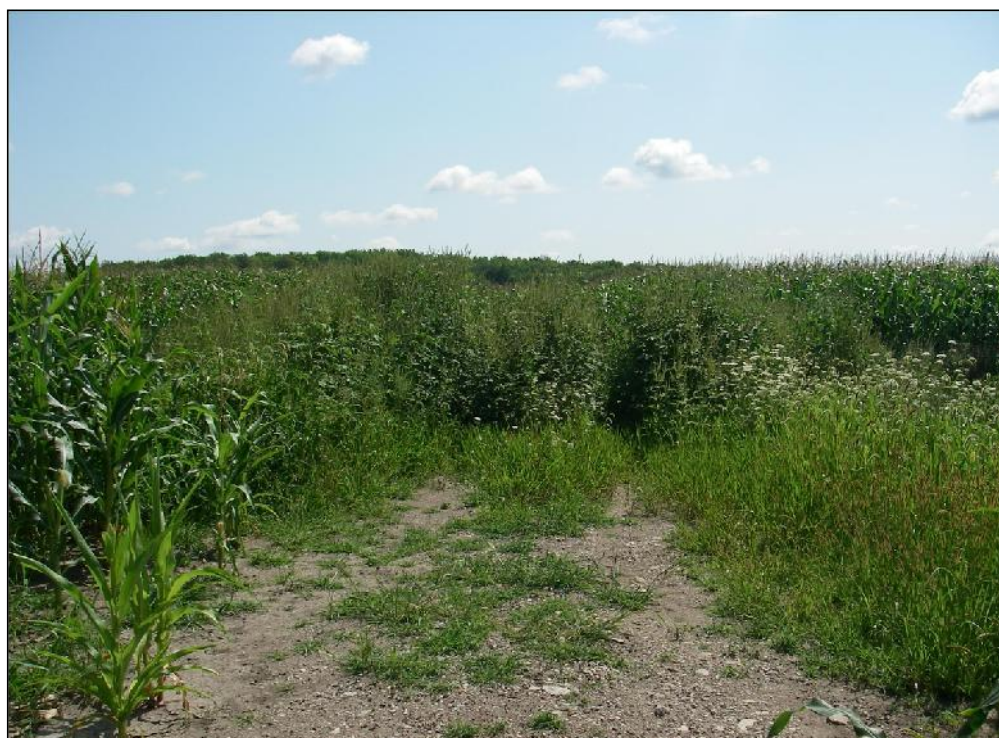
Photo 30. View of existing crossing of Stream W near Turbine 43.

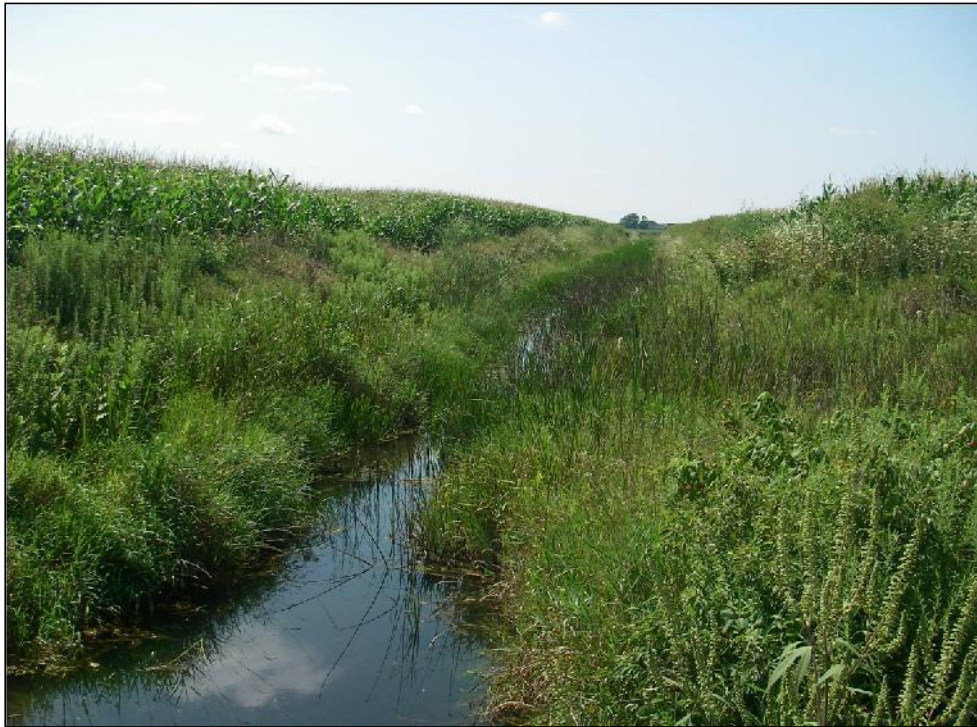
Photo 31. View of Stream W near Turbine 43 facing downstream looking south.

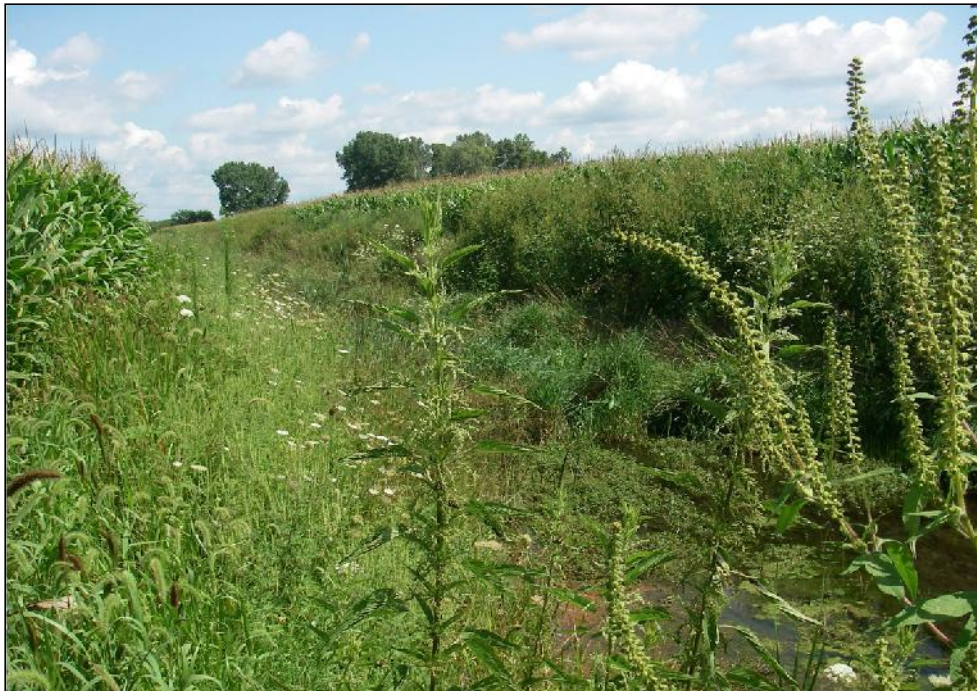
Photo 32. View of Stream W near Turbine 43 facing upstream looking north.

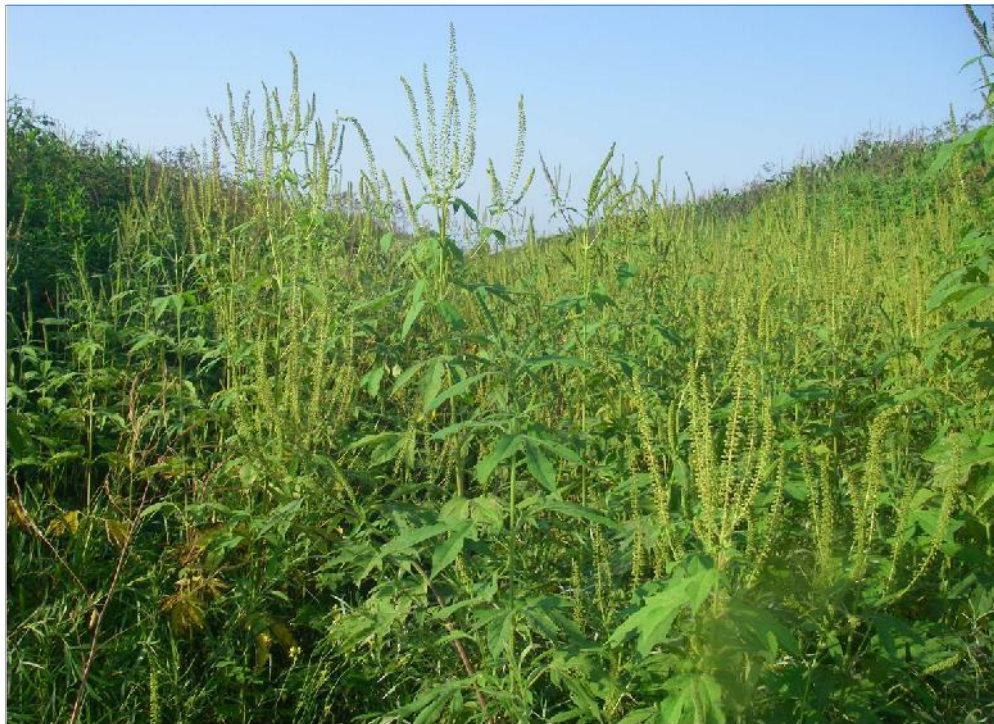
Photo 33. Stream Y (Buck Creek) looking south.

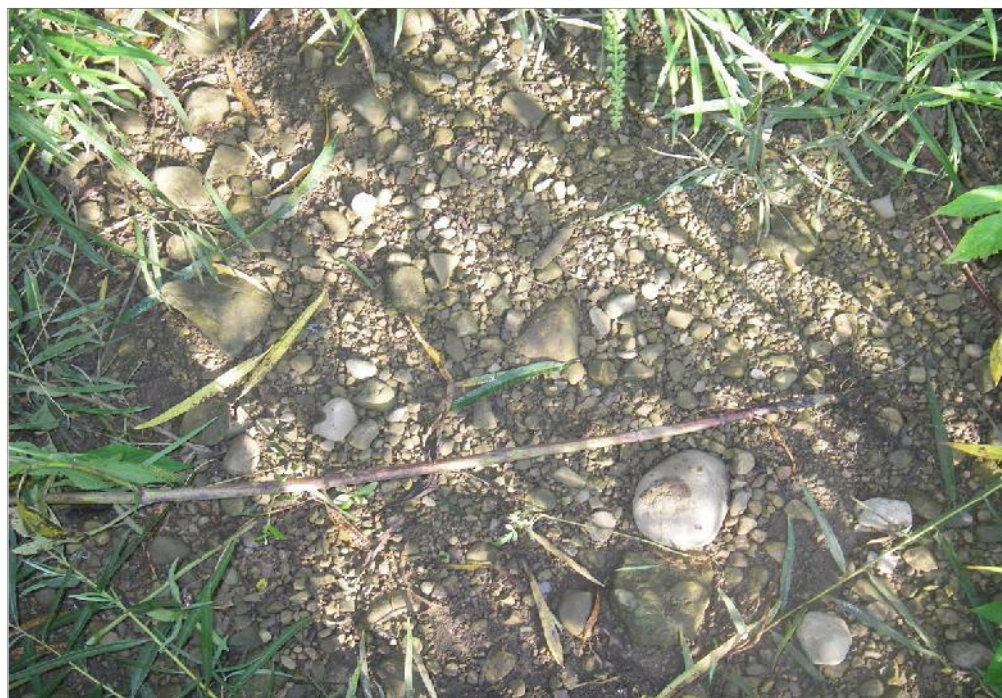
Photo 34. View of substrate in Stream Y (Buck Creek).

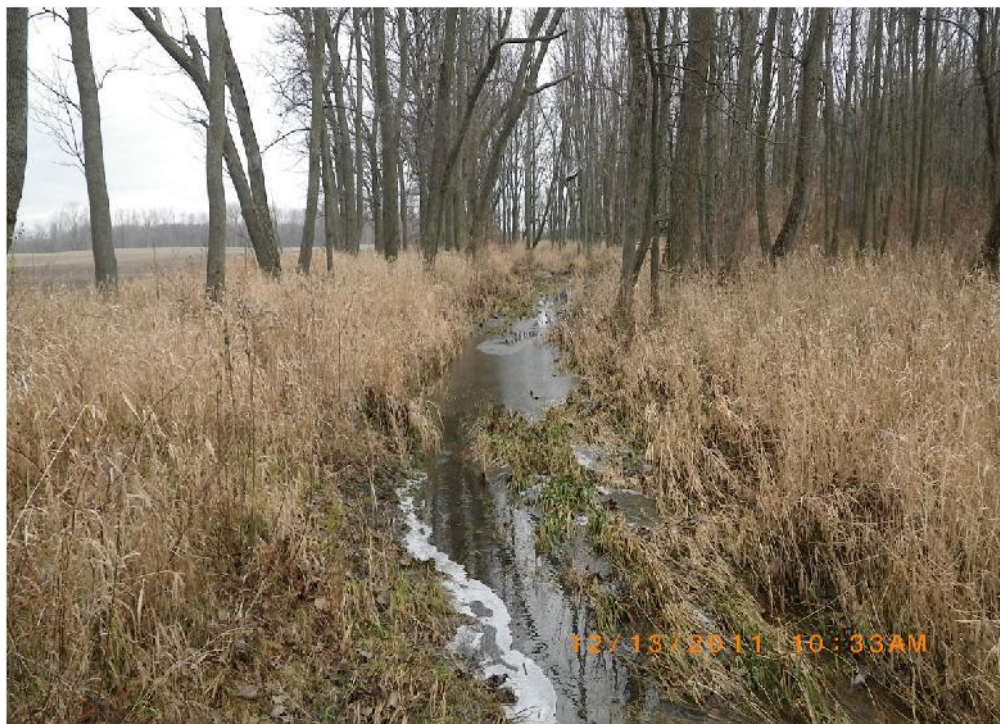
Photo 35. Stream Y-2 (Buck Creek) looking upstream.

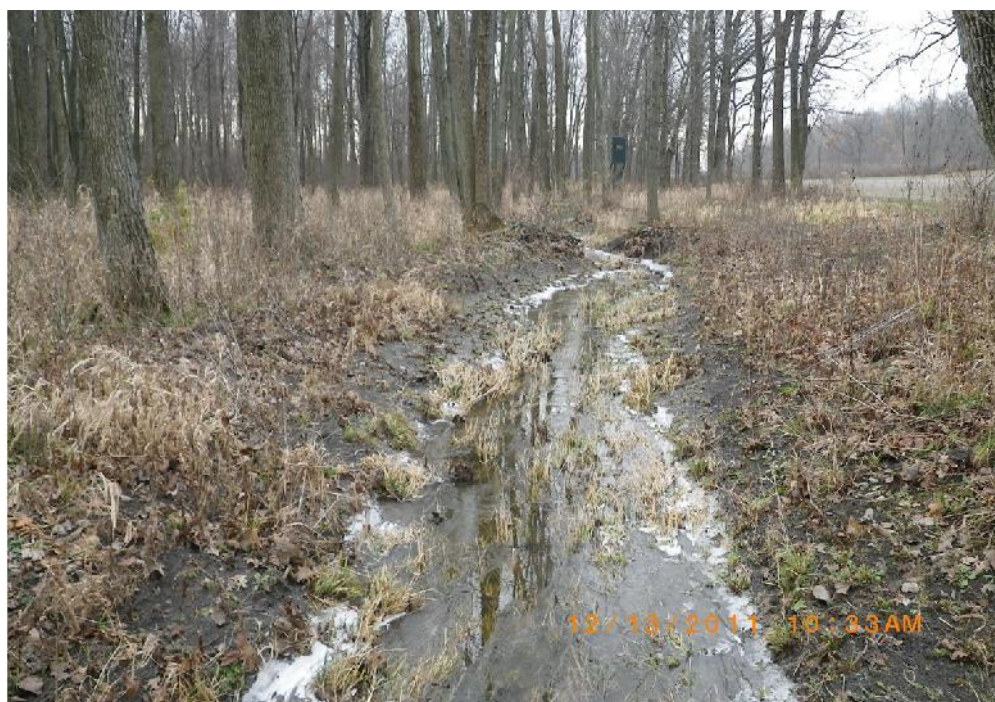
Photo 36. Stream Y-2 (Buck Creek) looking downstream.

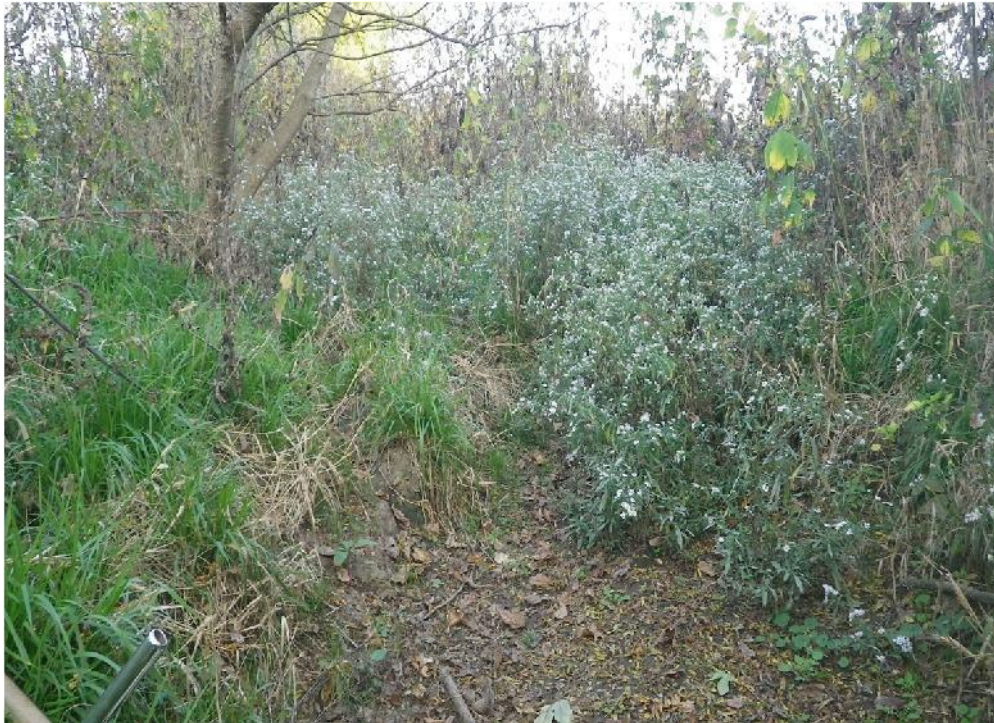
Photo 37. Stream Y-3 (Buck Creek) looking upstream facing East.

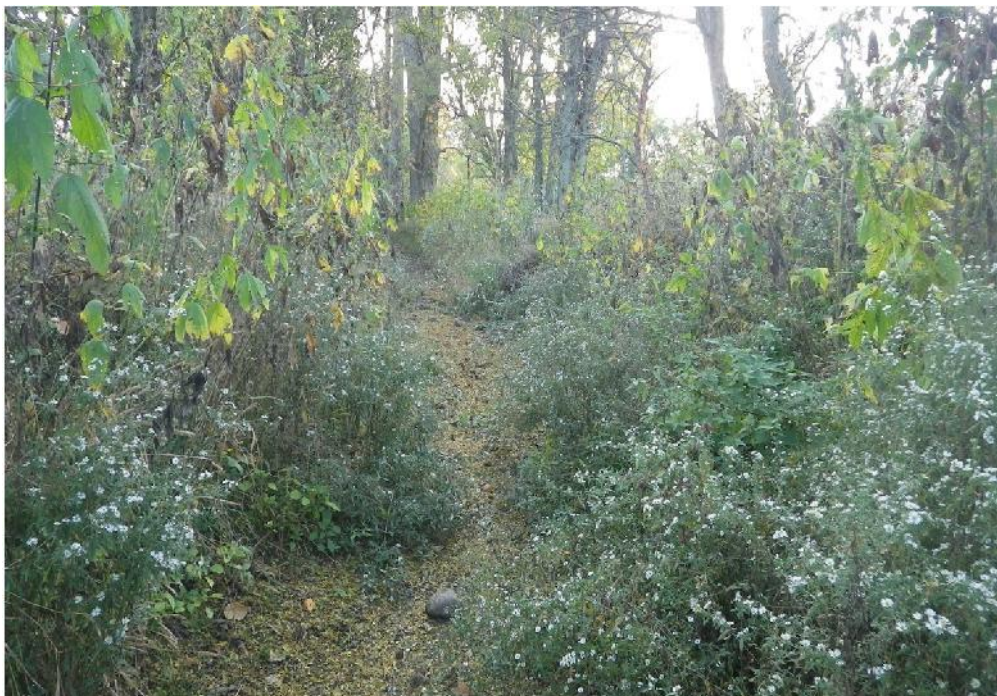
Photo 38. Stream Y-3 looking downstream facing West.

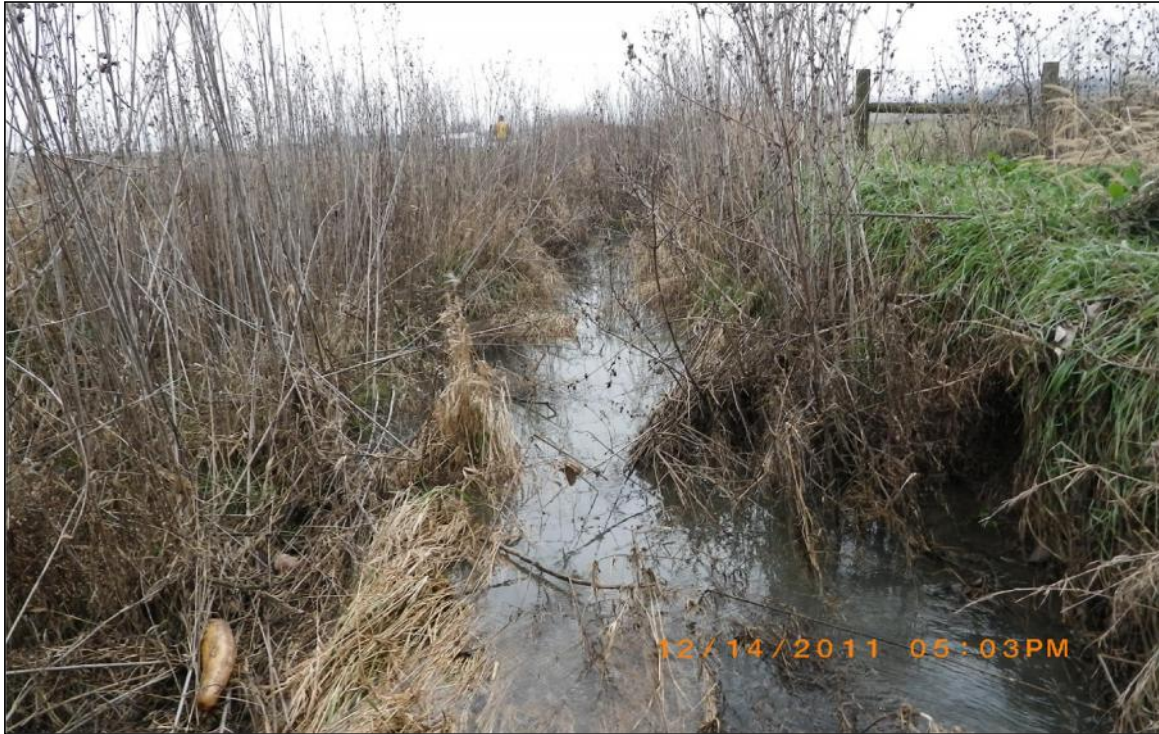
Photo 39. Stream Y-4 (Buck Creek) looking upstream facing East.

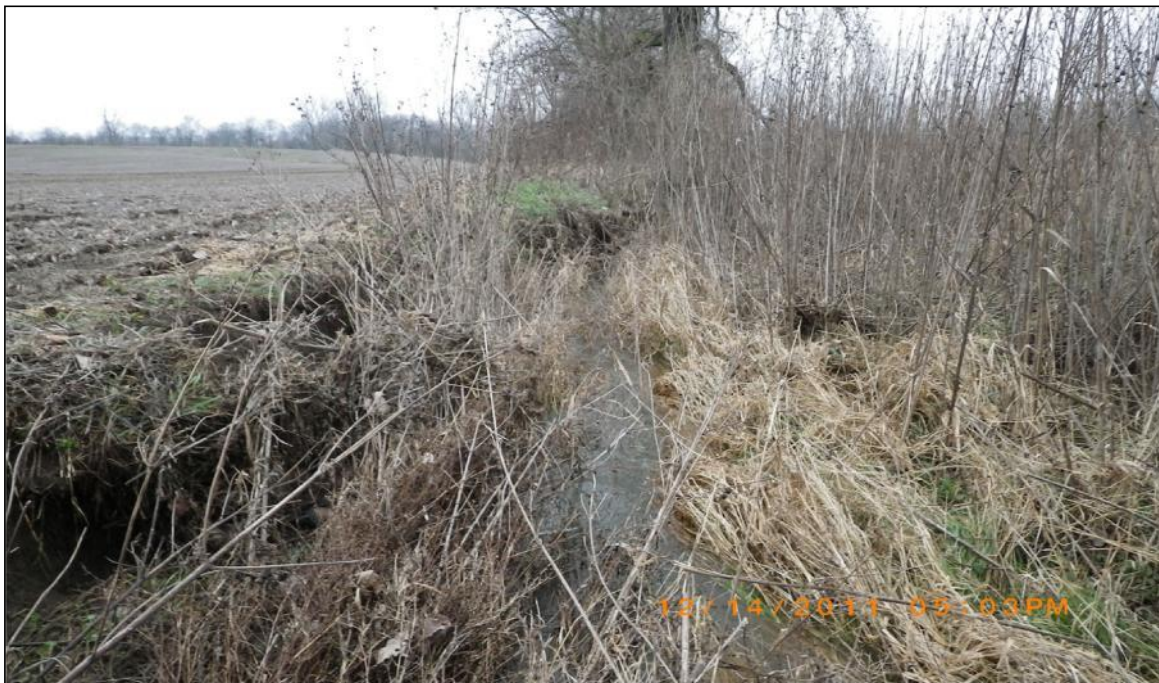
Photo 40. Stream Y-4 (Buck Creek) looking downstream facing West.

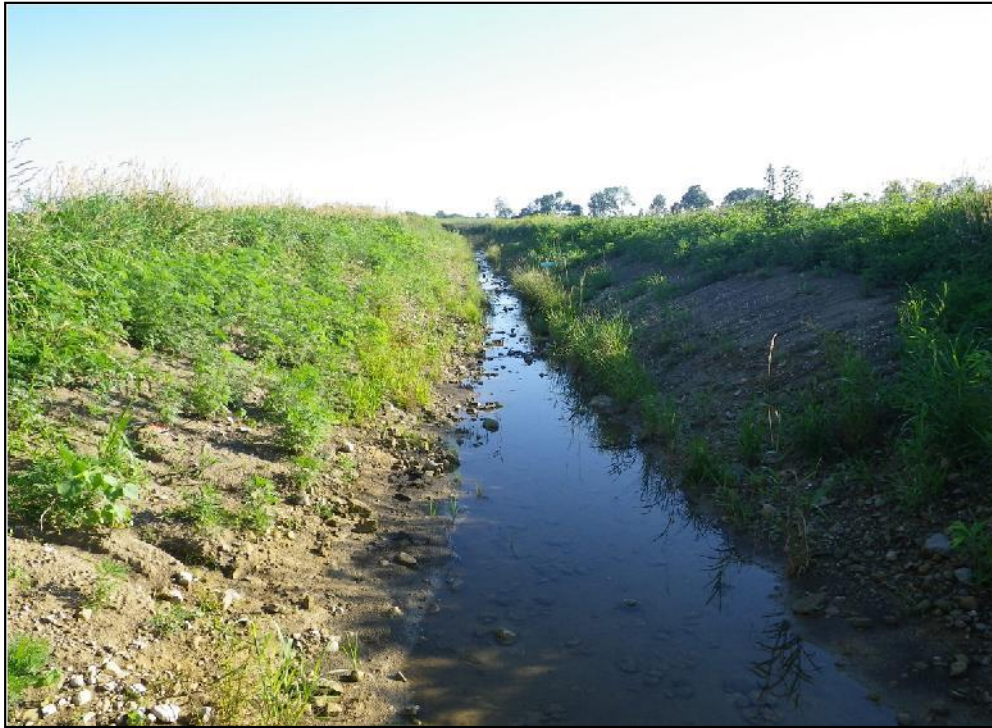
Photo 41. View of Stream AA looking upstream.

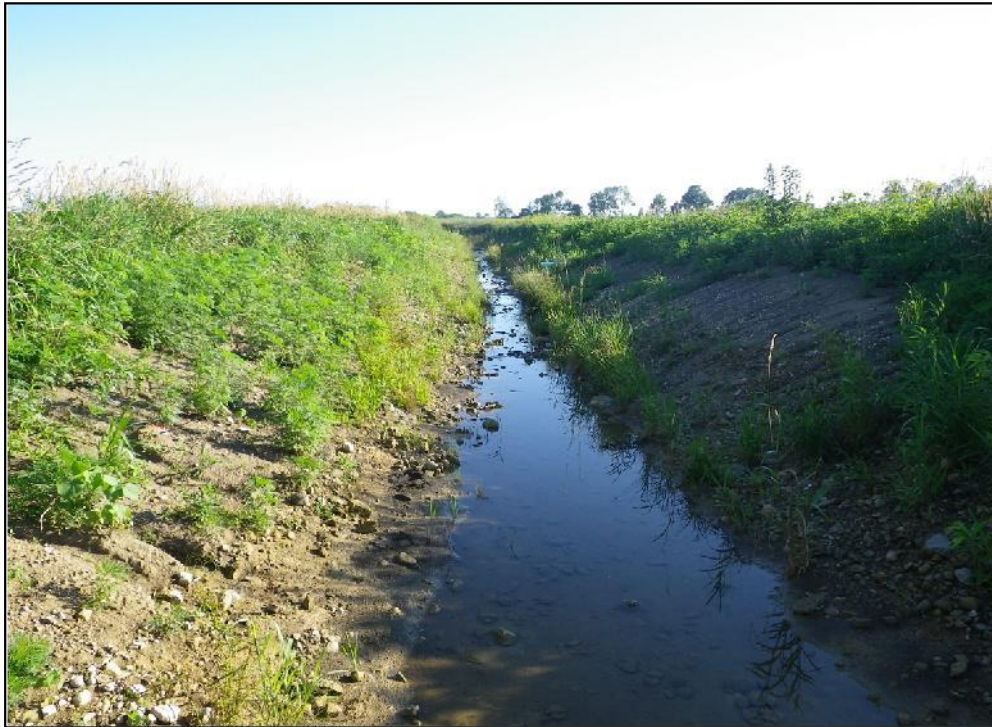
Photo 42. View of Stream AA looking upstream.

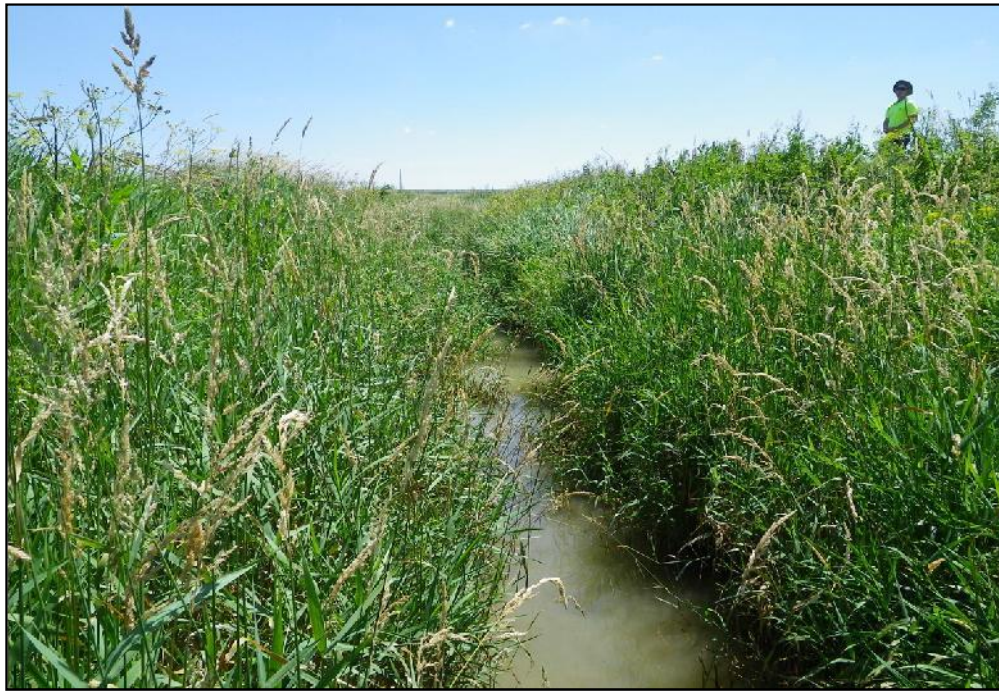
Photo 43. Stream BB (Treacle Creek) looking upstream.

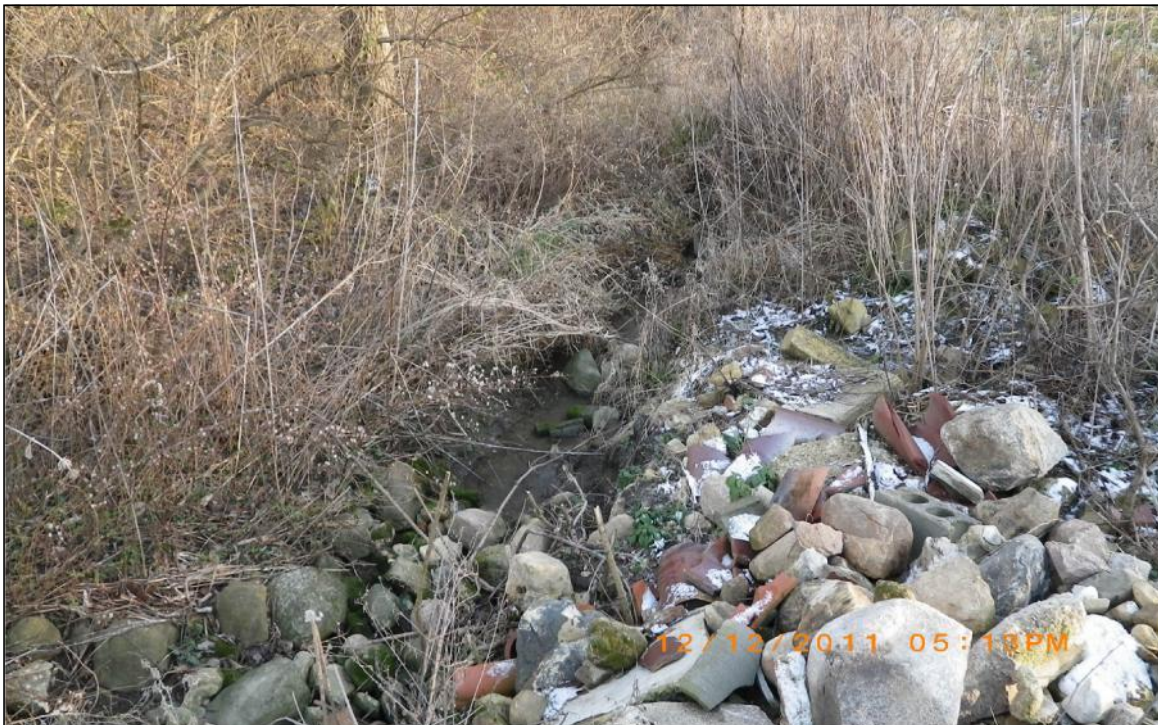
Photo 44. Start of Stream BB-3 (Treacle Creek) looking upstream facing Northwest.

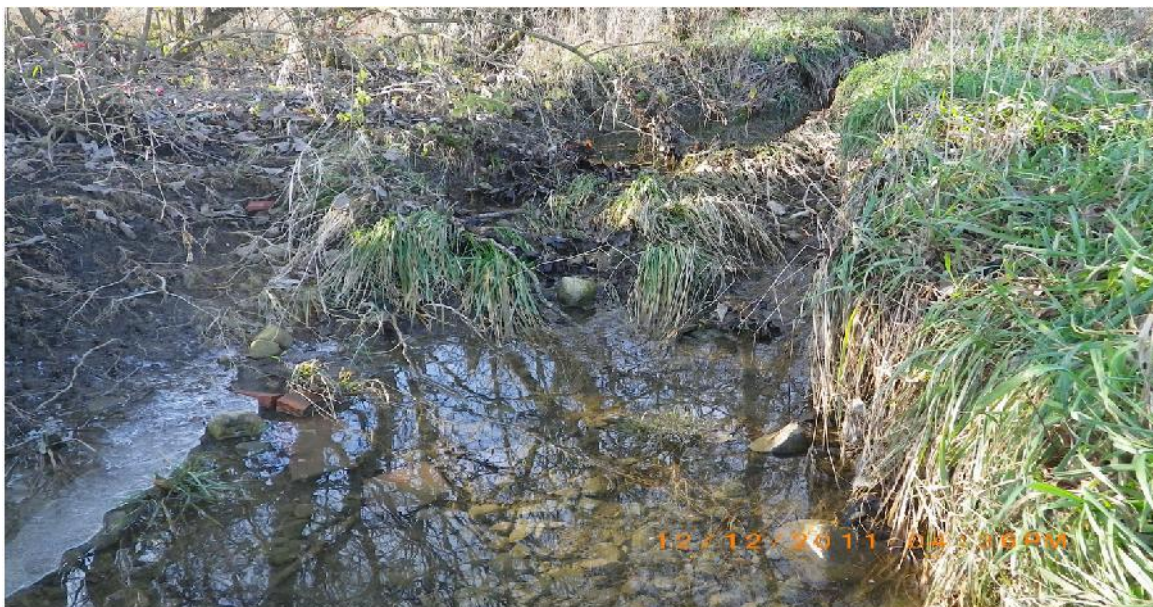
Photo 45. Stream BB-3 (Treacle Creek) looking upstream facing West.

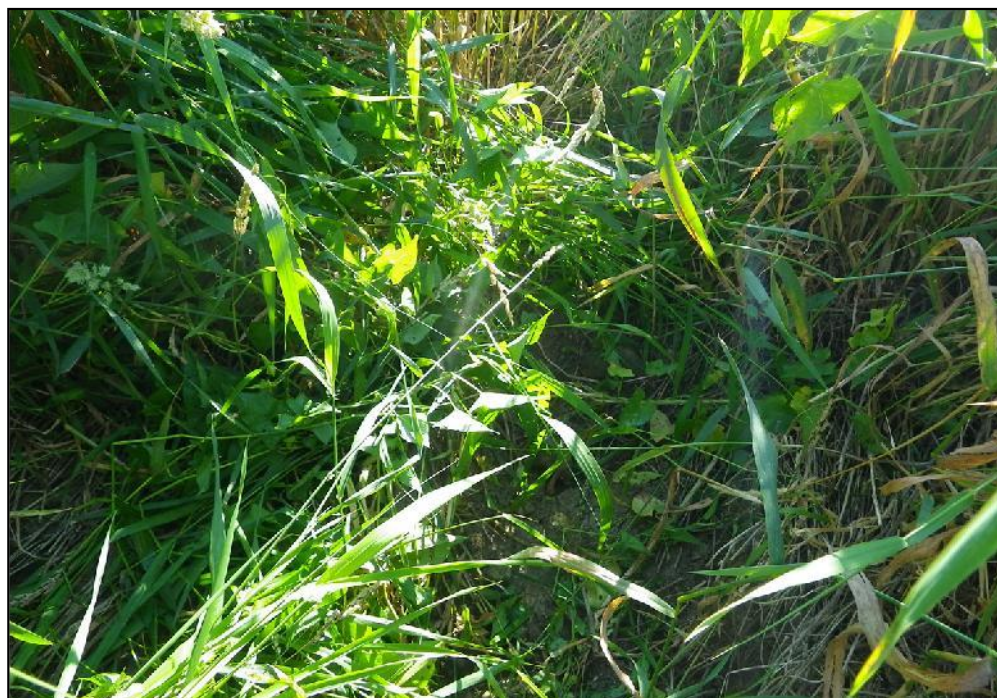
Photo 46. Stream CC looking upstream.

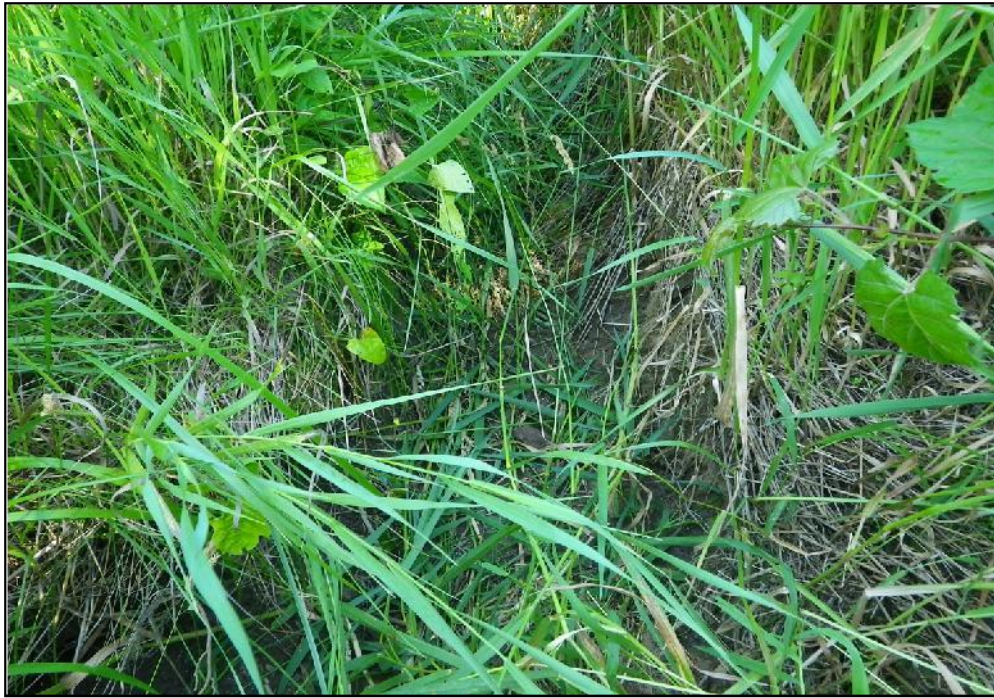
Photo 47. Stream DD looking upstream.

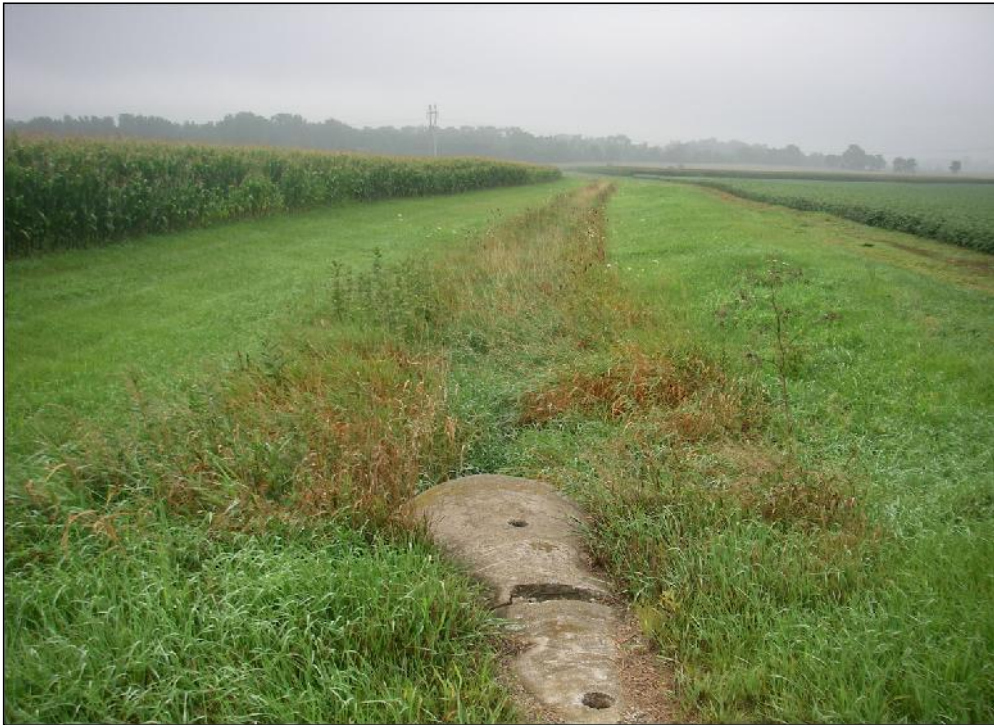
Photo 48. View of Stream EE near Turbine 69 facing south.

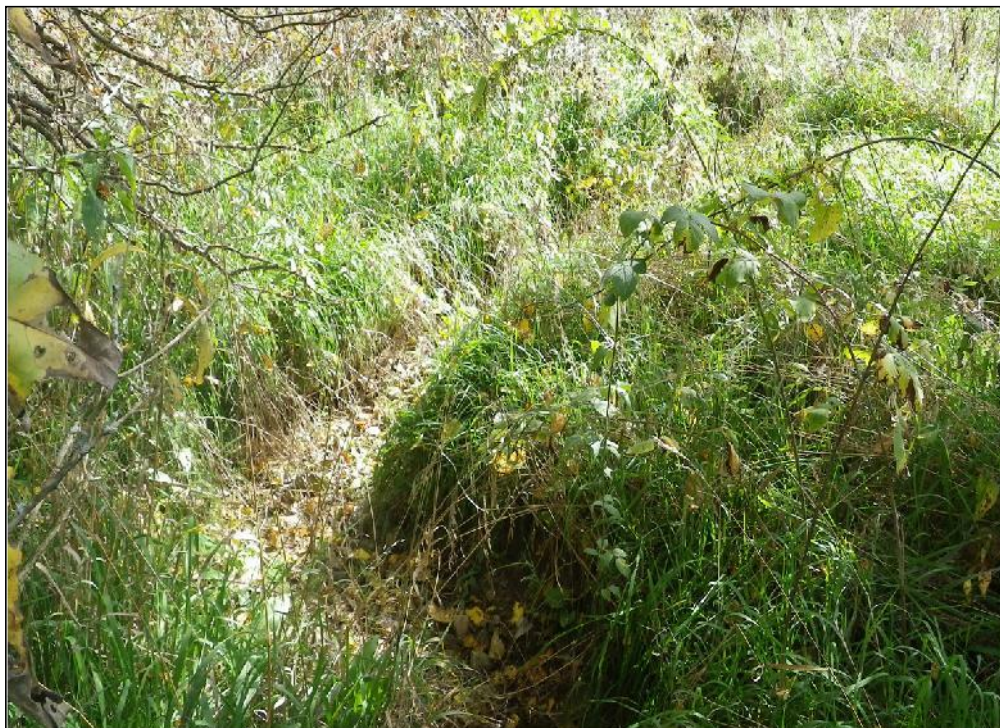
Photo 49. Stream GG looking upstream facing South.

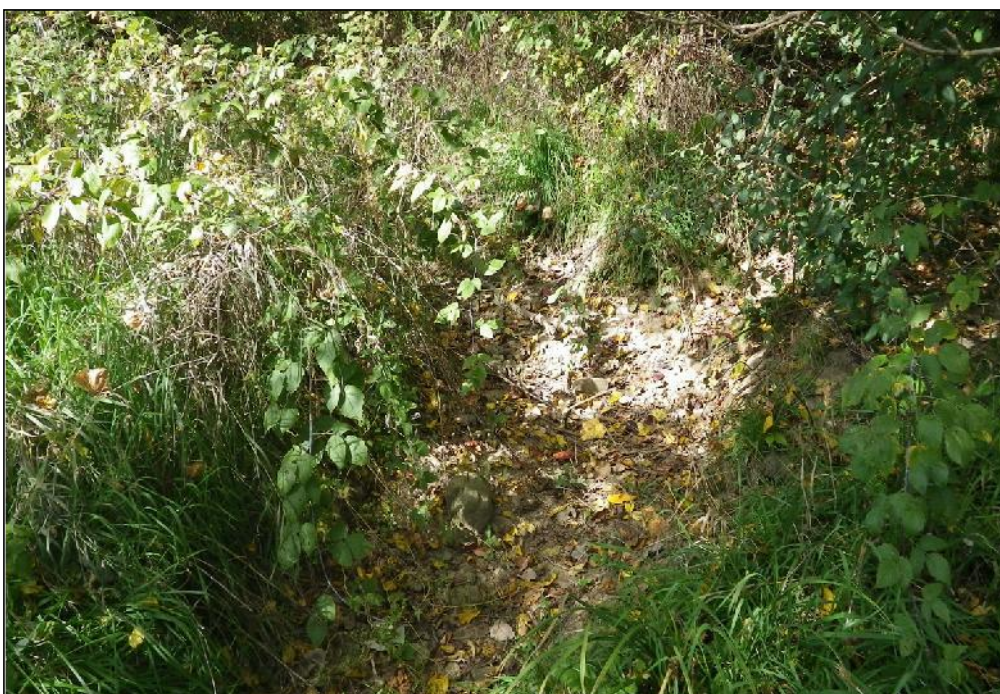
Photo 50. Stream GG looking downstream facing North.
