# **WETLAND DELINEATION AND STREAM ASSESSMENT REPORT**

## **FREMONT AREA IMPROVEMENTS: MELMORE TO TIFFIN CENTER 138KV LINE REBUILD**

**SENECA COUNTY, OHIO**

Report Date: September 2013

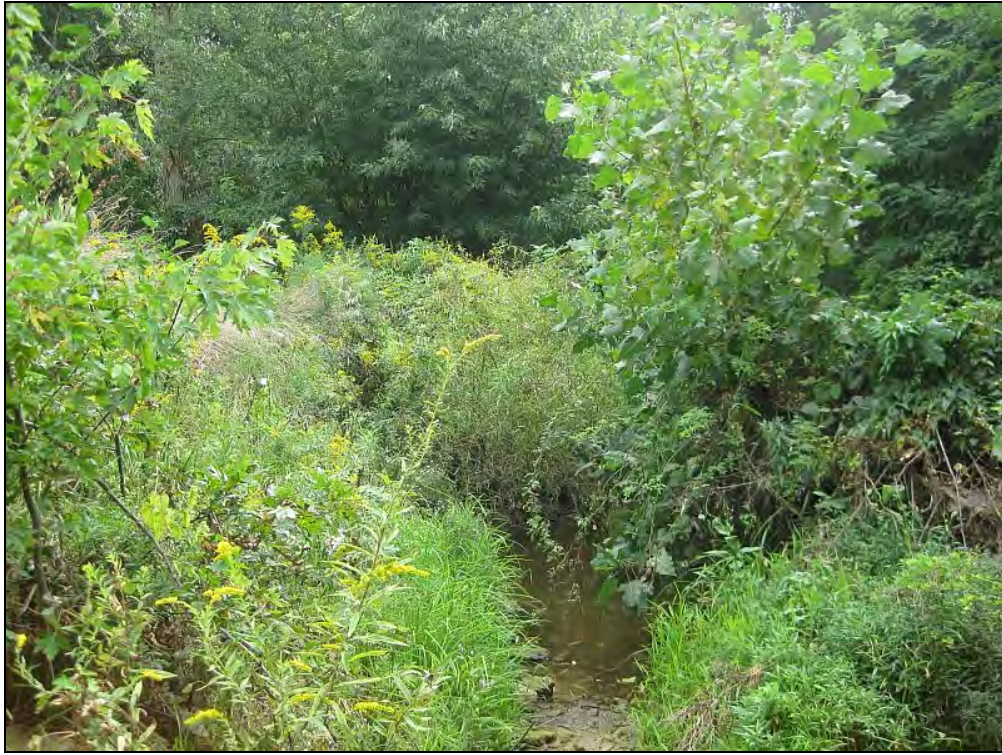
Photograph 1: Between structures 6 and 7, facing southeast and overlooking Stream 01. Water flow in the stream is northwest to Mohawk Lake.

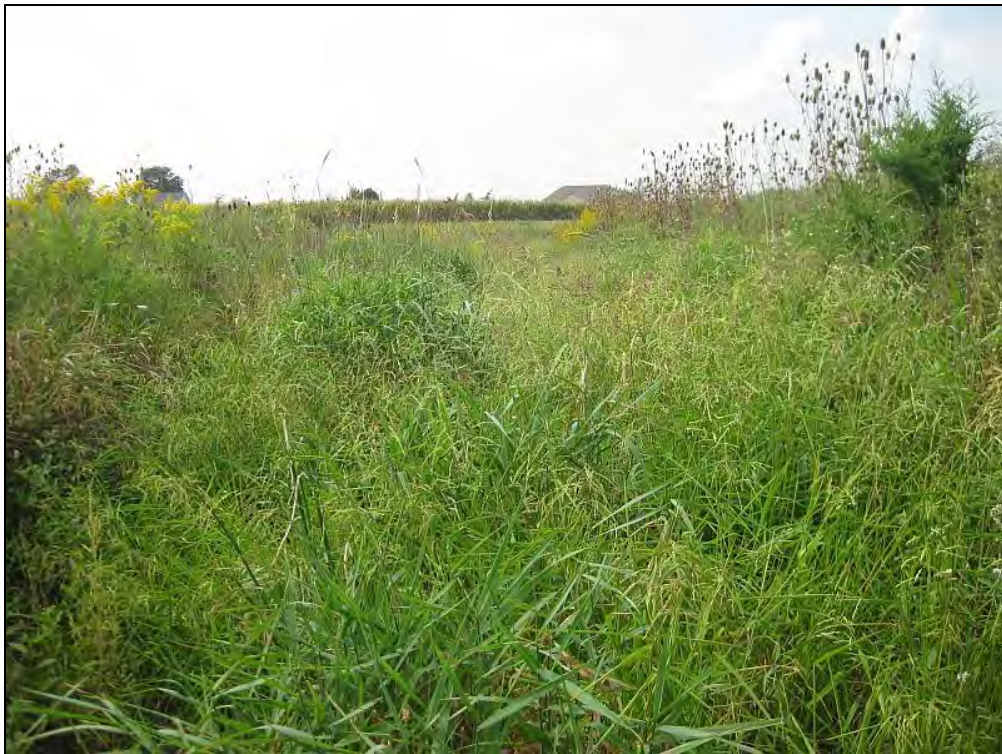
Photograph 2: Between structures 12 and 13, facing west and overlooking Stream 02. Water flow in the stream is west, then east to Rock Creek.

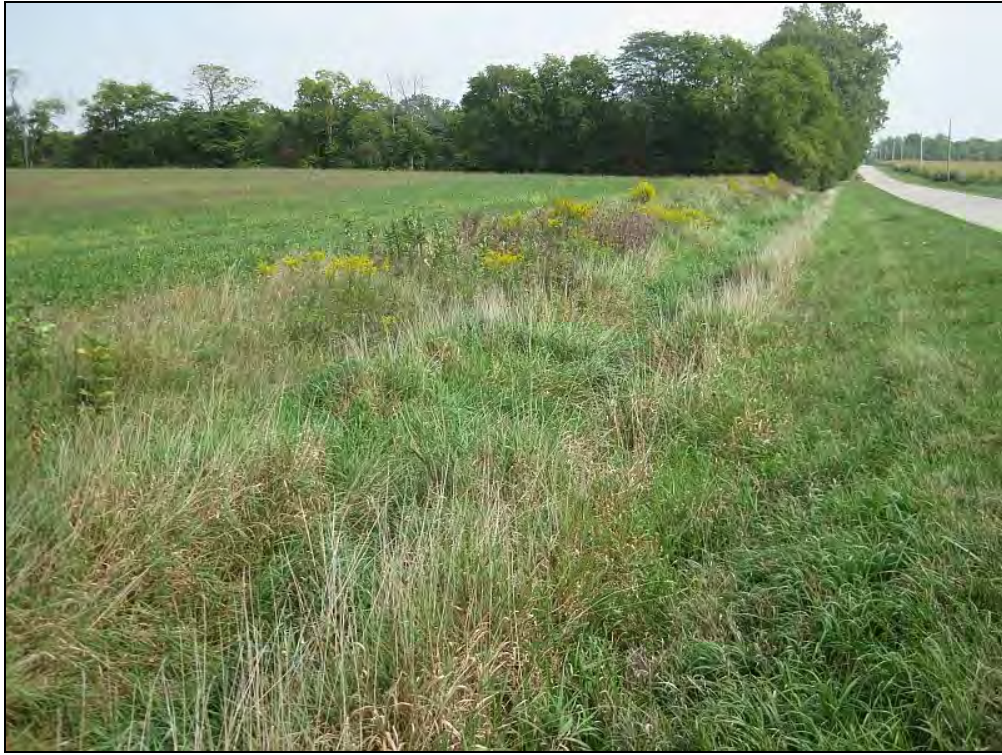
Photograph 3: Between structures 13 and 14, facing east and overlooking Stream 02. Water flow in the stream is east to Rock Creek.

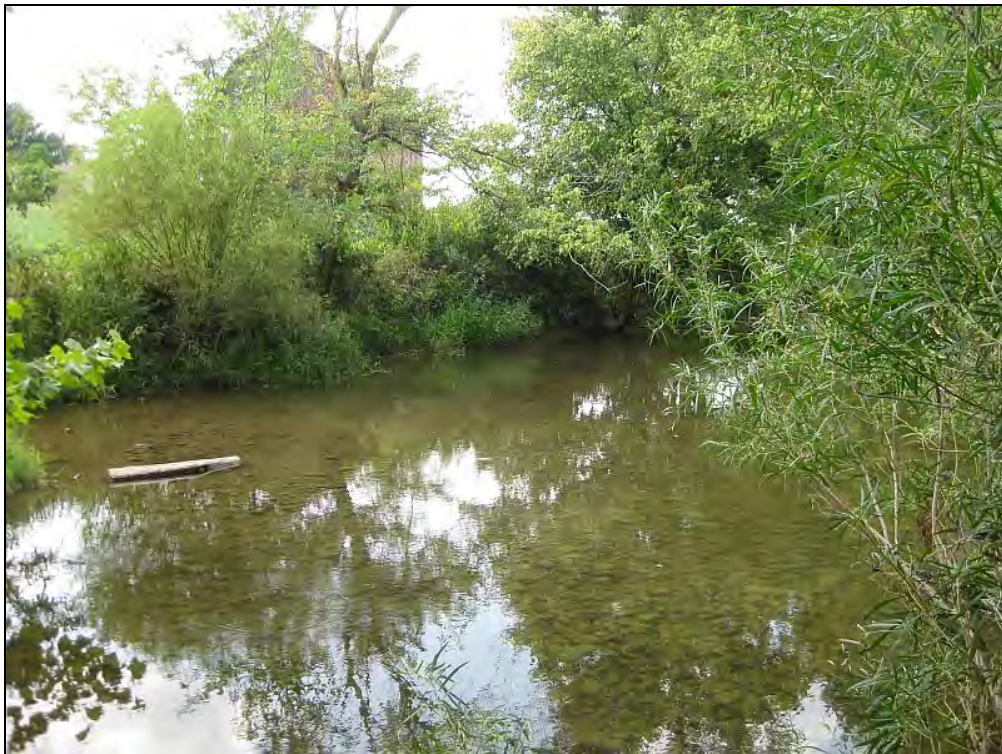
Photograph 4: Between structures 17 and 18, facing west and overlooking Stream 03 (Rock Creek). Water flow in the stream is northwest to the Sandusky River.

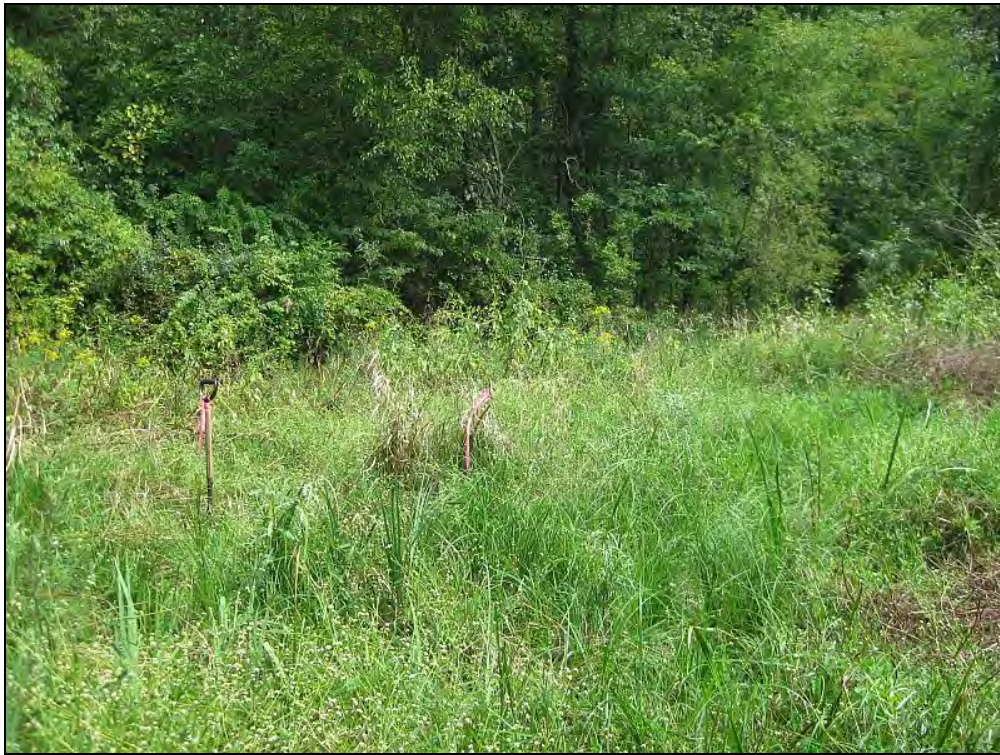
Photograph 5: South of structure 18, facing southeast, and overlooking Wetland 01. The wetland adjoins the north side of Stream 03 (not in the photo). Pink flagging near the center of the photo denotes the location of the wetland sample point.

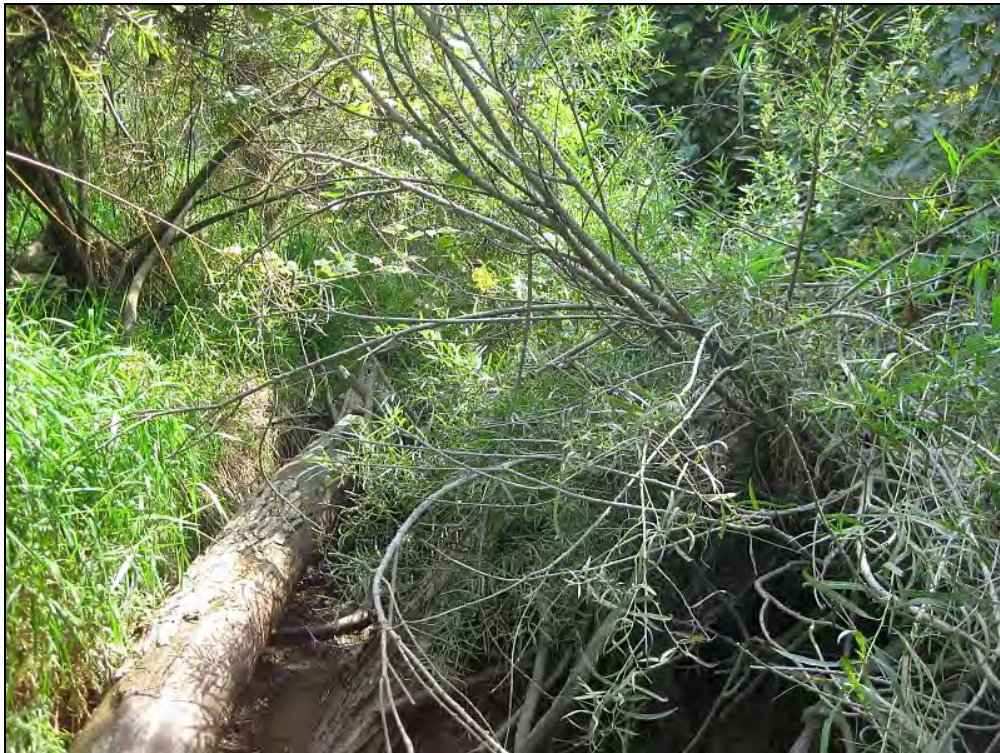
Photograph 6: Between structures 20 and 21, facing northwest and looking down Stream 04. Water flow in the stream is northwest to Rock Creek.

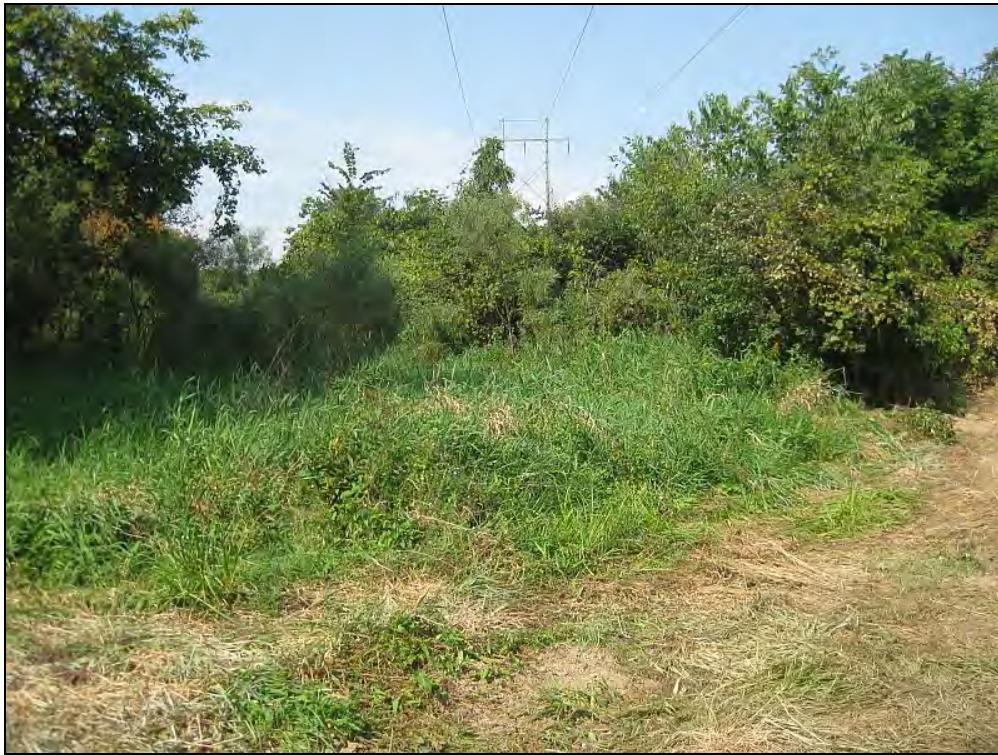
Photograph 7: South of structure 21, facing north, and overlooking Wetland 02. The wetland adjoins the east side of Stream 03 (not in the photo).

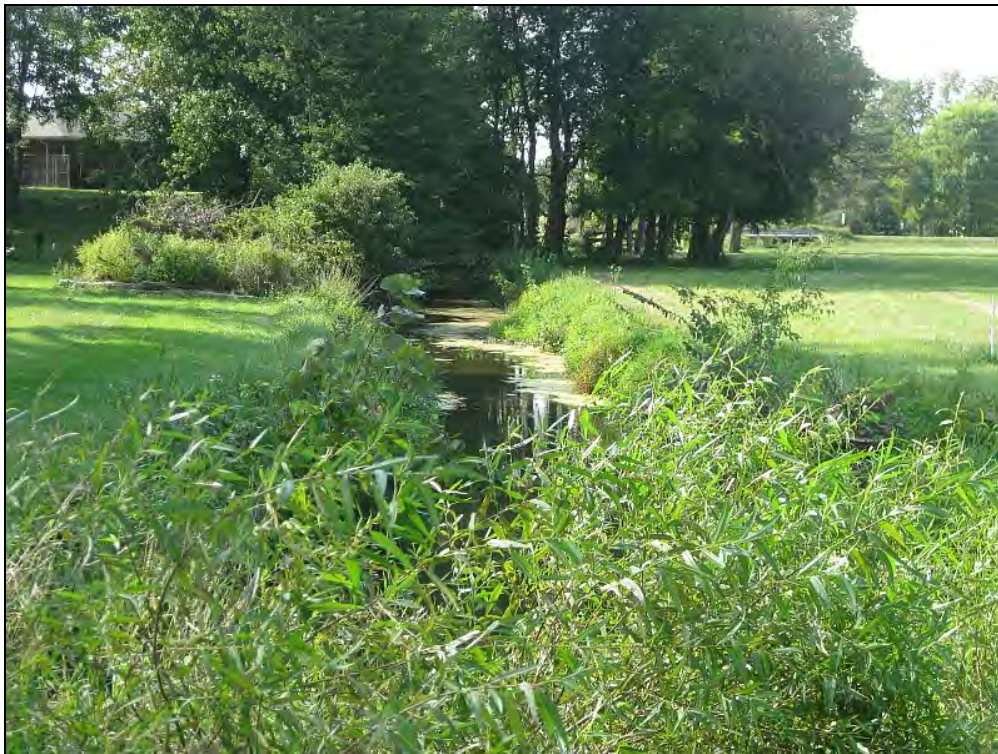
Photograph 8: Between structures 27 and 28, facing northwest and looking down Stream 05. Water flow in the stream is west to Rock Creek.

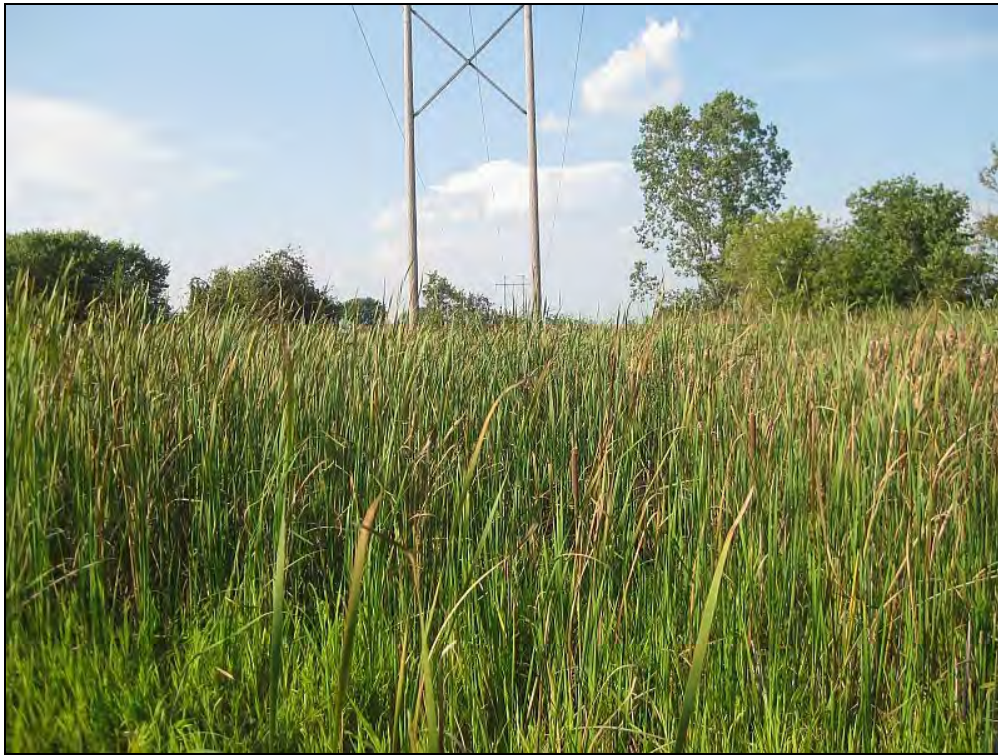
Photograph 9: South of structure 30, facing north, and overlooking Wetland 03. Structure 30, in the background, is approximately 35 feet from the edge of the wetland.

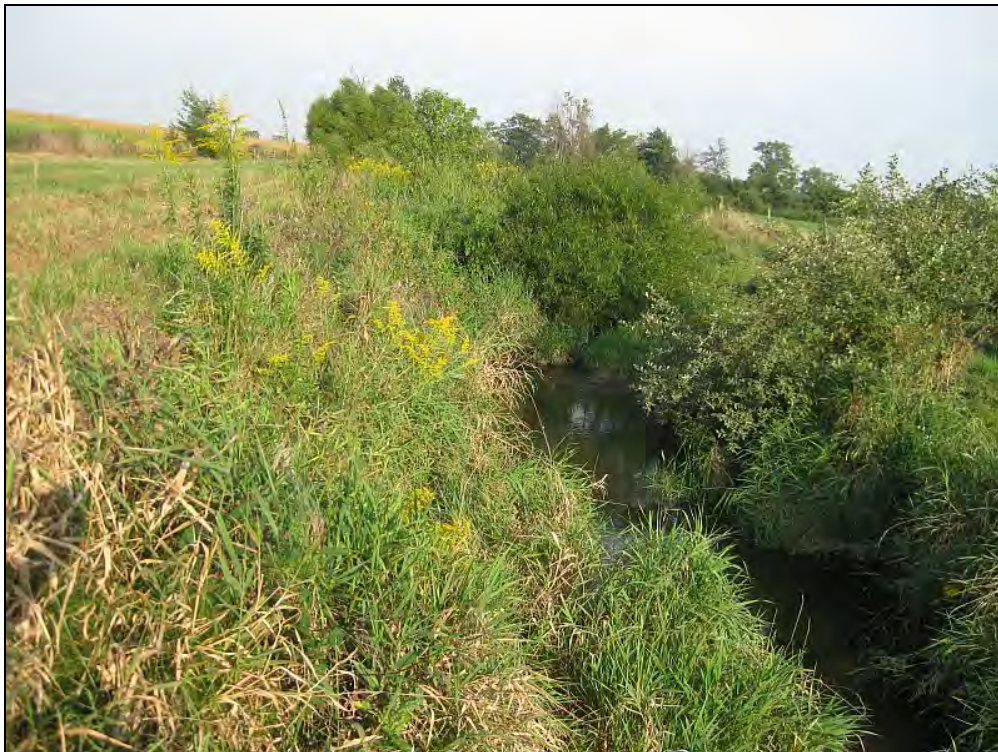
Photograph 10: South of structures 34A and B, facing east, and looking down Stream 06 (Willow Creek). Water flow in the stream is west to the Sandusky River.

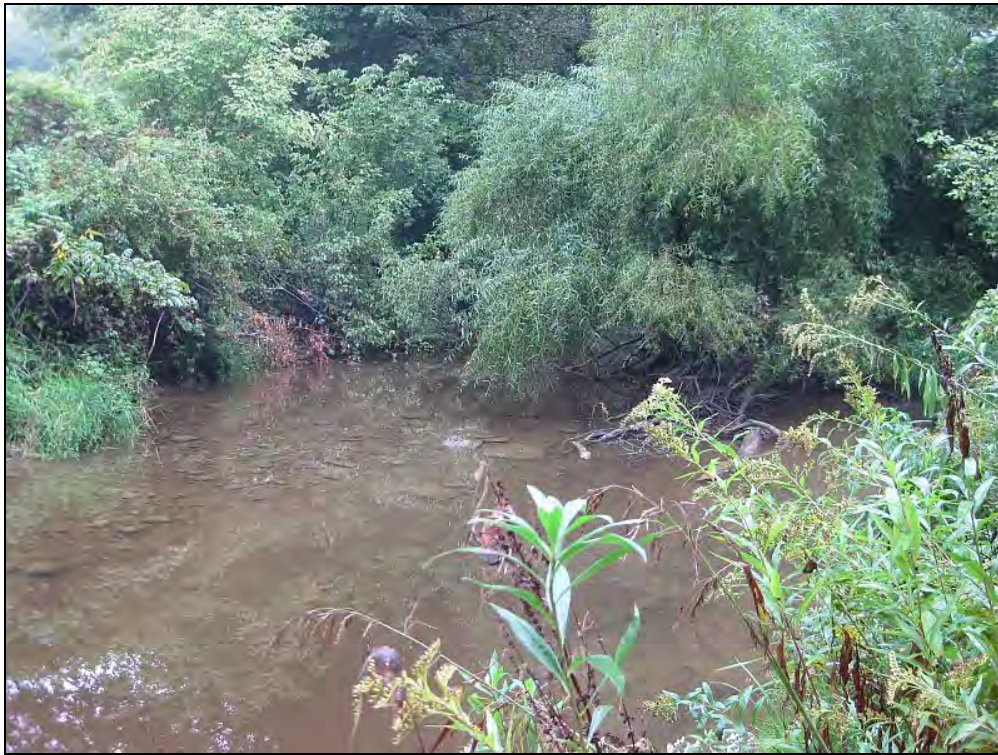
Photograph 11: Between structures 43 and 44, facing east, and overlooking Stream 07 (Morrison Creek). Water flow in the stream is northwest to the Sandusky River.

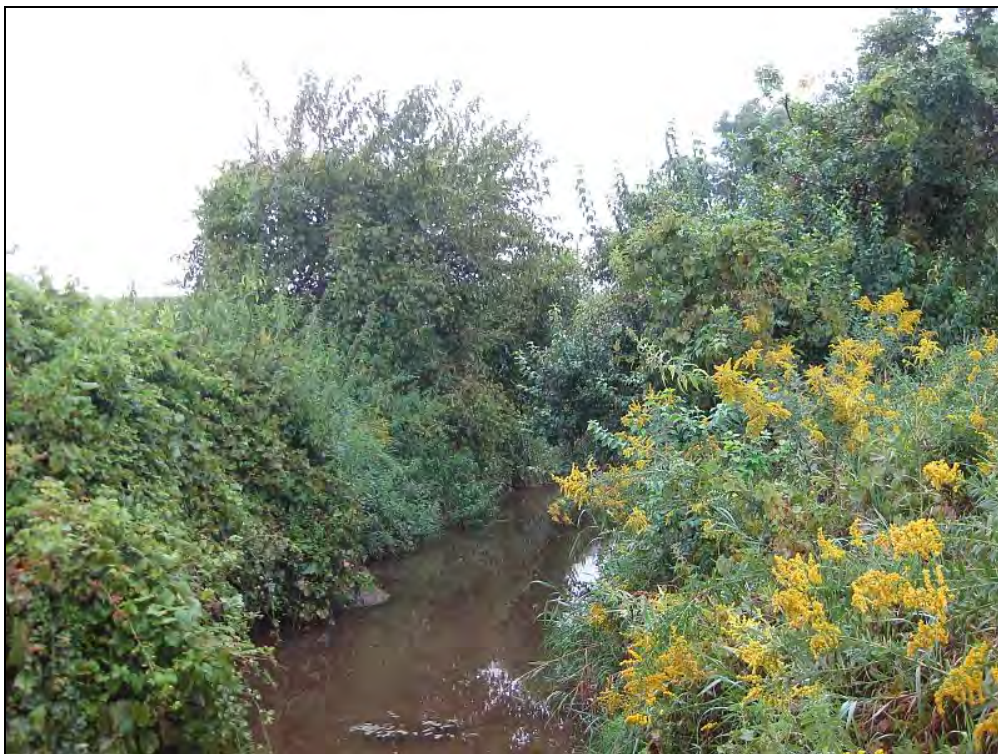
Photograph 12: Between structures 46 and 47, facing east, and overlooking Stream 08. Surface water flow in the stream is west to Morrison Creek.
