From: [Puco ContactOPSB](#)
To: [Puco Docketing](#)
Subject: Public Comment for Case number: 19-0778-GE-BRO
Date: Tuesday, June 25, 2019 9:42:12 AM
Attachments: [Van Wert Ohio Wind Turbine Blade Failure August 2018.png](#)

Huron Wind Vestas V80 Wind Turbine Blade Failure May 4, 2018

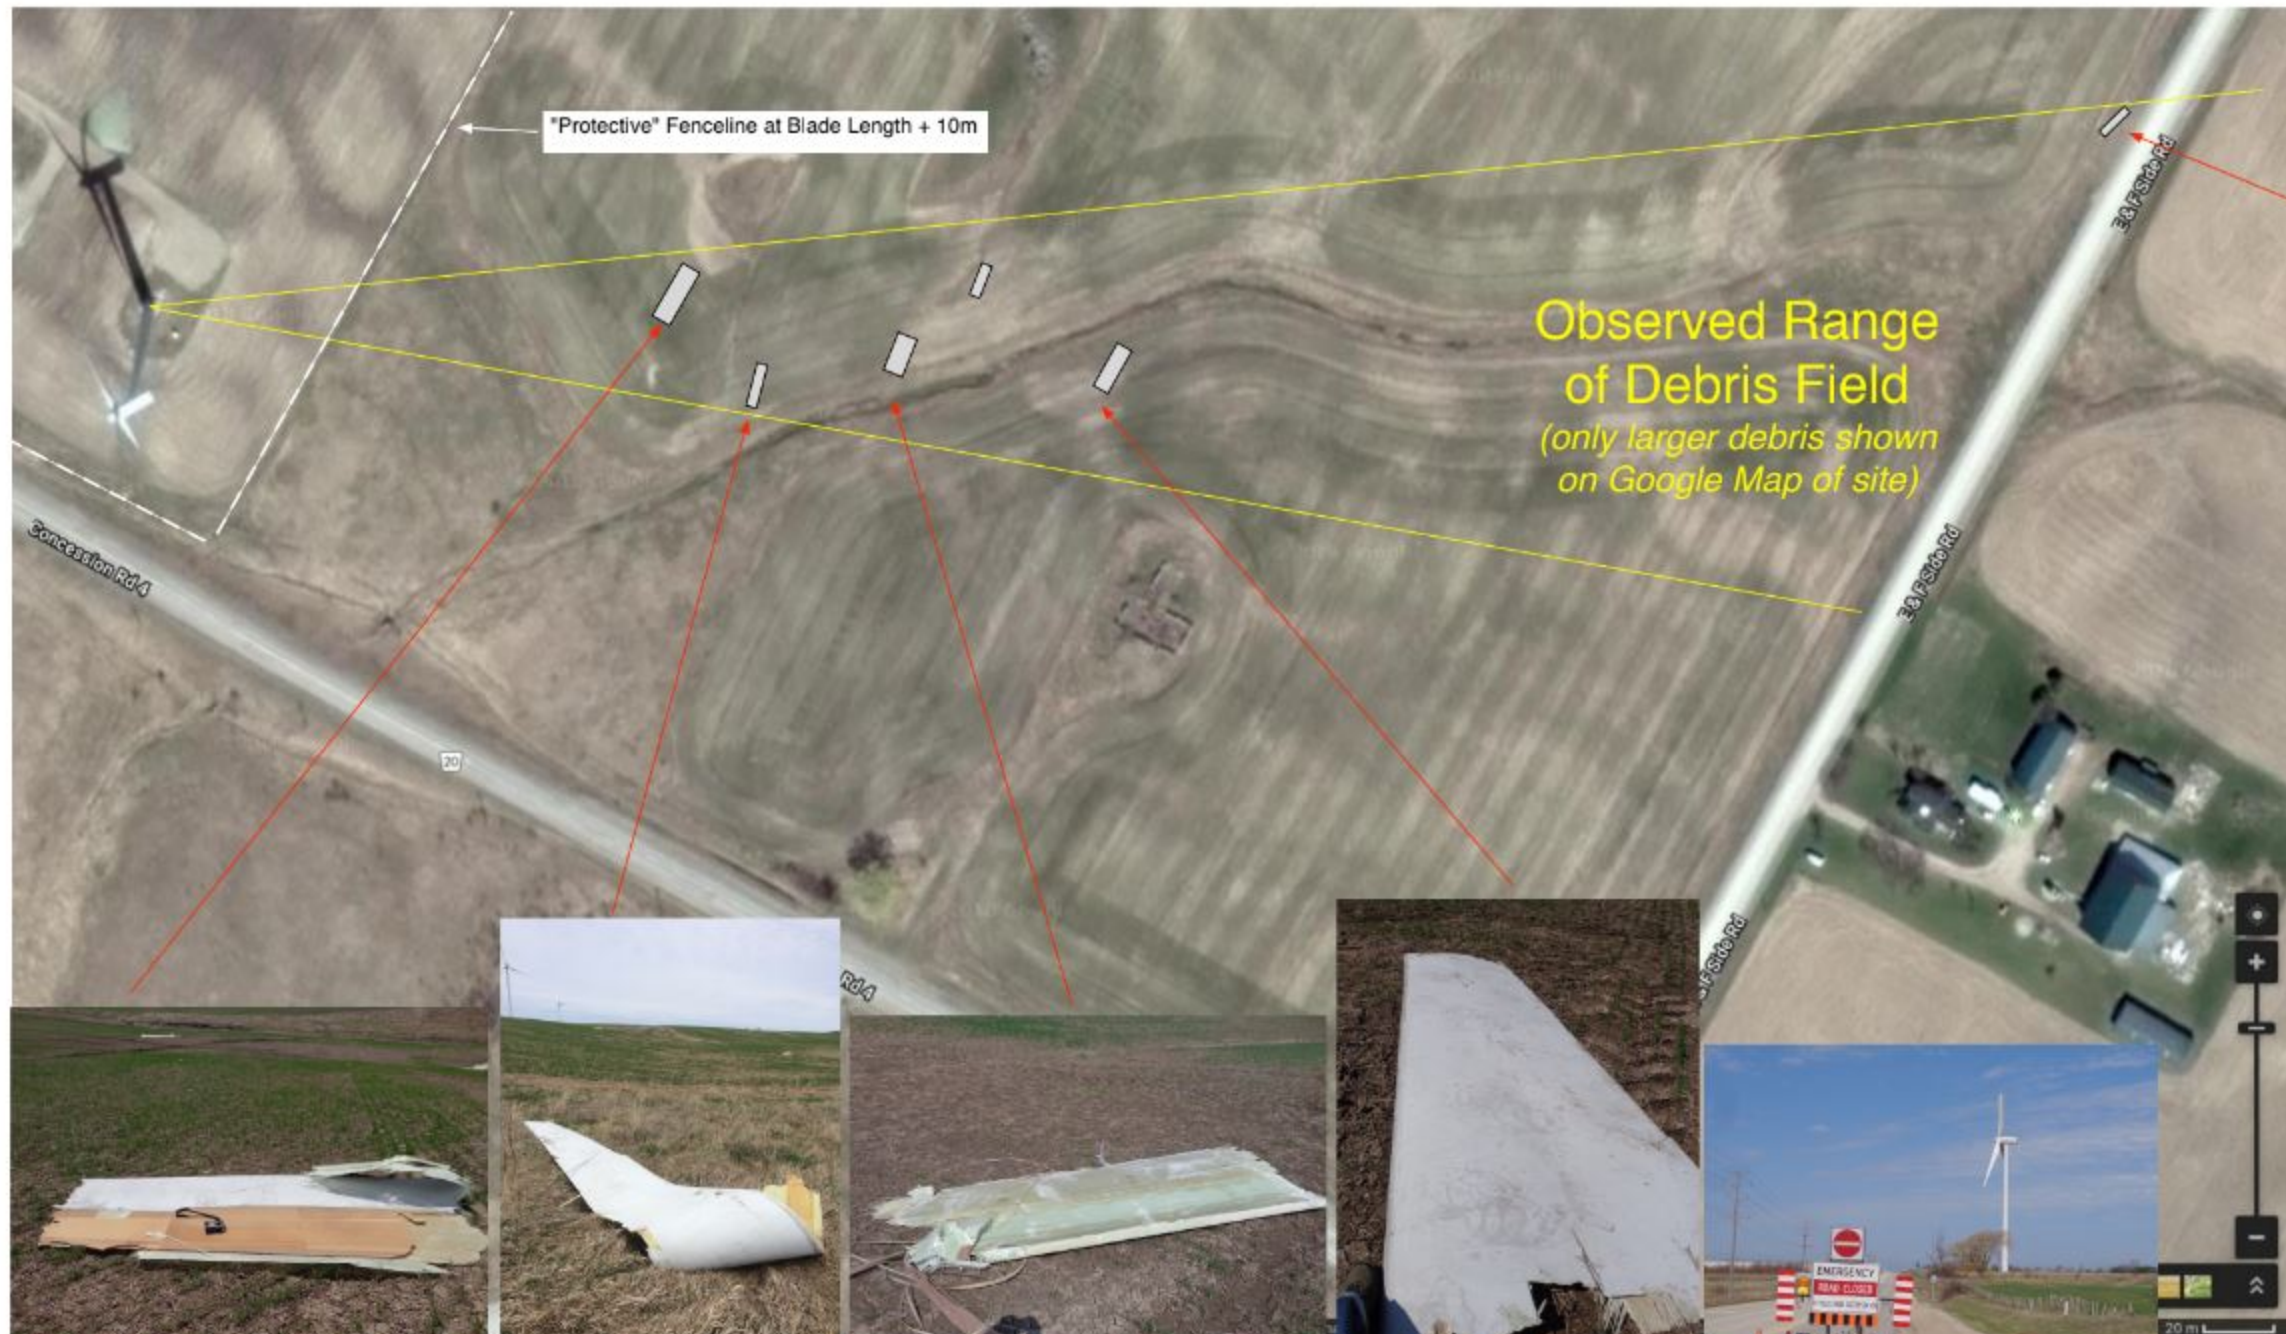
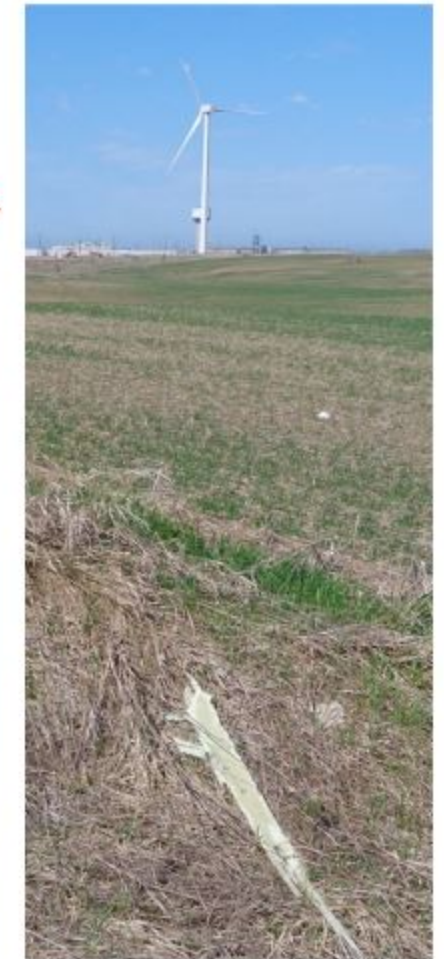
Estimated environmental conditions at time of failure - from Environment Canada
Wiarton Airport Monitoring Site

Wind speed at 10m above ground 14 to 15 m/s, gusting to 17 to 24 m/s

Debris at 560m from tower - 1 m x 0.15m

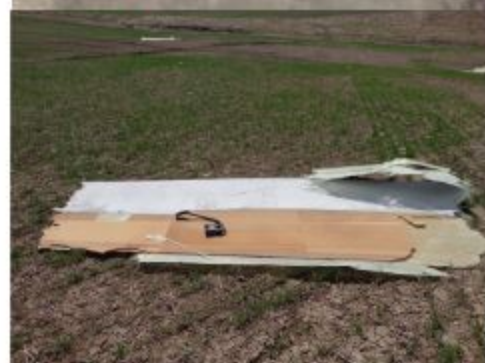
Debris at 150m from tower - 1.2m x 3.6m
- Note Binoculars placed on debris for Scale

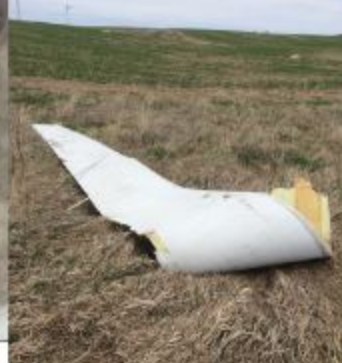
Debris at 170m from tower - 1m x 3.6m

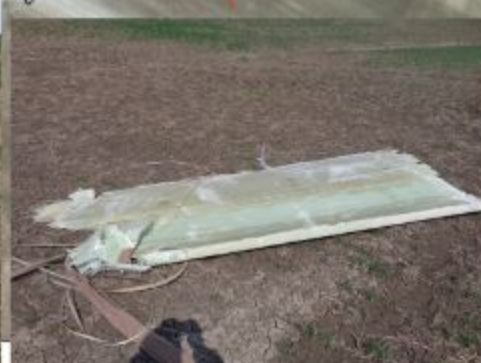
Debris at 210m from tower - 1.2m x 3.0m

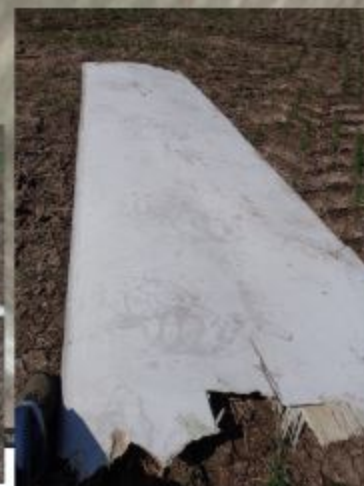
Debris at 280m from tower - 1.2m x 3.0 m
- Note Boot at bottom left corner for Scale

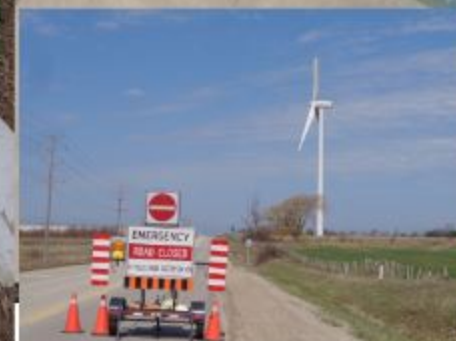
Emergency road closure Conc 4 due to hazard
May 4, 2018 - ongoing - looking westerly
