# **Columbia Gas of Ohio - Zanesville Regulator Failure**

# Low Pressure MAOP Excursion – May 9, 2019

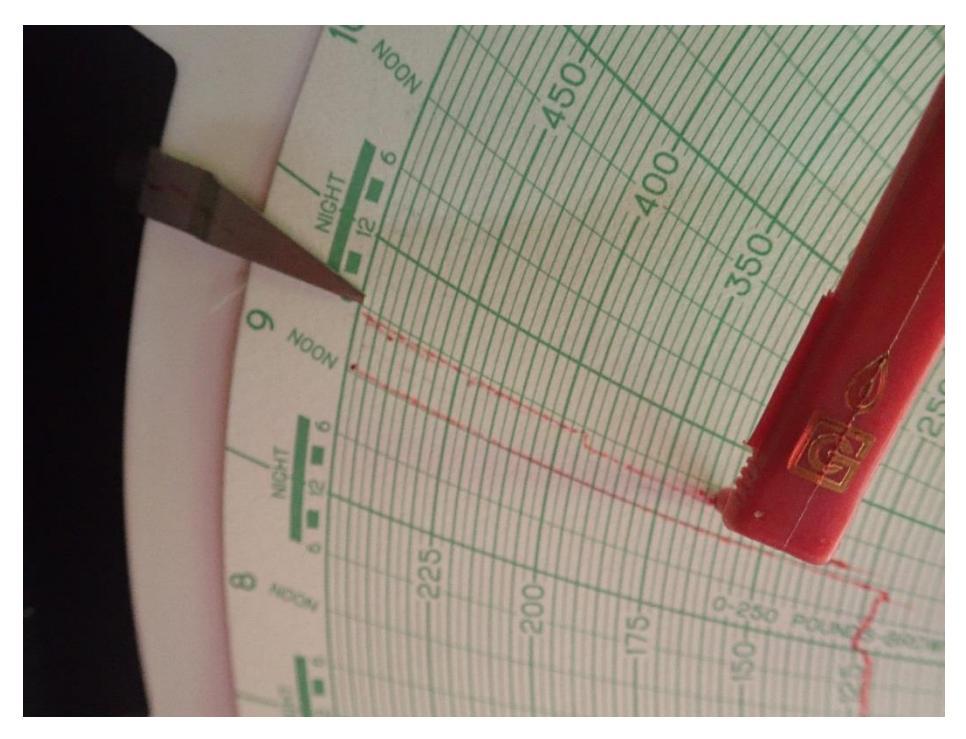
Pressure exceeded chart recorder element pressure (0-25"wc) at Indiana Station

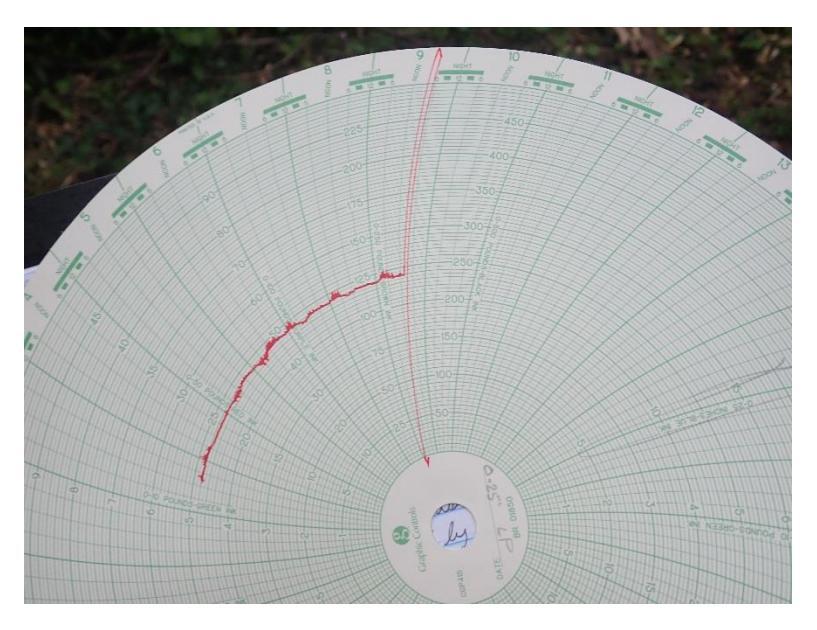
Pressure exceeded chart recorder element at Muskingum station

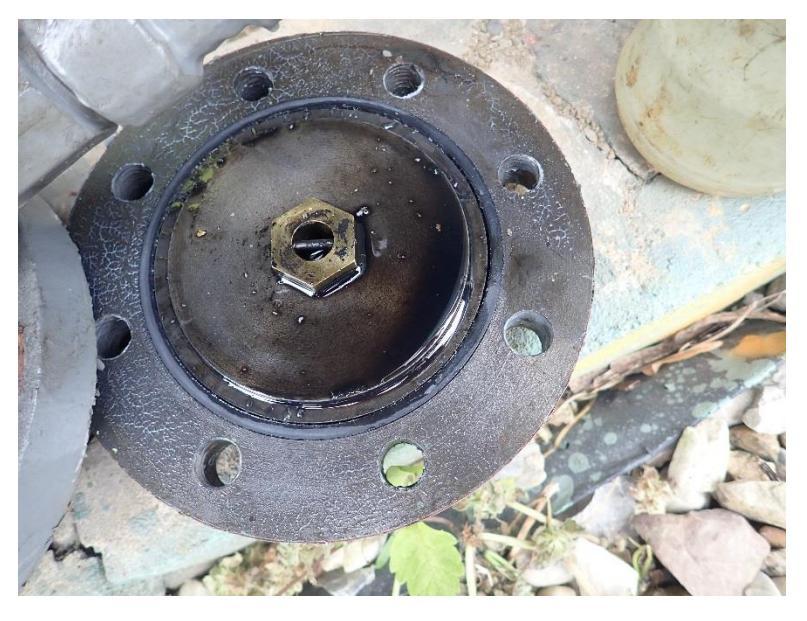
The operator installed at drip near the piping at the Indiana Low Pressure Regulator Station and found 14 gallons of production fluid. The operator also has producers feeding into the Zanesville systems.

Production Oil – Bottom of Inspection Plate at Indiana Station

- Installing filter/separator on the control lines or upstream of the pressure regulator stations where they have know fluid in the system. Due to the fact regulators do not work properly when any type of fluid is introduced into the system.
- Installing a token relief valve or full capacity relief valve downstream of the low pressure regulator station, to prevent a reoccurrence.

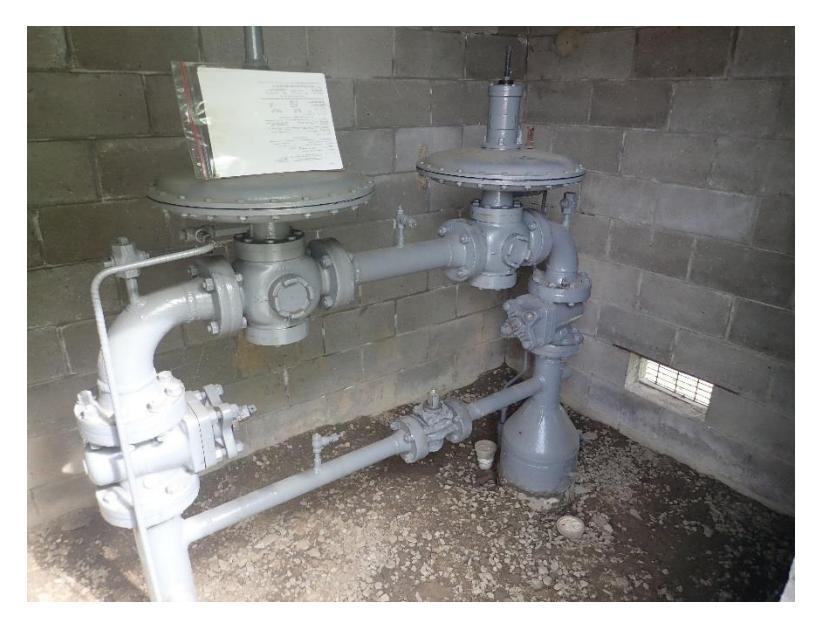
Indiana Station Prior to Lock-up and Tear Down

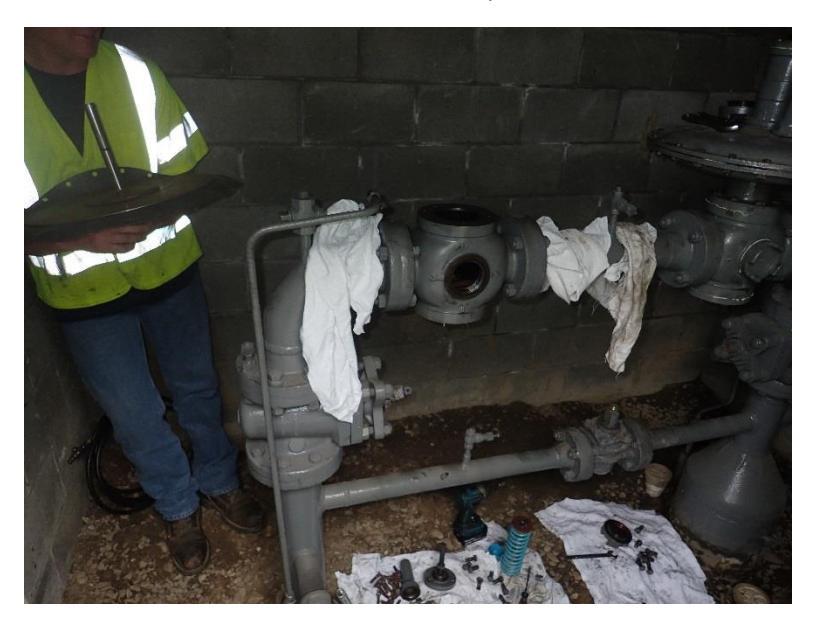
Complete Tear-down Indiana Monitor Regulator

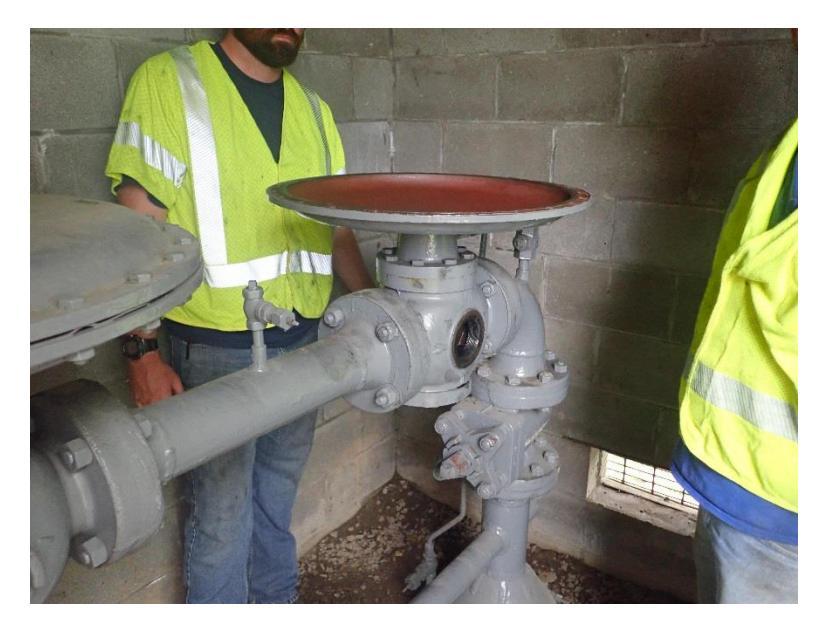
Performing Complete Tear Down of Control Regulator at Indiana Station

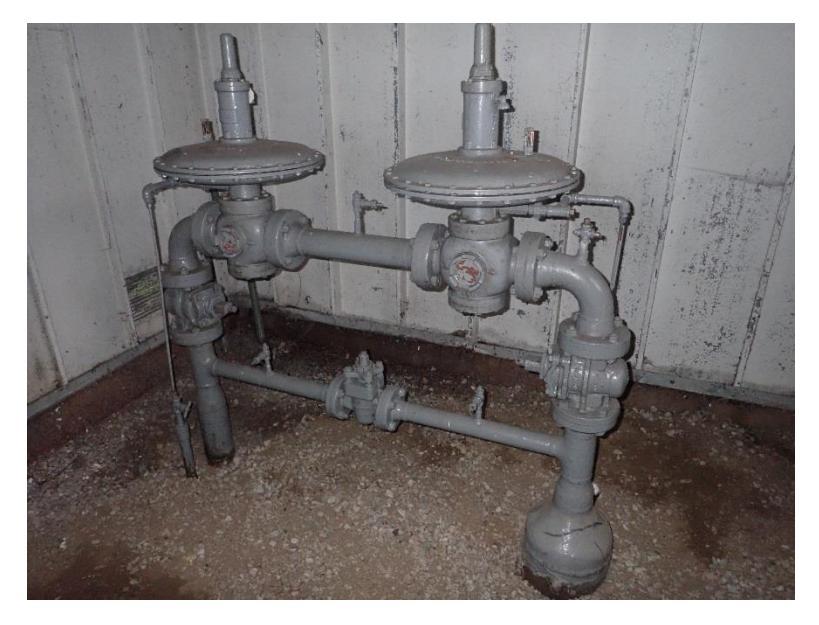
Regulator Station Prior to Lock-up / Tear Down at Muskingum Station
