**BEFORE  
THE PUBLIC UTILITIES COMMISSION OF OHIO**

RICHARD D. BIHLAJAMA,	)	
	)	
Claimant,	)	
	)	
vs.	)	CASE NO. 21-857-EL-CSS
	)	
THE CLEVELAND ELECTRIC	)	
ILLUMINATING COMPANY,	)	
	)	
Respondent.	)

**DIRECT TESTIMONY OF CHRISTOPHER SLATTERY ON BEHALF OF  
THE CLEVELAND ELECTRIC ILLUMINATING COMPANY**

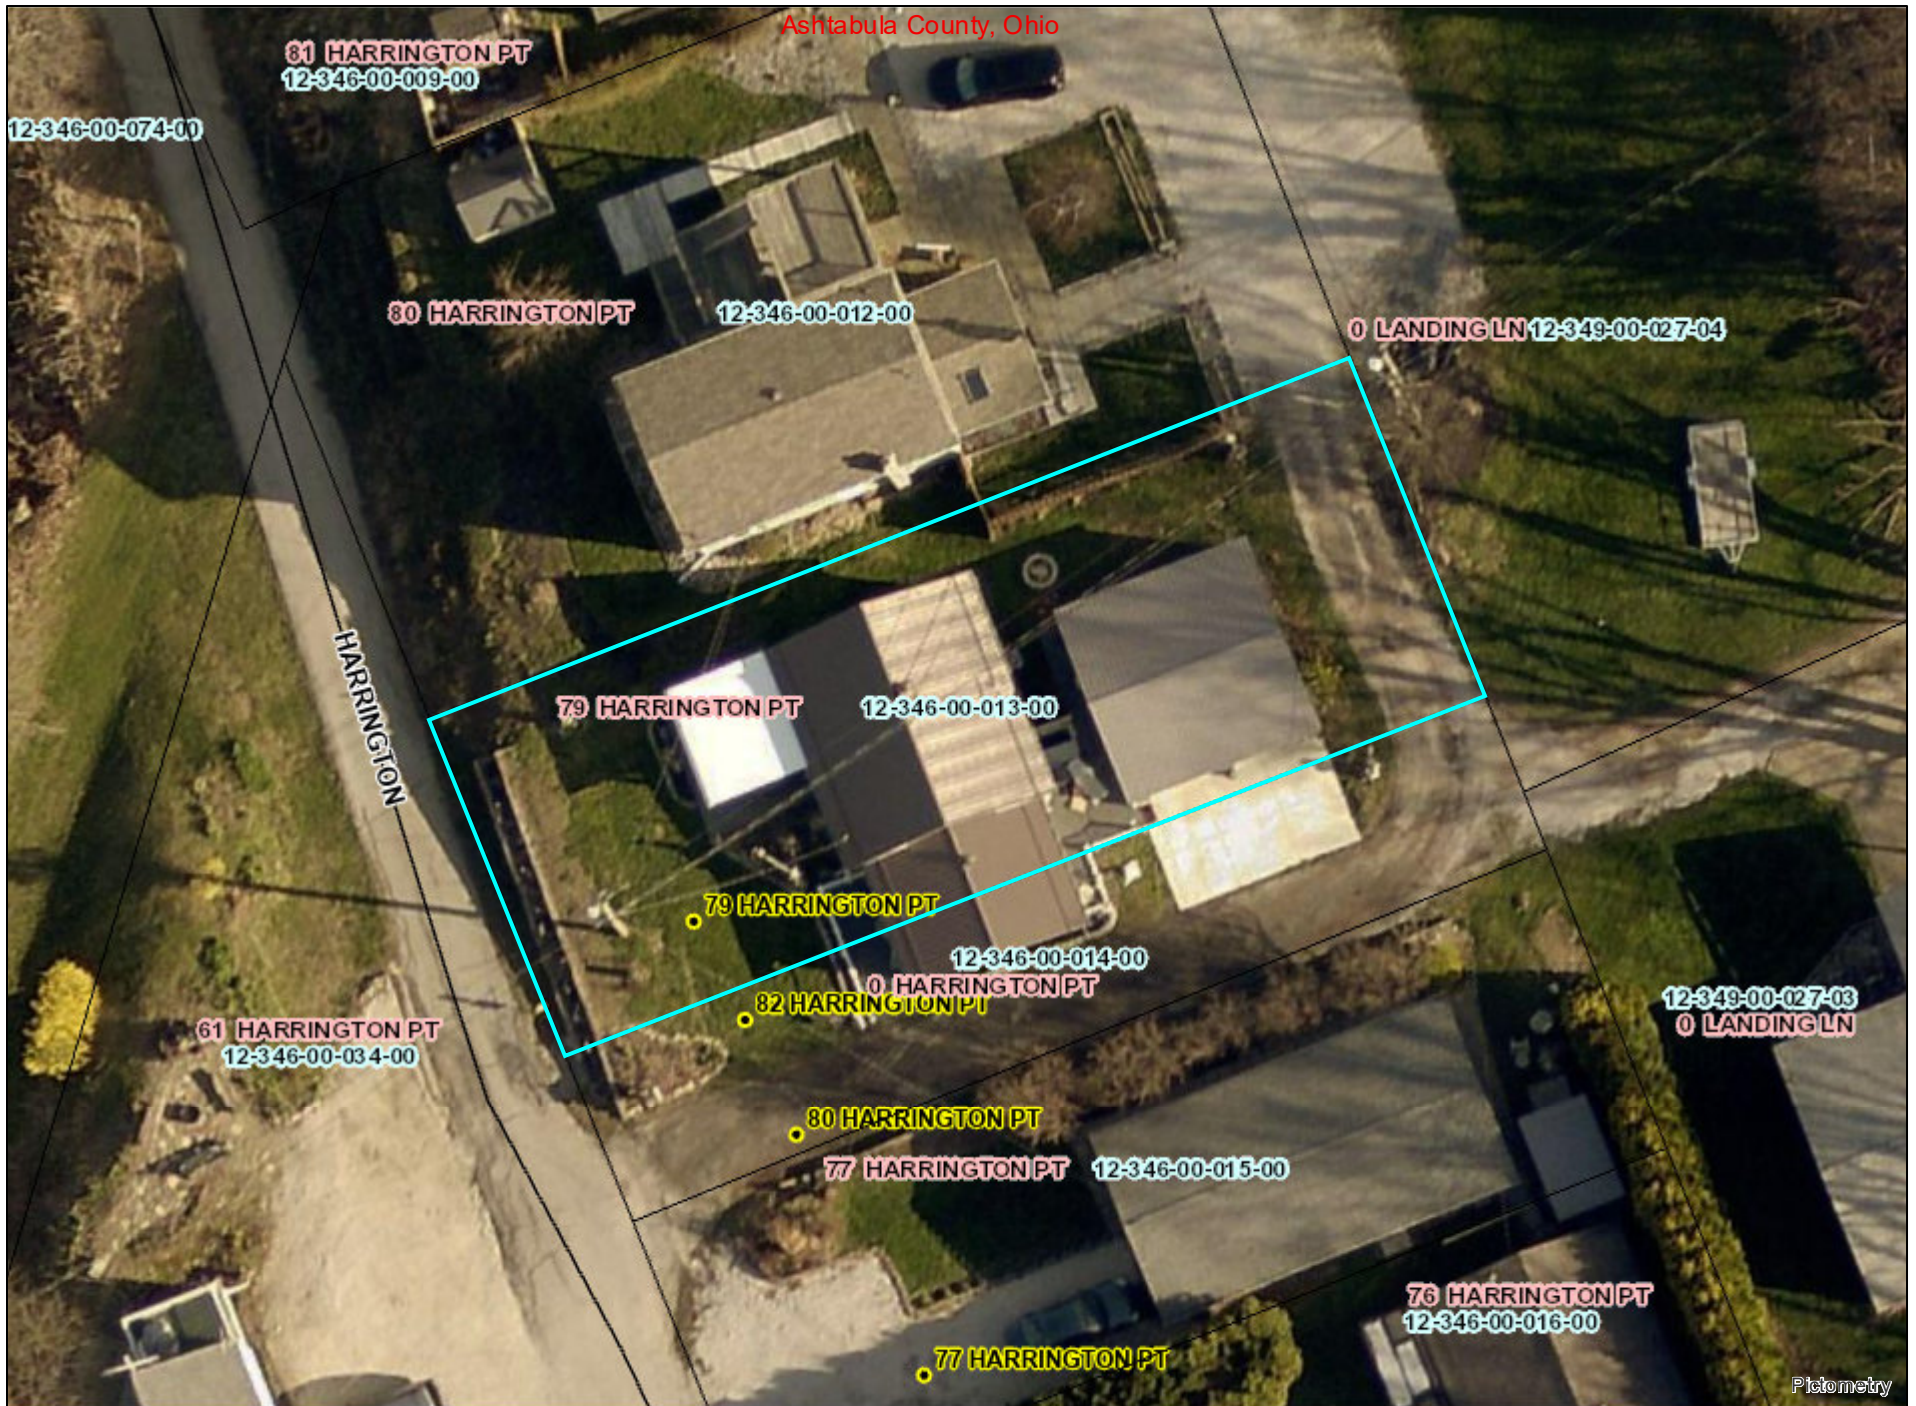
13 A. The roof over the main residence is not readily accessible. The garage, however, appears  
14 to have an accessible deck built above it. According to the Ashtabula County Auditor's  
15 aerial photos, the deck above the garage was not constructed by 2020. Prior to 2020, the  
16 garage roof was not readily accessible. A copy of the 2020 Ashtabula County Auditor's  
17 aerial photograph is attached hereto as **Exhibit A**.

1 A. No. The survey would have indicated if the crew believed that the lines did not meet the  
2 minimum clearance requirements of the NESC. Nothing was reported, which indicates that  
3 the crew did not identify any clearance violations. According to the Auditor's photographs,  
4 in 2020, the triplex wire would have had sufficient clearance over the not readily accessible  
5 roof of the garage and therefore there would not have been a clearance violation to report.

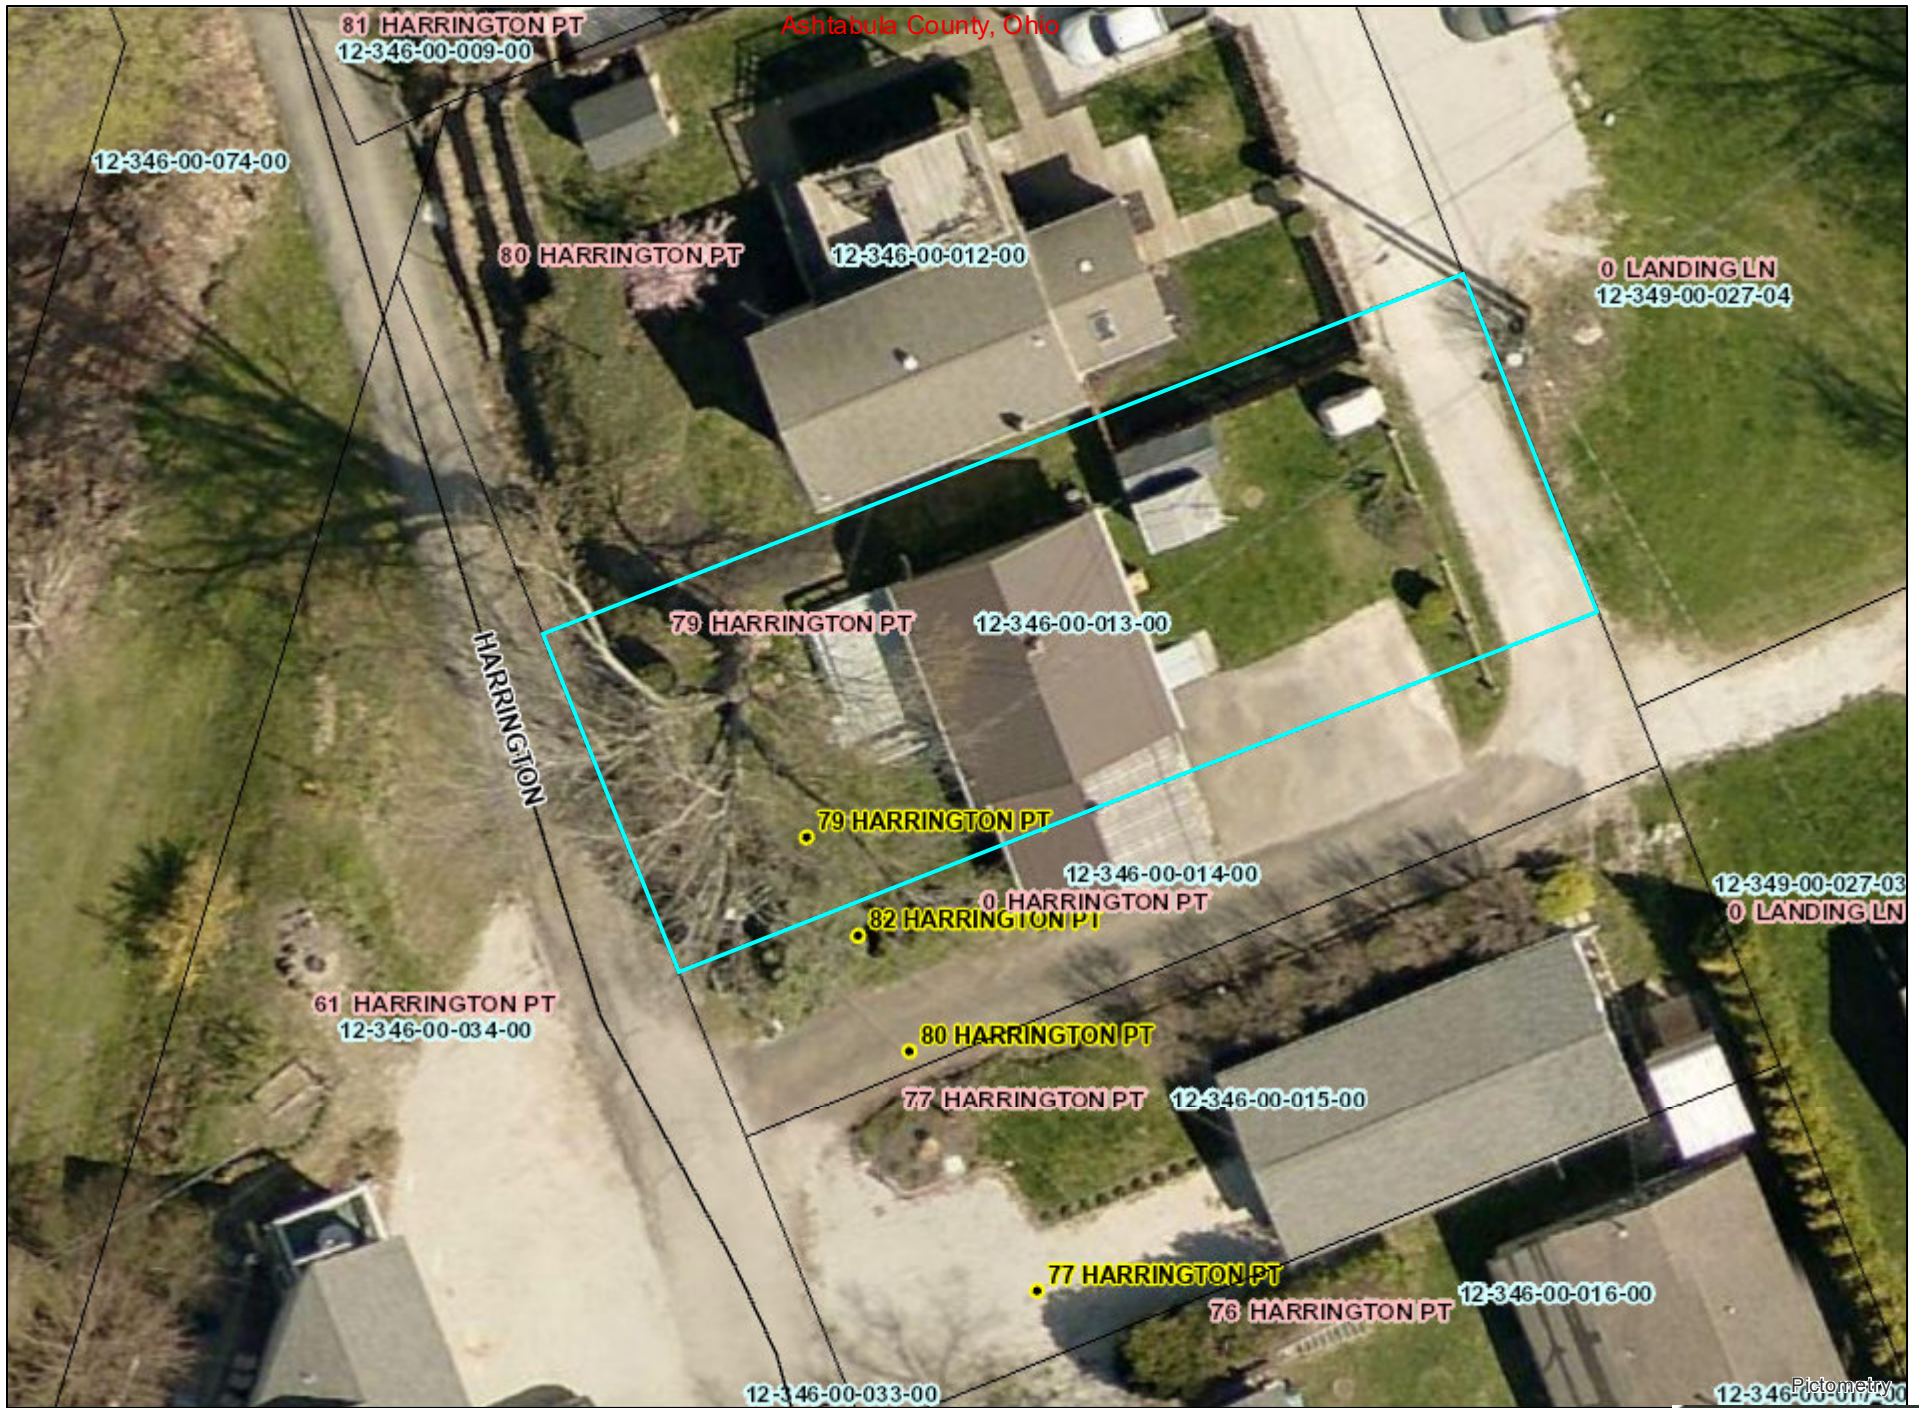
B

19 A. According to the 2017 aerial photographs from the Ashtabula County Auditor, attached  
20 hereto as **Exhibit B**, the garage did not exist in 2017. The 2020 aerial photograph reveals  
21 that the garage was constructed with a non-accessible roof. According to the Auditor's  
22 website, the garage was constructed in 2018. A true and accurate printout of the  
23 outbuildings page from the Auditor's website is attached hereto as **Exhibit C**.

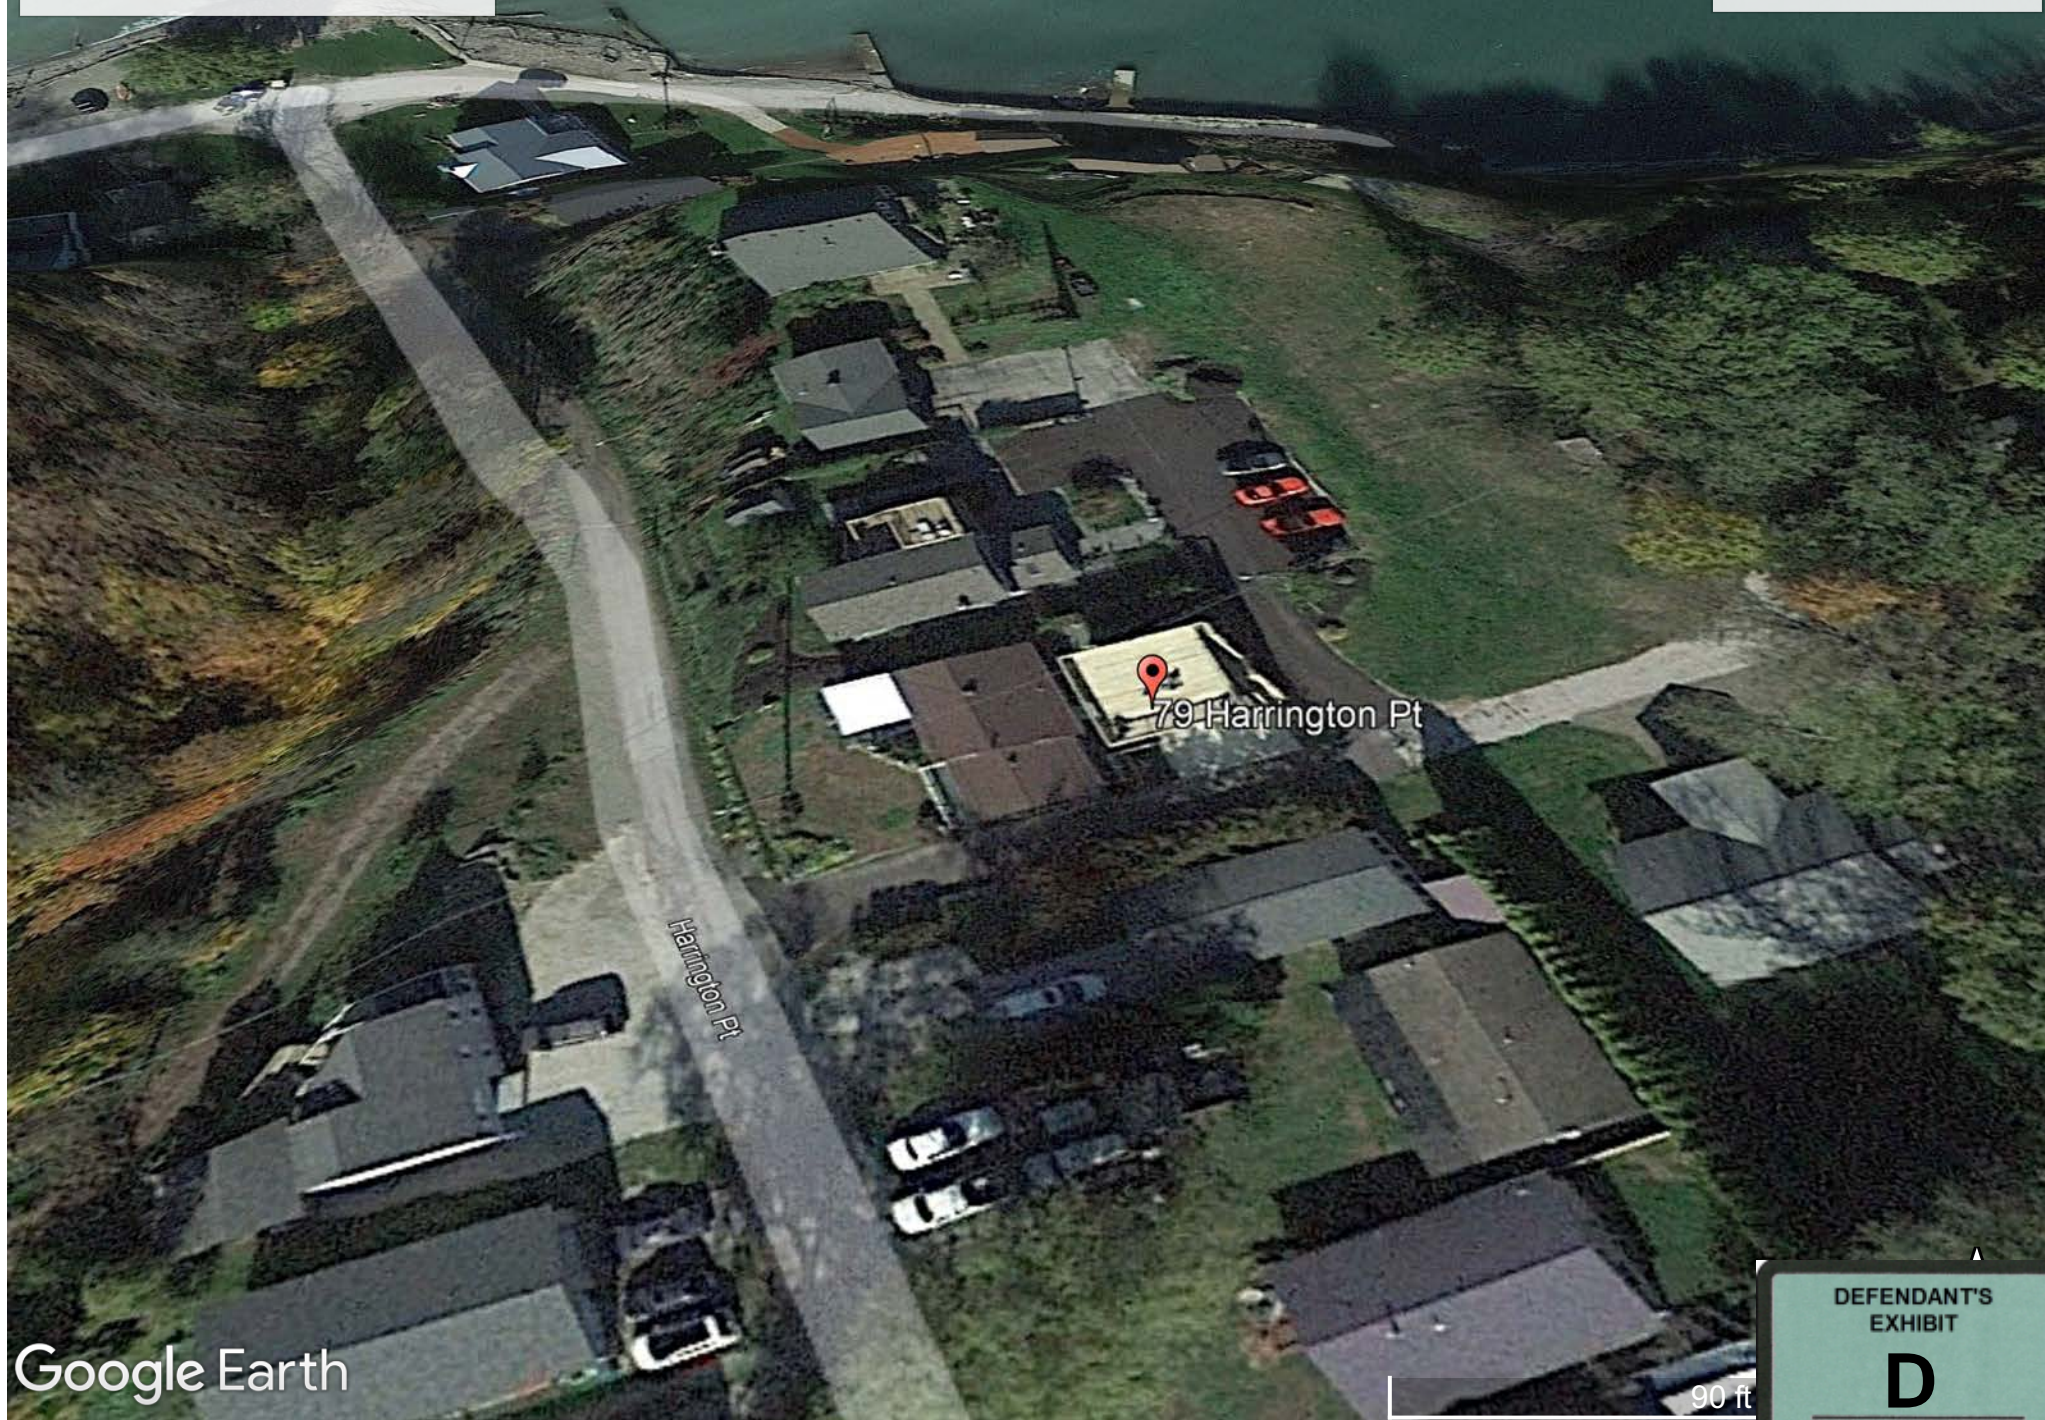
D

2    A.    Sometime after 2020. The latest photograph from the Ashtabula County Auditor is from  
3           2020, which does not reveal a deck on the garage. According to Google Earth satellite  
4           photographs, a satellite image dated November 2021 appears to show the construction of a  
5           deck. A printout of this November 2021 Google Earth image is attached hereto as **Exhibit**  
6           **D.**
