JUG STREET-KIRK 138 kV CIRCUIT PROJECT

AREAS OF ECOLOGICAL CONCERN, WETLAND DELINEATION, AND STREAM ASSESSMENT REPORT

URS 525 Vine Street, Suite 1800 Cincinnati, Ohio 45202

July 2012

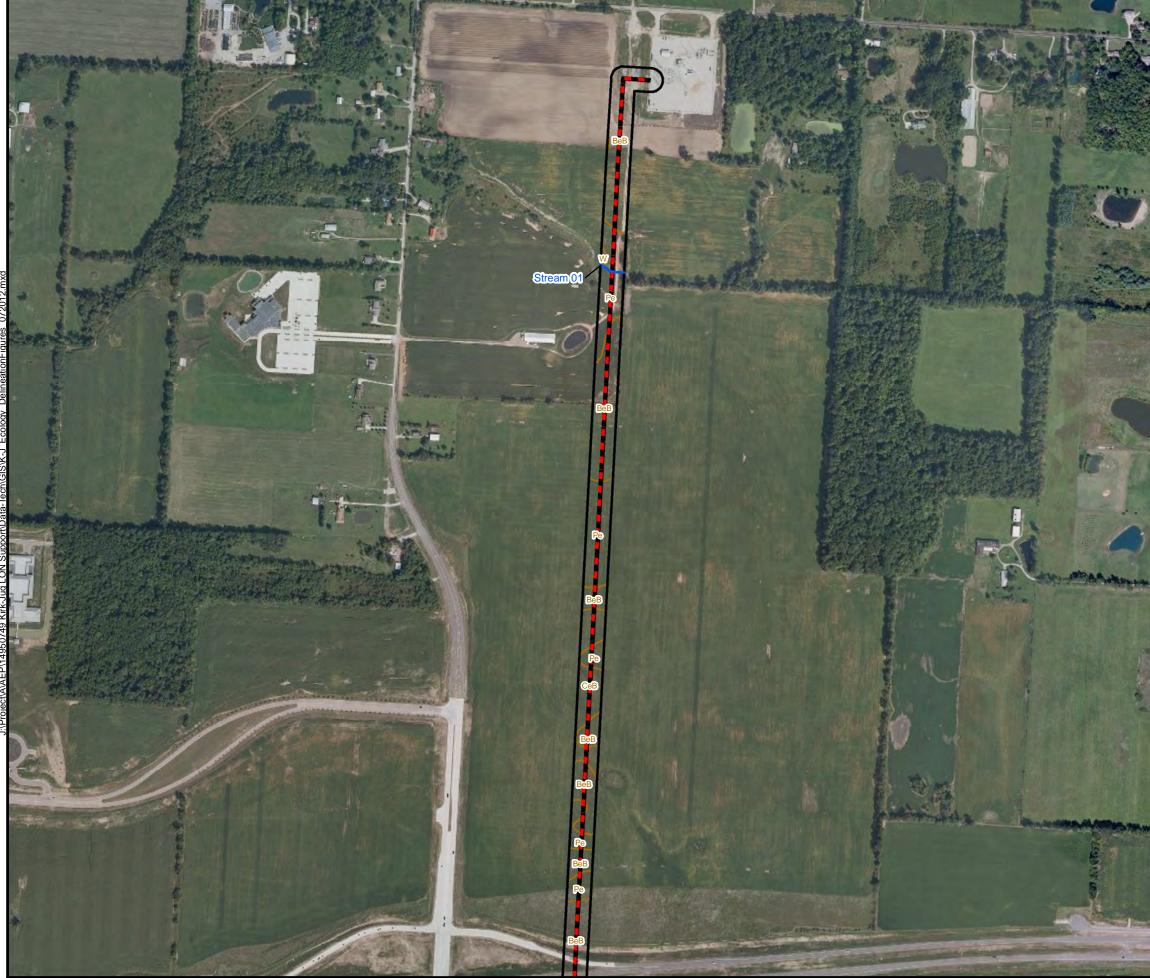
FIGURE 2A ECOLOGICAL SURVEY RESULTS

The locations and approximate extents of the wetlands identified within the Jug Street-Kirk survey corridor are shown on Figures 2A through 2I. Completed USACE wetland delineation and ORAM forms are provided in Appendix A. Color photographs were taken of each delineated wetland during the field survey and are provided in Appendix C. Table 2 lists the vegetation that was identified in delineated wetlands during field surveys.

Streams within the 150-foot survey corridor are provided in Table 5. The locations of streams identified within the 150-foot survey corridor are shown on Figures 2A through 2I. Within the 150-foot survey corridor, 15 streams, totaling 3,414 linear feet were assessed: seven ephemeral, seven intermittent, and one perennial waterbodies. Fourteen streams were assessed using the HHEI methodology (drainage area less than 1 mi²). The remaining stream was assessed using the QHEI methodology (drainage area greater than 1 mi²). Based on USGS topographic quadrangle maps, none of these streams appear to be named. URS has preliminarily determined the 15 streams appear to be jurisdictional (i.e., "Waters of the U.S.").
