# Scioto Ridge Transmission Line

# Wetland & Waterbody Delineation Report

Scioto Ridge Transmission Line

Prepared for	EverPower
Project Name	Scioto Ridge Transmission Line
Project Number	73760003
Project Manager	Ryan Rupprecht
Date	September 19, 2013

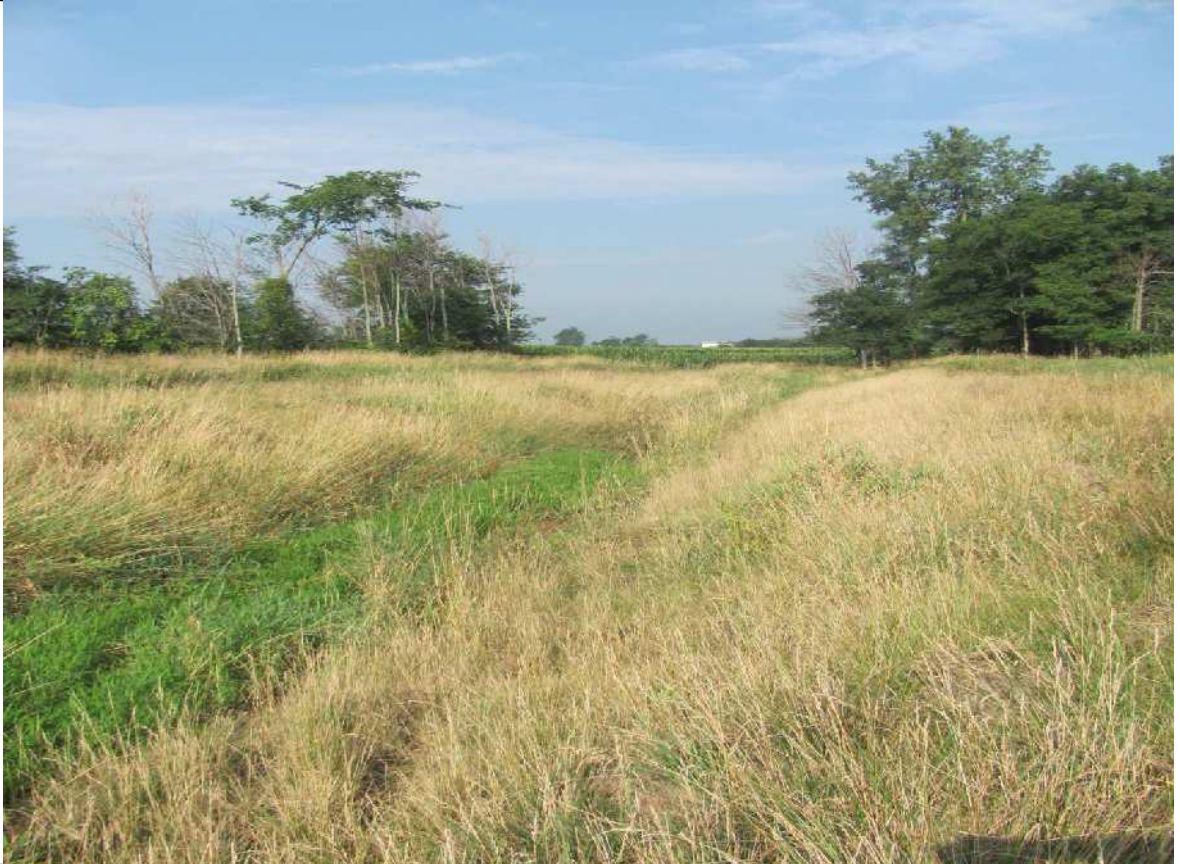
**Photo: SOH-T01 DS from  
Flag 1 to SOH-045**

**Description: Photo of  
stream T01 which runs  
between two agricultural  
fields and has maintained  
grassy banks**

**SOH-T01** is an agricultural ditch draining multiple adjacent corn fields. The steep banks of SOH-T-01 were heavily vegetated with tall grasses that appeared to be mowed regularly. There was little significant tree growth along the banks of the ditch and no riffle development in the delineated reach of the ditch. Field teams identified a field tile drainage that was actively flowing and acting as a source of the feature at the northern end. The ditch bottom was identified as primarily silt with limited sand and gravel components. No mussels were observed in SOH-T01. Although it scored as 52 on the HHEI, the lack of shade providing trees and riffles led to the stream scoring a 24 on the QEHI.

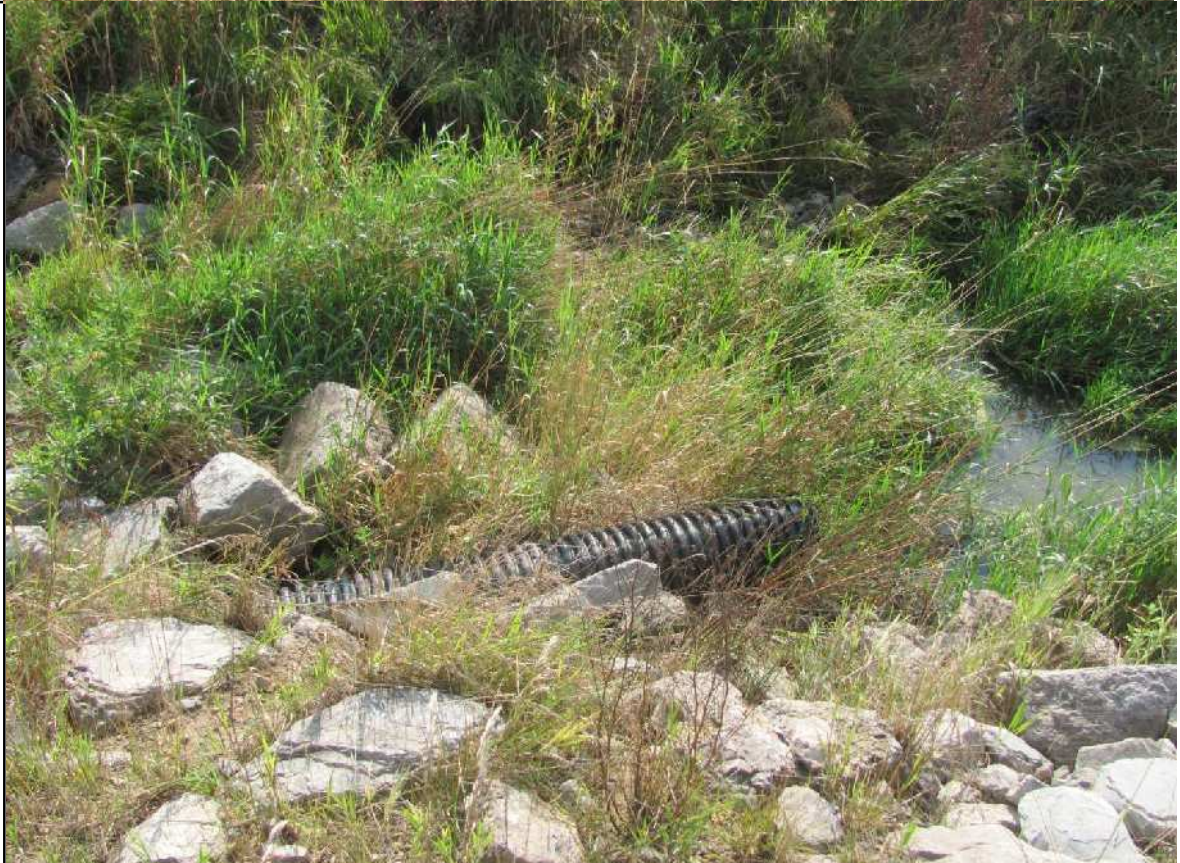
**Photo: SOH-T01 Cross  
Channel from Flag 6  
showing field tile**

**Description: Photo of  
stream T01 which was fed  
primarily by this field tile,  
draining nearby corn fields.**

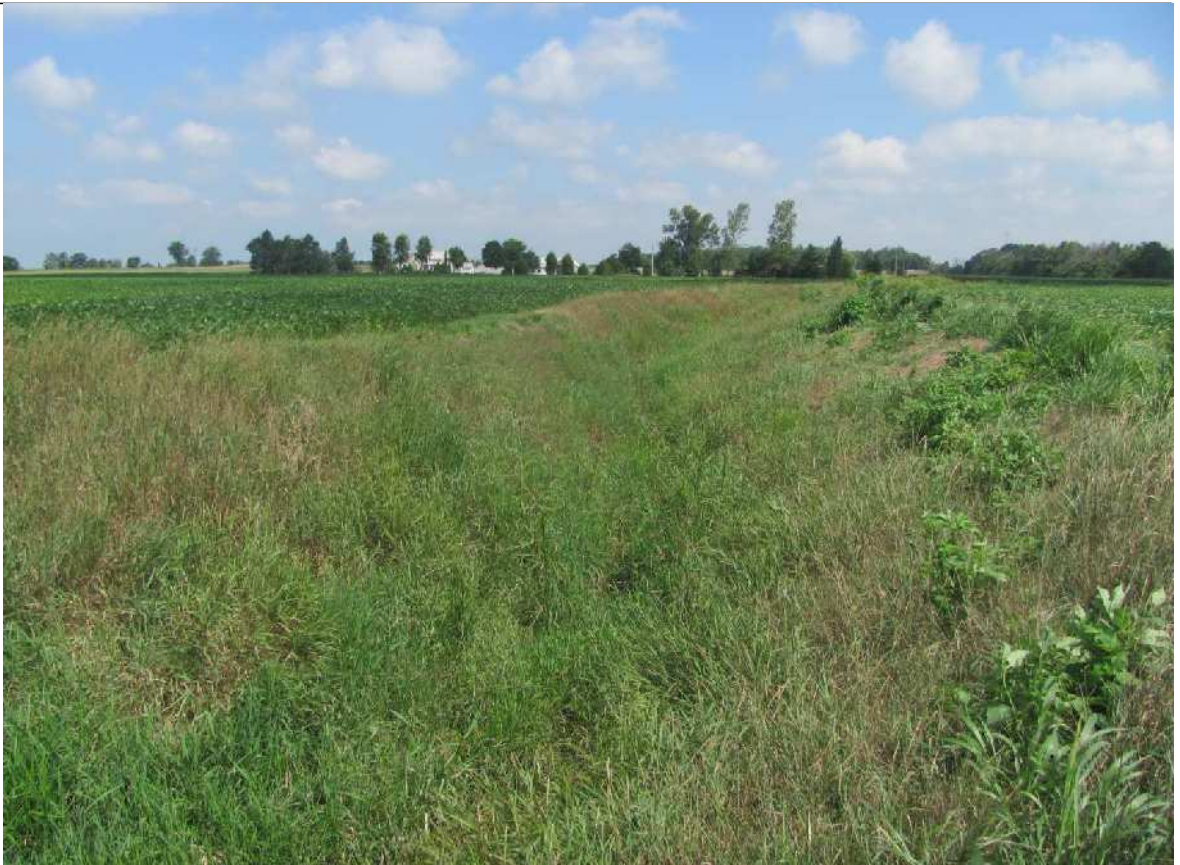
**Photo: SOH-T04 US from  
Flag 4**

**Description: Typical stream  
found in the corridors;  
Agricultural canal located  
between two active crop  
areas with grassy banks.**

**SOH-T-04** was another agricultural ditch that feeds into SOH-T03. It has steep, heavily vegetated banks which appear to be maintained. The bottom substrate was identified as mostly silt with significant gravel components. The HHEI scored the ditch as a 36. No QEHI was performed due to a lack of pools 40 cm in depth. No mussels were observed in the ditch.

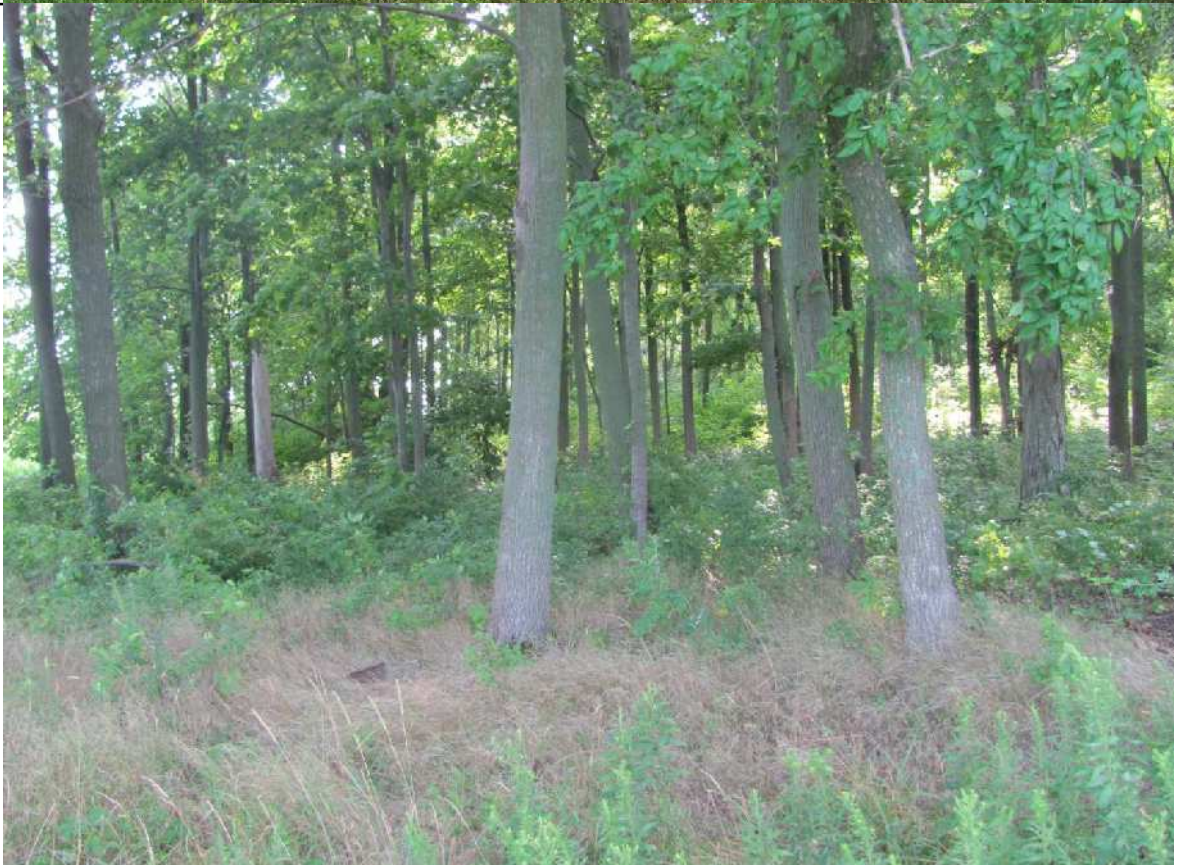
**Photo: Habitat Point near  
Stop 3 Additional 2**

**Description: Photo of a  
woodlot with no evidence of  
wetlands that had been  
previously mapped as  
potential wetland. No  
wetlands were found during  
field verification. Many of  
the potential sites exhibited  
similar compositions of  
upland species and lacked  
hydrology.**

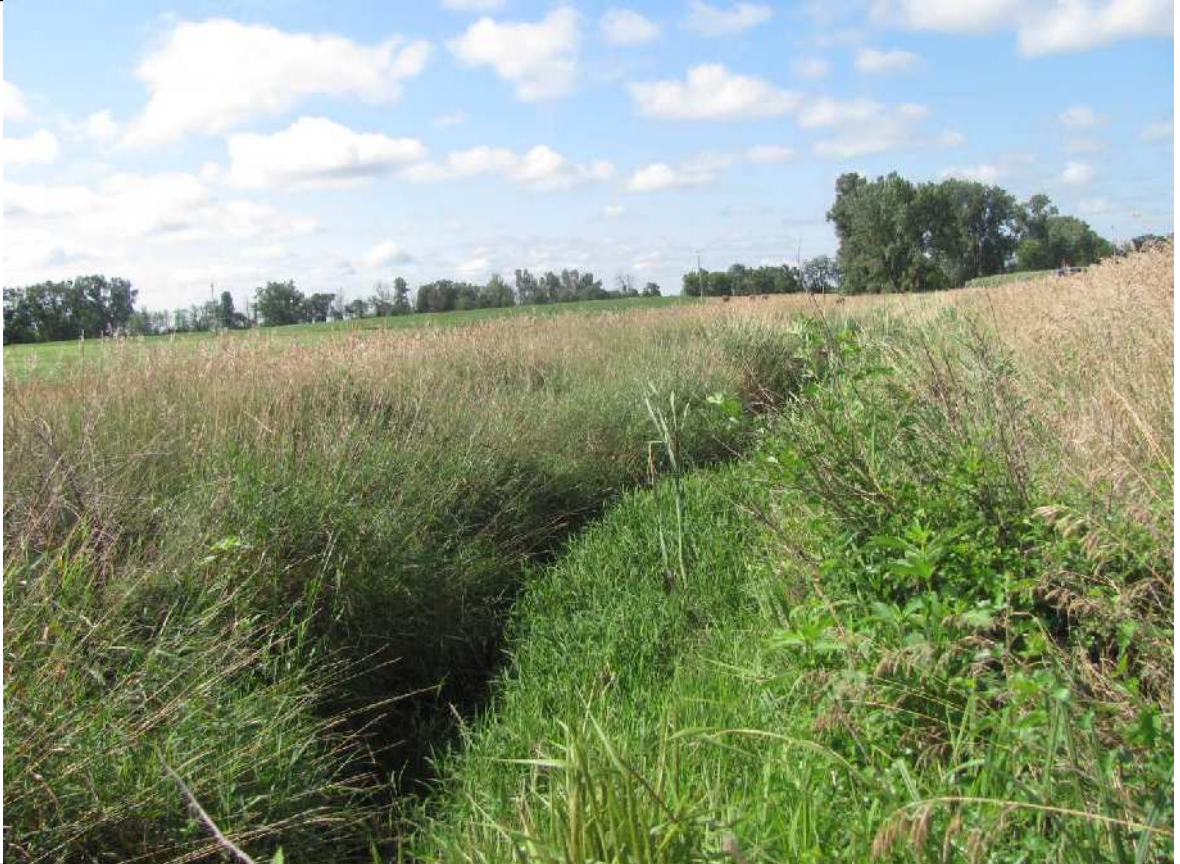
**Photo: SOH-T05 DS from  
Flag 2**

**Description: Heavily  
vegetated ditch with limited  
open water portion. Depth of  
water approximately 6  
inches.**

**SOH-T05** is an agricultural ditch draining adjacent corn fields. The steep banks are heavily vegetated with grasses and appear to be mowed annually. Although vegetated, the banks lack any tree coverage. The ditch bottom was identified as primarily silt with minor components of sand and gravel. The HHEI scored the ditch as a 41. No QEHI was performed due to a lack of pools 40 cm in depth. No mussels were observed in the ditch

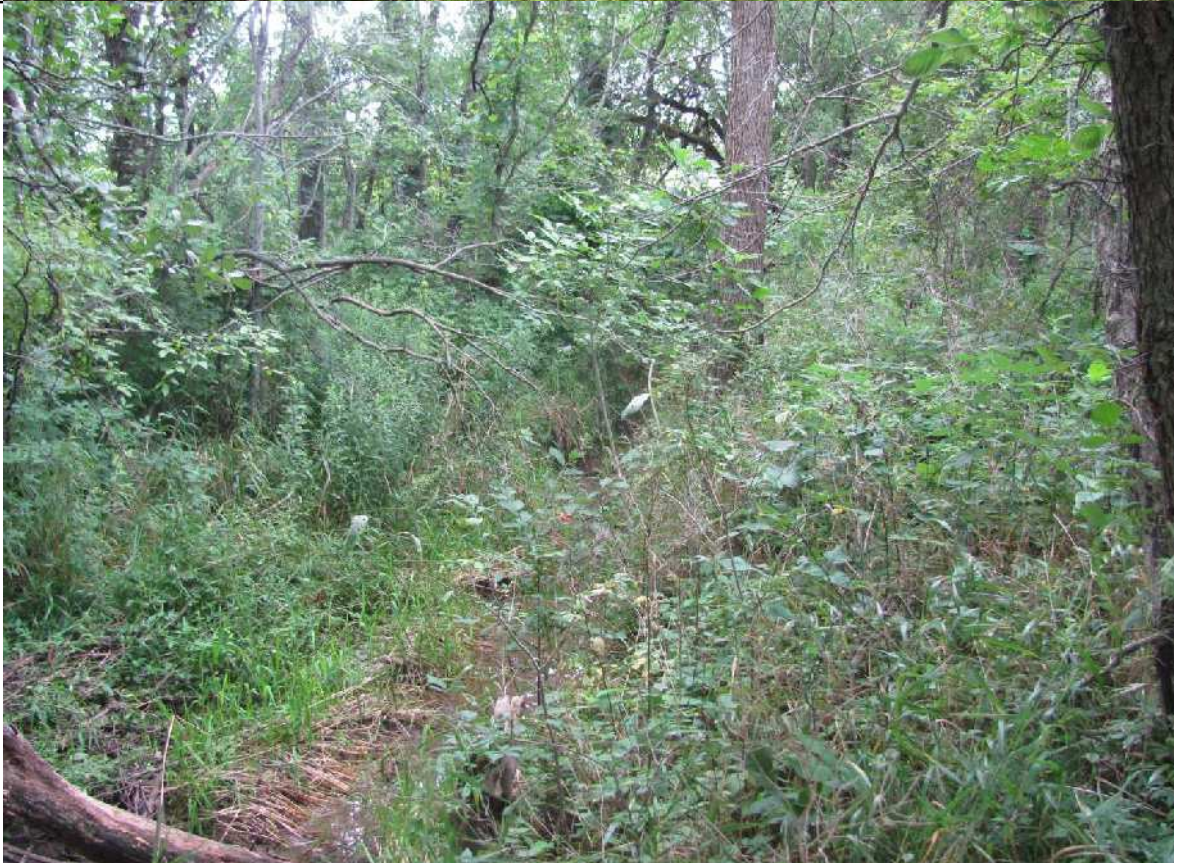
**Photo: SOH-T06 DS from  
Flag 5**

**Description: The only  
forested stream identified  
during the field efforts was  
SOH-T06. Heavy canopy  
cover was provided by trees  
growing along bank.  
Channel was somewhat  
overgrown. SOH-T06  
occurred in the Alternate  
Study Area.**

**SOH-T06** is a forested stream that is located in a narrow woodlot between active corn and soybean fields. Portions of SOH-T06 were overgrown with reed canary grass (*Phalaris arundinacea*). Additional vegetation on the banks included young willows (*Salix sp.*) and poison ivy (*Toxicodendron radicans*). The substrate of the stream was identified as primarily silt and sand, with additional components of gravel and limited muck. Despite heavily vegetated banks with moderate shading, the HHEI scored the stream as a 48. No QEHI was performed due to a lack of pools 40 cm in depth. No mussels were observed in the stream.
