# **Historic Architecture Survey**

## **Carroll County Energy**

Washington Township, Carroll County, Ohio

October 2013

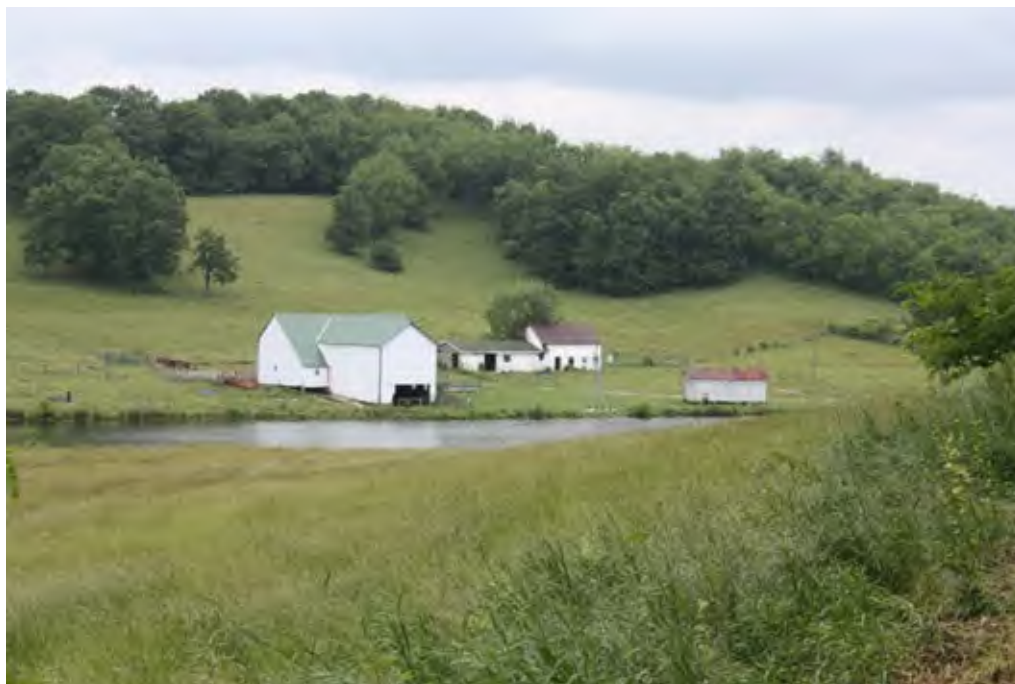
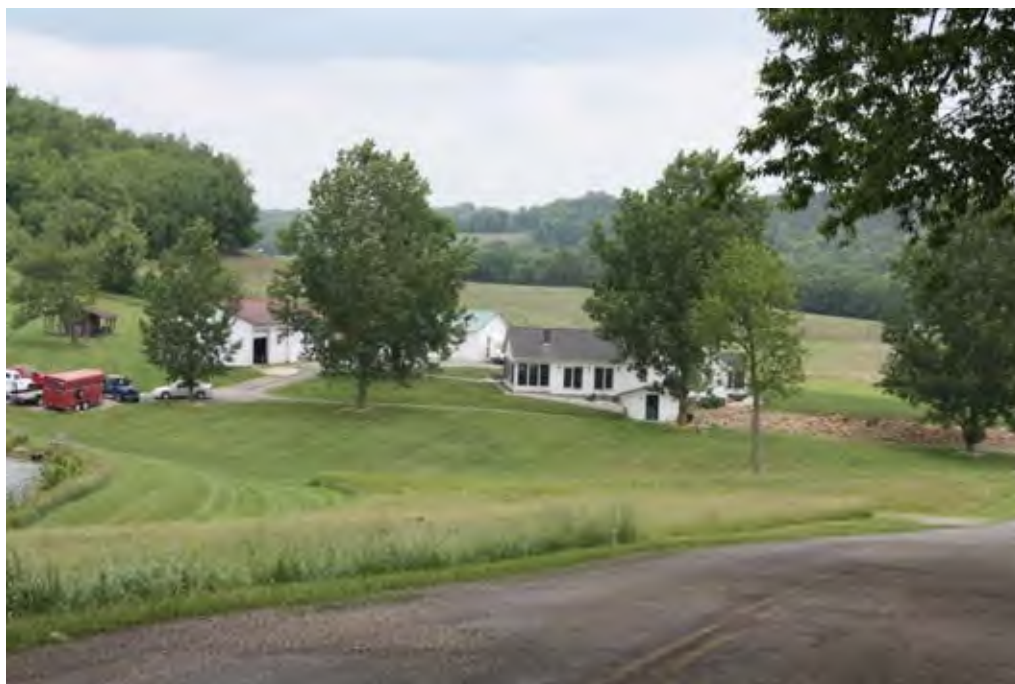
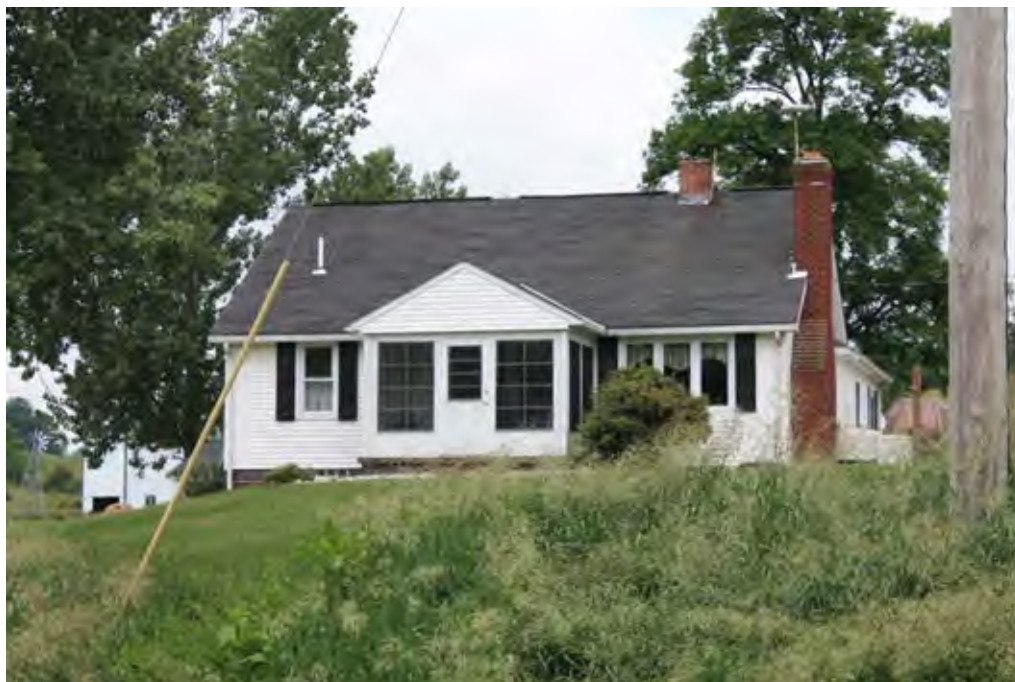
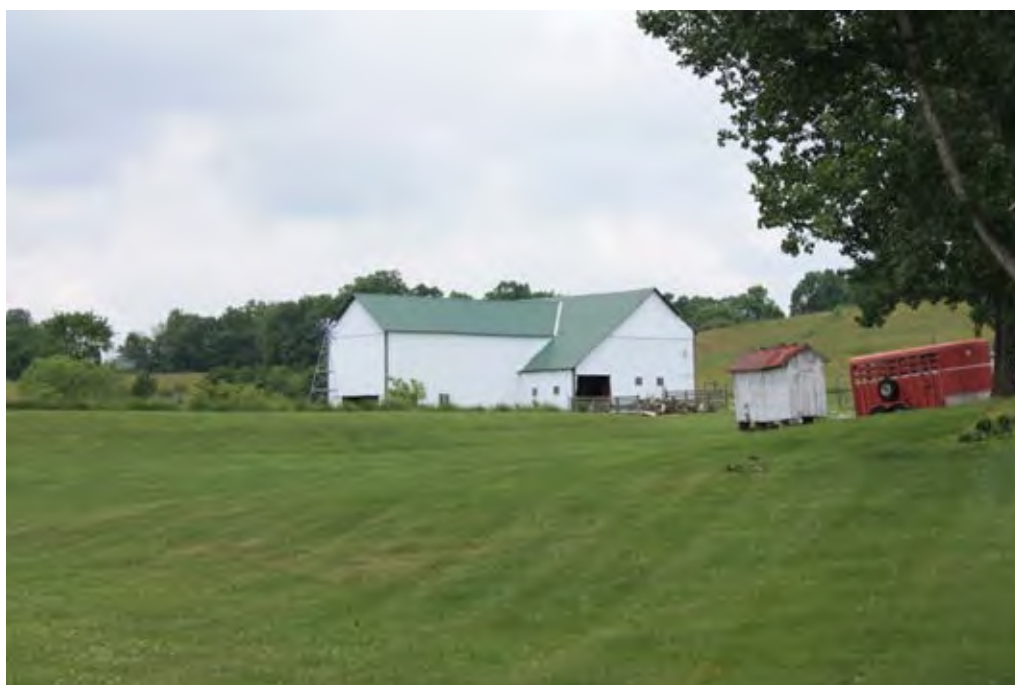
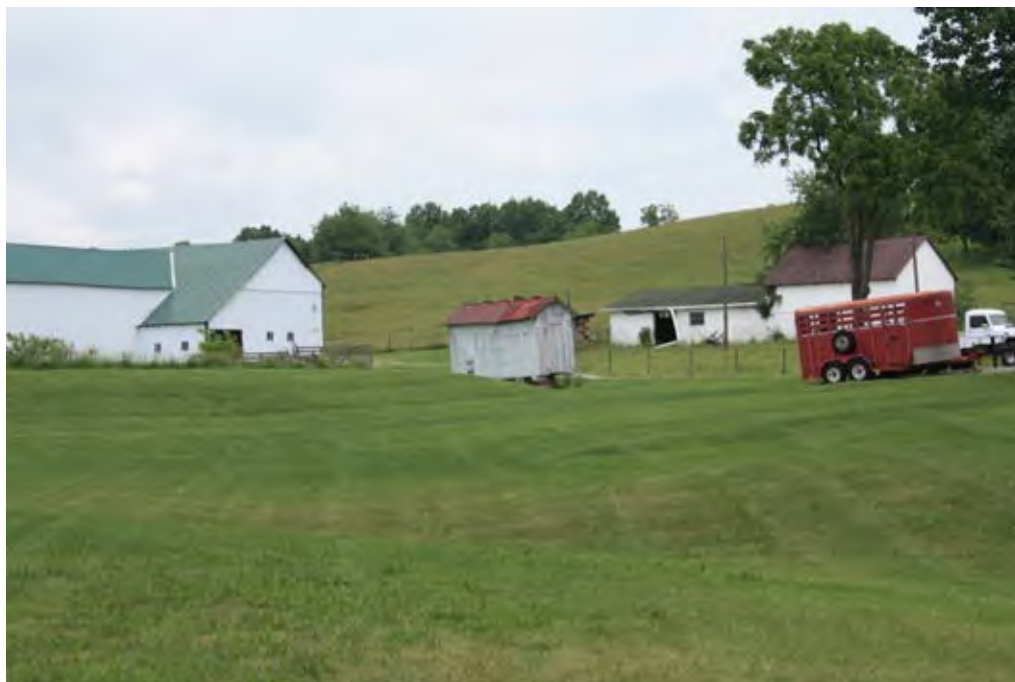
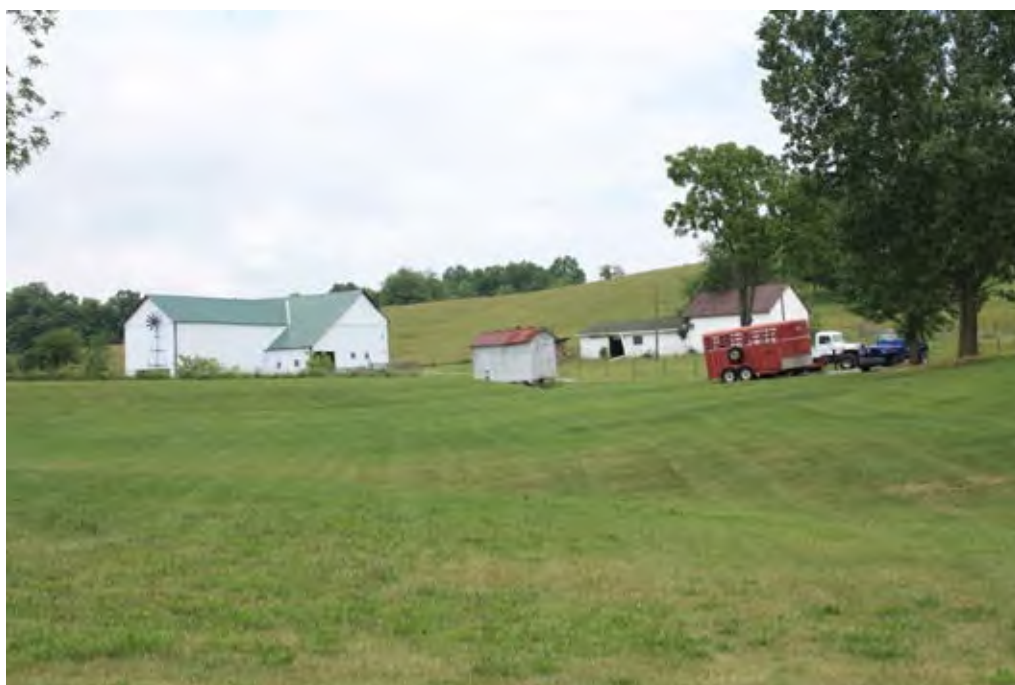
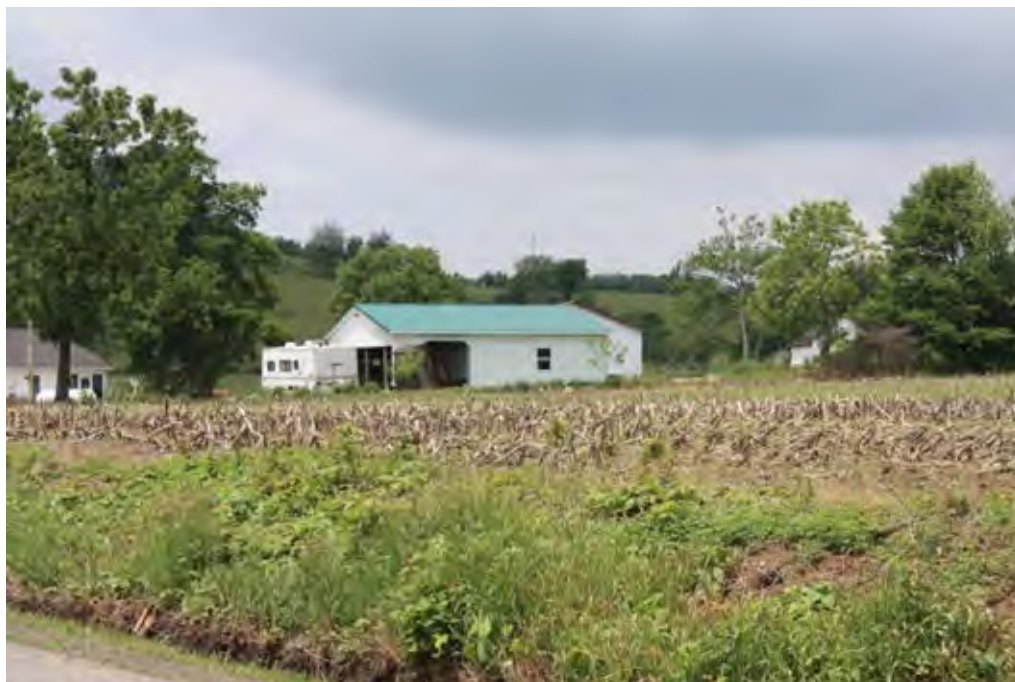
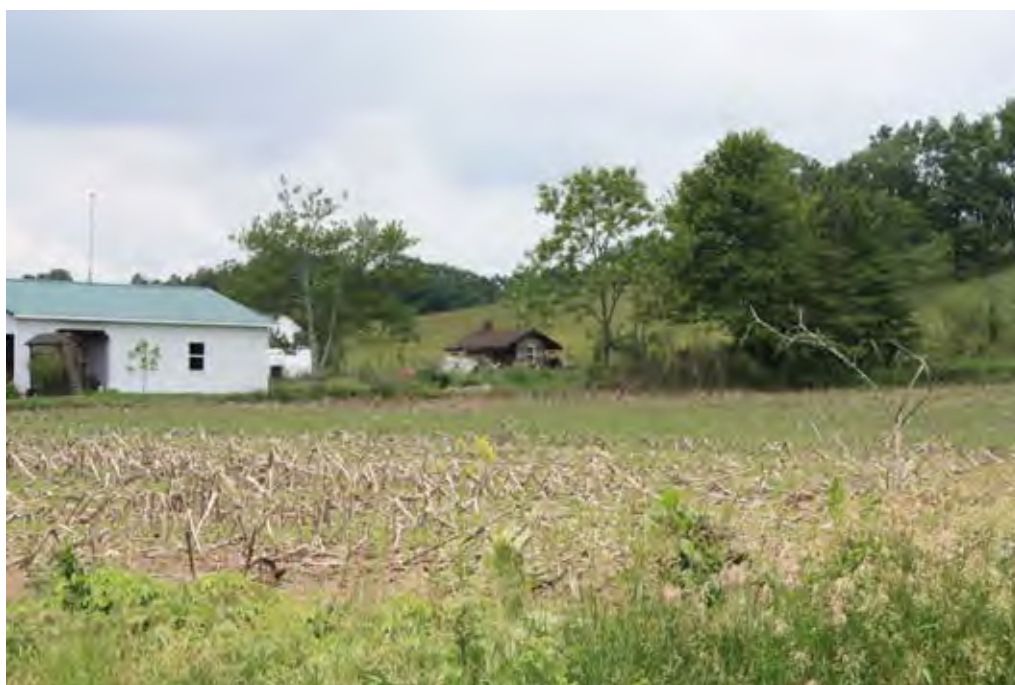
Tt11 is a large farmstead with six outbuildings. The main house is a one-story, side gable building. It has been reclad with aluminum siding and the windows are replaced. The largest barn, which overlooks a

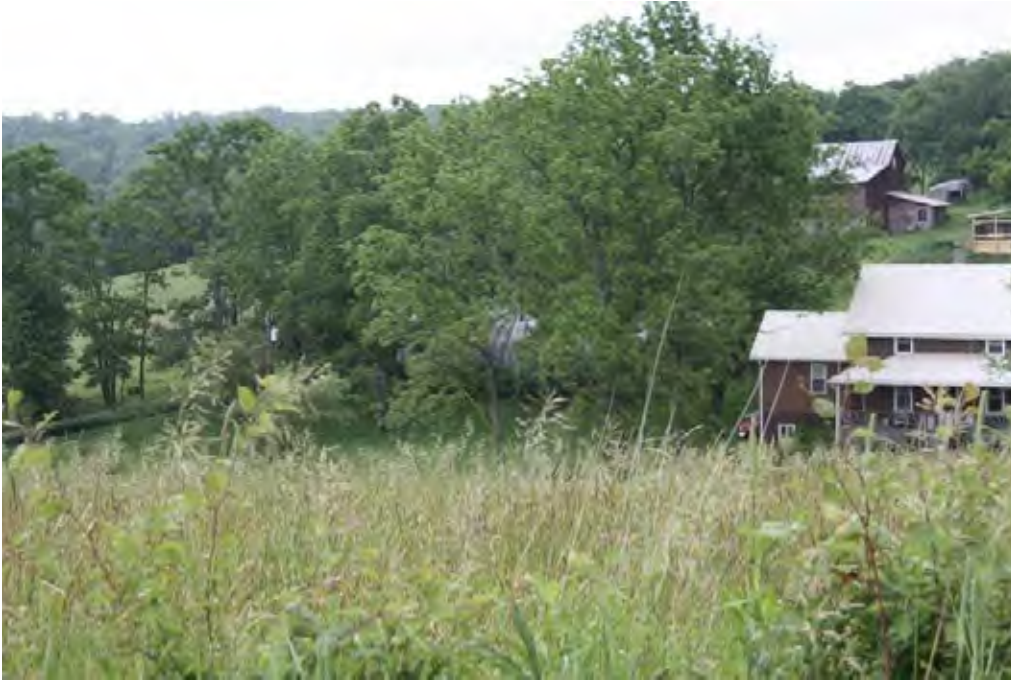
**Photograph 43-- Looking west at Tt13. The Quonset barn is in the middle of the photo behind the trees.  
(June 11, 2013)**

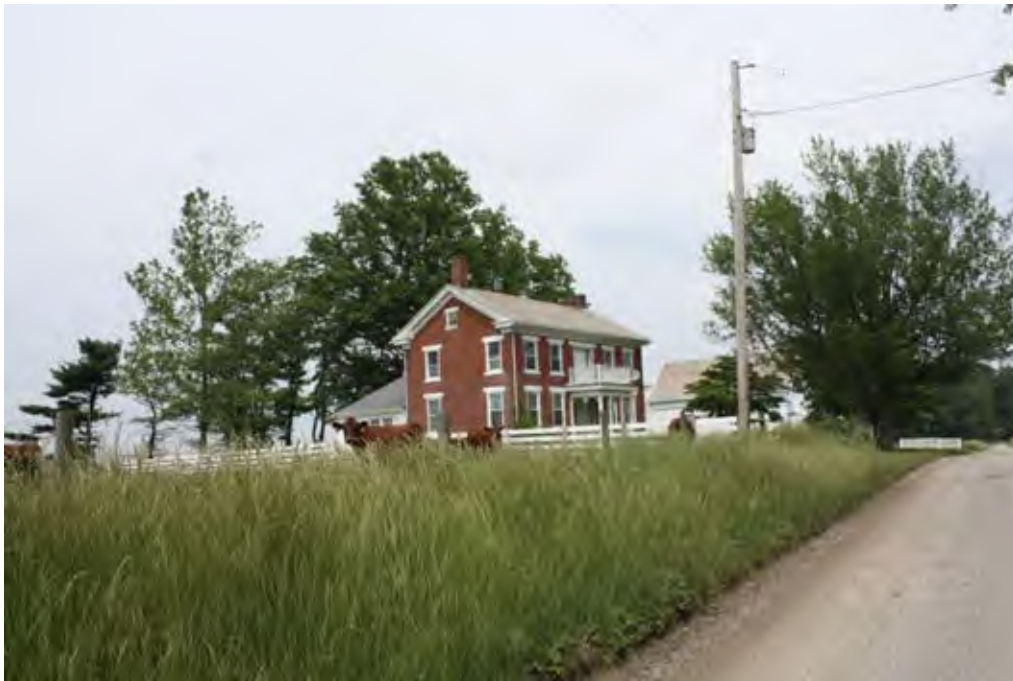
Photograph 48-- Looking southwest at Henry and Mary Pottorf House and Farmstead. (June 12, 2013)

- Henry and Mary Pottorf House and Farmstead – 4971 Meter Road, Mechanicstown (1858) – Photograph 48 – The Pottorf House and Farmstead is a well preserved farmstead that includes a two-story brick I-house (1858) with Greek Revival details, a wood-frame bank barn (1914), two milk houses (1920 and 1940) and a well. The Pottorf House and Farmstead is located more than 4.7 miles to the northeast of the Facility. It is situated on the north side of the road, so that when one views the resources from the public right-of-way, the Facility will be behind the viewer.
- Van Horn Building/Saltzman Drugstore – Corner of W. Main Street and N. Lisbon Street, Carrollton (1829) – Photograph 49 – The Van Horn building is a three-story Italianate commercial building. It sits in a commanding location at the northern end of the town square. The Van Horn Building is

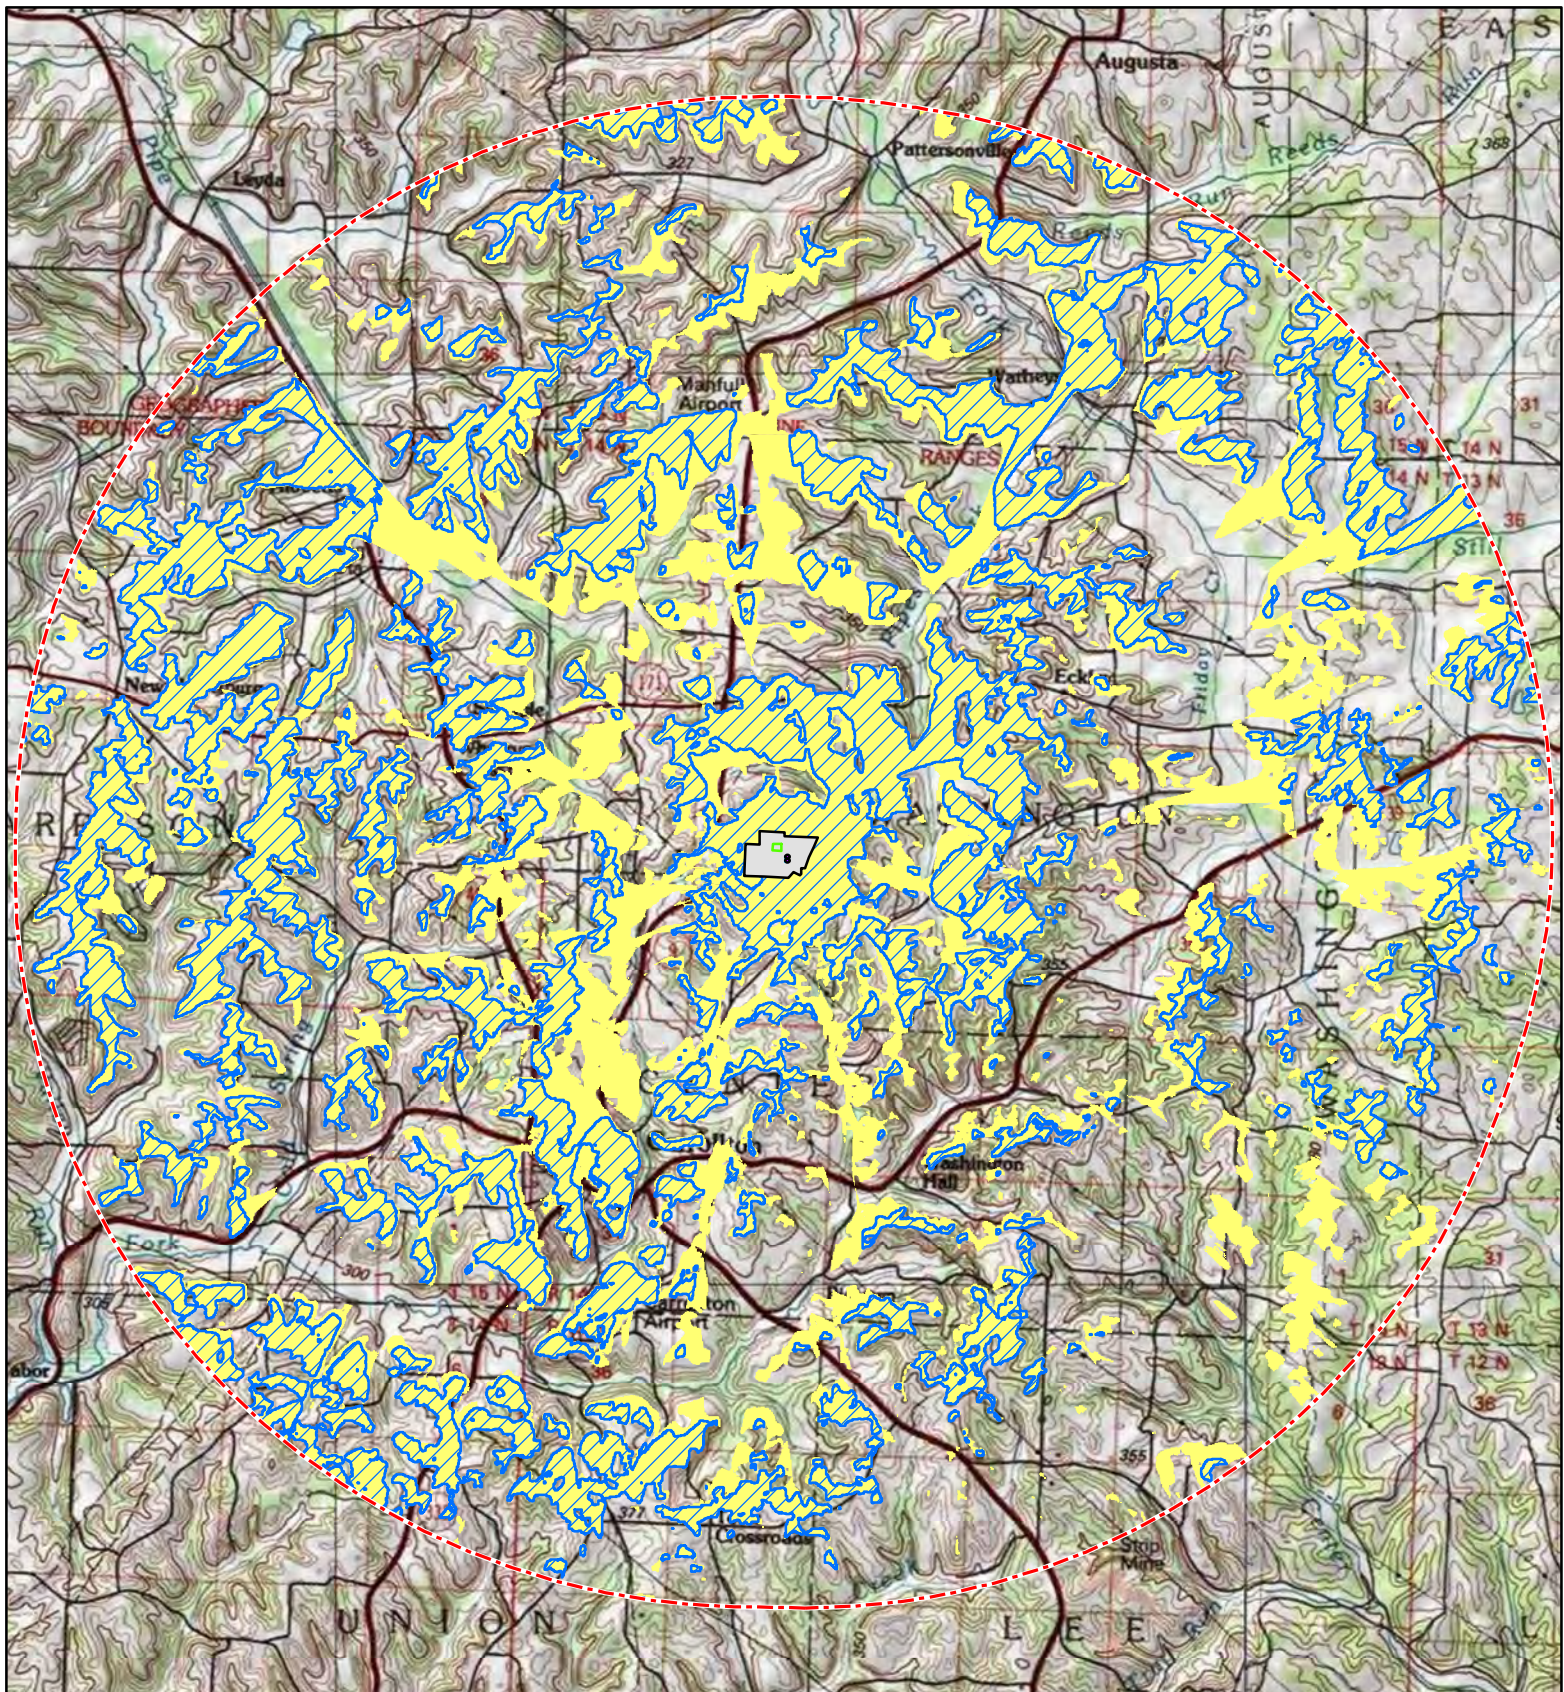
- Stack Location (275')
- Air Cooled Condensor (110')
- Heat Recovery Steam Generator (110')
- Areas where facilities would be visible (viewshed based on 110' facility elements)
- Areas where facilities would be visible (viewshed based on 275' stack)
- Facility Site
- 5-mile Viewshed Extent

The objective of this survey design was to develop a framework for a reconnaissance survey to determine the potential for resources listed in the NRHP, the OHI data base, and those newly recommended as potentially NRHP-eligible to be affected by the construction of the Facility. The first step in this process was the definition of the Area of Potential Effect (APE). As no historic structures are to be directly affected in the construction of the Facility, the primary potential effect is visual. Because of that, Tetra Tech defined the APE as all areas within five miles of the Facility Site that a topography-only<sup>3</sup> computer generated viewshed model indicated would potentially have a view of part or all of the Facility (Figure 3).
