**FIGURE 1
POTENTIAL BAT ROOST TREES**

**EAST AMSTERDAM PROJECT
AMERICAN ELECTRIC
POWER COMPANY**

East Amsterdam – Miller Switch 69 kV Rebuild, APEX Relocation

ATTACHMENT C

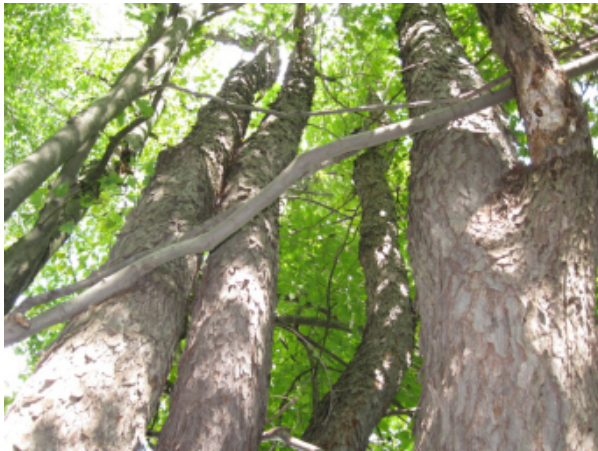
ID #	Species	Tree DBH	Tree Status	Roost Type	Roost Potential		GPS (Wpt. or Coords.)	Photo(s)	Description/Comments
					MYSO	MYSE			
RR-01	<i>Pinus serotina</i>	36	L	EB, CA	L	M	RR-01	3679	Very large cherry with multiple trunks. Very shaggy. Possible hollow with cavity entrance. Small snag. Most bark falling away.
RR-02	<i>Acer rubrum</i>	6	D	EB	L	L	RR-02	3680	
RR-03	<i>Carya ovata</i>	14	L	EB	M	H	RR-03	3681	Medium-sized shagbark with generous amount of exfoliating bark.
RR-04	<i>Pinus serotina</i>	8	D	EB	L	L	RR-04	3682	Very small snag with small amount of ext. bark.
RR-05	<i>Ulmus americana</i>	9	D	EB	L	L	RR-05	3683	Small snag with most bark shed, but almost base. Very small amount of ext. bark. Good snag.
RR-06	<i>Pinus serotina</i>	8	D	EB	L	L	RR-06	3684	Snag with most bark still on tree. Very little ext. bark.
RR-07	<i>Ulmus americana</i>	12	D	EB	H	H	RR-07	3685	Elm snag with large slabs of ext. bark. Good snag exposure.
