# Threatened and Endangered Species Assessment

American Electric Power Sparrow 138 kV Transmission Line Loop Project

> Cadiz and Green Townships Harrison County, Ohio

# Potential Bat Roost Tree Identification Survey along the Sparrow 138 kV Loop Project in Harrison County, Ohio

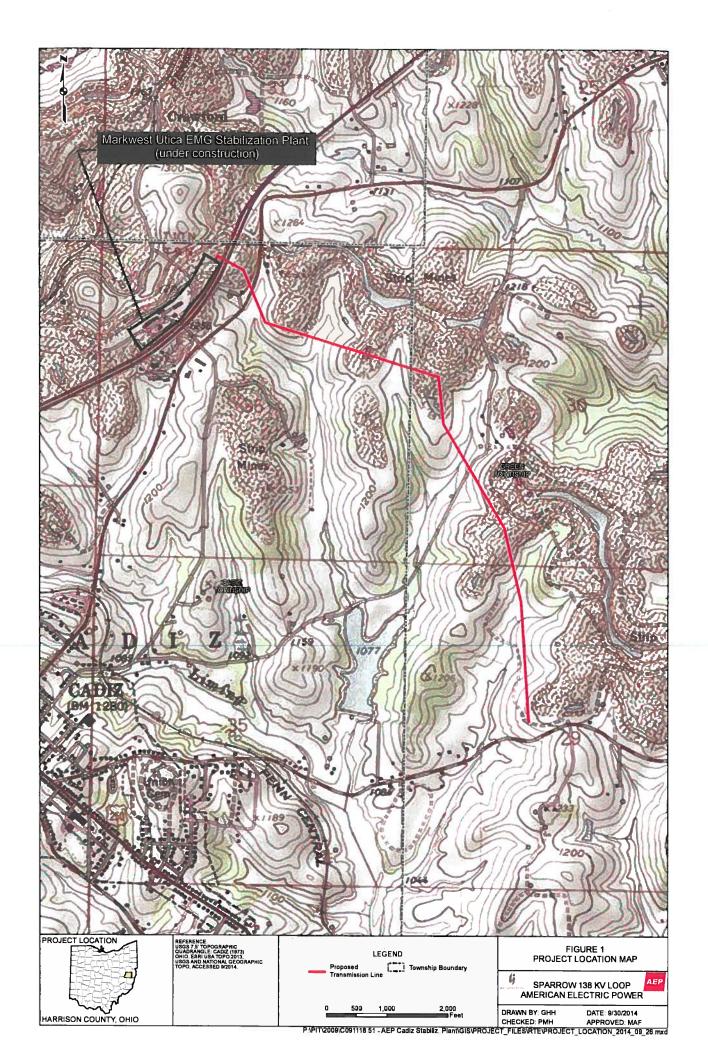
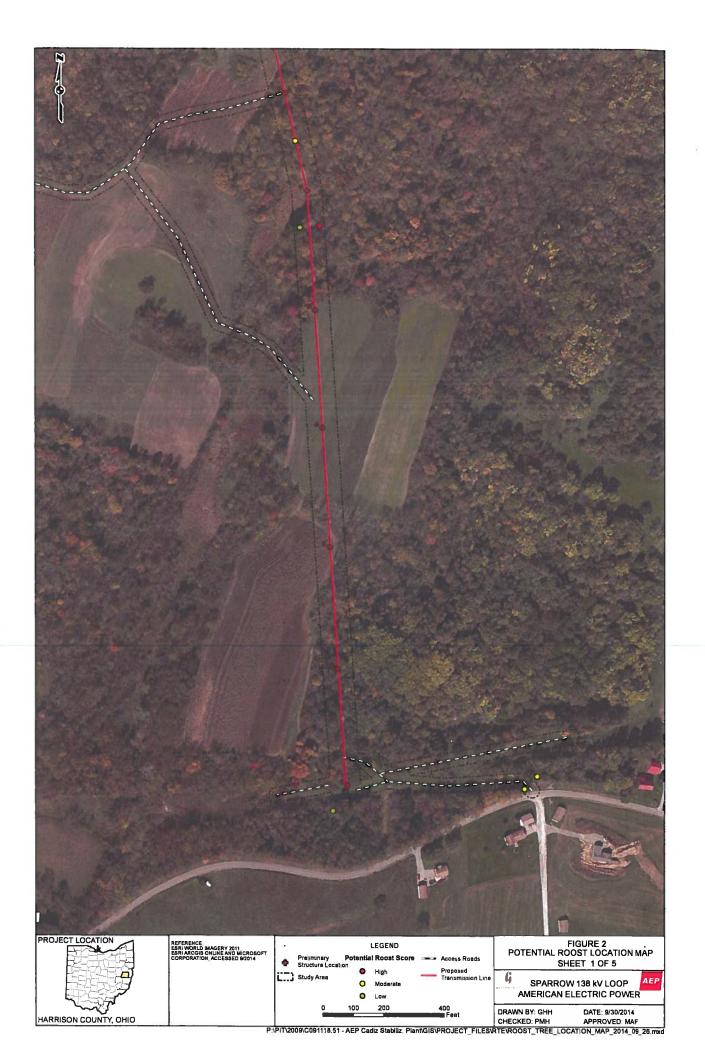
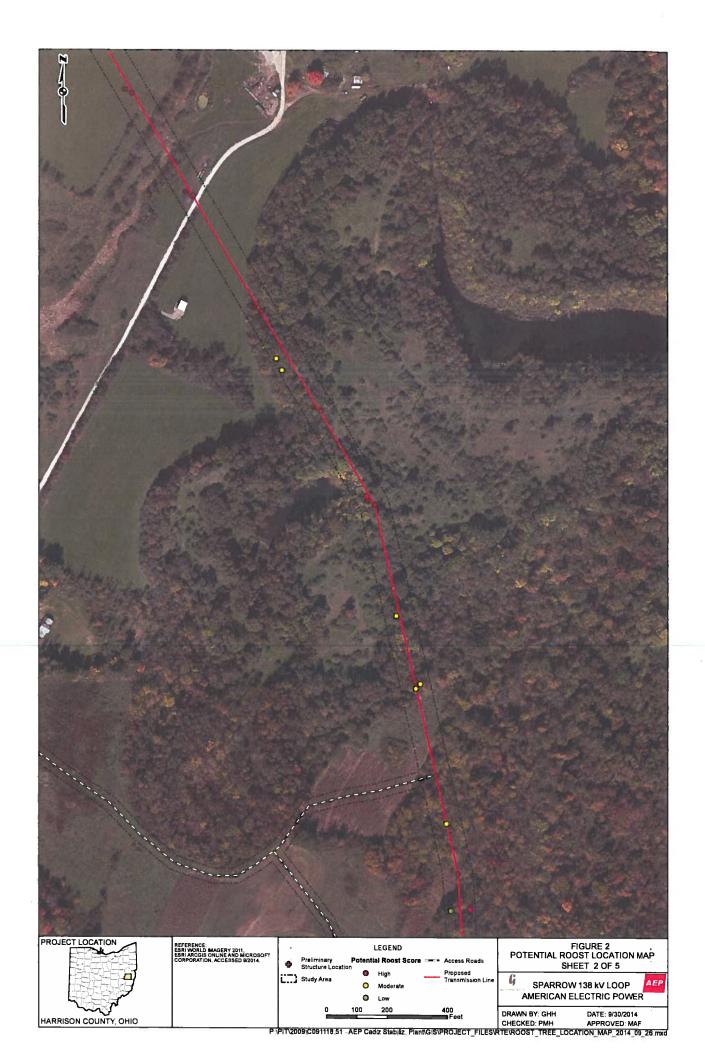
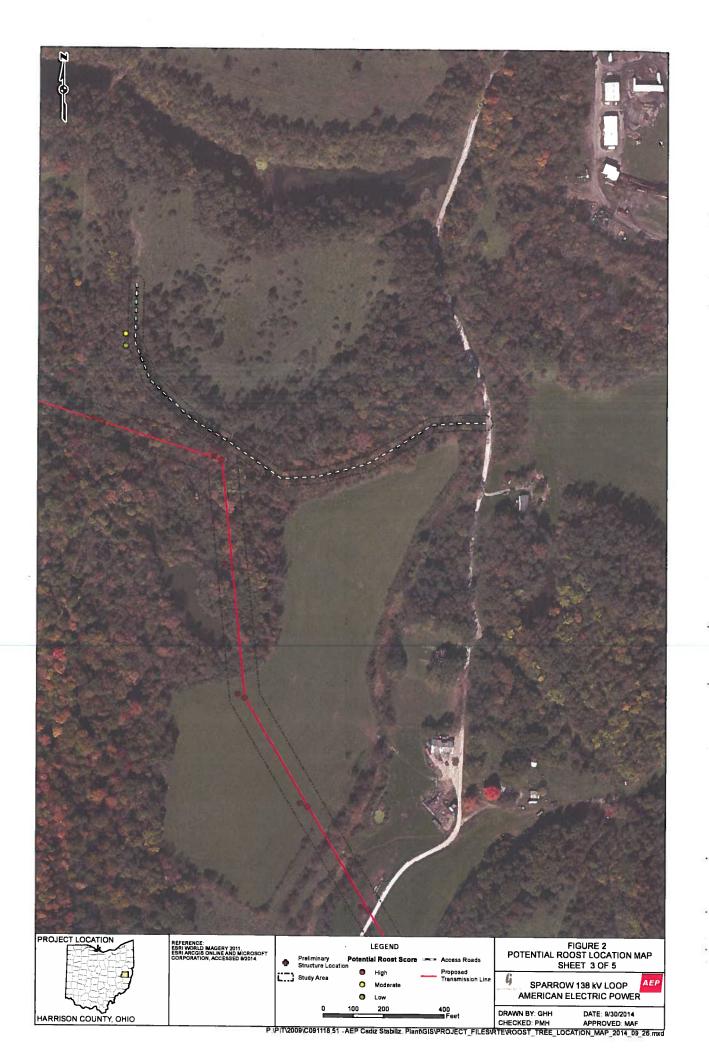
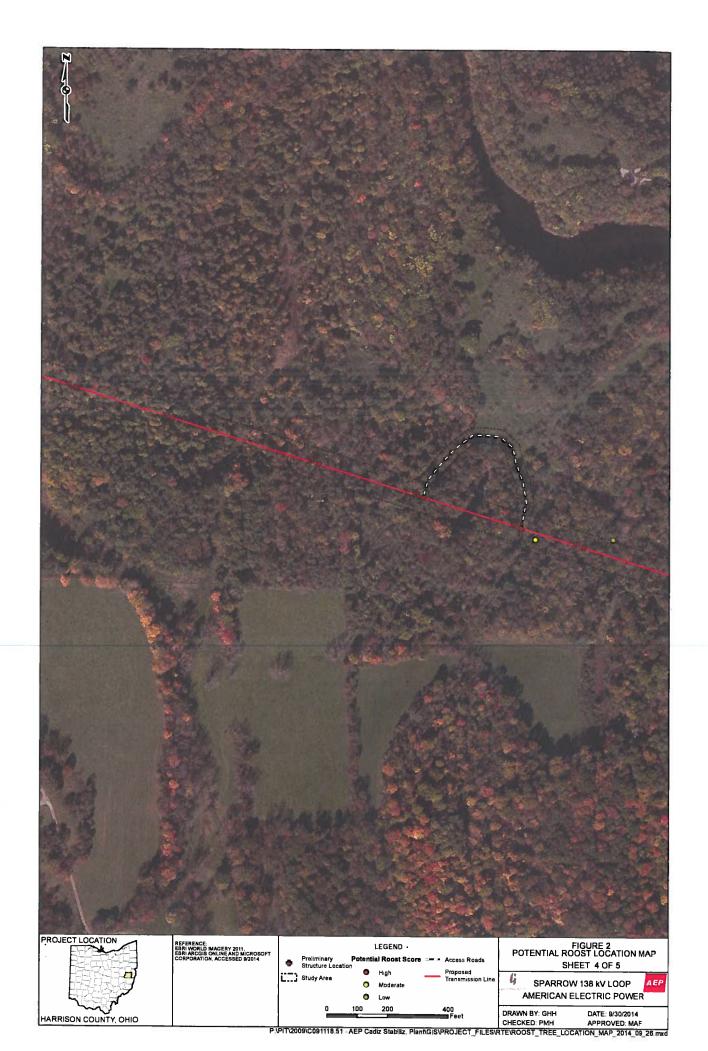
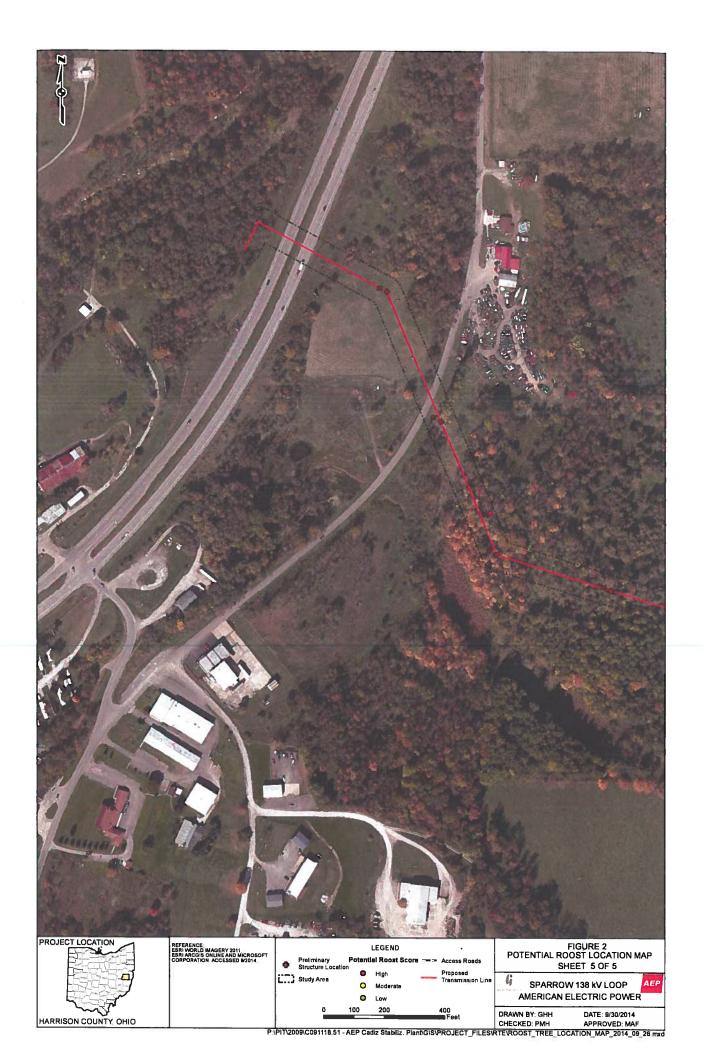
## **ATTACHMENT A**

A total of 20 potential roost trees was identified in the Project area. Figure 2 (Attachment A) shows the location of each tree within the Project area. Potential roost trees included eight black locust (*Robinia pseudoacacia*), three shagbark hickory, two wild black cherry (*Prunus serotina*), two black walnut (*Juglans nigra*), two red elm (*Ulmus rubra*), two tree-of-heaven (*Ailanthus altissima*), and one osage orange (*Maclura pomifera*; Attachment D). Ten (50 %) potential roost trees were live, five (25 %) were dead, and five (25 %) were partially dead. Of these, four (20 %) potential roost trees were considered to be of high value to Indiana bats, while ten (50 %) were considered to be of moderate value, and six (30 %) were considered to be of low value.
