**BEFORE**  
**THE PUBLIC UTILITIES COMMISSION OF OHIO**

In the Matter of the Application of Duke )  
Energy Ohio, Inc., for Approval of an )  
Alternative Rate Plan Pursuant to Section ) Case No. 14-1622-GA-ALT  
4929.05, Revised Code, for an )  
Accelerated Service Line Replacement )  
Program. )

**DIRECT TESTIMONY OF**

**EDWARD A. McGEE**

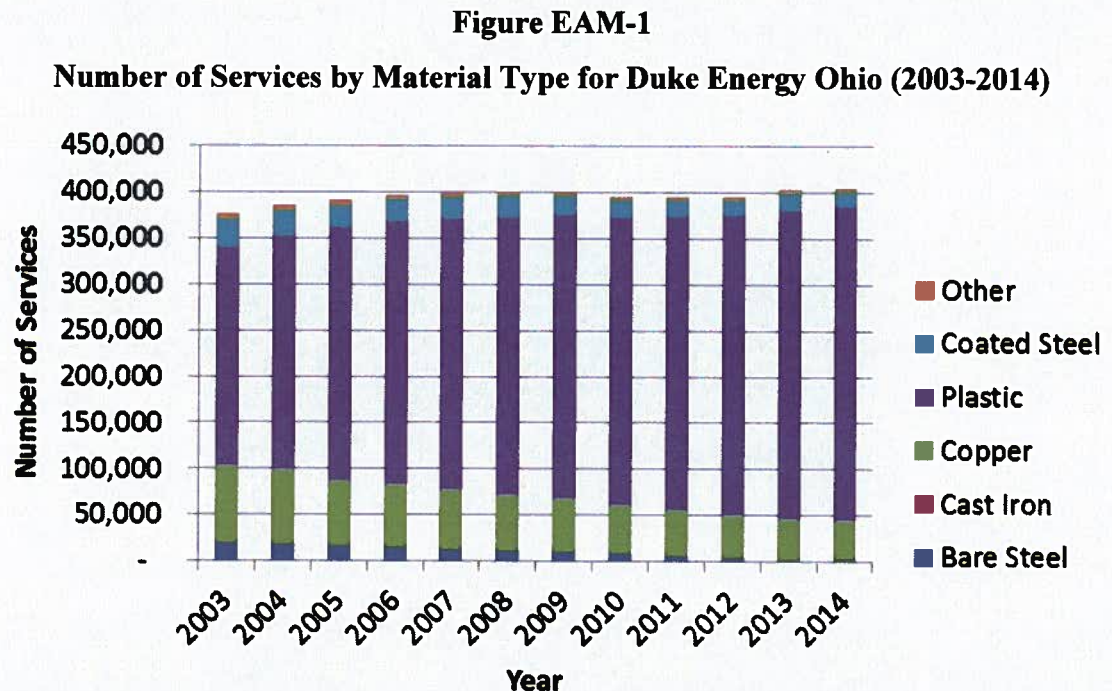
1 Ohio's AMRP. A smaller number of services have also been removed under  
2 Duke Energy Ohio's annual replacement policy based on their condition and  
3 judged level of obsolescence. However, a number of service lines (57,805)  
4 composed of metallic materials remain since these were not associated with the  
5 replaced mains. The change in composition in the past twelve years is pictured in  
6 Figure EAM-1 shown below (and also appears in the Lummus Supplement as  
7 Figure 3):

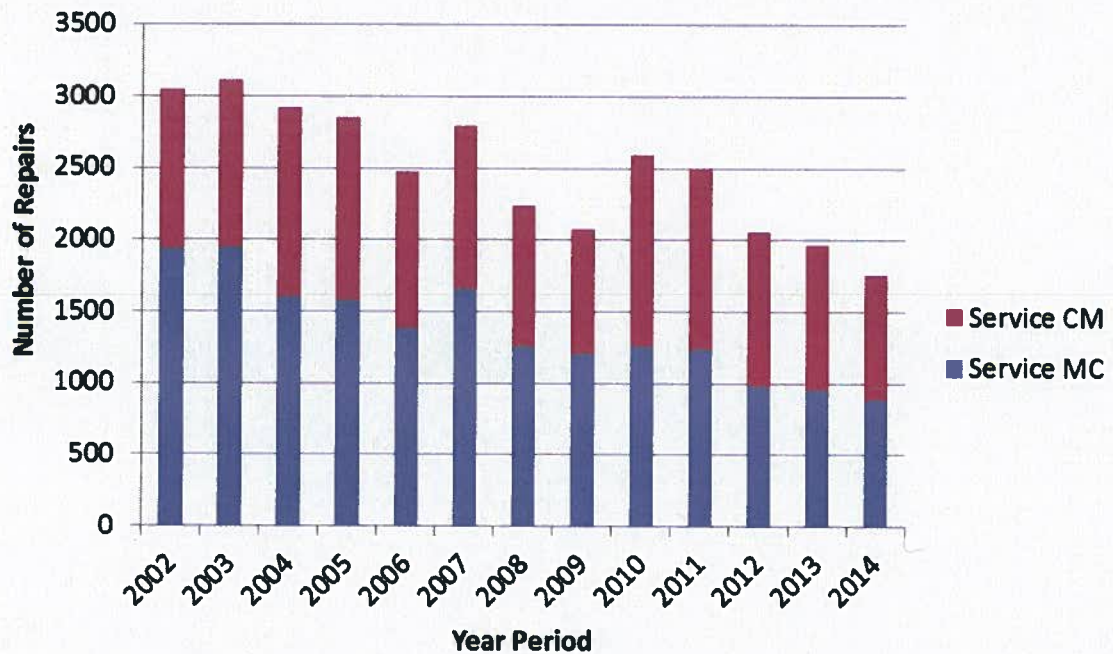
**Figure EAM-2**

5 A. No, not for reported leaks, as the DOT reports do not carry this breakdown.  
6 However, the information maintained by Duke Energy Ohio for repaired leaks  
7 that was analyzed by Lummus does contain information on the portion of the  
8 service line where the leak was repaired. Figure EAM-2, below, shows the  
9 history of leaks repaired between 2002 and 2014 on the underground portions of  
10 the service lines. Leaks are identified separately as M-C (leaks that developed on  
11 the underground portion of the service line stretching from the main to the curb  
12 box) and C-M (leaks that developed on the underground portion of the service  
13 line leading from the curb box toward the meter).

**Duke Energy Ohio's Repaired Leaks on Services (Repairs per Year)**

1    **Q.    DOES FIGURE EAM-2 INDICATE ANY OTHER LEAK TRENDS?**

2    A.    Yes. Figure EAM-2 also demonstrates that, in particular, the number of repaired  
3    leaks on the C-M portion of service lines, which is closest to buildings and their  
4    occupants, has grown in proportion to the number of repaired leaks on the M-C  
5    portion of service lines, which is furthest from the buildings. In 2002, the number  
6    of repaired leaks on the C-M portion of the service lines was 36% of the total  
7    leaks. Currently (2014) the C-M portion of the service lines accounts for 49% of  
8    the total repaired service leaks. The number of leaks repaired per year on the M-  
9    C portion of the service lines has been reduced by 54% over the thirteen year  
10   period, whereas leaks on the C-M portion of the service line have been reduced a  
11   significantly smaller amount (22%) over the latest thirteen year time period,

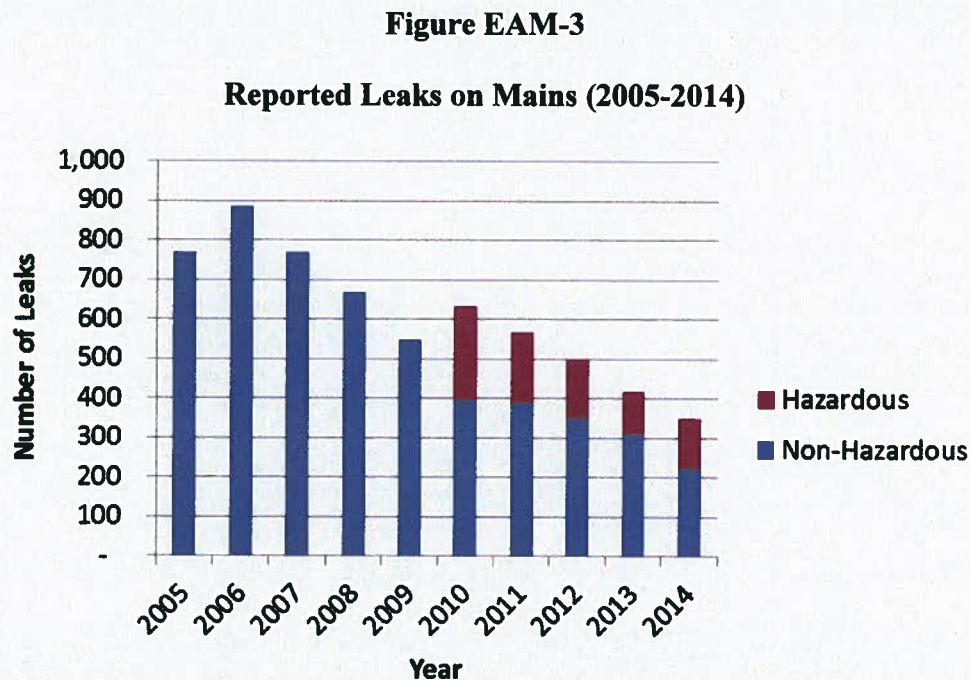
3 A. The DOT has only been classifying leaks as hazardous or non-hazardous for the  
4 past five years. Hazardous leaks are Grade 1 leaks that must be repaired  
5 immediately. The following chart (EAM-3) shows the hazardous leak trends on  
6 Duke Energy Ohio's mains for the past five years, as well as all mains leaks for  
7 ten years.

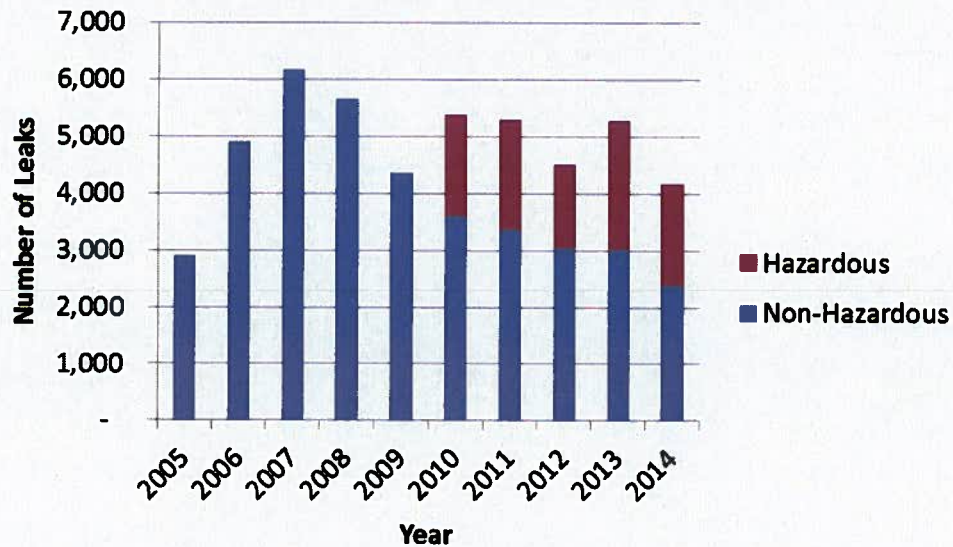
**Figure EAM-4**  
**Reported Leaks on Services (2005-2014)**

8 The next chart (EAM-4) shows the hazardous leak trends on Duke Energy Ohio's  
9 services for the past five years, as well as all service line leaks for ten years.

1 For the most recent year (2014), the number of hazardous leaks on Duke Energy  
 2 Ohio's services amounted to 1,776 leaks. The number of hazardous leaks on  
 3 Duke Energy Ohio's mains was 125. Therefore the number of hazardous leaks on  
 4 service lines for the most current year was fourteen times as great as the number  
 5 of hazardous leaks on mains.

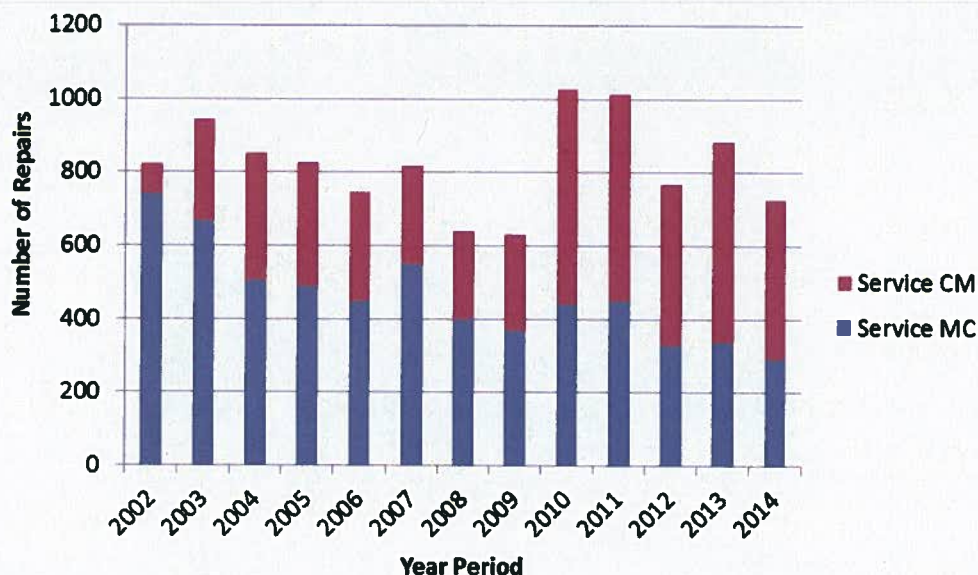
**Figure EAM-5**  
**Repaired Leaks on Services (due to Corrosion)**

2    A.    Yes. The trend of corrosion-caused leaks is shown in Figure EAM-5. In this  
3       figure, leaks seem to be increasing in some recent years; particularly on the C-M  
4       portion of the service line, which is closest to buildings and their occupants.

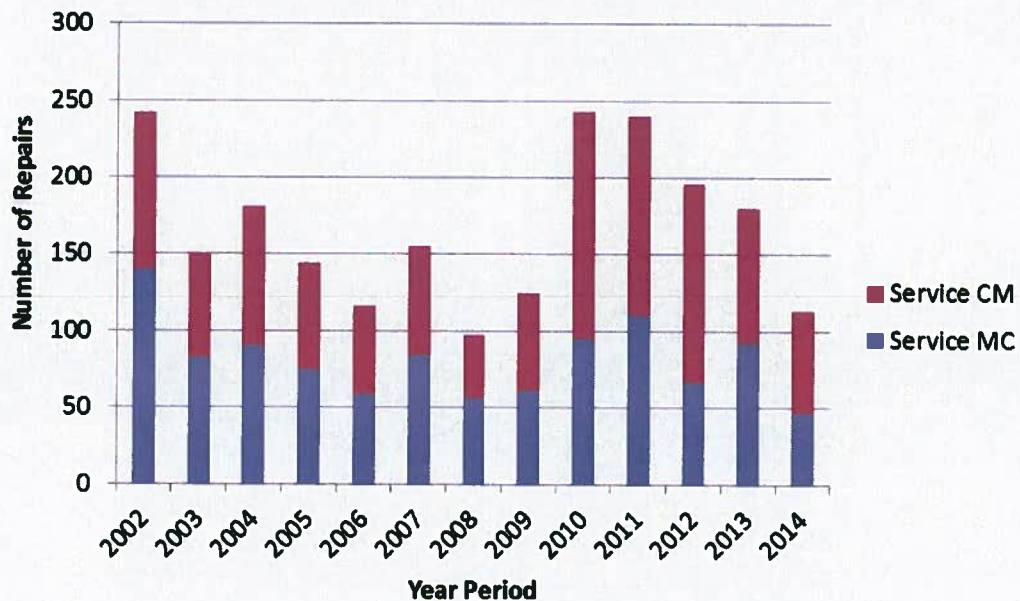
**Figure EAM-6**

6    A.    Yes. The trend of material and welds-caused leaks is shown in Figure EAM-6.  
7       This figure shows an unstable pattern of leaks over the thirteen-year period  
8       shown. The number of leaks from this cause of leak surprisingly did not decline  
9       during the period the AMRP was undertaken. In the latest year, leaks from this  
10      cause may be starting to decline, but a longer time period may be required to be  
11      certain, due to the unstable patterns exhibited in earlier years.

**Repaired Leaks on Services (due to Materials and Welds)**

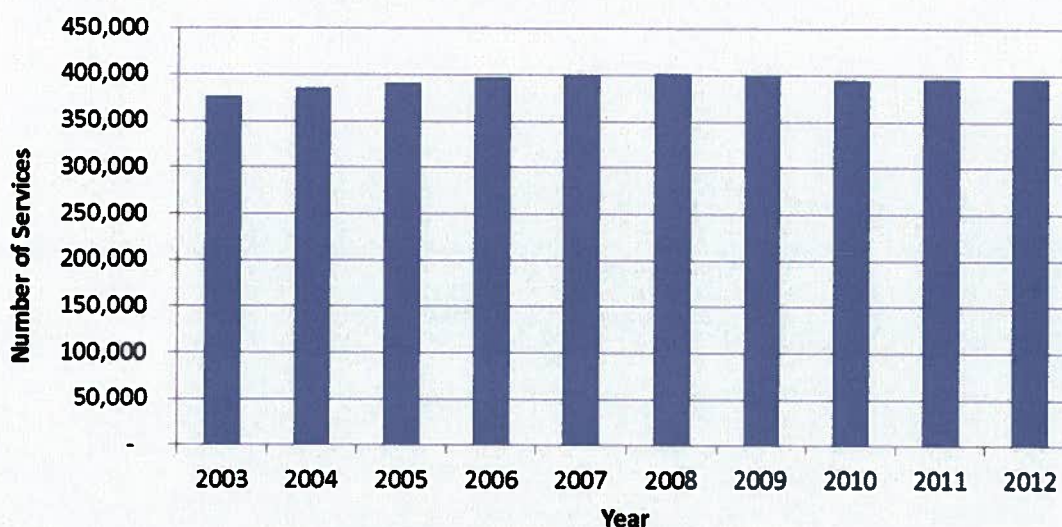
Figure 1. Total Number of Services (2003-2012)

Duke Energy and its predecessor gas distribution companies have served the greater Cincinnati, Ohio area for more than 175 years. Recent counts of its customers show a stabilizing market, as indicated in Figure 1.

A stable customer count is typical of urban-centered LDCs. In contrast to some suburban-based LDCs that have substantial customer growth into new or growing areas, and are able to maintain a newer piping system partially through growth, Duke Energy relies on replacement to maintain the reliability of its piping system. Pipe replacement is generally considered to be a more cost-effective way of controlling leaks than continuously repairing leaks as they occur.

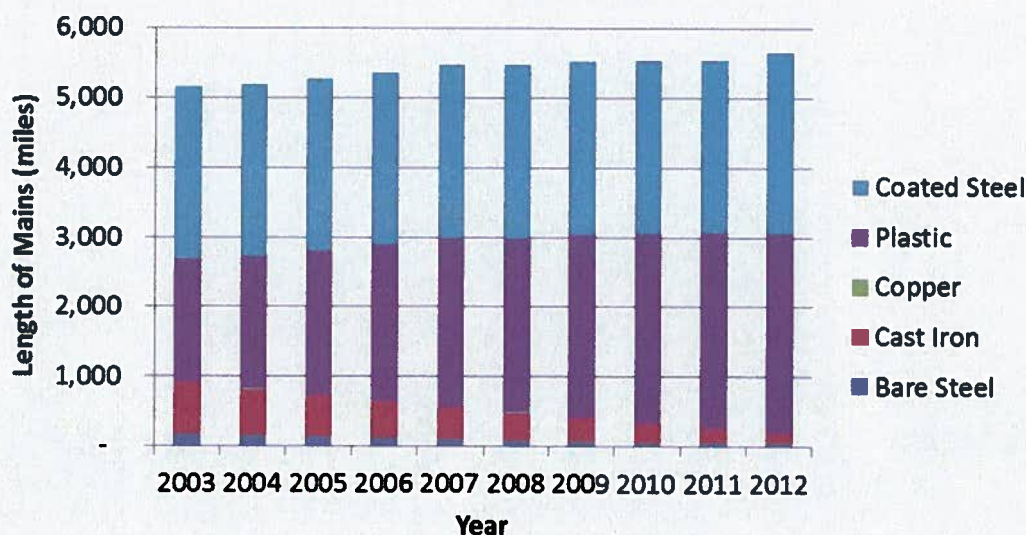
Figure 2. Length of Mains (2003-2012)

Over the past decade (year 2003 through year 2012), Duke Energy has replaced a substantial number of obsolete types of main lines with modern materials – primarily through its AMRP program. As a result of this replacement, bare steel mains have been reduced by 114.6 miles, cast-iron mains have been reduced by 622.2 miles, and copper mains have been reduced by 2.2 miles. Through replacement of the older metallic mains, as well as the installation of entirely new mains, plastic mains have increased by 1,102.6 miles and coated steel mains have increased by 146.7 miles<sup>1</sup>. Lummus Consultants considers these replacement mileages to be commendable, both in terms of Duke Energy's accomplishment and the PUCO's authorization to implement this accelerated program. These changes in mains mileage are shown in Figure 2.

As shown in the above chart, Duke Energy has nearly eliminated its cast-iron and bare steel mains (). In their place, Duke Energy has installed the most modern materials (plastic and cathodically-protected coated steel).

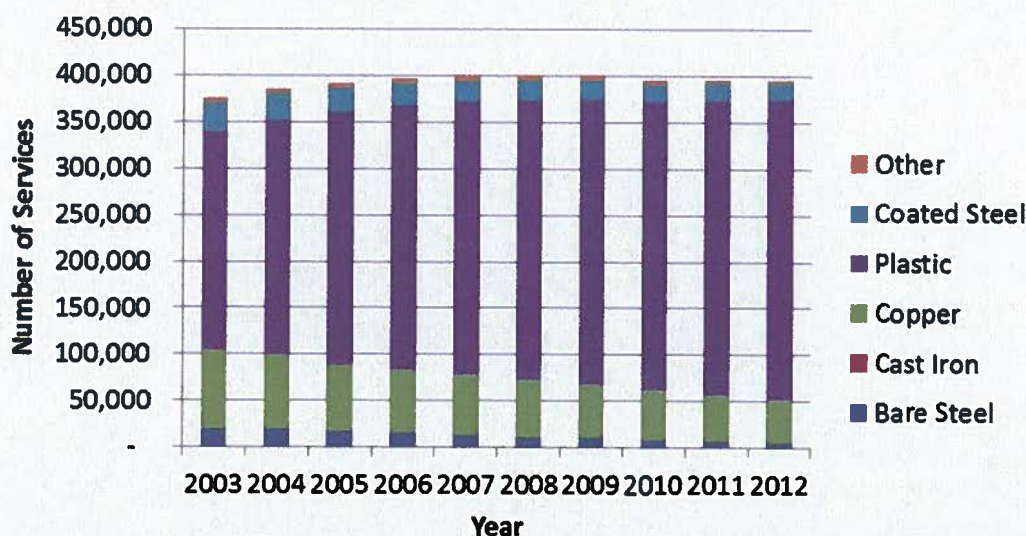
Figure 3. Number of Services (2003-2012)

Under Duke Energy's program, the amount of bare steel service lines were reduced by 14,308; cast-iron service lines were reduced by 42; coated steel service lines were reduced by 13,694; copper service lines were reduced by 38,171; and "other" service lines were reduced by 1,634. During the same decade the number of plastic service lines in the Ohio system was increased by 87,416<sup>2</sup>. Figure 3 illustrates the changes in service line materials.

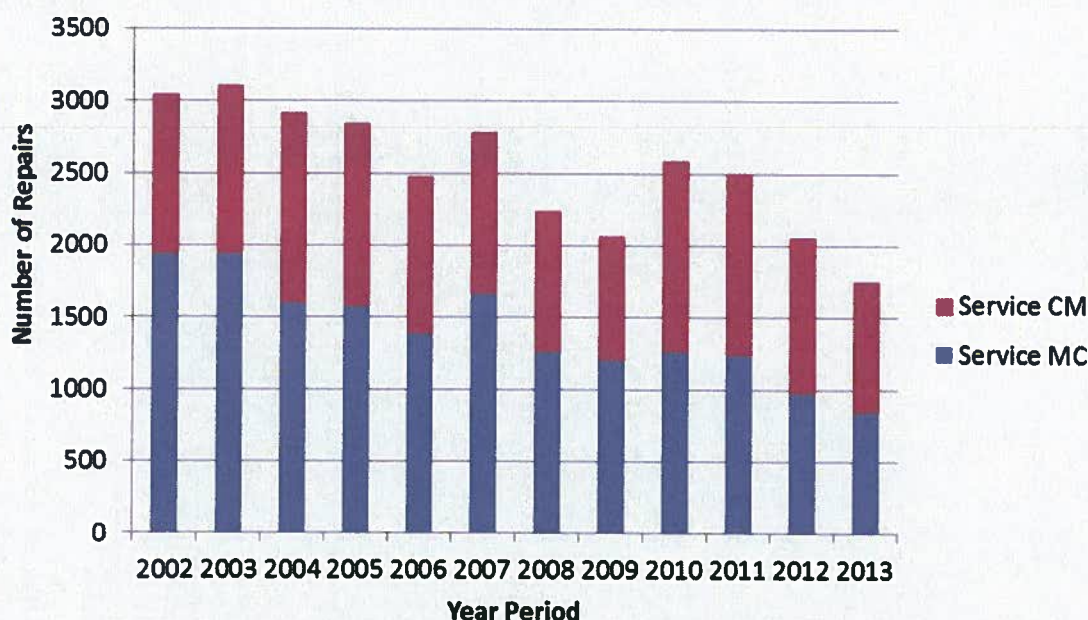
Figure 6. Repaired Leaks on Services

In the above chart, leaks on service line segments are seen to be declining overall, but possibly not quite as fast as one might anticipate, given the extensive AMRP program that has taken place.

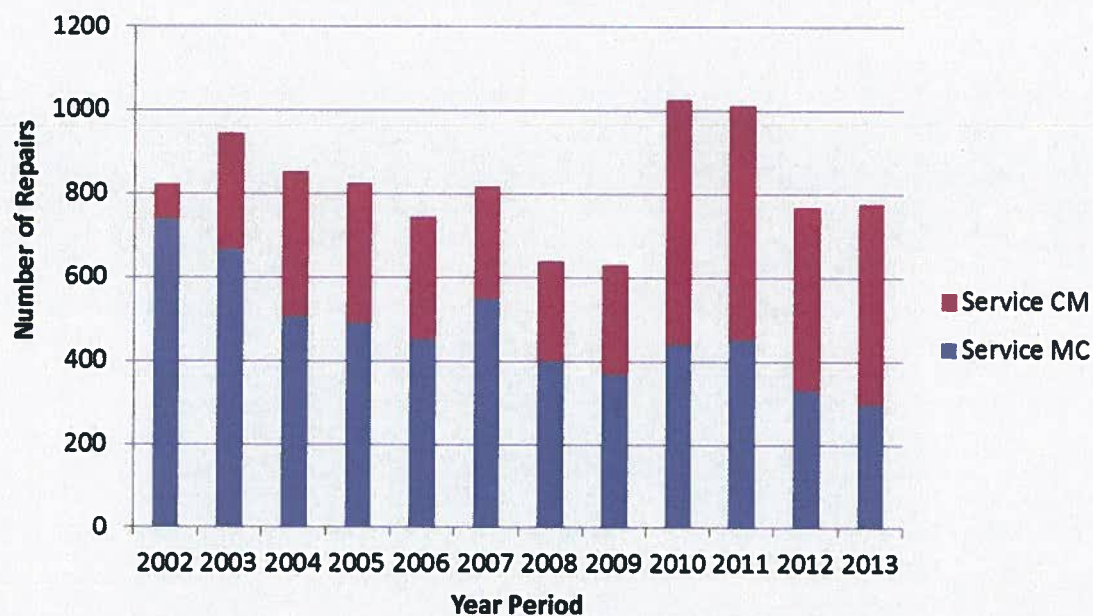
Figure 7. Repaired Leaks on Services due to Corrosion

As shown in Figures 7 and 8, the trends in the cause of the leaks are unexpected and relate to continuing deterioration of primarily metallic service lines. It appears that although overall service line leaks are declining, leak trends caused by the two categories, corrosion and materials & welds, have remained elevated. This may indicate that even after Duke Energy's Ohio AMRP program is completed, service line leaks may continue to rise due to age, soil condition, stray-current, or other promoting continued deterioration of metallic services. In direct contrast to the trends shown in Figures 7 and 8, Figure 9 indicates all other leaks causes (not including Excavation Damage) have been declining.

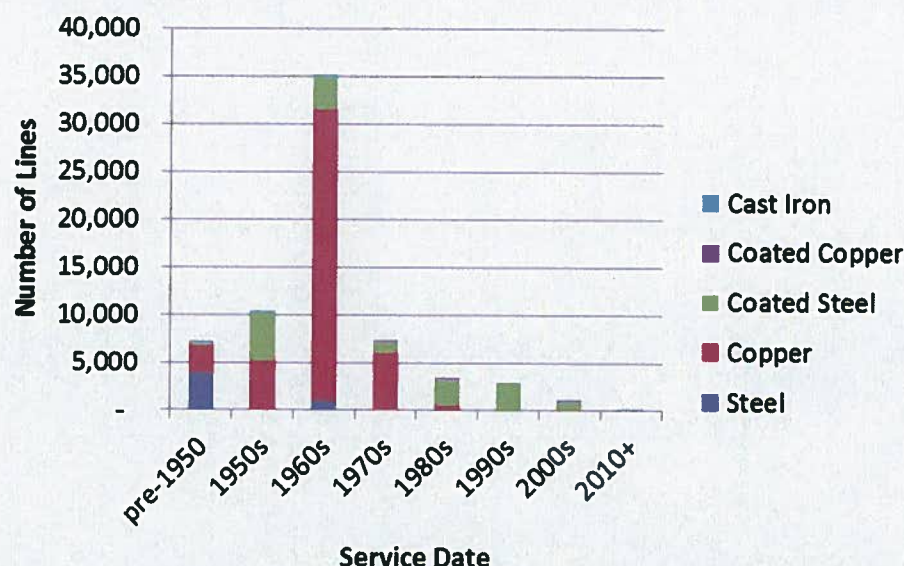
Figure 10. Service Installation Date versus Material Type – M-C Ohio Metallic Services

Figure 10 pictorially represents the installation date and associated type of metallic material that was used on service lines.

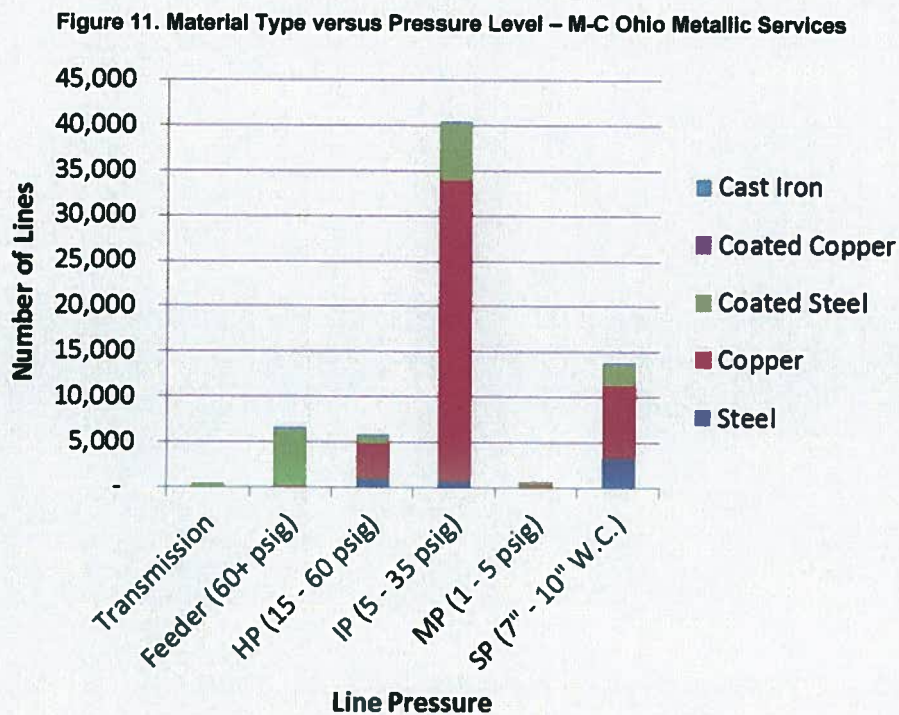
Figure 11 identifies the number of service lines with the indicated operating pressure regimes for the various types of metallic materials.

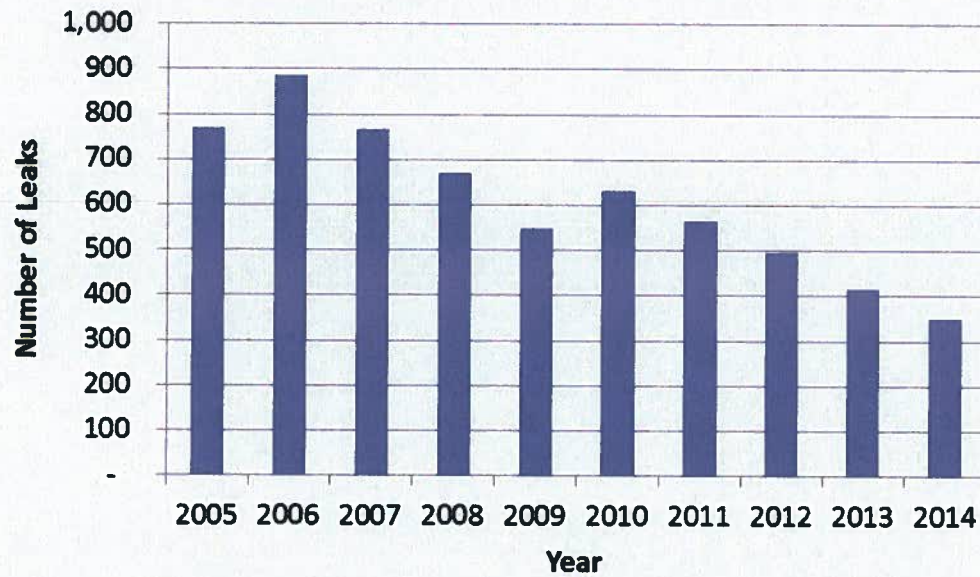
**Figure 4. Reported Leaks on Mains (2005-2014)**

13   A.    The number of reported leaks on services for 2014 was 4,174 (as shown  
14           graphically in Figure 5 in the Supplemental Report) versus 349 leaks reported on  
15           mains (as shown in Figure 4). Thus for the current year services have about  
16           twelve times the number of reported leaks that have been reported for mains.

4    A.    No. Leaks on service lines have not shown the significant decrease that has been  
5           accomplished for main leaks (see Figures 4 and 5 in the Lummus Supplement for  
6           the annual number of reported leaks on mains and services, respectively, for the  
7           time period 2005 through 2014). Over this ten-year period, annual reported leaks  
8           on mains have decreased by 55% (from 769 to 349). Over the same period,  
9           annual reported leaks on services have not shown a comparable decrease.
