## **APPENDIX B**

### Photographs

**Client Name:**  
American Electric Power (AEP)

**Project Name:**  
Poston – Lick 138kV Transmission Line Rebuild Project

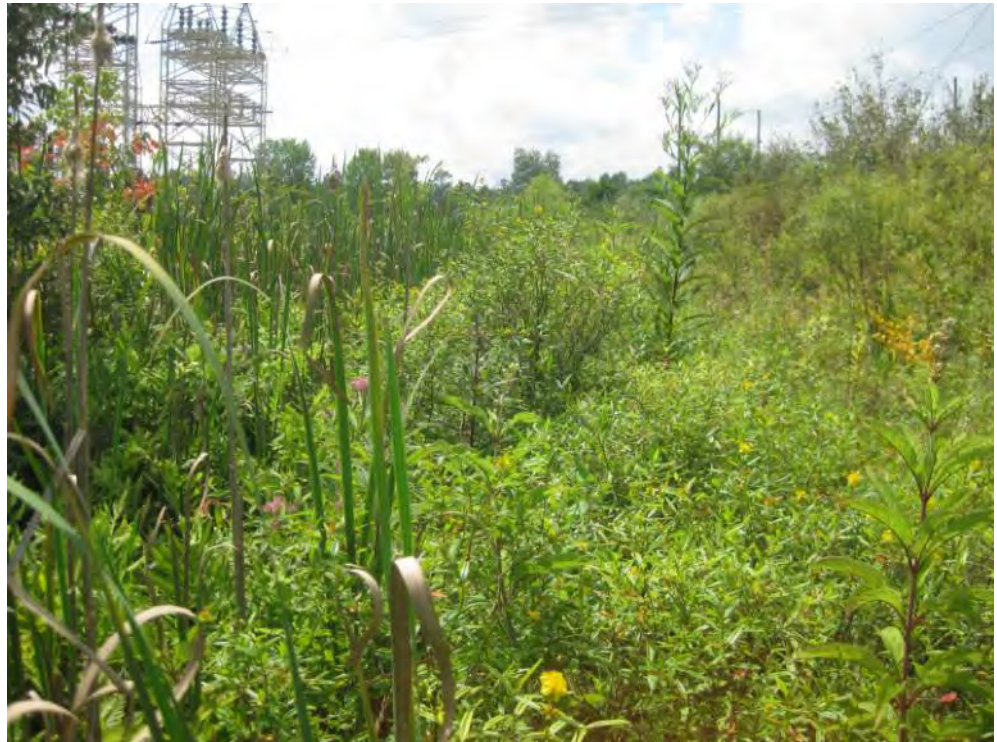
**Photo No. 1**

Wetland W1, facing west. No direct wetland impact is anticipated.

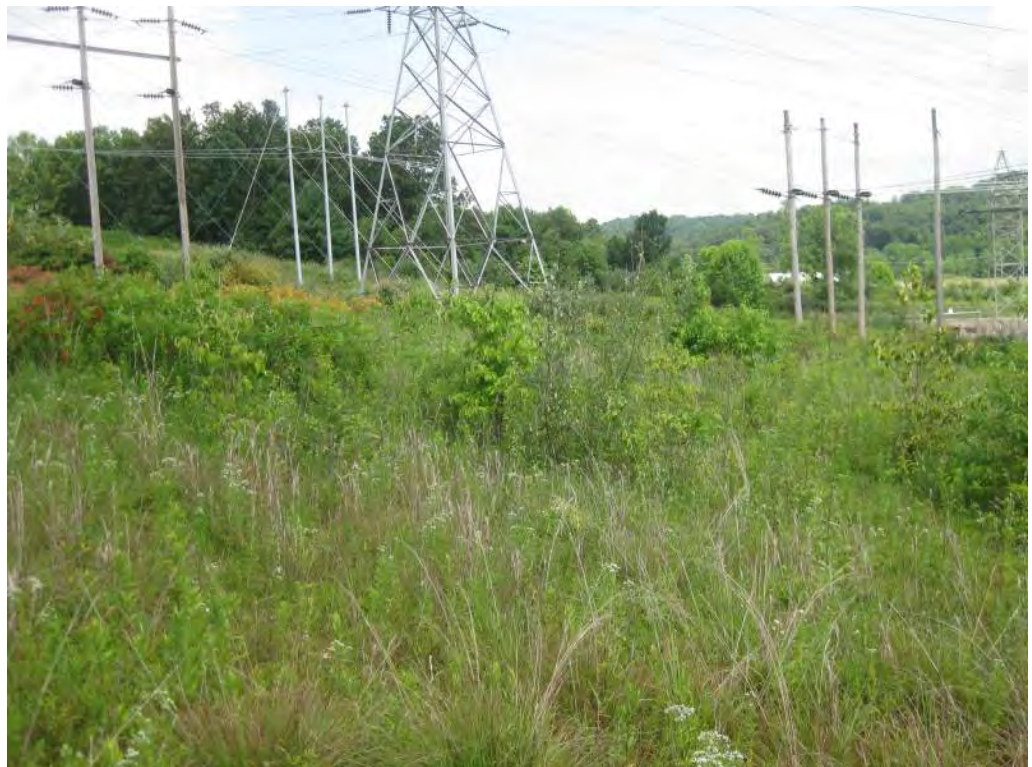
**Photo No. 2**

Ephemeral stream S1, facing east toward lattice tower 1. No direct stream impact is anticipated.

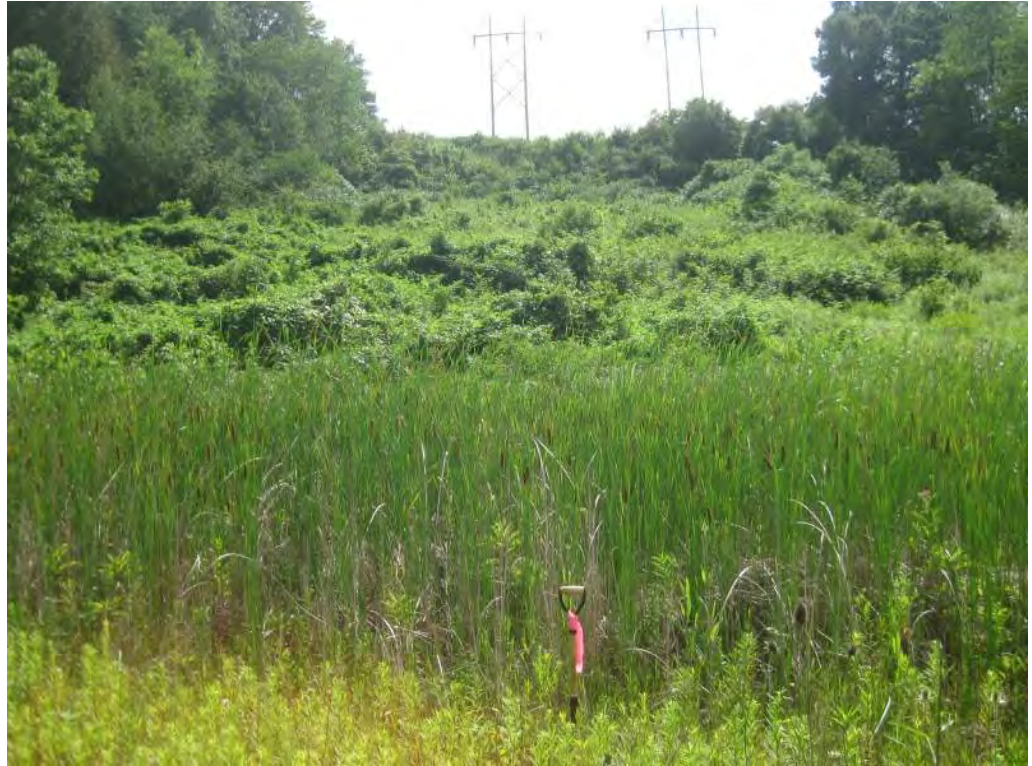
**Photo No. 3**

Wetland W2, facing southwest toward structure 1B. No direct wetland impact is anticipated.

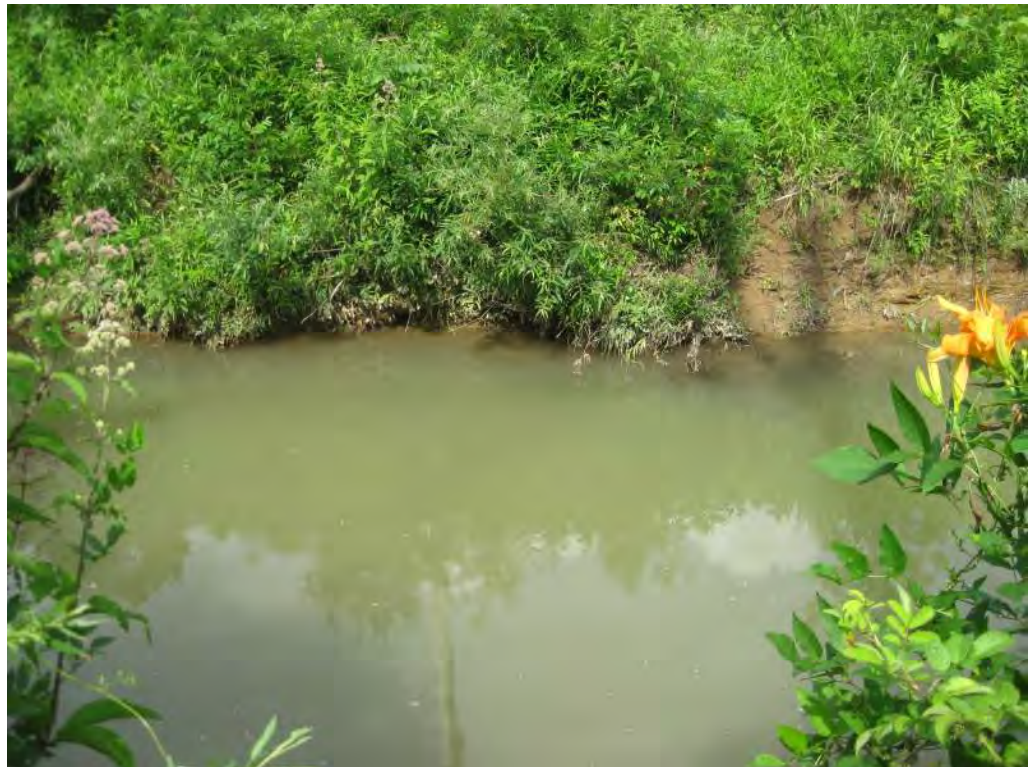
**Photo No. 4**

Perennial stream S2 (Hamley Run), facing east. No direct stream impact is anticipated.

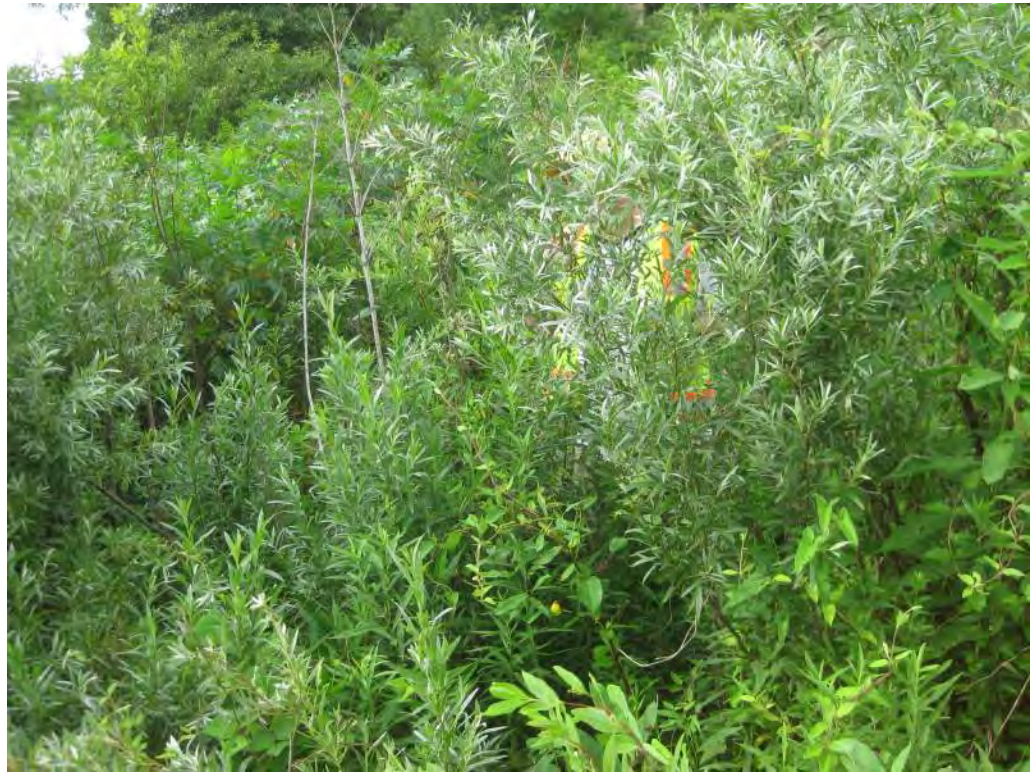
**Photo No. 5**

Perennial stream S3, facing east. No direct stream impact is anticipated.

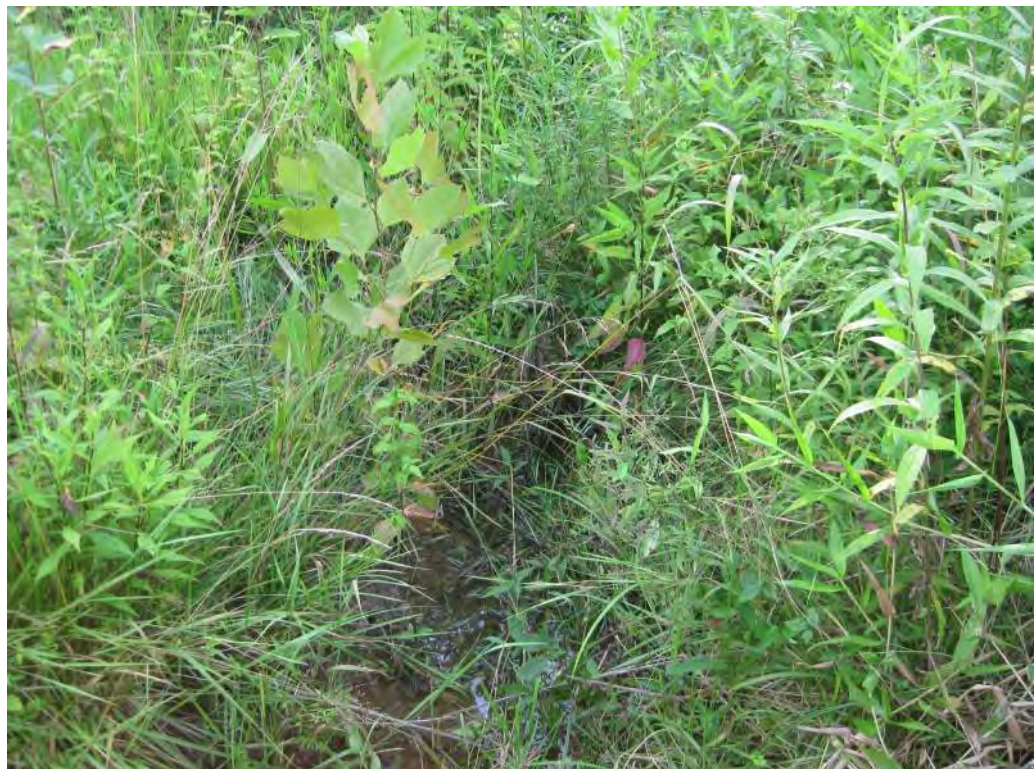
**Photo No. 6**

Intermittent stream S4, facing west. It is anticipated that this narrow stream will be crossed above the OHWM by timber mat to gain access to the locations for proposed poles 2b, 2c, and 3. No direct stream impact is anticipated.

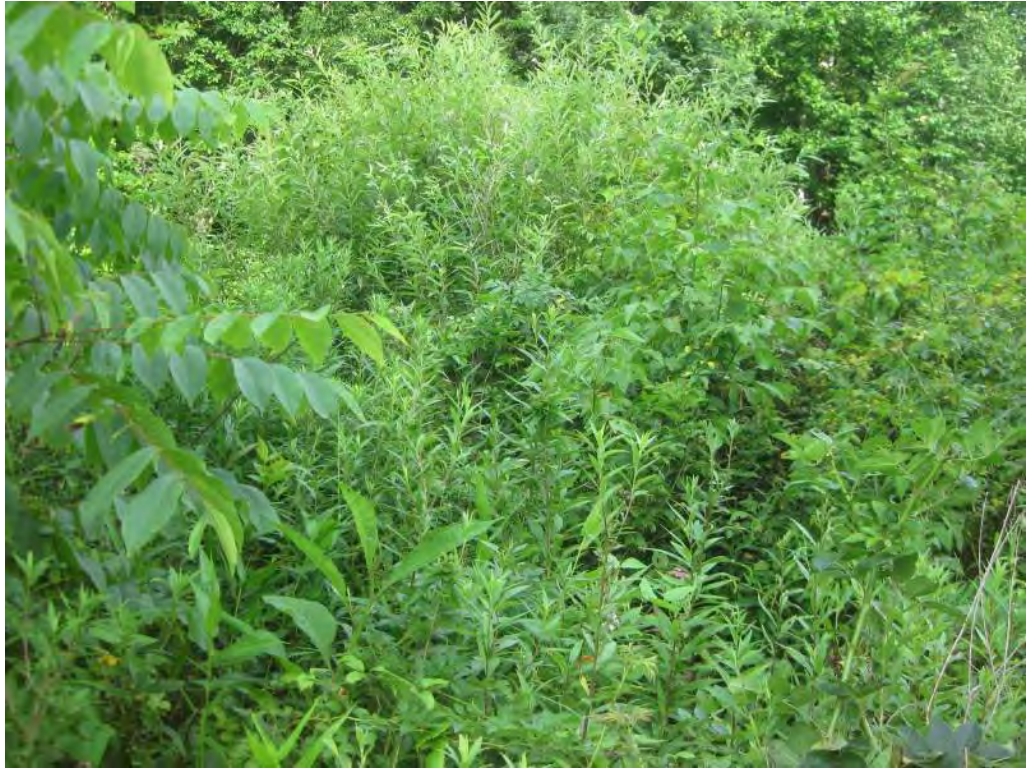
**Photo No. 9**

Wetland W3, north of proposed pole 4, facing east. No direct wetland impact is anticipated.

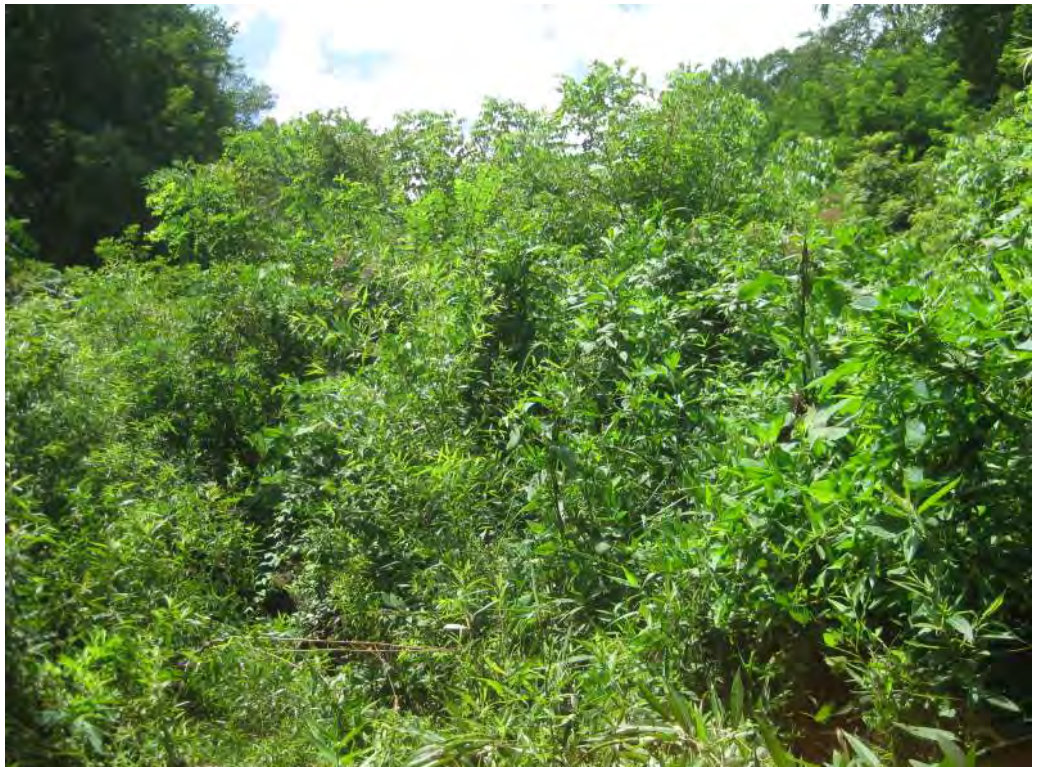
**Photo No. 10**

Wetland W4, west of proposed pole 4, facing southwest. No direct wetland impact is anticipated.

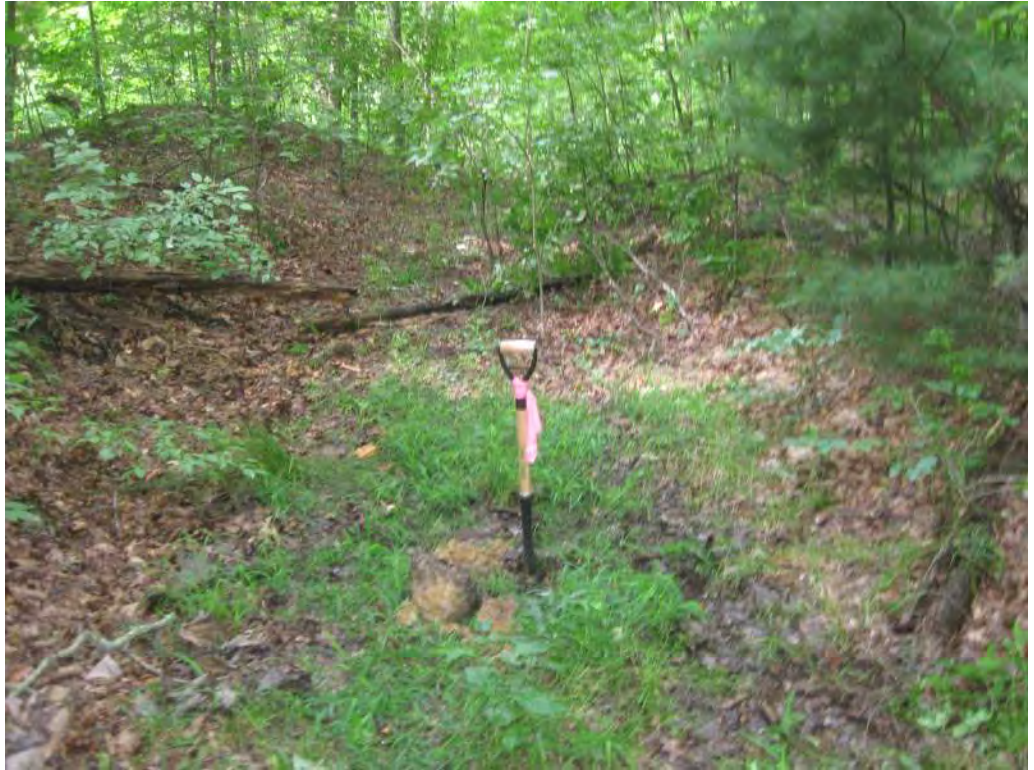
**Photo No. 11**

Wetland W5, facing south. It is anticipated that the wetland, located in the middle of an old access road, will be temporarily impacted by timber mat placed in the wetland to gain access to the location for proposed pole 4.

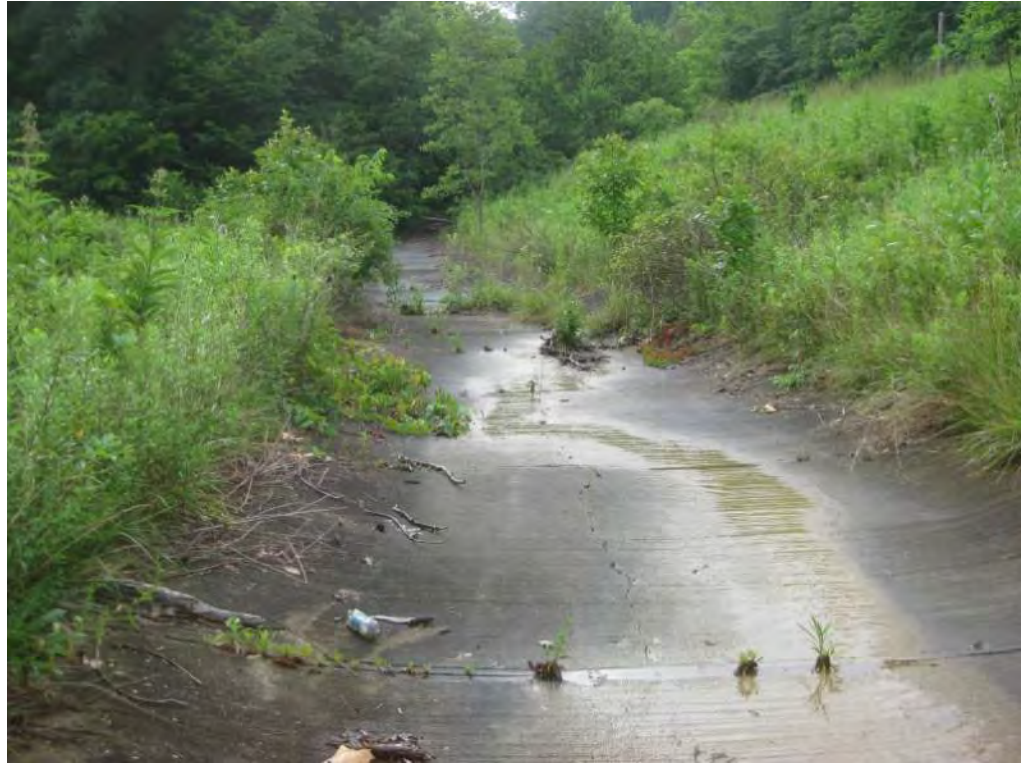
**Photo No. 13**

Ephemeral stream S8, facing east. It is anticipated that this is a non-jurisdictional, concrete stream and it will be crossed by timber mat placed in the stream to gain access to the location for proposed pole 4.

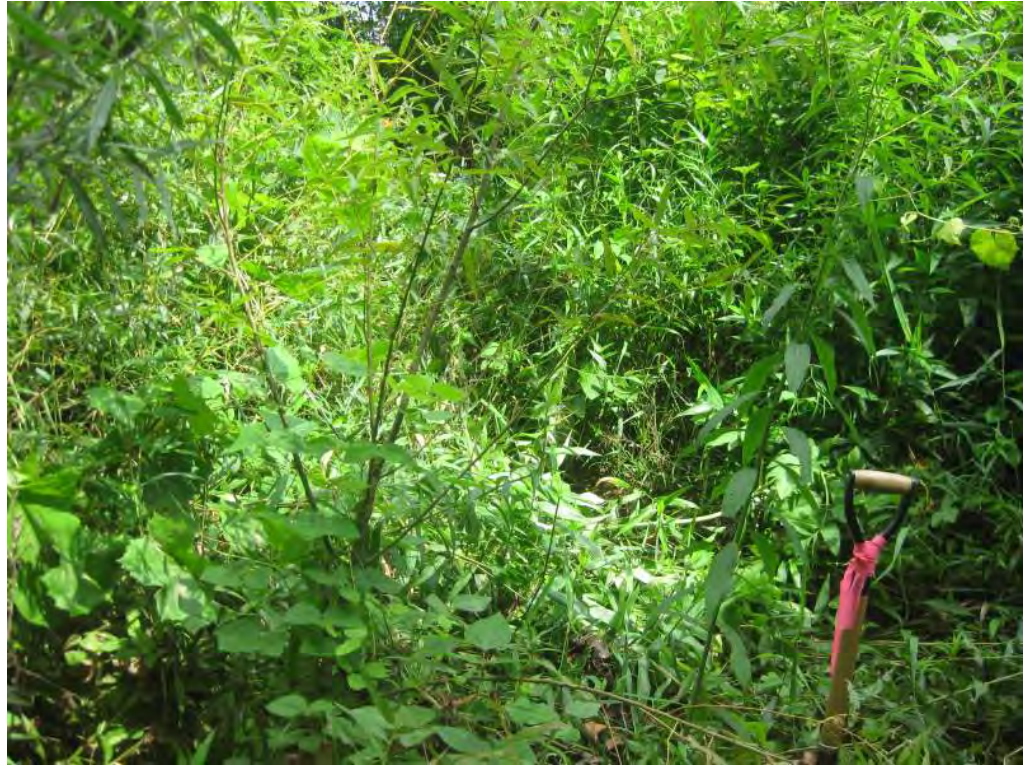
**Photo No. 15**

Wetland W6, facing northwest from S2. It is anticipated that this floodplain wetland may be permanently impacted by the installation of the south concrete foundation for proposed pole 5.

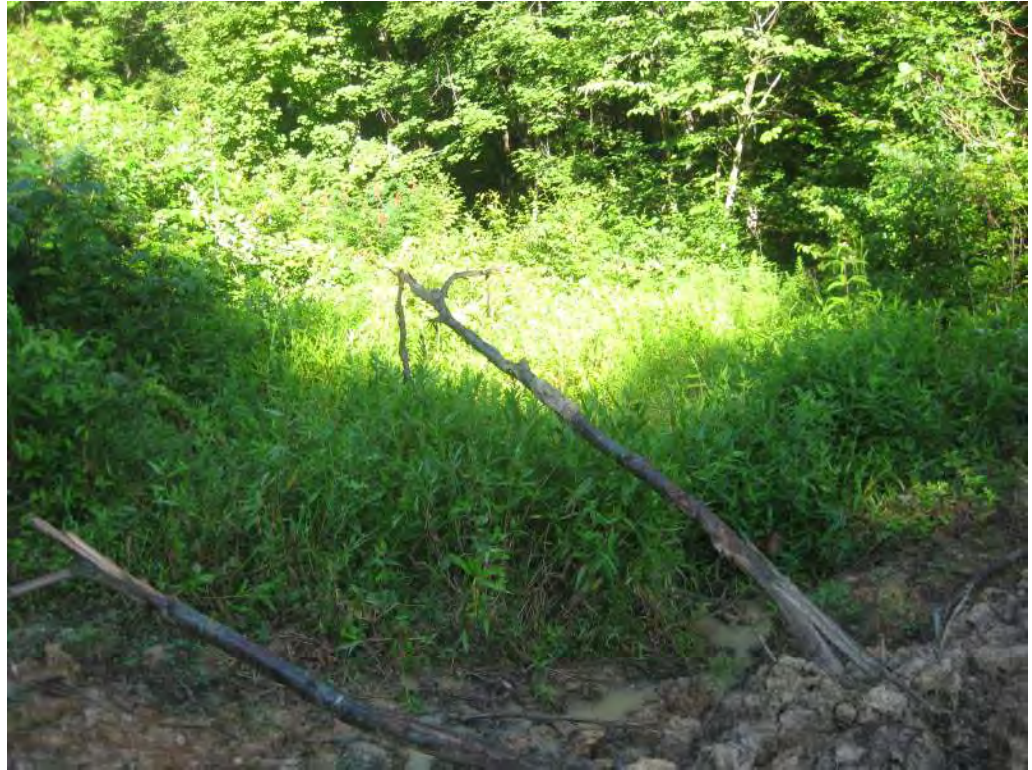
**Photo No. 21**

Ephemeral stream S13, facing southwest. No direct stream impact is anticipated. The stream appears to have been impacted by recent logging activities.

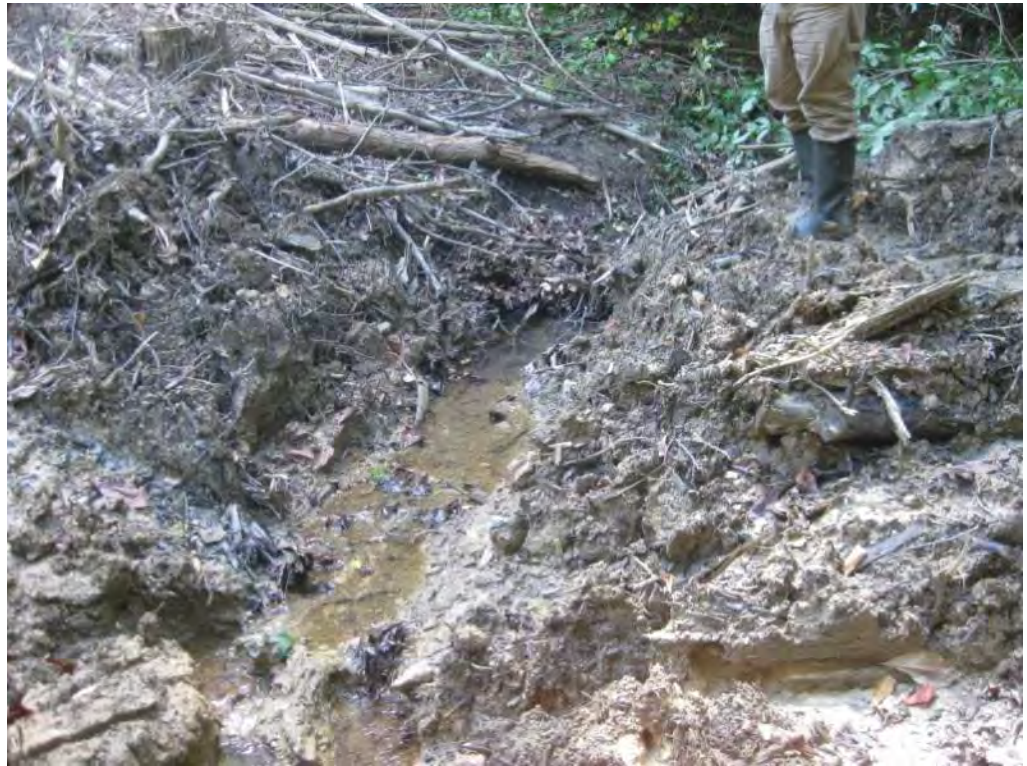
Intermittent stream S21, facing south. The stream is outside of the right of way but within a proposed access route. It is anticipated that this narrow stream will be crossed above the OHWM by timber mat to gain access to the location for proposed pole 11. The stream has been impacted by recent logging activities. No direct stream impact is anticipated.

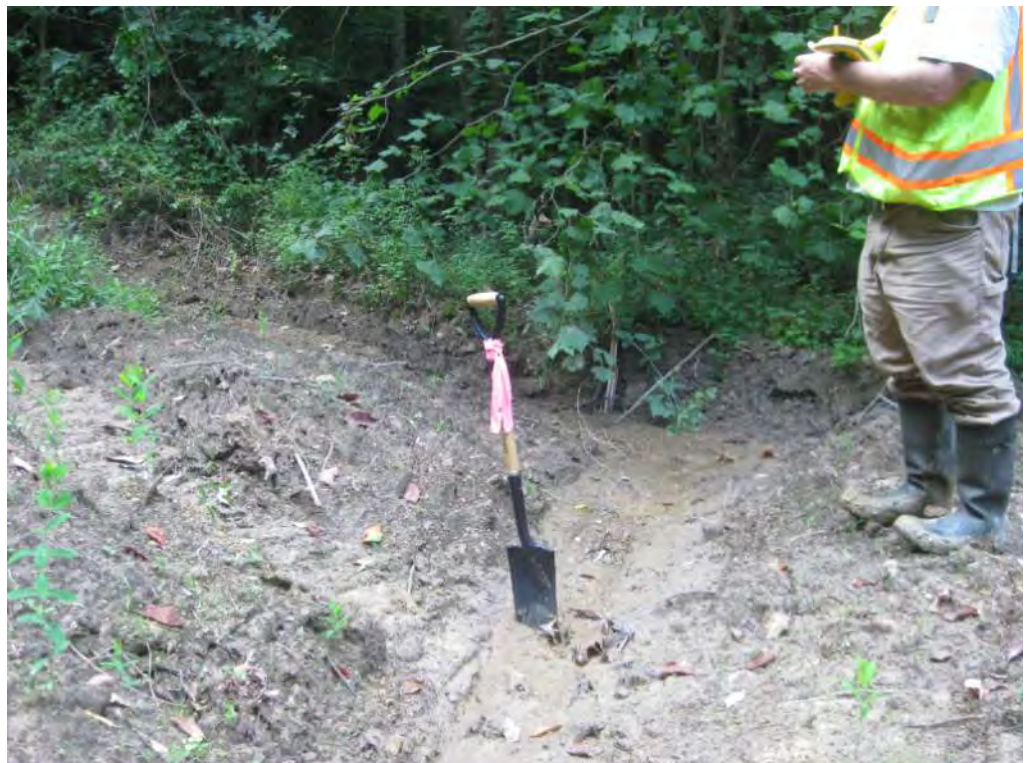
**Photo No. 30**

Ephemeral stream S22, facing east. The stream is outside of the right of way but within a proposed access route. It is anticipated that this narrow, shallow stream will be bridged by timber mat to gain access to the location for proposed pole 11. The stream has been impacted by recent logging activities. No direct stream impact is anticipated.

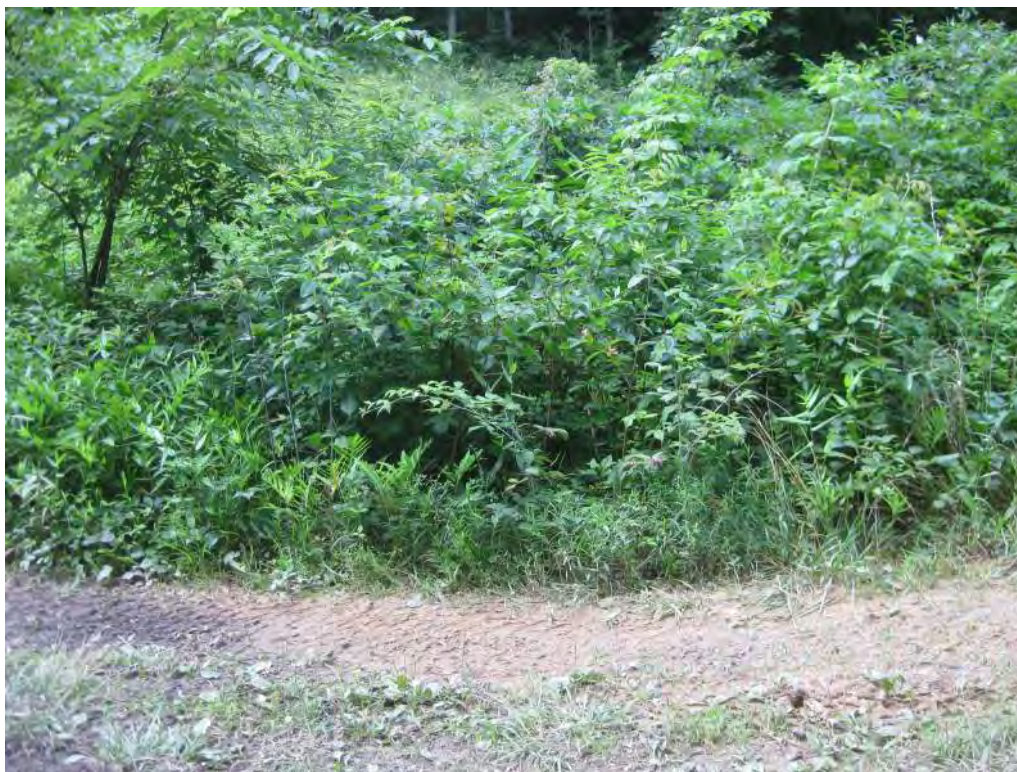
**Photo No. 34**

Ephemeral stream S25, facing north. The stream is culverted and the culverted crossing will be used to access the location for proposed pole 12. No direct stream impact is anticipated.

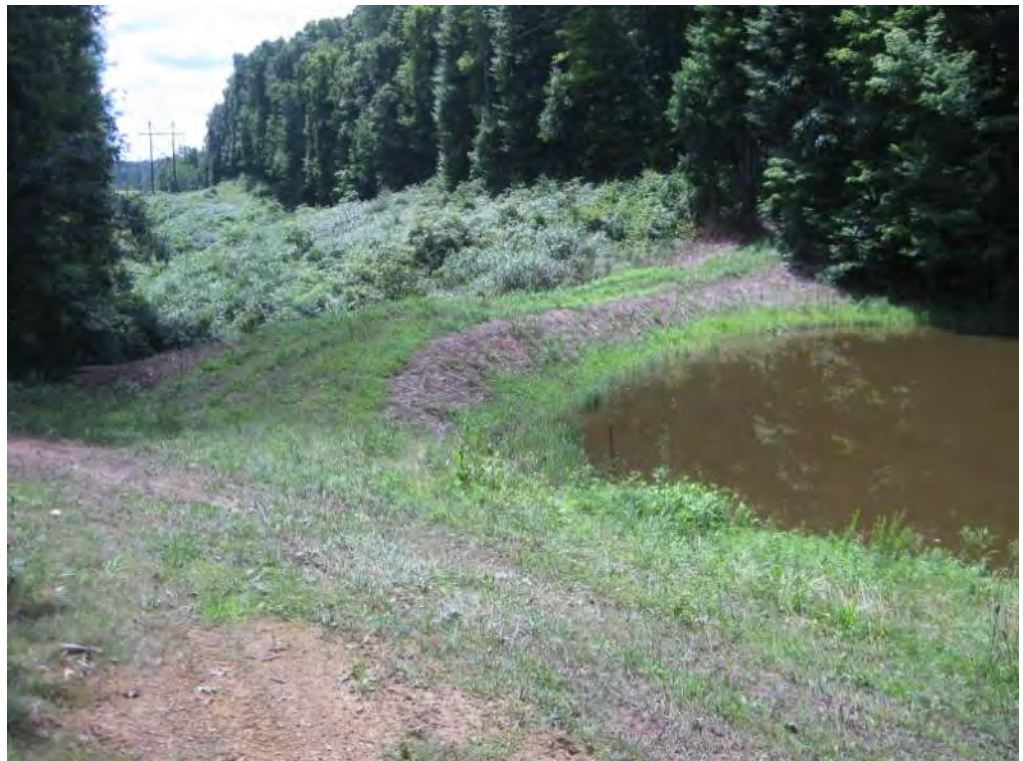
**Photo No. 36**

South side of P2, facing southwest. Wetland W9, which is in the background on the left side of the photo, accepts drainage from P2. No direct wetland impact is anticipated.

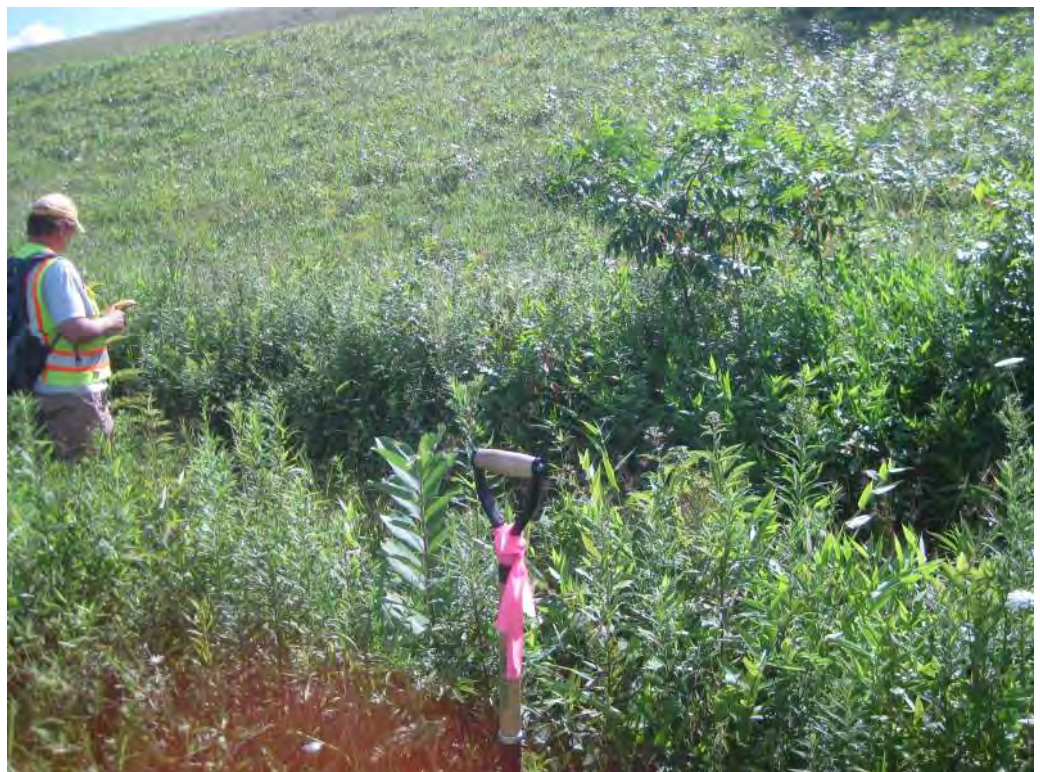
**Photo No. 38**

Intermittent stream S27, facing west. A culverted crossing of S27 located approximately 430 feet north of the surveyed point is anticipated to be used to gain access to the locations for proposed poles 17, 18, & 19. No direct stream impact is anticipated.

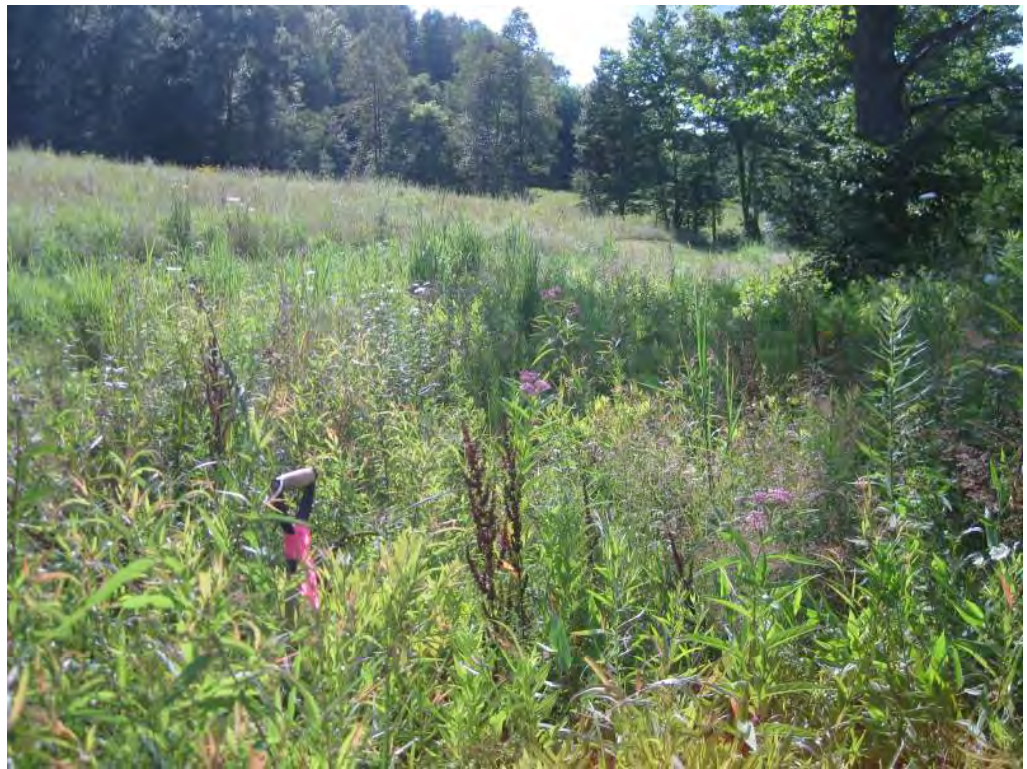
Intermittent stream S28, facing northwest. It is anticipated that this shallow stream will be bridged by timber mat to gain access to the locations for proposed poles 18 and 19. No direct stream impact is anticipated.

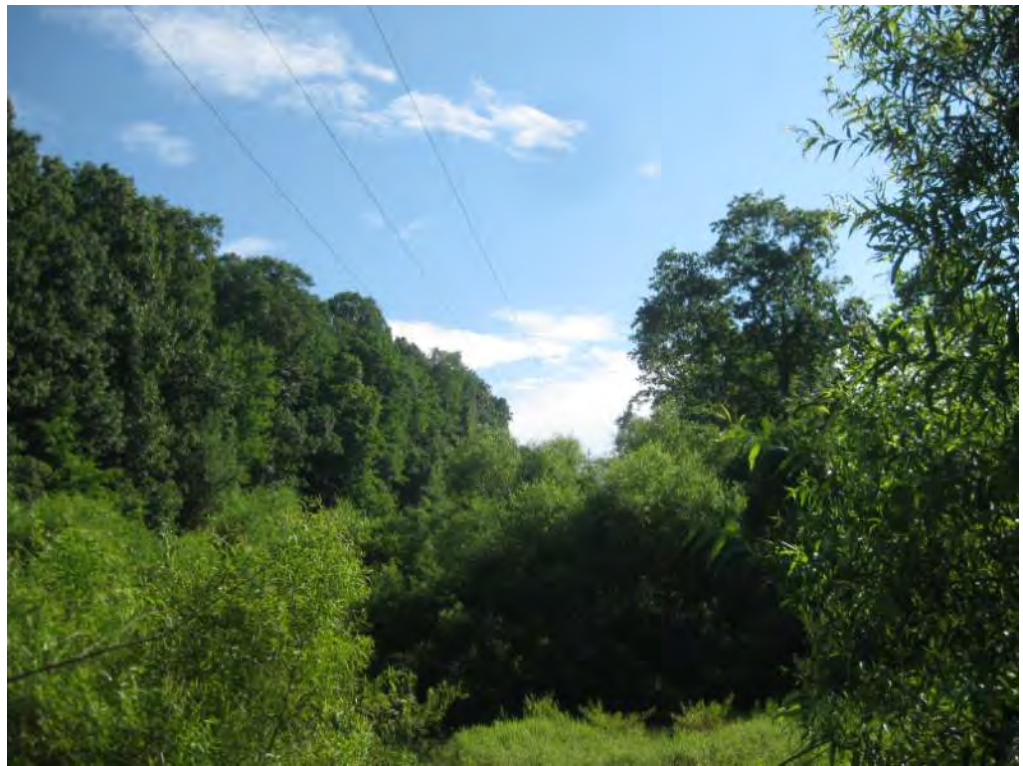
Wetland W10, facing north. This believed to be a Category 3 wetland. No direct wetland impact is anticipated.

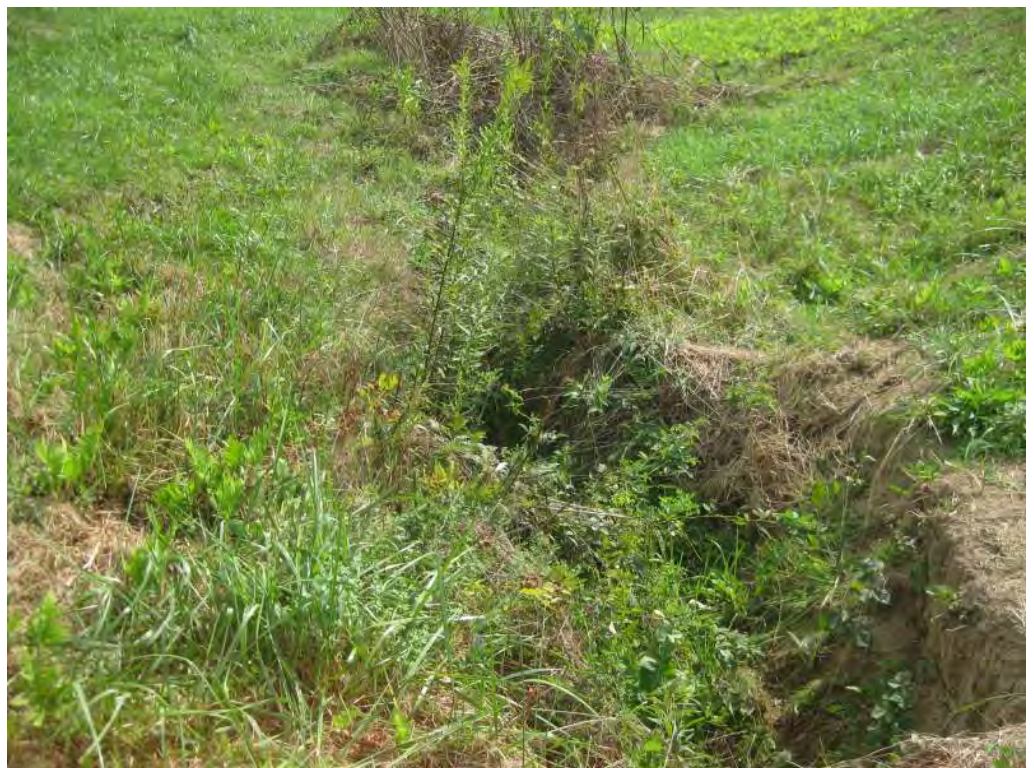
**Photo No. 46**

Ephemeral stream S34, facing southwest. The stream drains through a culvert to W11. No direct stream impact is anticipated.

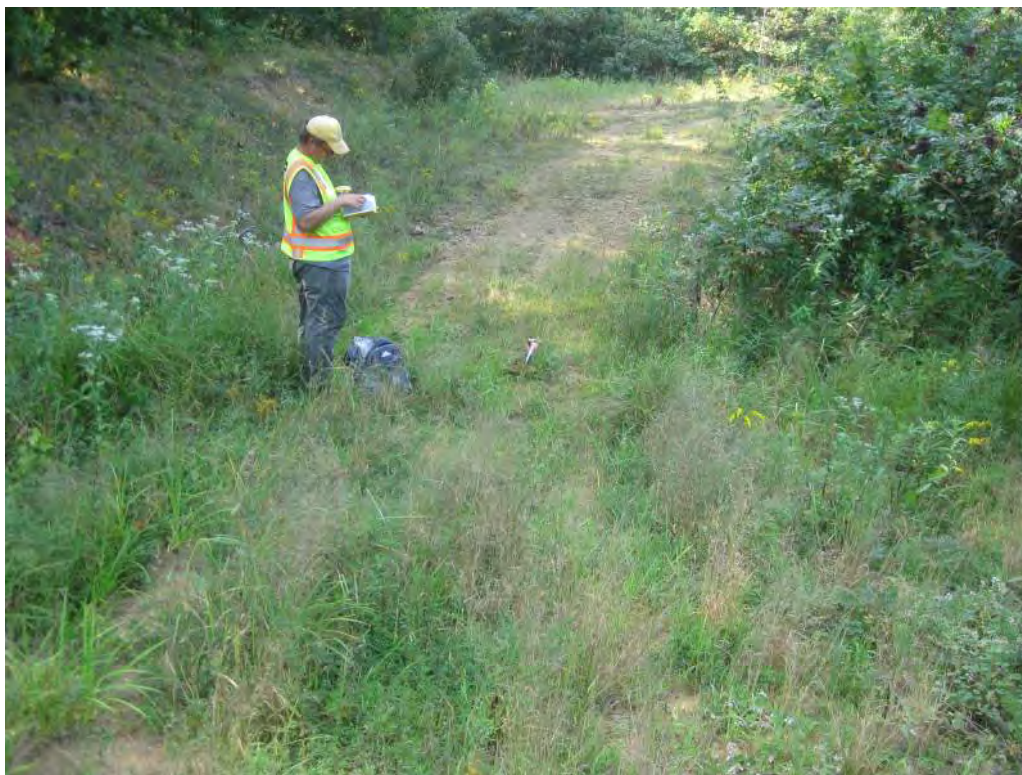
Wetland W12, facing south. The wetland drains to S35. It is anticipated that this wetland, located in the middle of an old access road, will be temporarily impacted by timber mat placed in the wetland to gain access to the locations for proposed poles 52 and 53.
