LETTER OF NOTIFICATION FOR THE
5680 - 138kV TODHUNTER TO NICKEL REBUILD

PUCO Case No. 16-1759-EL-BLN

Name of Project: Duke Energy 5680-138kV Todhunter to Nickel

Duke Energy proposes to remove and replace approximately 3.35 miles of 138 kV transmission line between the existing Todhunter Substation to the Nickel Substation, located in City of Monroe, Butler and Warren County, Ohio. The proposed project area consists of approximately 3.35 miles of existing 90-foot wide Duke Energy transmission line corridor Right-Of-Way (ROW), and includes the replacement of twenty nine (29) structures. The Project begins at Duke Energy's Todhunter Station located south of Todhunter Road and west of Wicklow Lane Butler County, OH (39.454930, -84.376347) and terminates at Duke Energy's Nickel Station, Warren County, OH (39.426871, -84.426871).

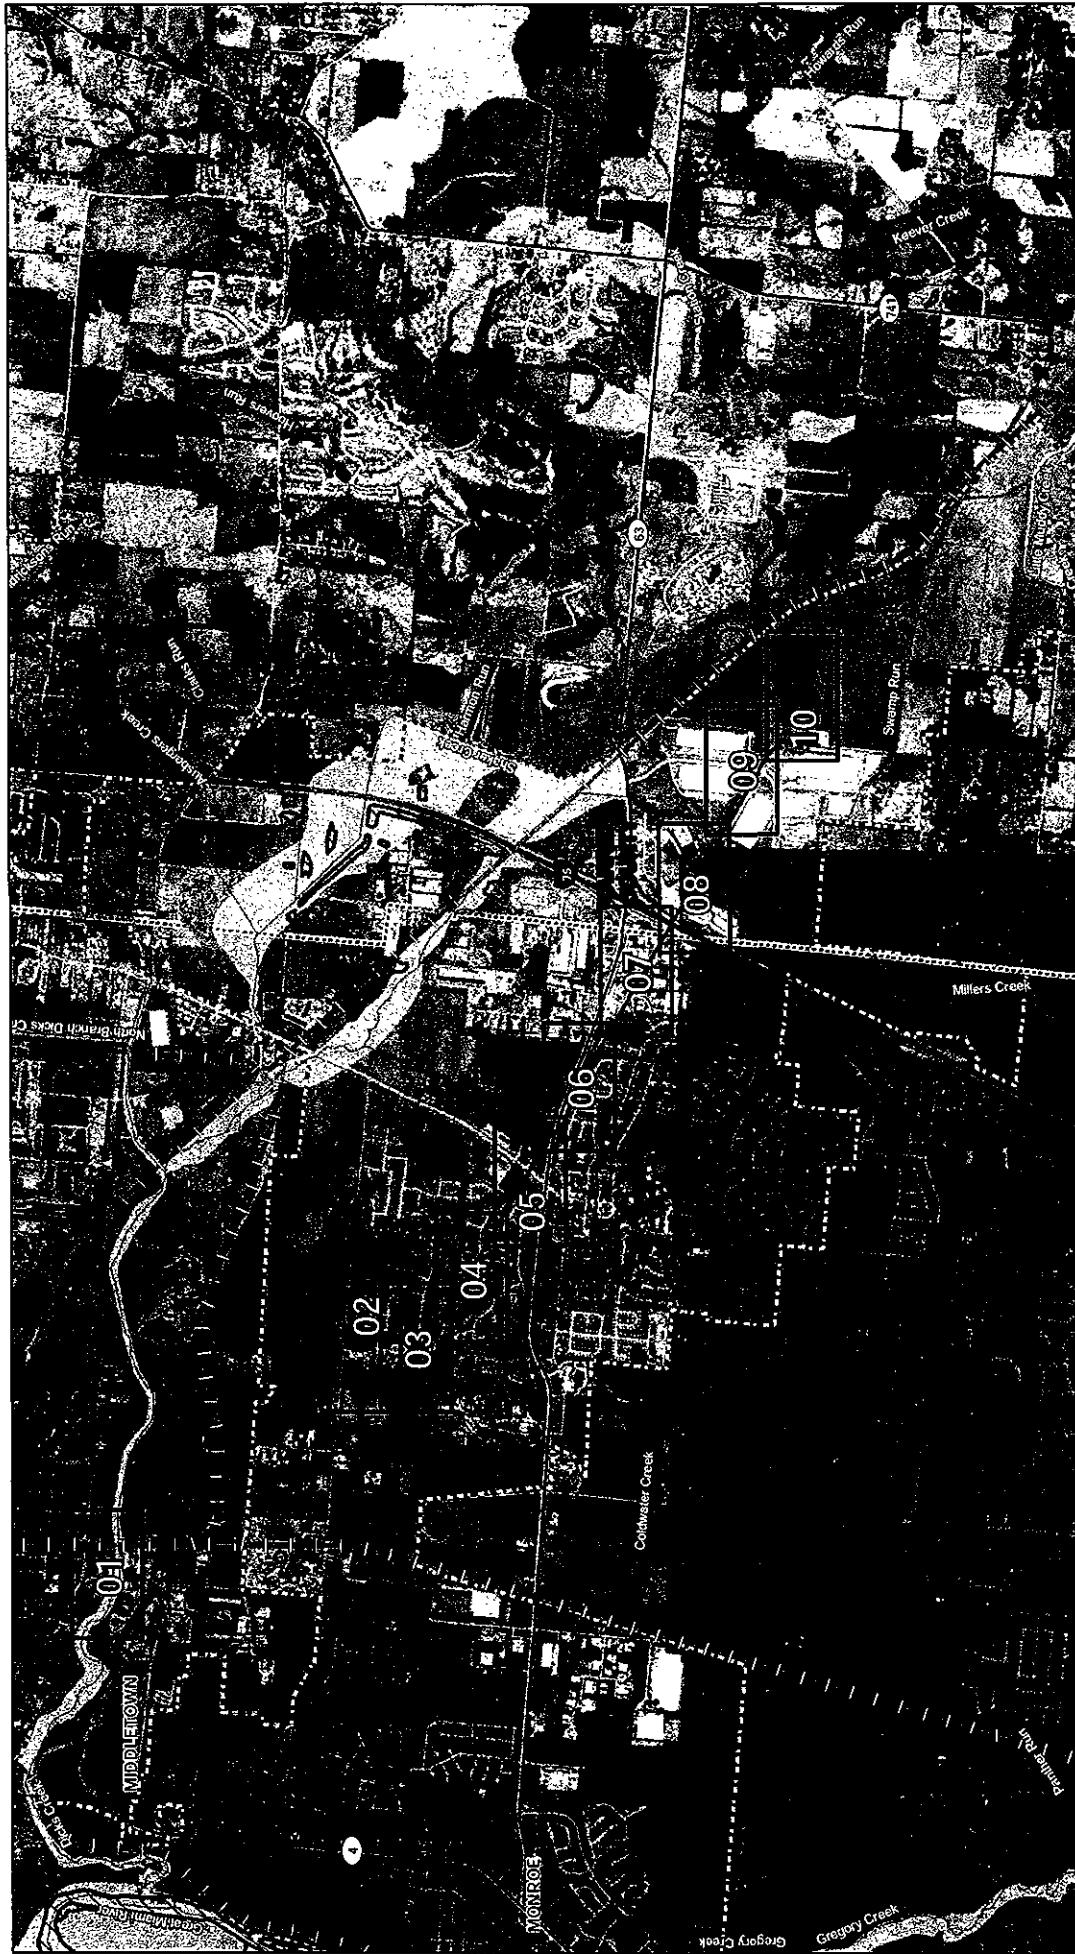
FIGURE 2

OPSB LETTER NOTIFICATION
5680 138KV TODHUNTER TO NICKEL REBUILD
DUKE ENERGY
ENVIRONMENTAL ACCESS INDEX SHEET

As a part of the investigation Cardno identified 100 year floodplains using the FEMA National Flood Hazard Layer within the Project Area. Appendix A, Figure 2 depicts the location of the 100 year floodplains in relation to the Project Area. No changes in flood elevations are anticipated in the identified floodplain. Confirmation was received from the designated Floodplain Administrator for the City of Monroe, its Public Works & Utilities Director, Daniel J. Arthur stating that the project is exempt from floodplain permit requirements due to the limited project footprint (See Appendix D)

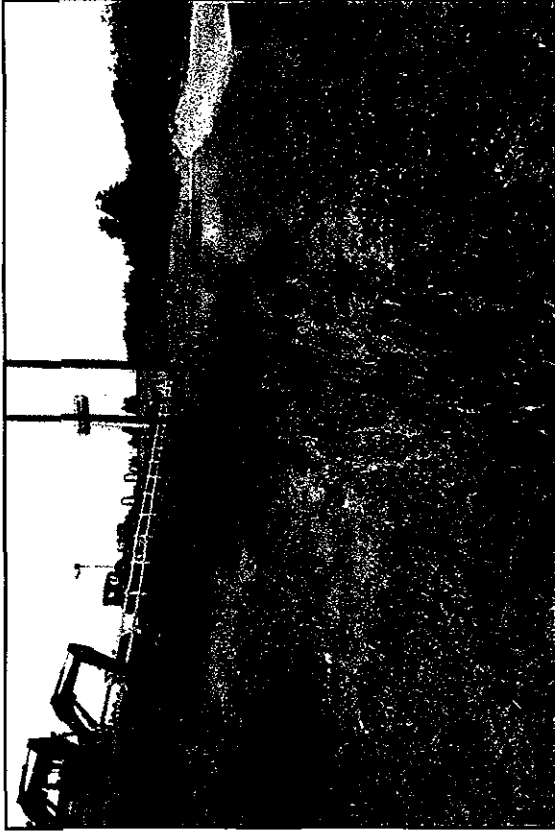
Photo 2: View of upland Wetland 2, facing southwest.

Dominant vegetation within these wetlands included Kentucky Blue Grass (*Poa pratensis*, FAC), and Hybrid Cattail (*Typha X glauca*, OBL). In addition, non-dominant vegetation observed included Single-Vein Sweetflag (*Acorus calamus*, OBL), Blunt Spike-Rush (*Eleocharis obtusa*, OBL), Dark-Green Bulrush (*Scirpus atrovirens*, OBL), Curly Dock (*Rumex crispus*, FAC), and Common Fox Sedge (*Carex vulpinoidea*, FACW). The soil within these wetlands were mapped as Dana Silt Loam (Da), and met the Depleted Matrix (F3), and Redox Depressions (F8) hydric soil criteria. Primary indicators of hydrology included Saturation (A3), and secondary indicators of hydrology observed included Drainage Patterns (B10), Geomorphic Position (D2), and the FAC-Neutral Test (D5). DP03 represents Wetland 2 and Wetland 3 located in a low area adjacent to Lebanon Road.
