AEP OHIO TRANSMISSION COMPANY Glencoe Station Expansion Project

GLENCOE STATION EXPANSION PROJECT, BELMONT COUNTY, OHIO

SOCIOECONOMIC, LAND USE, AND AGRICULTURAL DISTRICT REVIEW REPORT

RARE, THREATENED, AND ENDANGERED SPECIES SURVEY REPORT

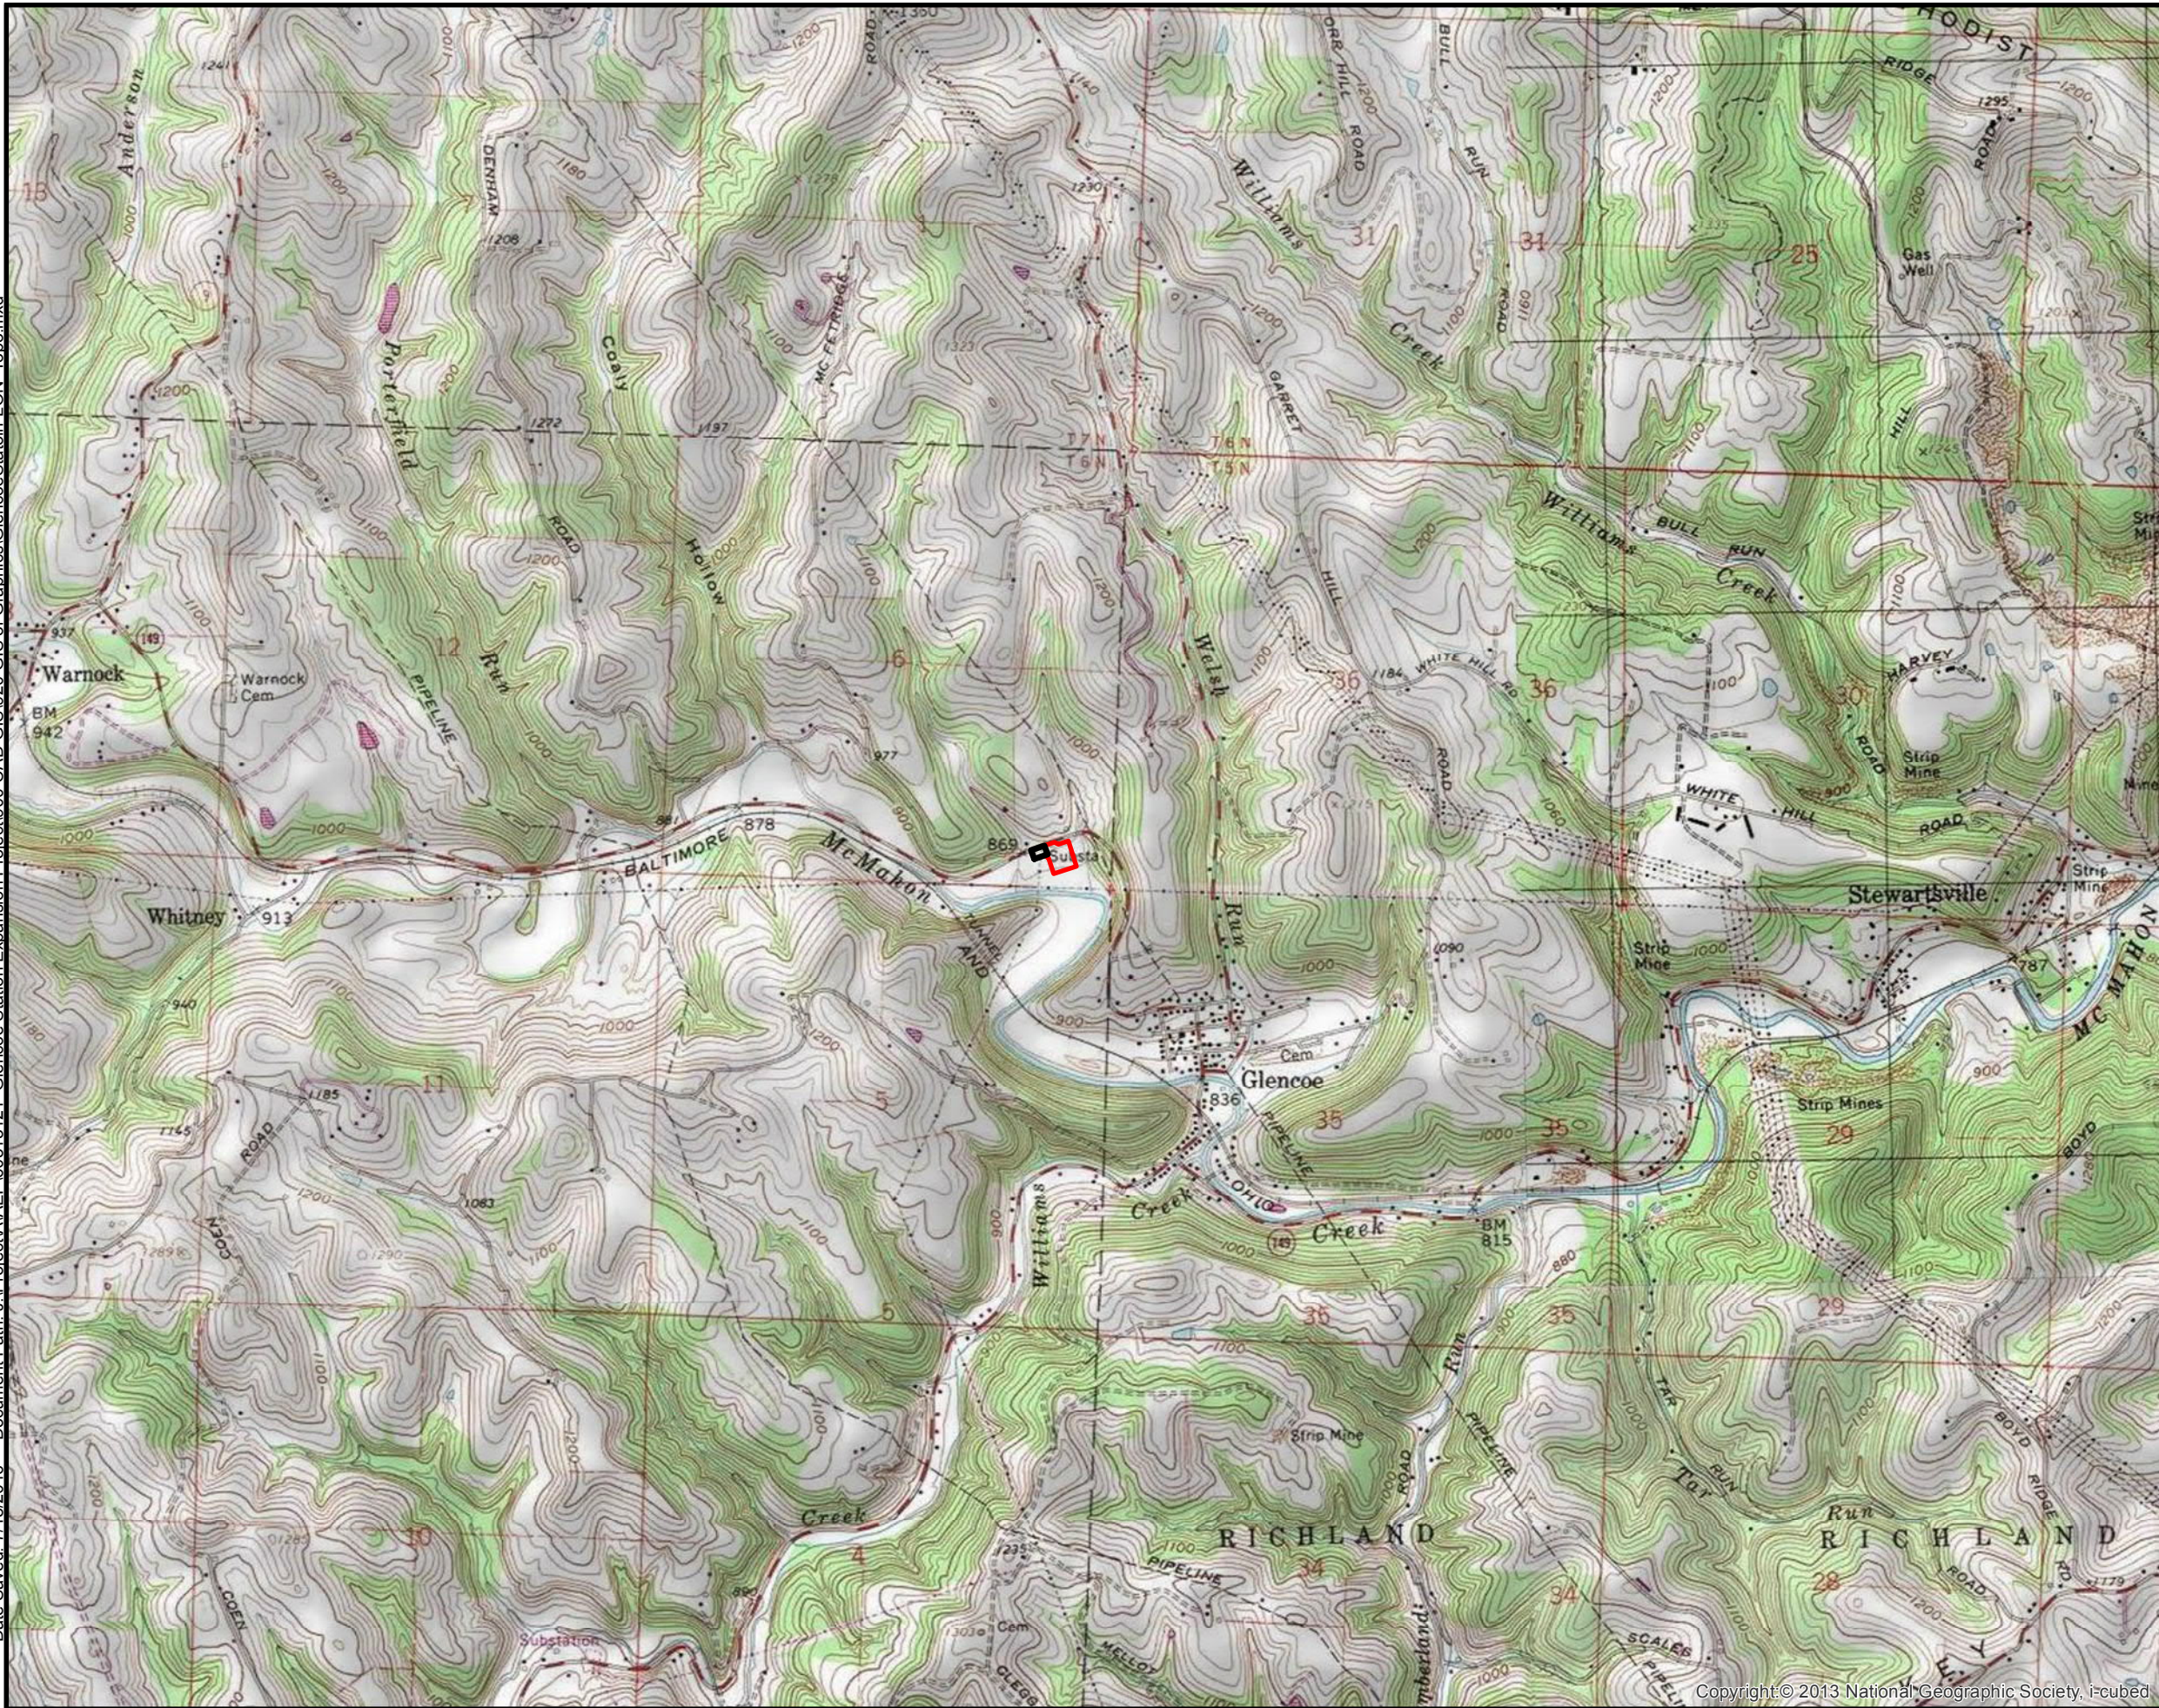
FIGURE 1
PROJECT OVERVIEW

- LEGEND:
- Existing Glencoe Station
 - Proposed Expansion Area

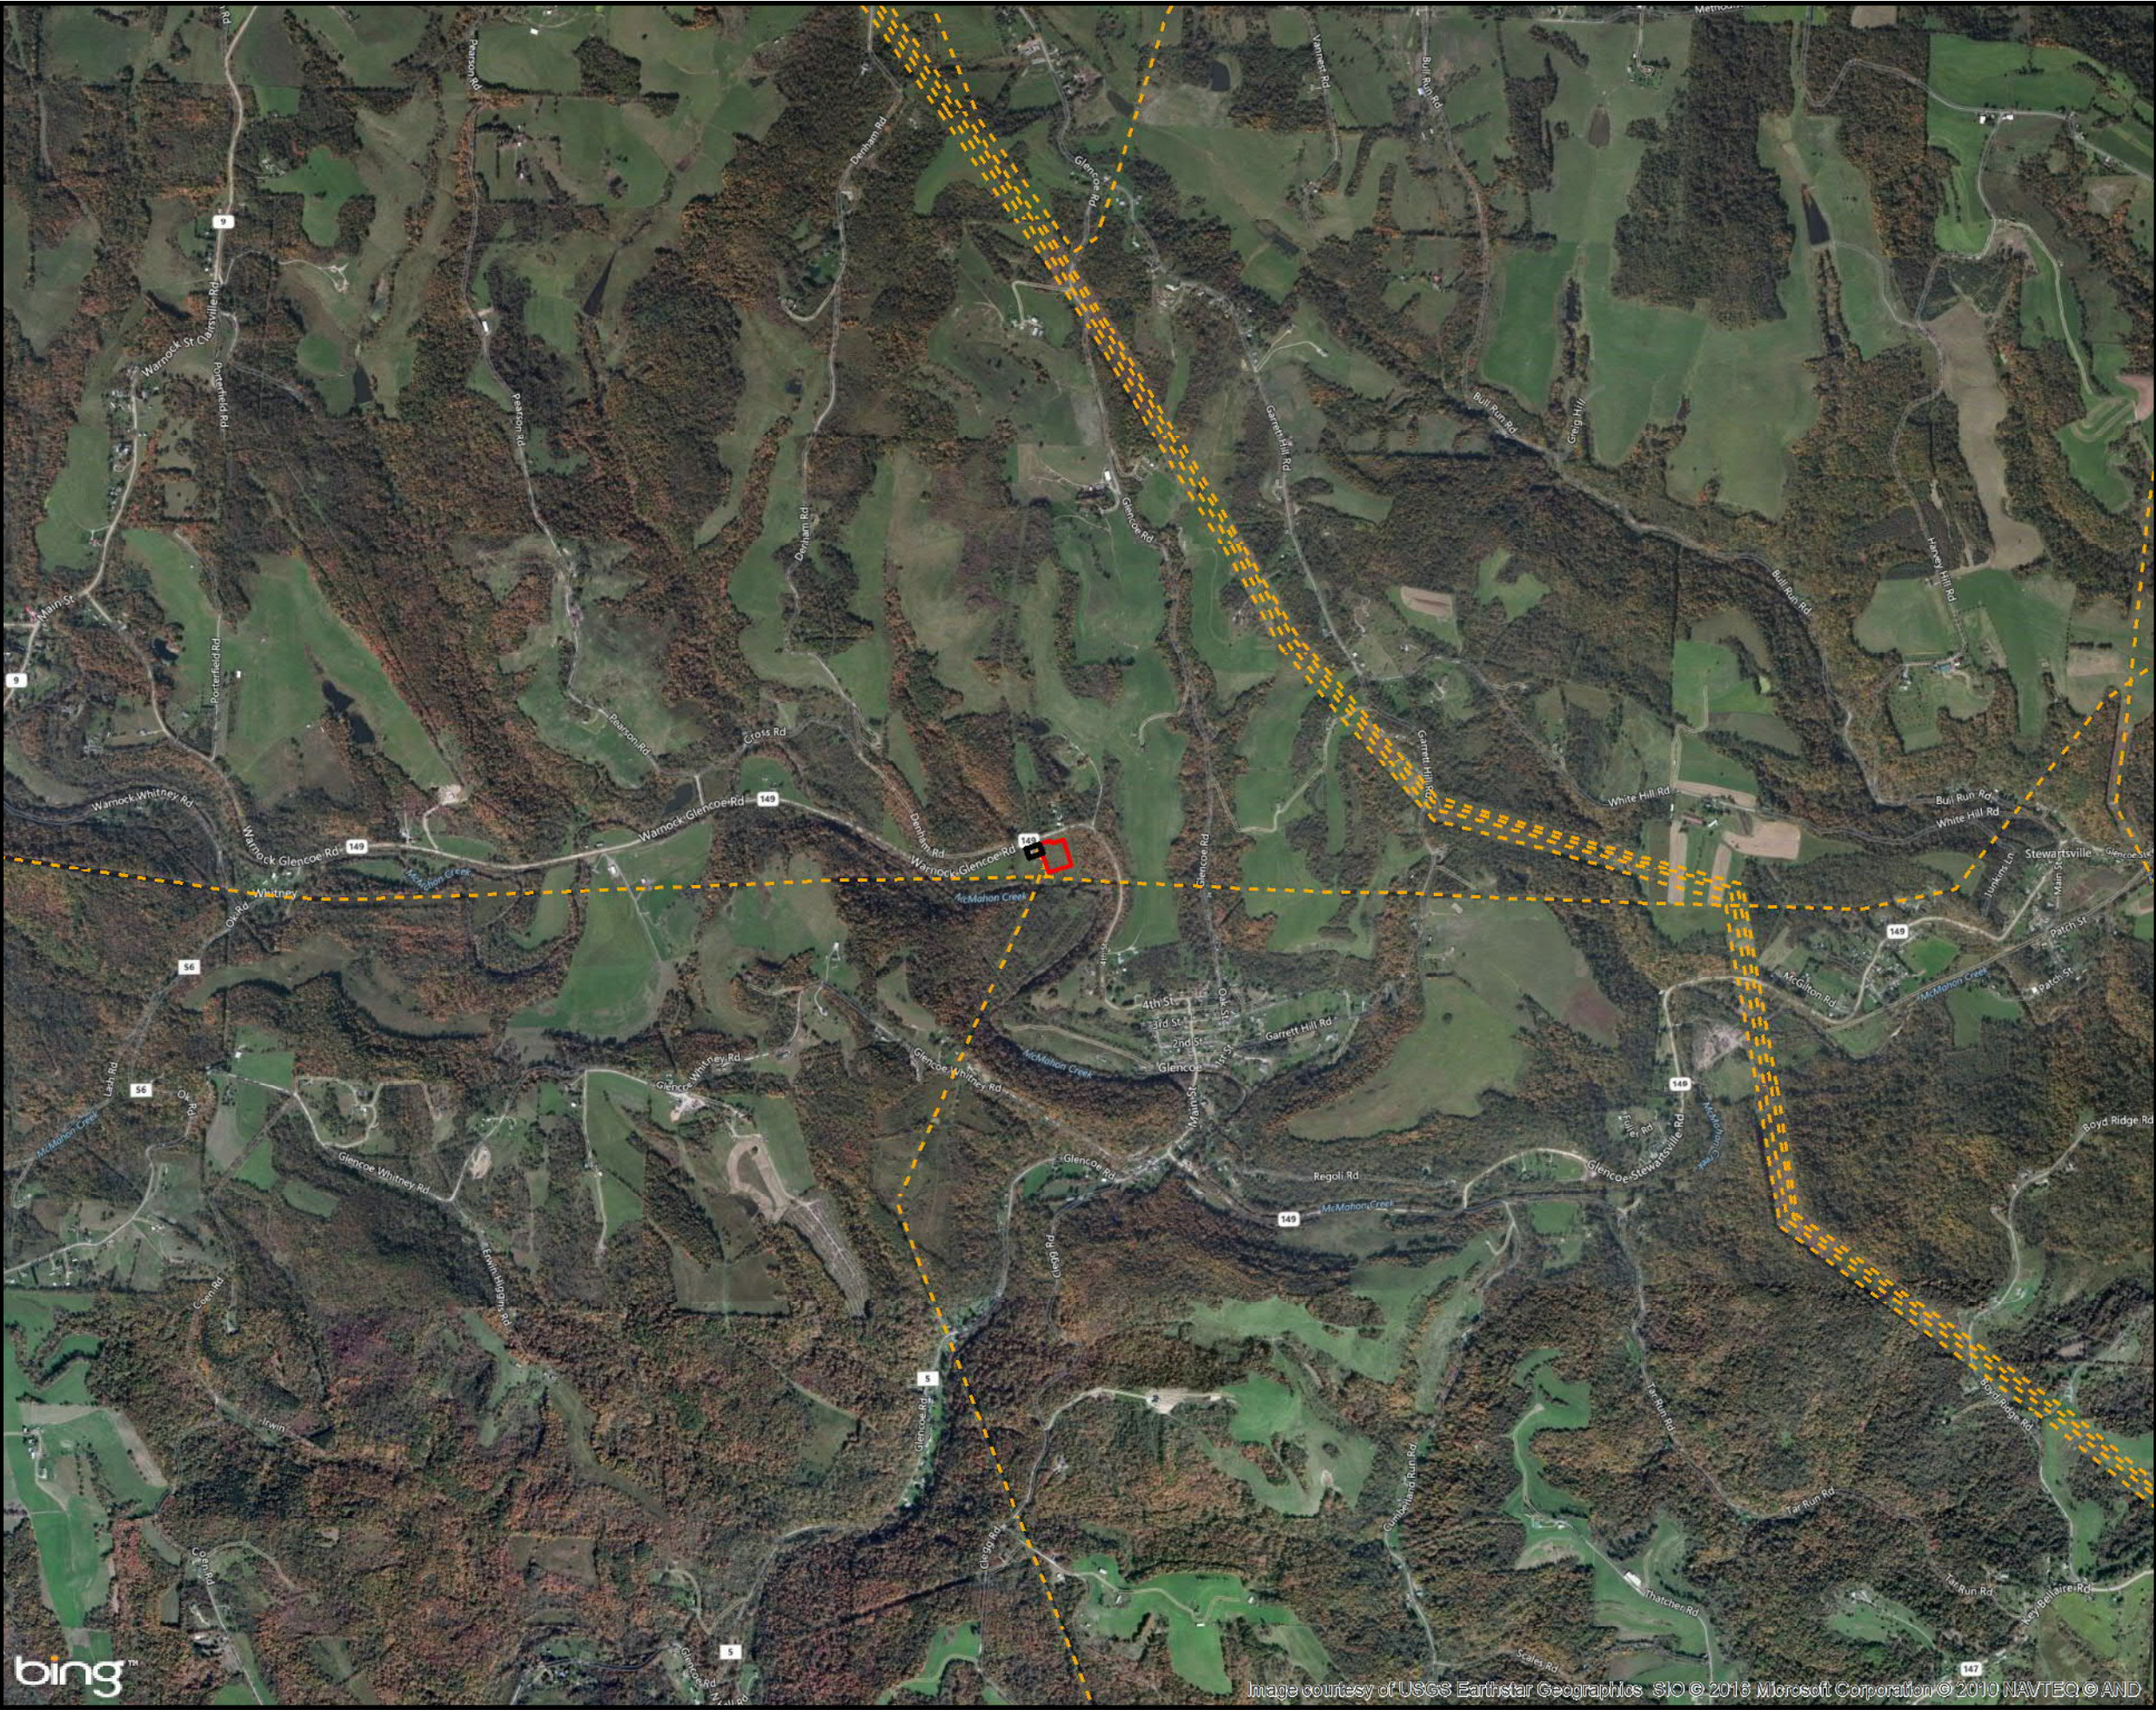
FIGURE 2
AERIAL PHOTOGRAPHY OF
THE PROJECT VICINITY

- LEGEND:
- Existing Glencoe Station
 - Proposed Expansion Area
 - Existing Transmission Line

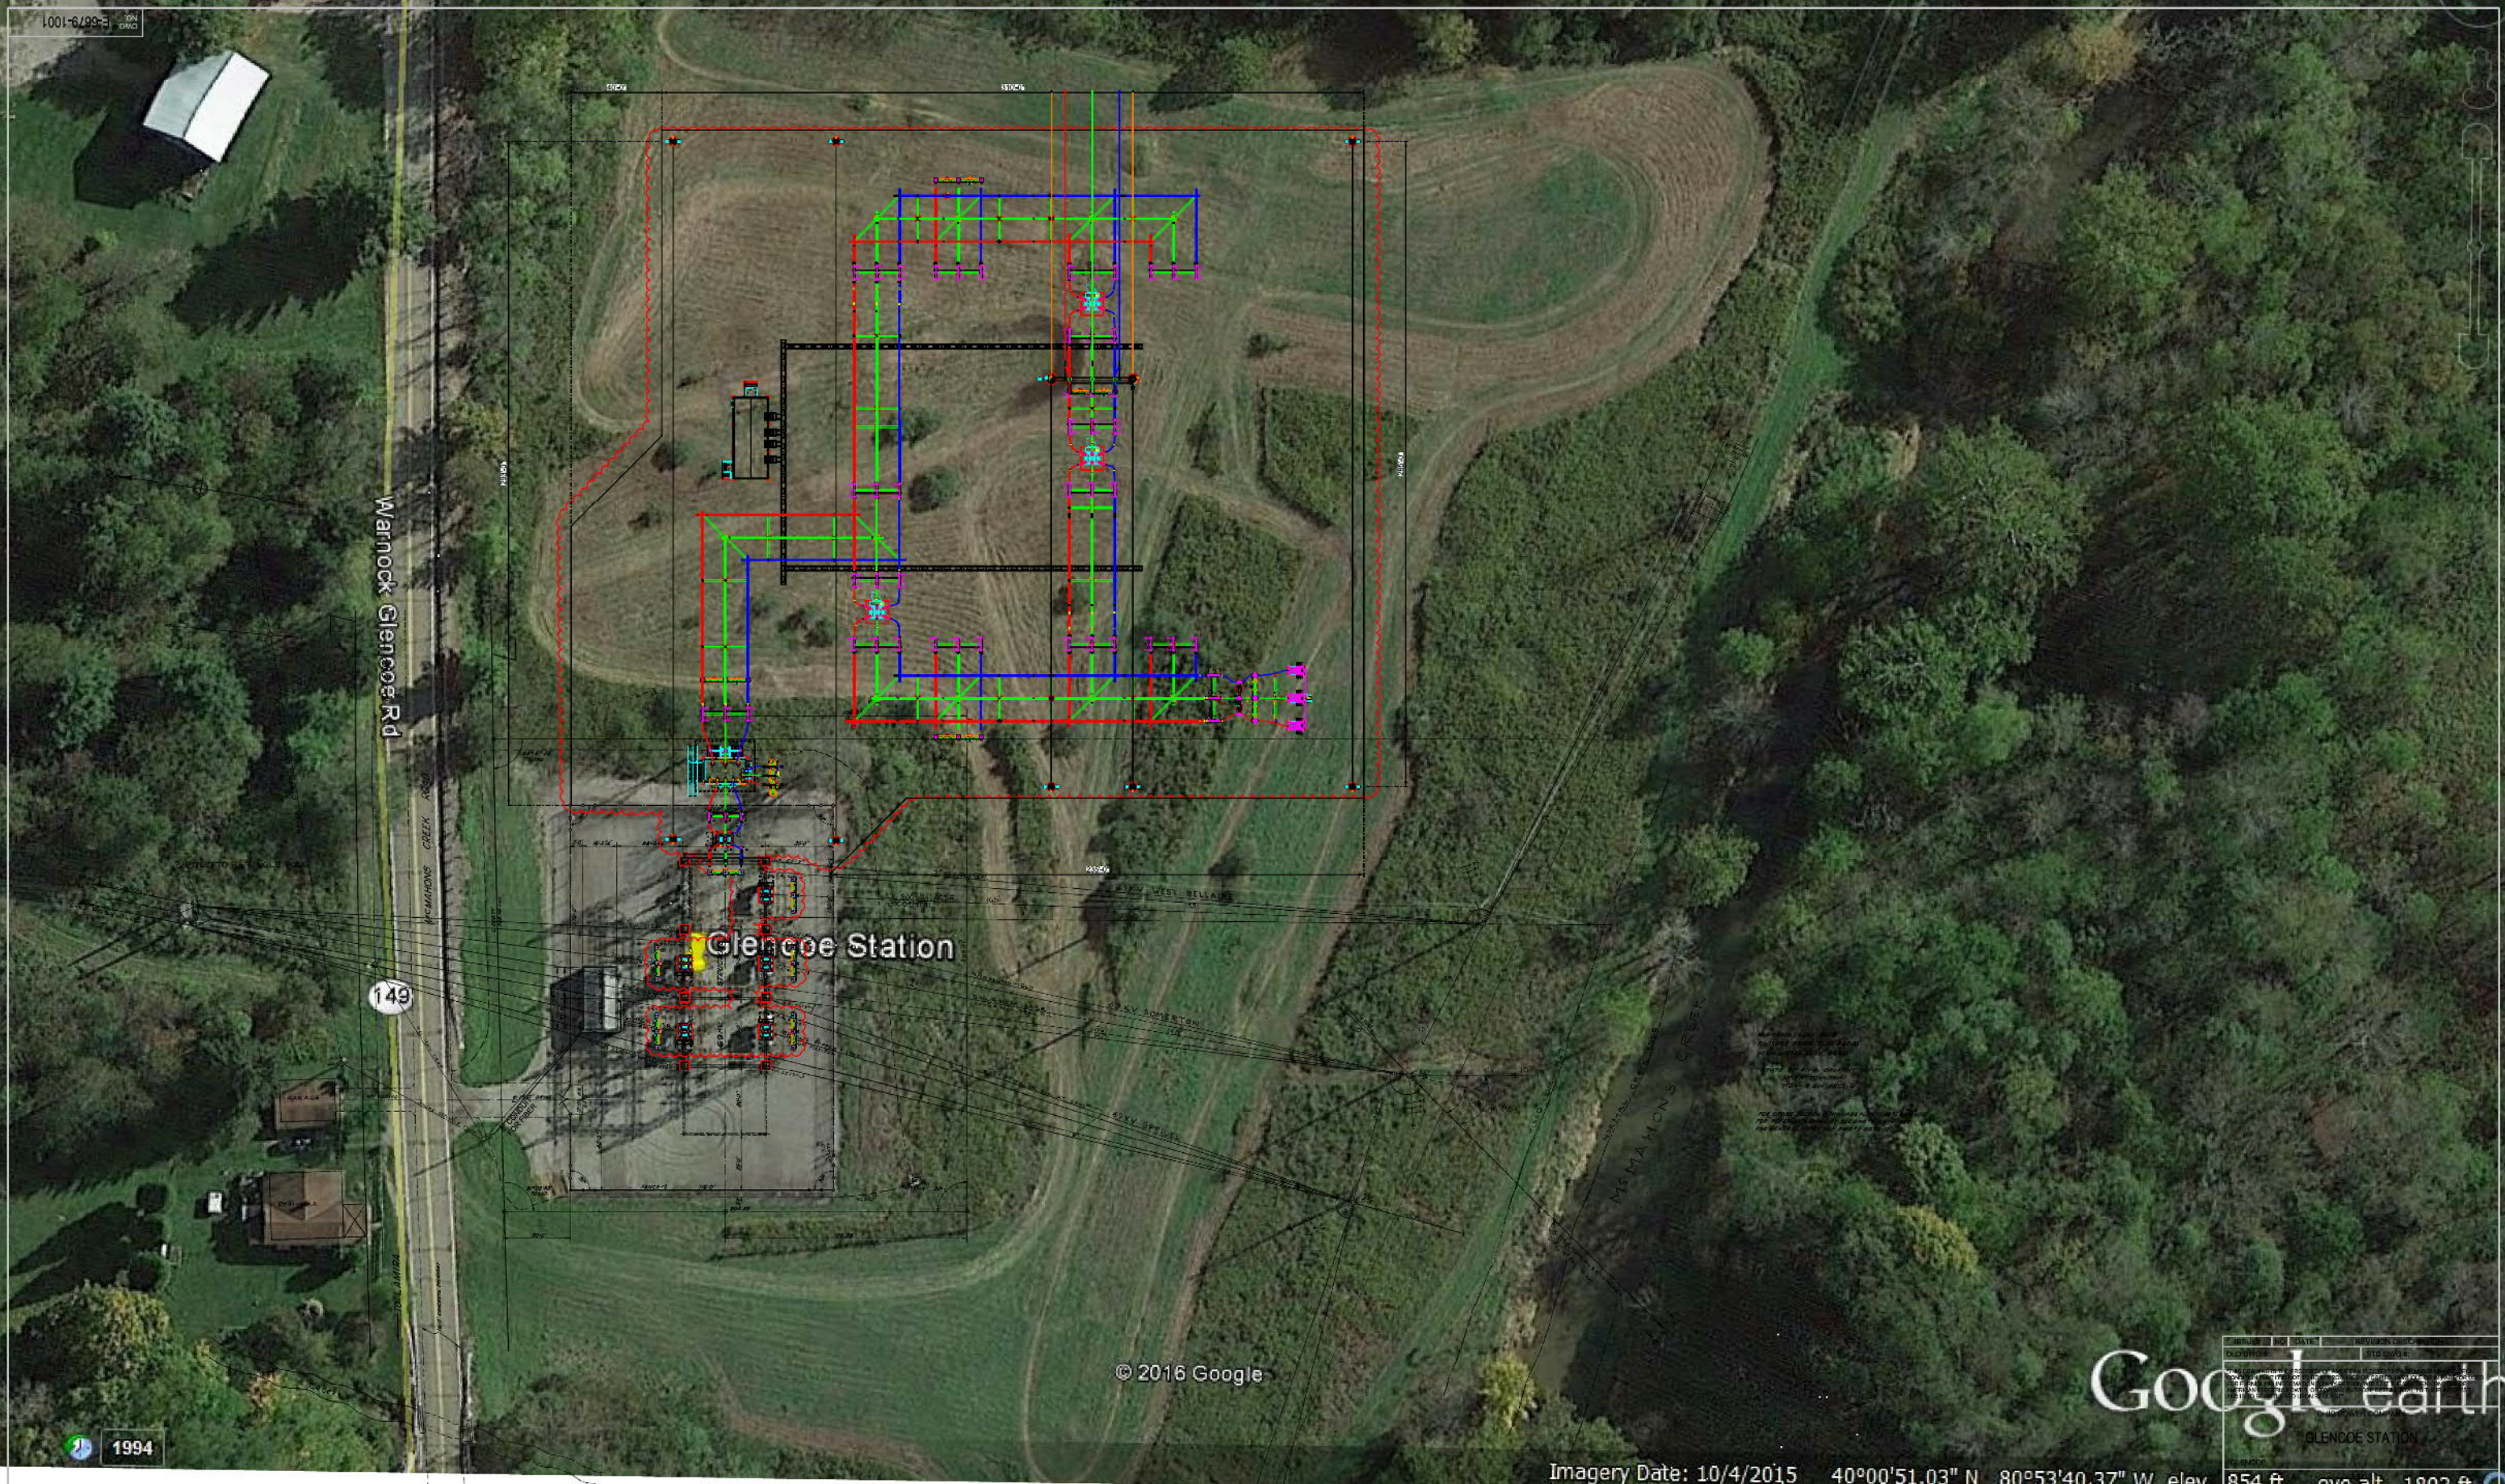
PROJECT NO. E-6679-1001	
LOCATION PLAN	
STATION PROJECTS ENGINEERING	
SCALE: 1" = 25'	
DRAWN BY: AMU	
CHECKED BY: PHILIP	
DATE: 5/4/2016	
APPROVED BY:	
AMERICAN ELECTRIC POWER	
1 RIVERSIDE PLAZA BOLLING, OH 43024	
5

Imagery Date: 10/4/2015 40°00'51.03" N 80°53'40.37" W elev 854 ft eye alt 1893 ft

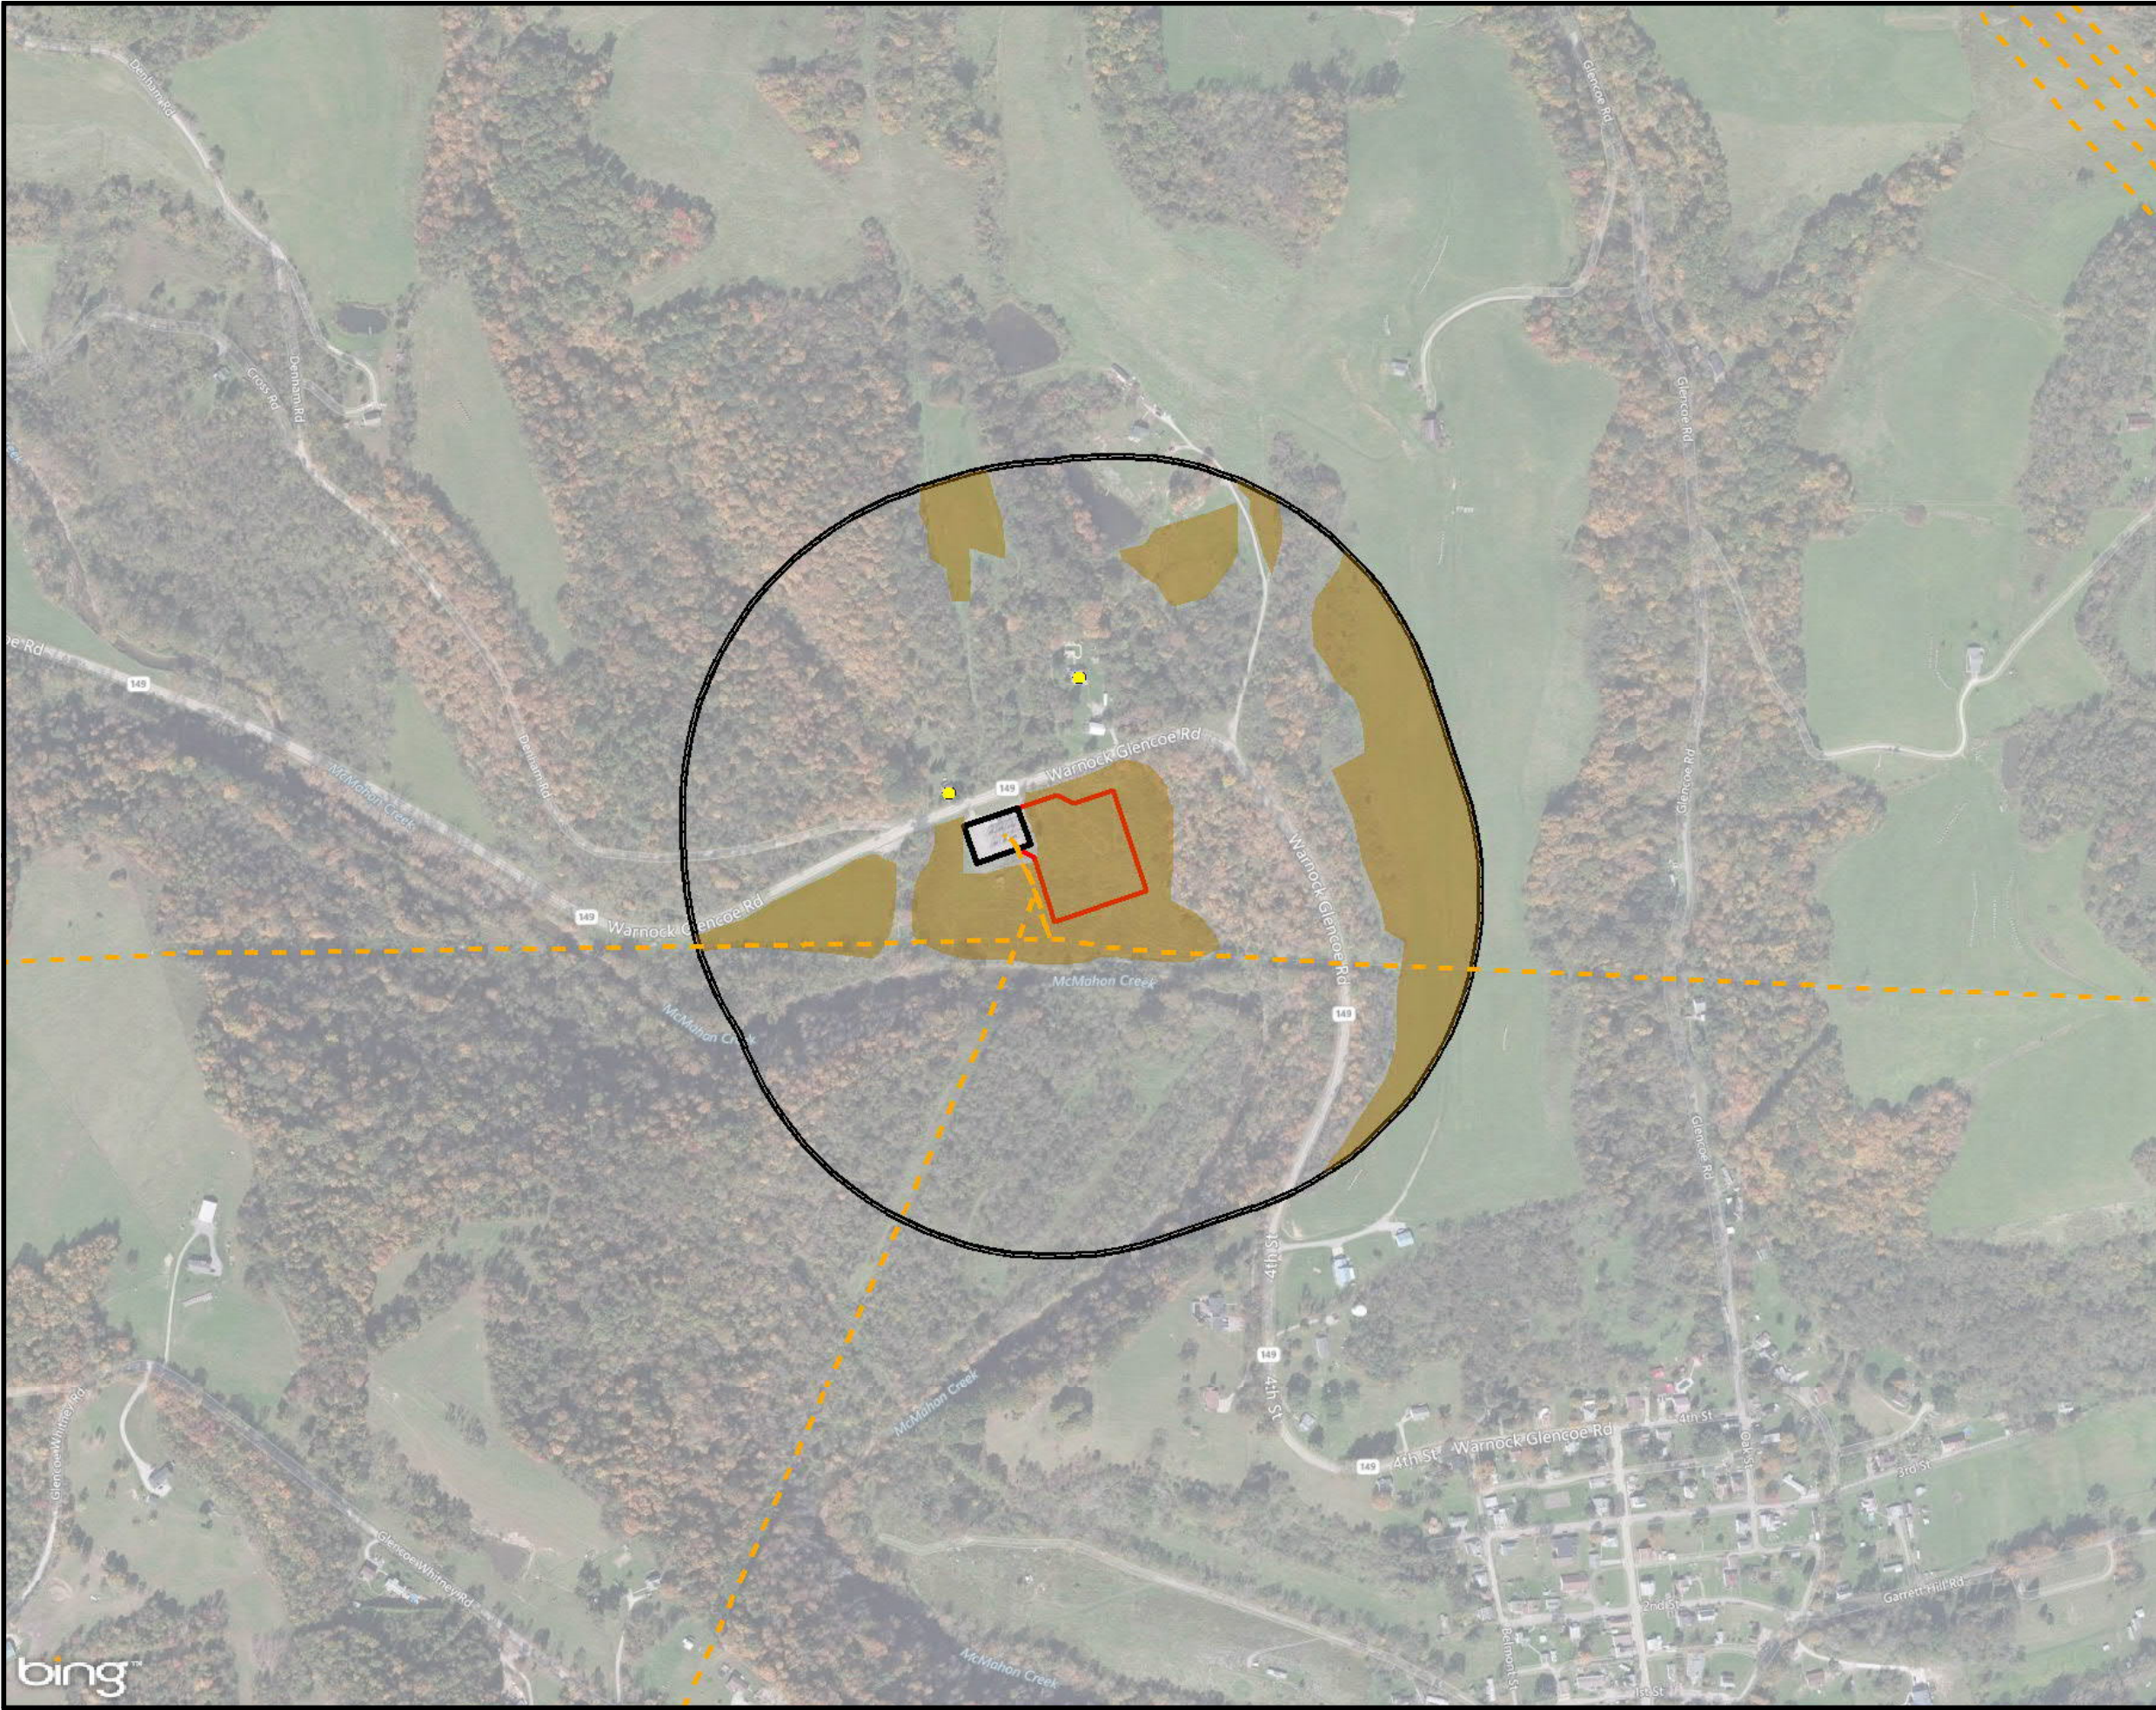
FIGURE 1
LAND USE MAP

Land use within the study area is shown on Figure 1. Current land use characteristics were obtained through review of aerial photography taken in 2013; the United States Geological Survey (USGS) 7.5-minute topographic map of the St. Clairsville, Ohio (1985) quadrangle; and a field reconnaissance conducted in December 2015. The primary land uses within 2,000 feet of the proposed station expansion area include undeveloped woodland, pastures, and residences. Two residences were identified within 2,000 feet, the closest of which is approximately 60 feet to the northwest. Agricultural/pasture land accounts for approximately 24 acres of the 104-acre study area within 2,000 feet, including the entire 2-acre station expansion area (pasture). Transportation corridors are also present within the study area.

- LEGEND:
- Proposed Station Expansion Area
 - Existing Station Fence
 - Residence
 - Agricultural/Pasture Land
 - Existing Electric Transmission Line

The entire station expansion area and portions of the area within 2,000 feet are used as agricultural/pasture land as shown on Figure 1. AECOM contacted the Belmont County Auditor's office regarding parcels registered in the agricultural district land program. Based on the information provided for parcels in Smith and Richland Townships, there are no properties registered in the agricultural district land program within one mile of the expansion area. No impacts to agricultural district land parcels are anticipated.

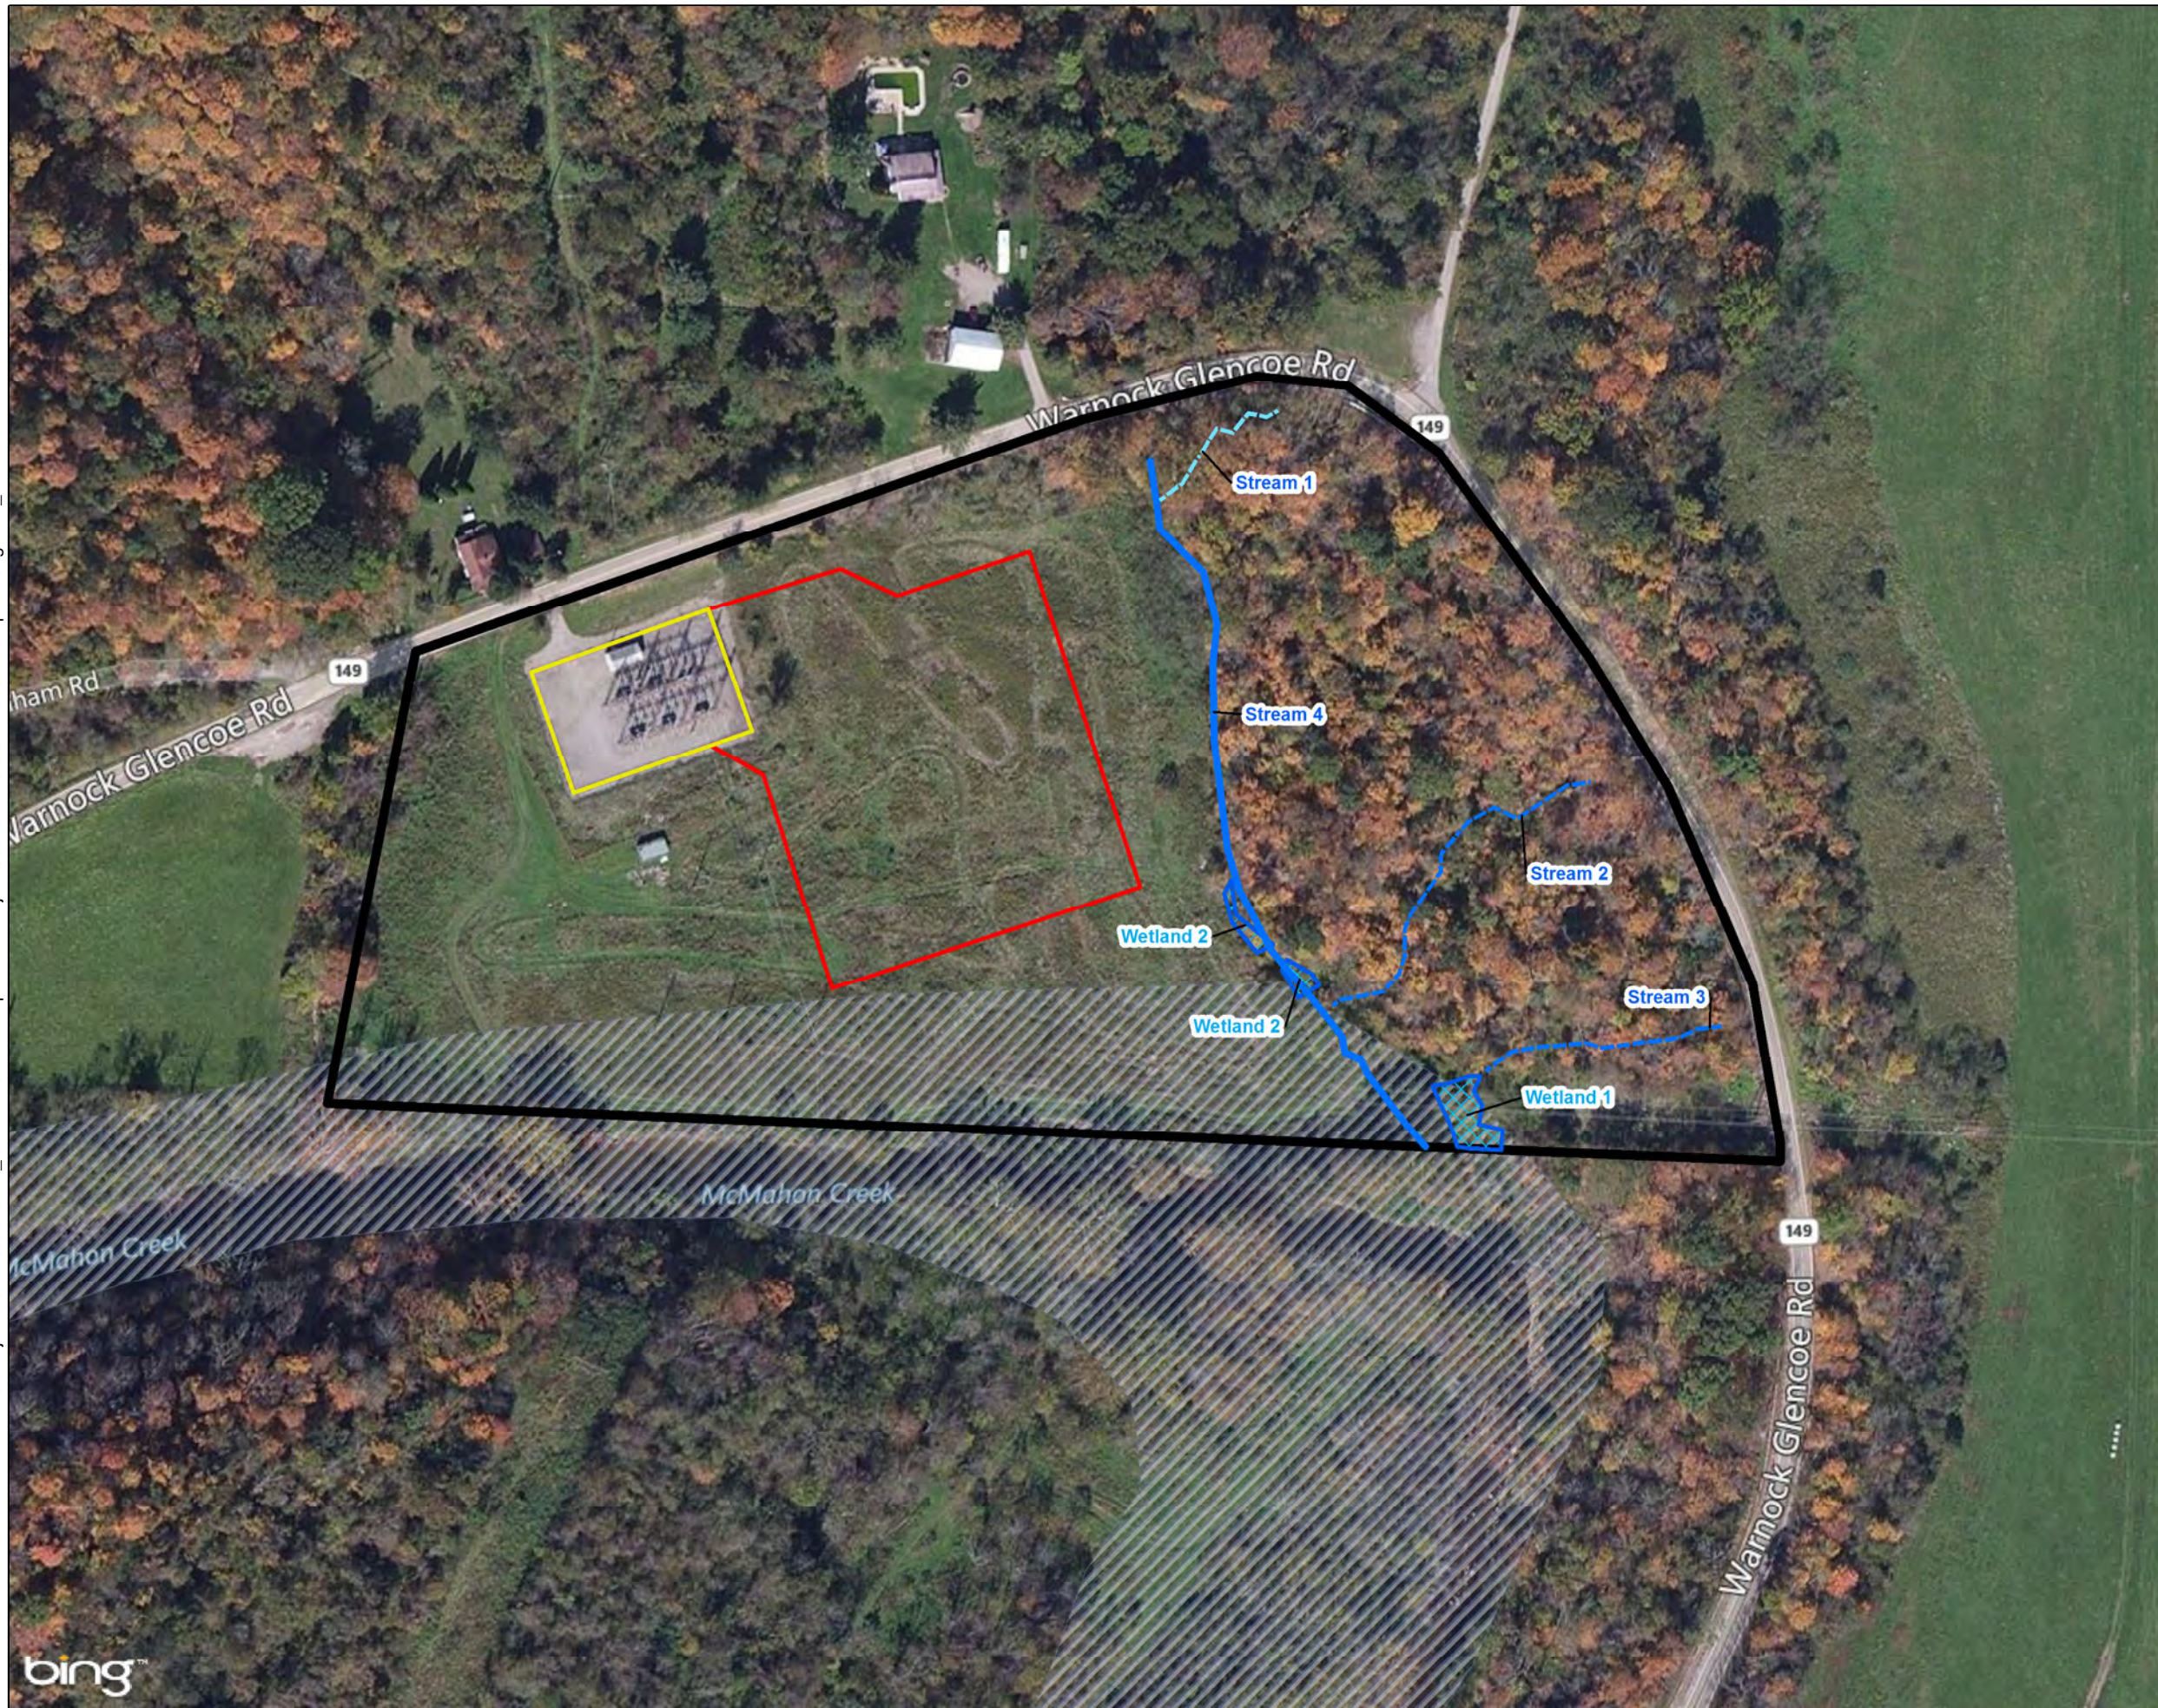
- Existing Station
- Expansion Area
- Ecological Survey Area
- Delineated Ephemeral Stream
- Delineated Intermittent Stream
- Delineated Perennial Stream
- Delineated Wetland
- 100-year Floodplain

According to the FEMA National Flood Hazard Layer (NFHL) (GIS shapefile), approximately 15 percent of the Project survey area is located within Flood Zone A, an area inundated by a percent annual chance of flooding for which no base flood elevations have been determined. The remaining 85 percent of the Project survey area, including the entire Project station expansion area, is located outside of the 100-year floodplain. No changes in flood elevations are anticipated as a result of the Project.

AECOM identified four streams, totaling 1,419 linear feet, within the approximately 15.3-acre Project survey area as shown in Table 2. One perennial stream totaling 697 linear feet was found within the survey area. Additionally, two intermittent streams totaling 573 linear feet and one ephemeral stream totaling 149 linear feet were also observed.
