**LETTER OF NOTIFICATION FOR MOUNT VERNON STATION TO HEDDING STATION 138 KV
TRANSMISSION LINE REBUILD PROJECT**

**Mt. Vernon Station – Hedding Station
138 kV Transmission Line Rebuild
Project, Knox and Morrow Counties,
Ohio**

**Ecological Resources Inventory
Report**

September 13, 2016

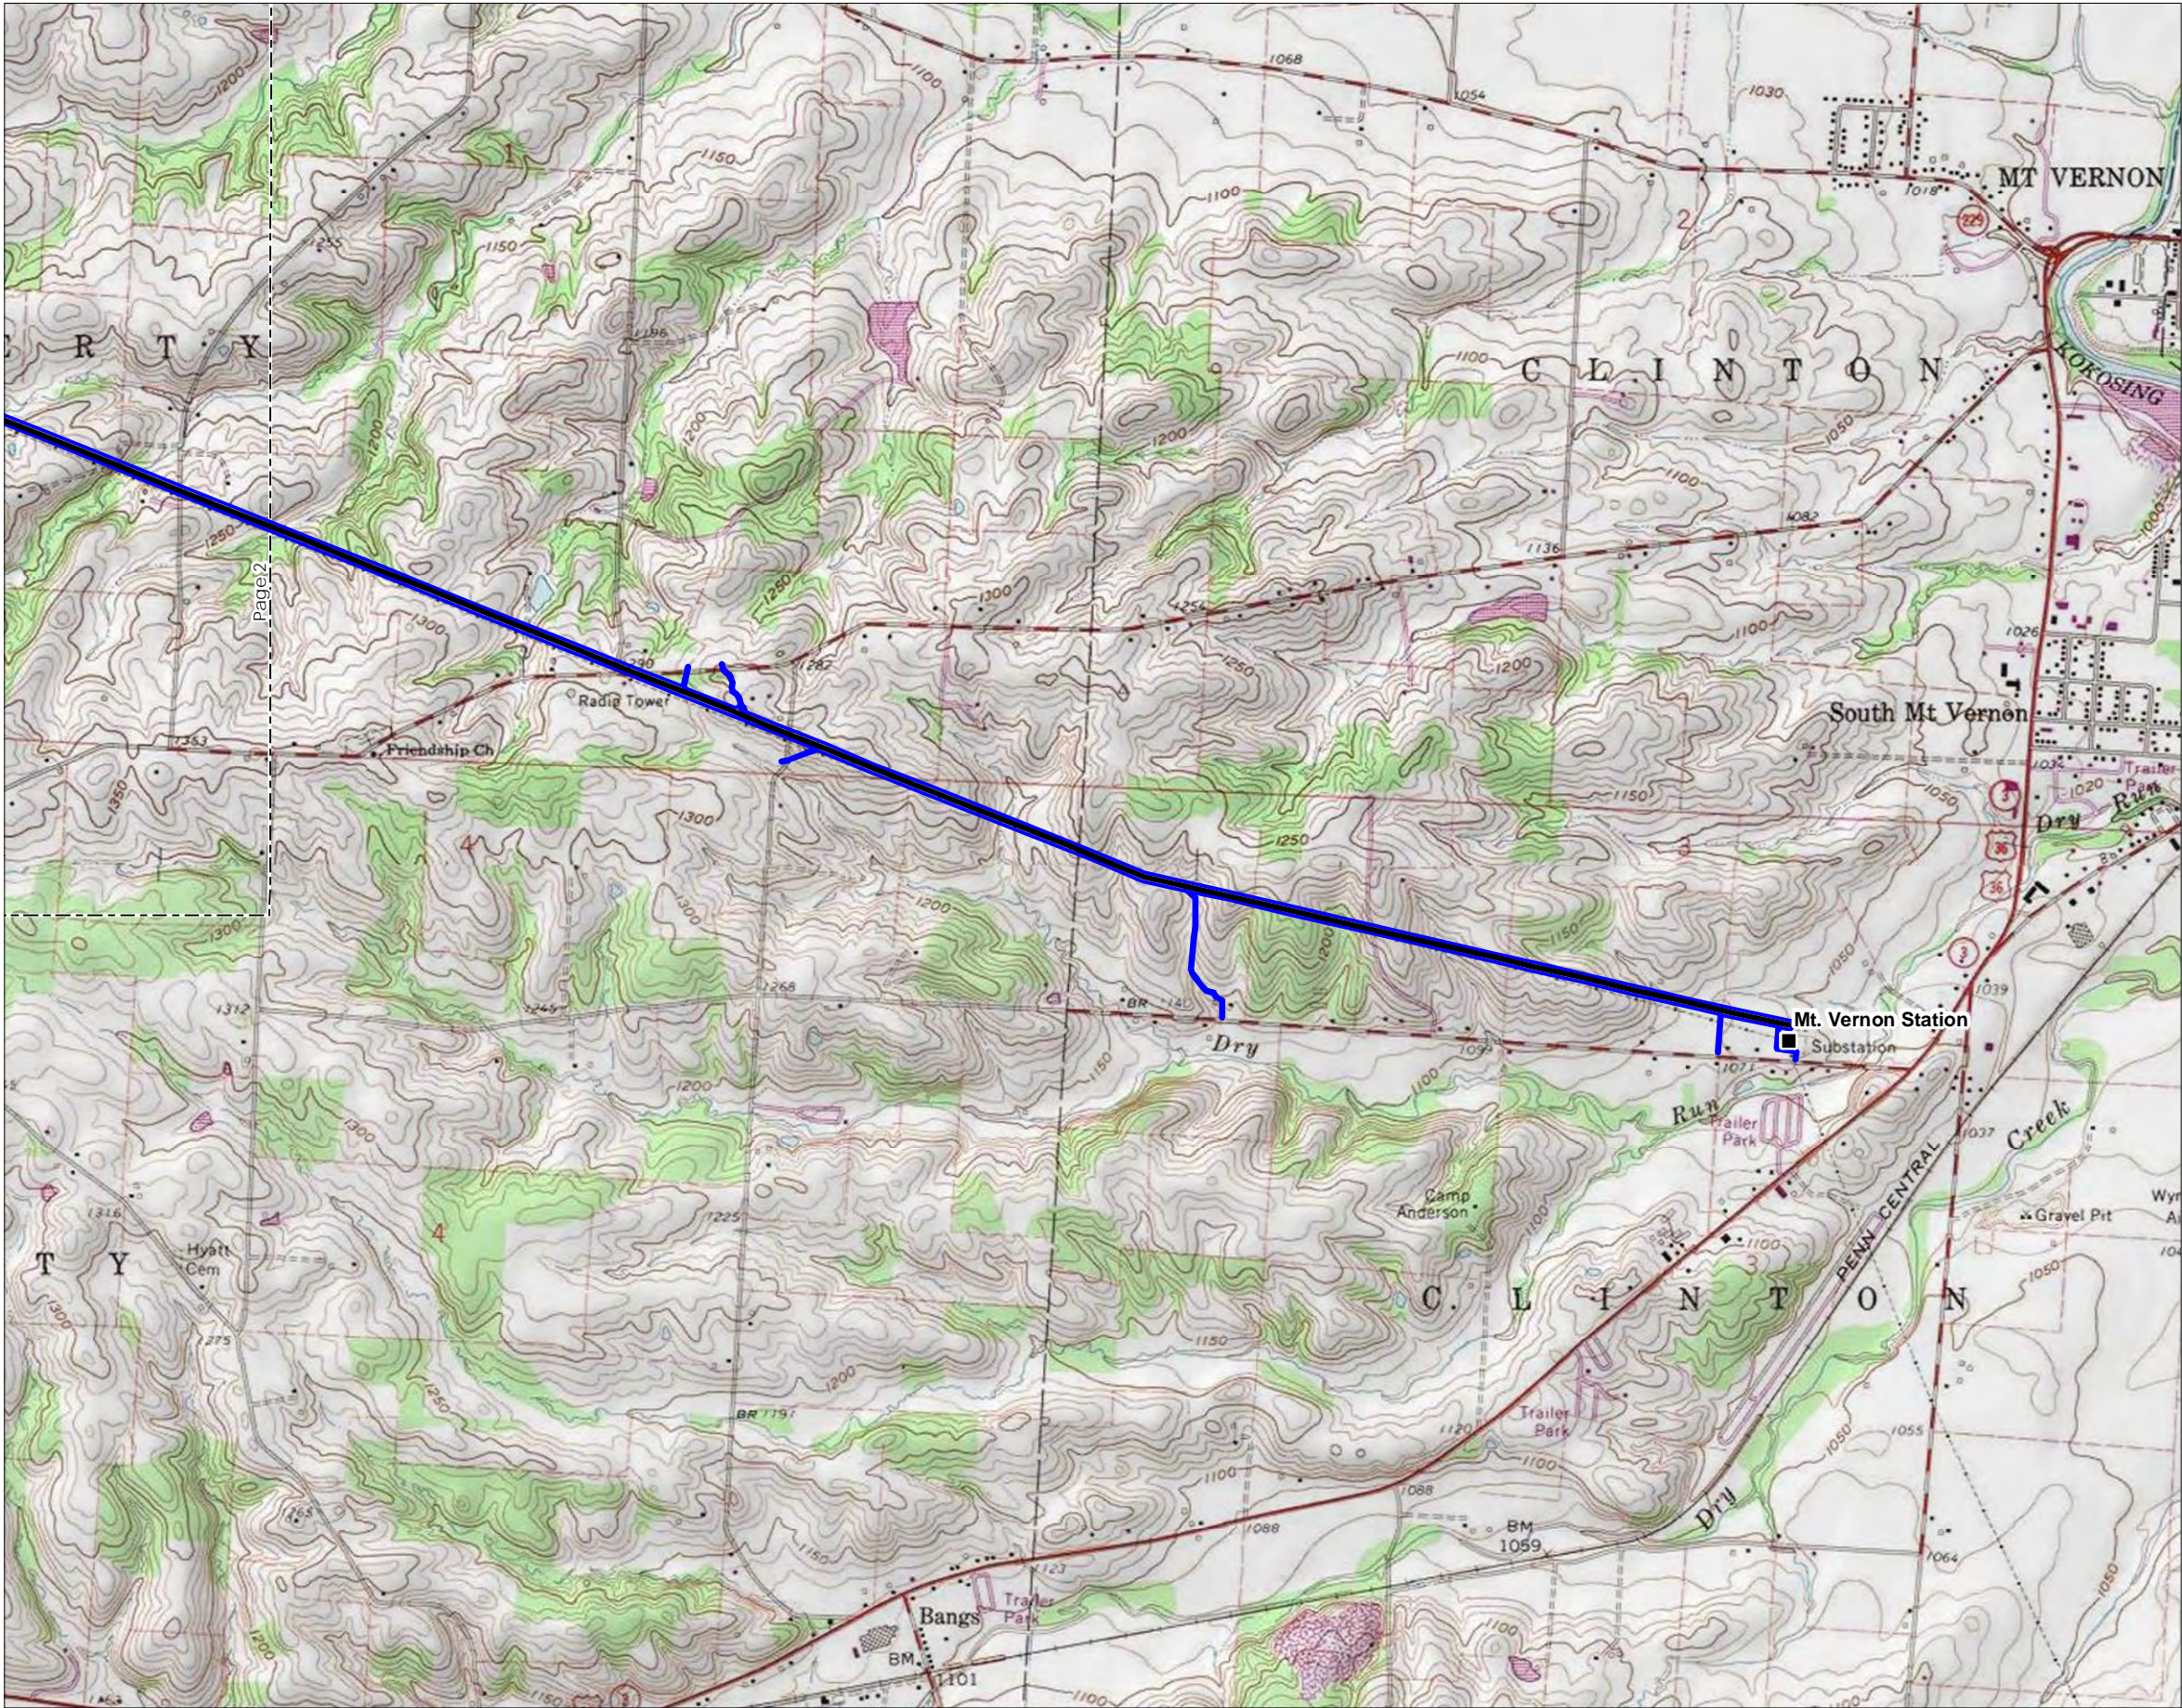
A.1 FIGURE 1 – PROJECT LOCATION MAP

Title
Project Location Map

American Electric Power (AEP) is proposing to rebuild/upgrade 63 structures on the Mt. Vernon – Hedding 138 kilovolt (kV) Transmission Line in Knox and Morrow Counties, Ohio (Figure 1, Appendix A). The Project will include the rebuild/upgrade of these structures within the existing right – of – way (ROW) and construction of associated access roads needed to perform the rebuild/upgrade activities (Figure 1, Appendix A). The existing ROW, including workspaces surrounding each of the 63 structures, and the proposed access roads were surveyed for wetlands, waterbodies, and potential threatened, endangered, and rare species habitat by Stantec Consulting Services Inc. (Stantec) biologists on August 10 through 12, 2016. The approximate locations of features located up to approximately 50 feet outside of the ROW limits were also recorded during the field surveys, where landowner access was permitted. However, no data forms were collected on features that did not extend into the ROW. These features are shown on the Figure 2 maps in Appendix A as “Approximate” wetlands, streams, and upland drainage features.

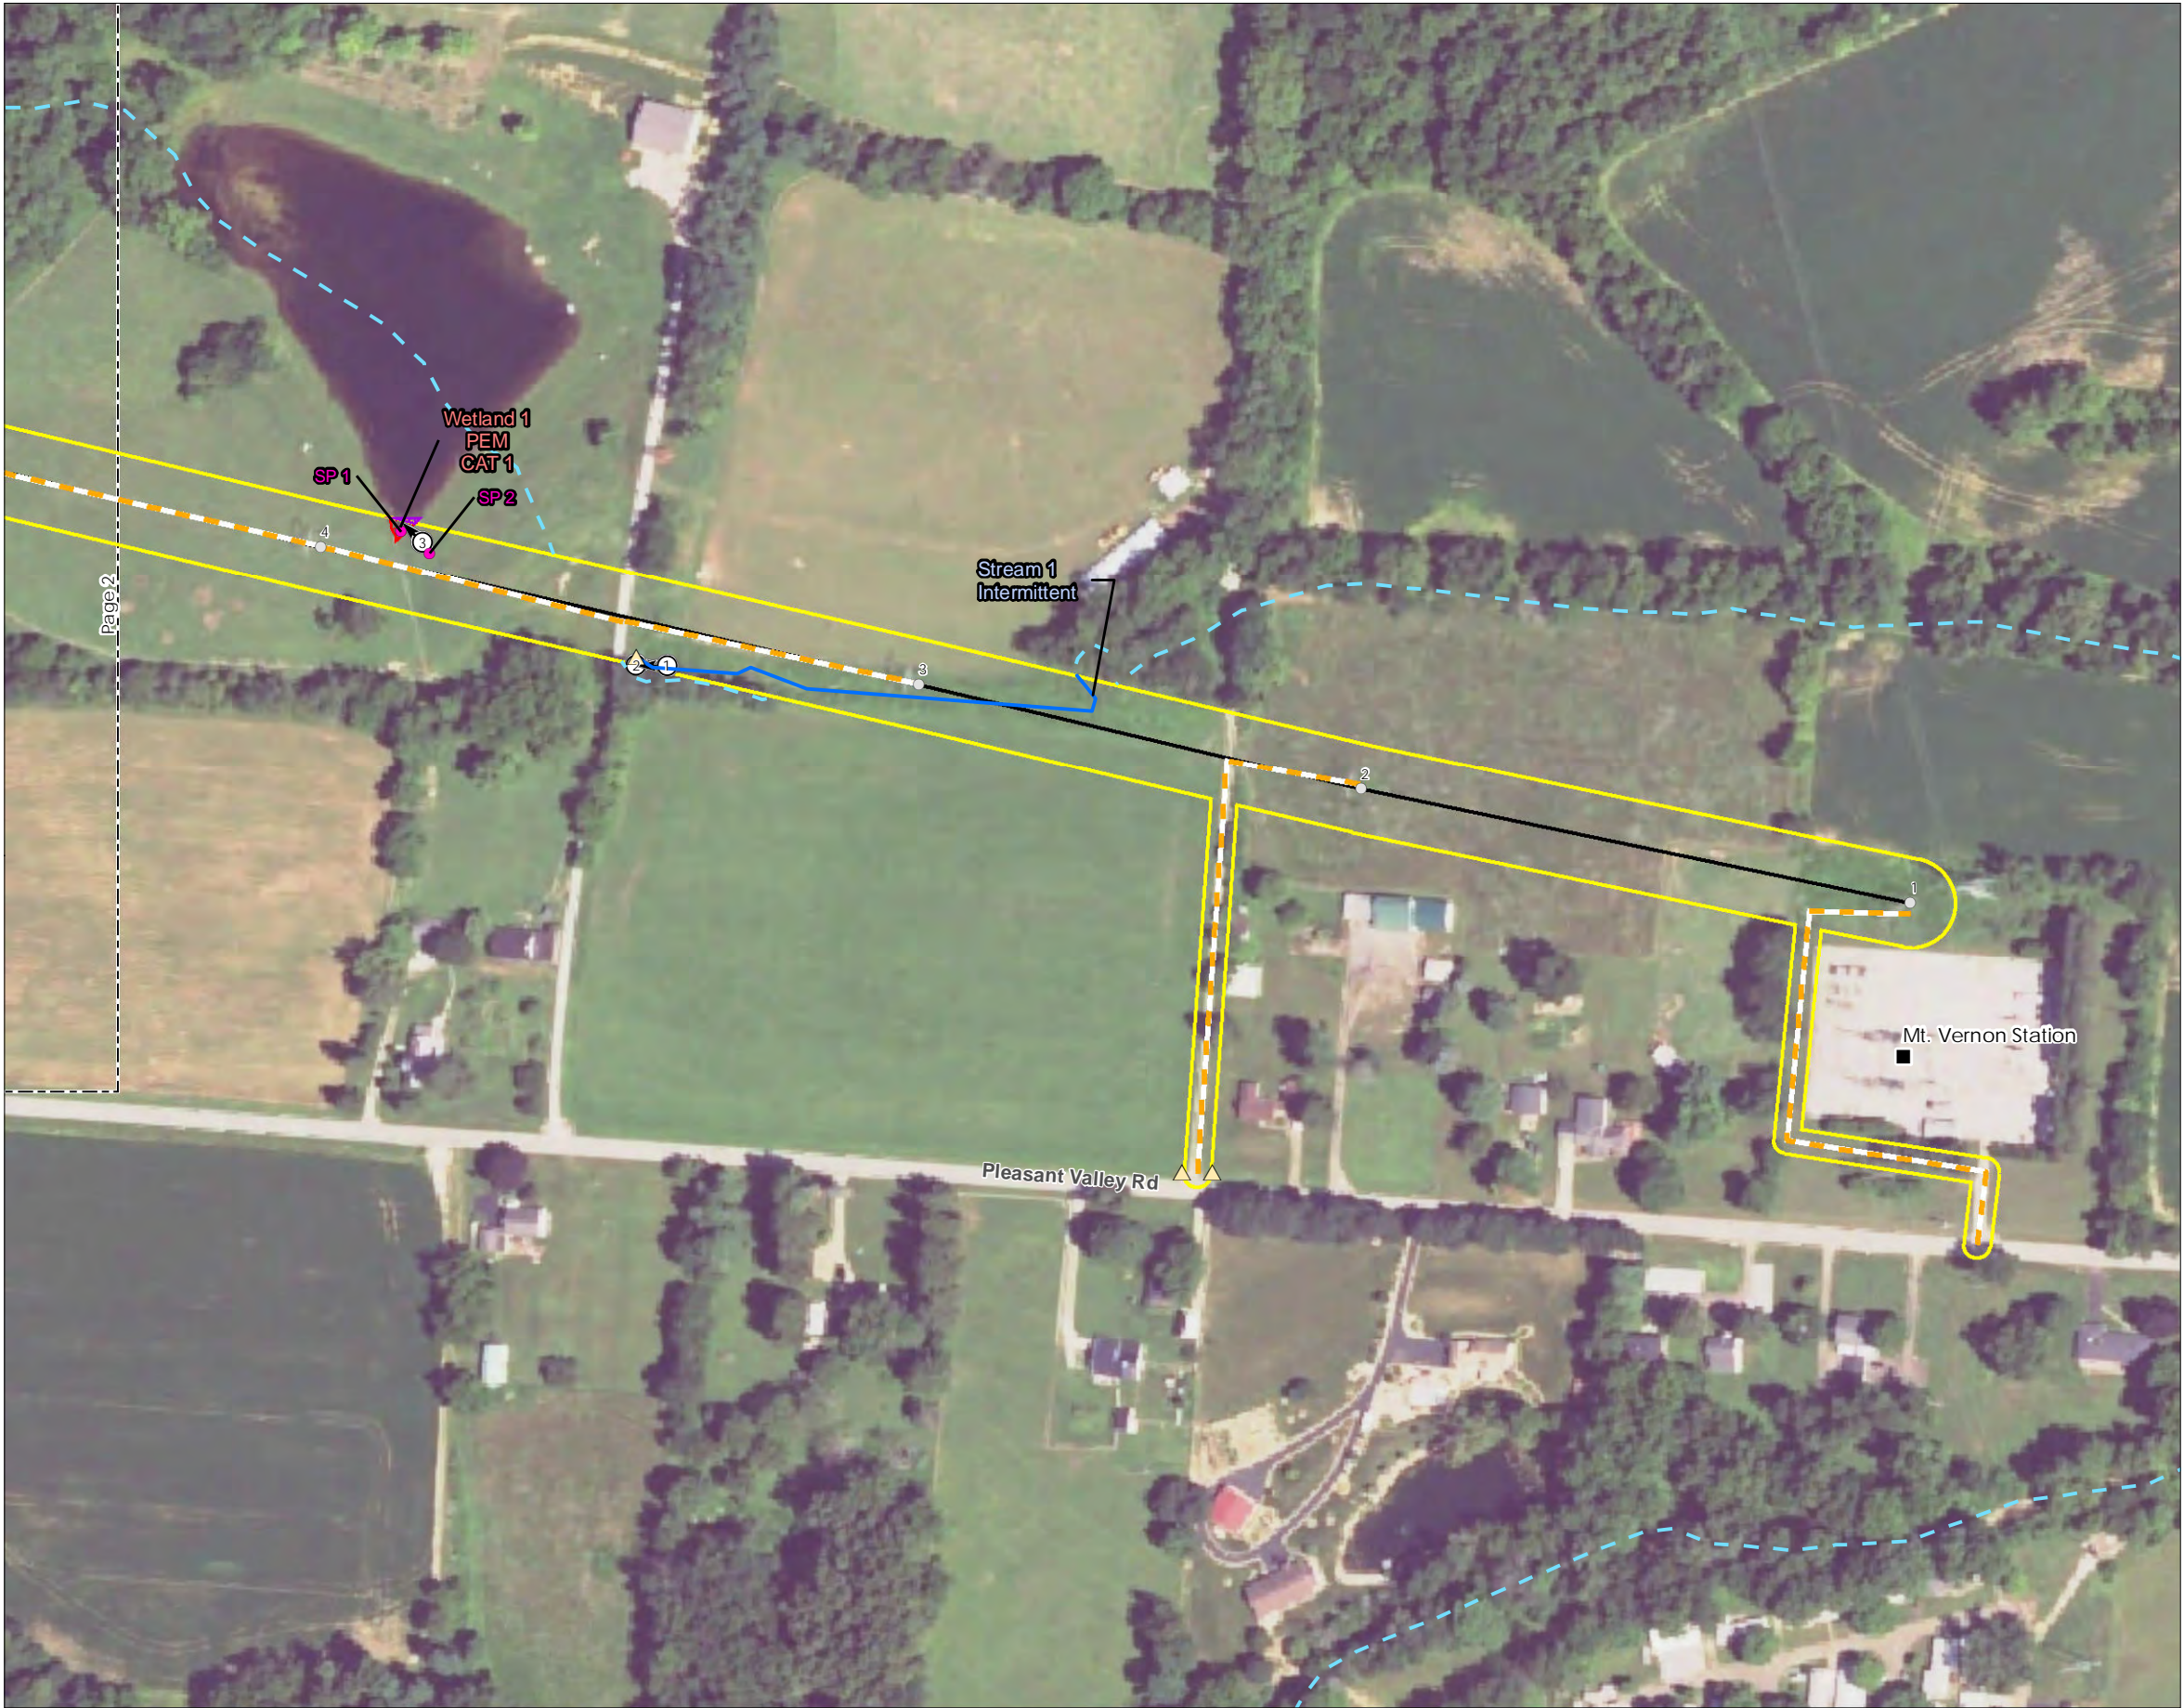
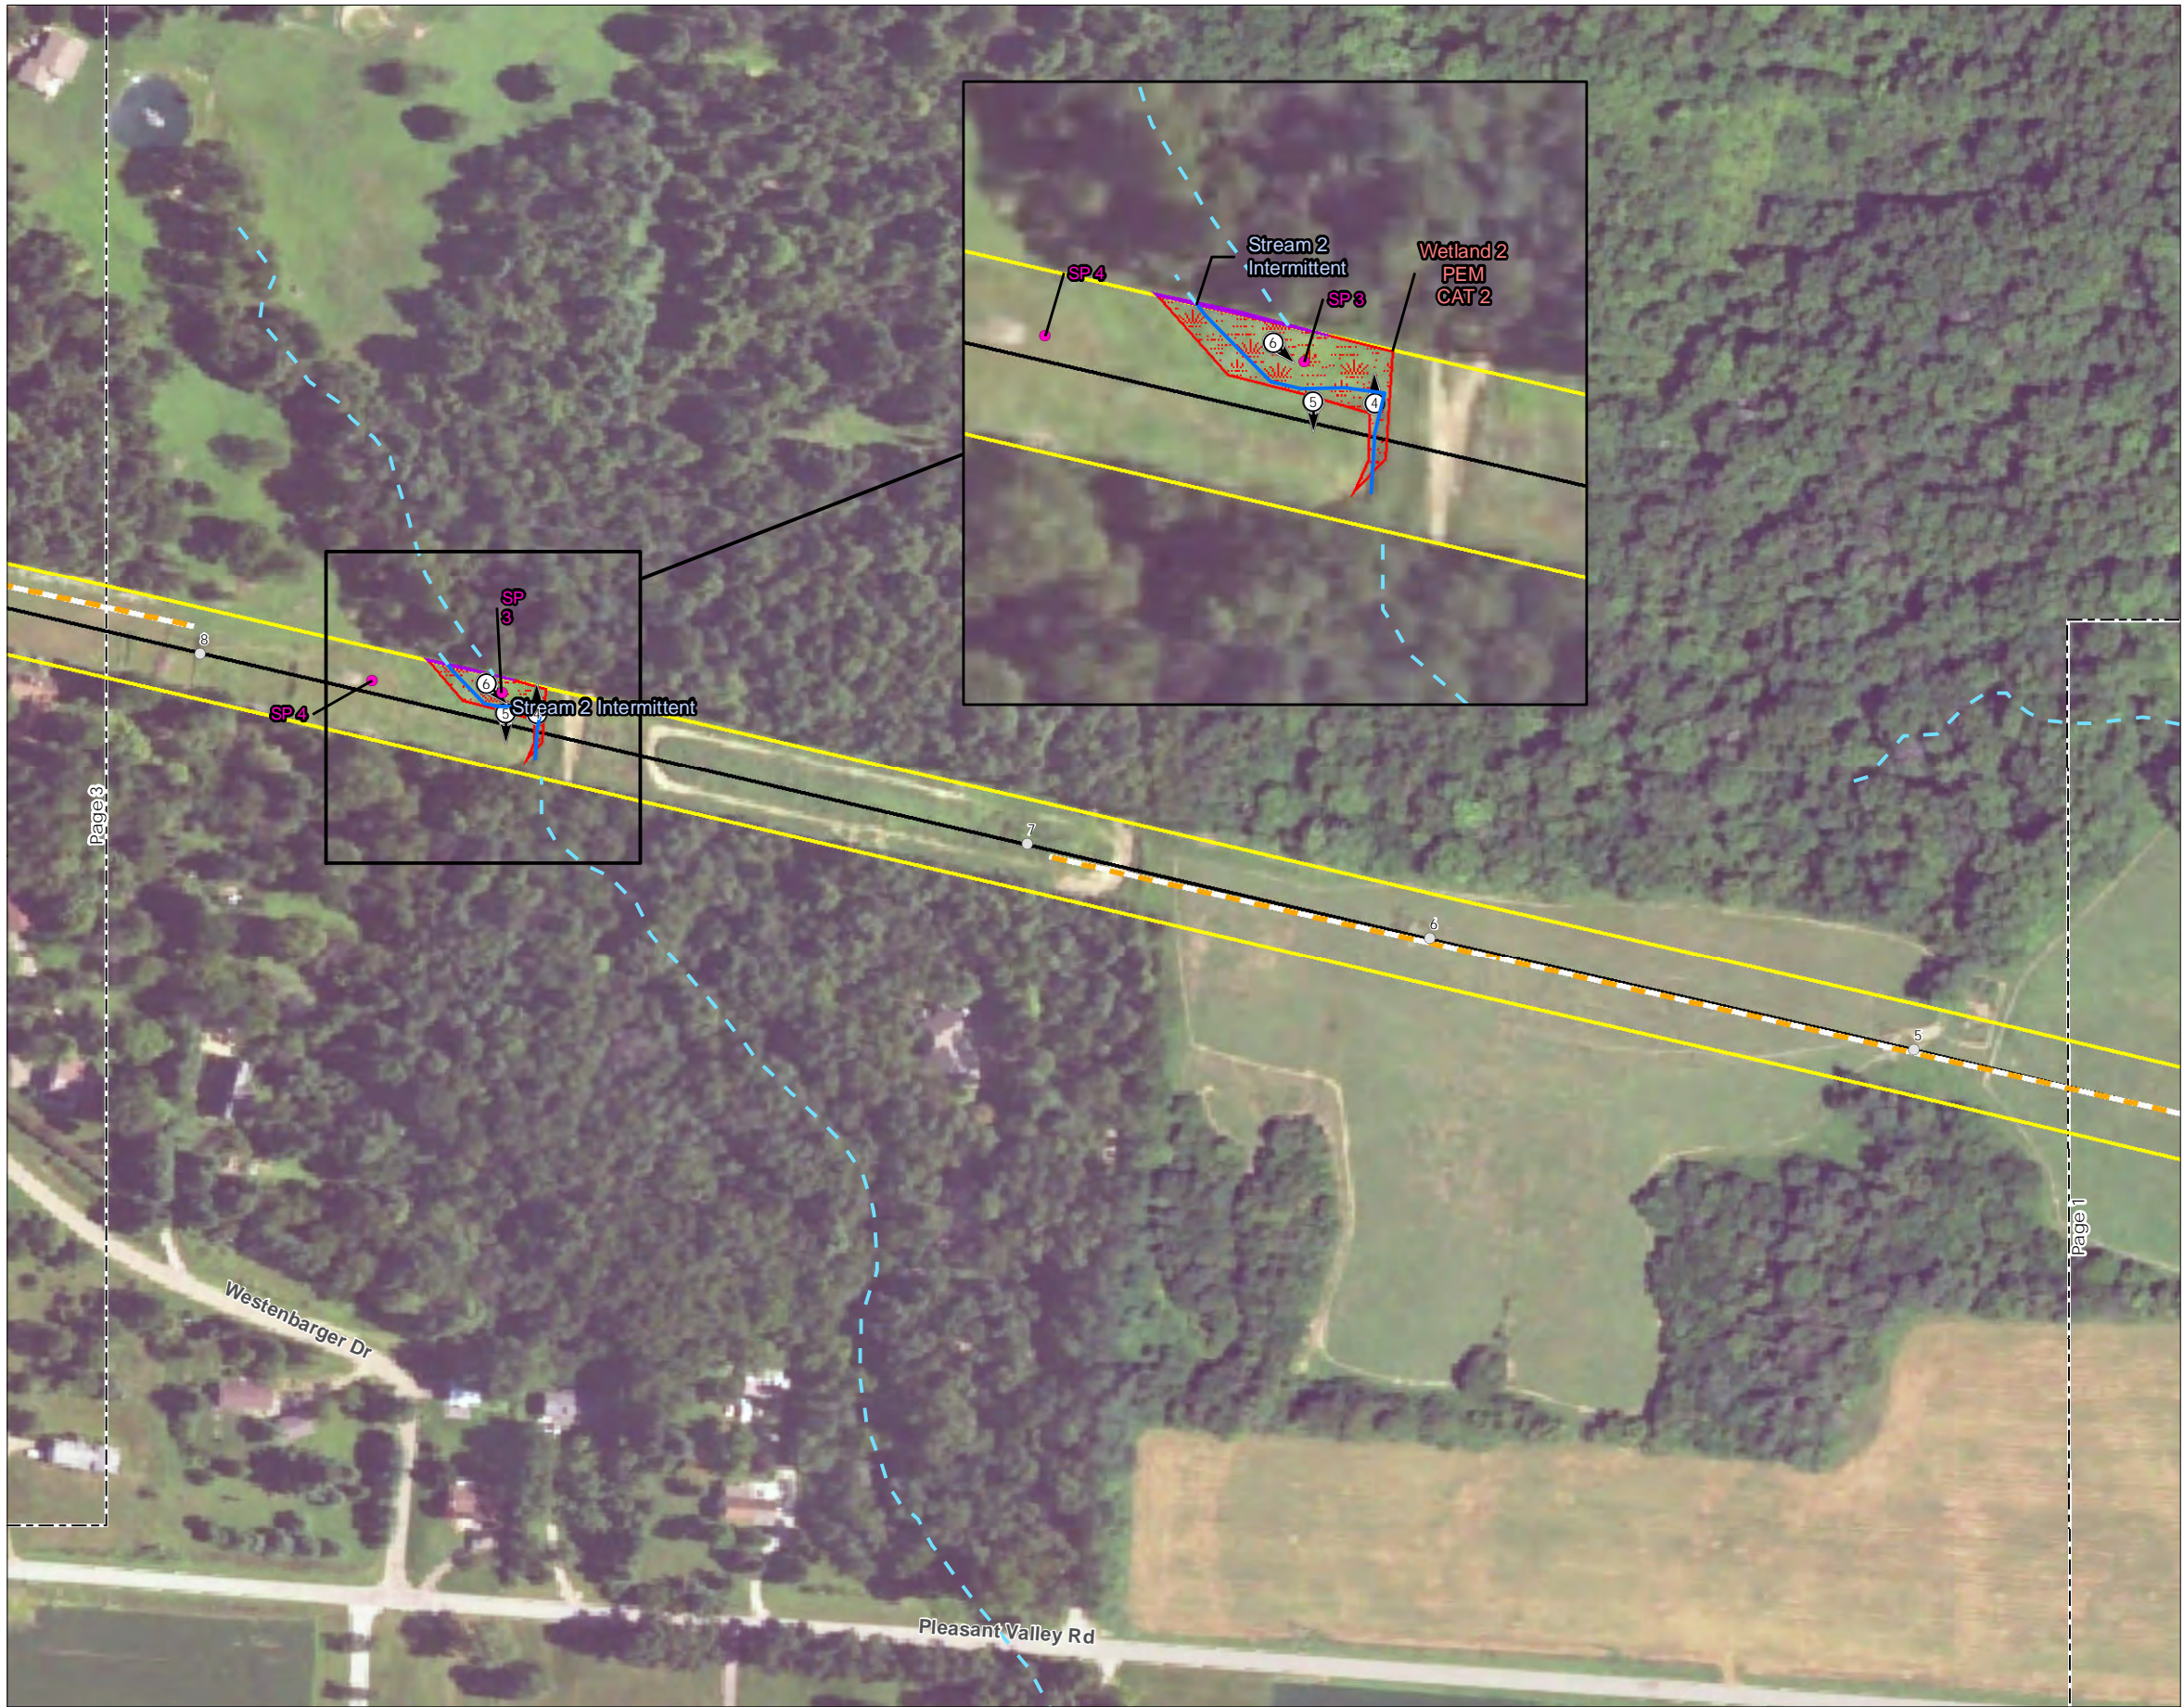
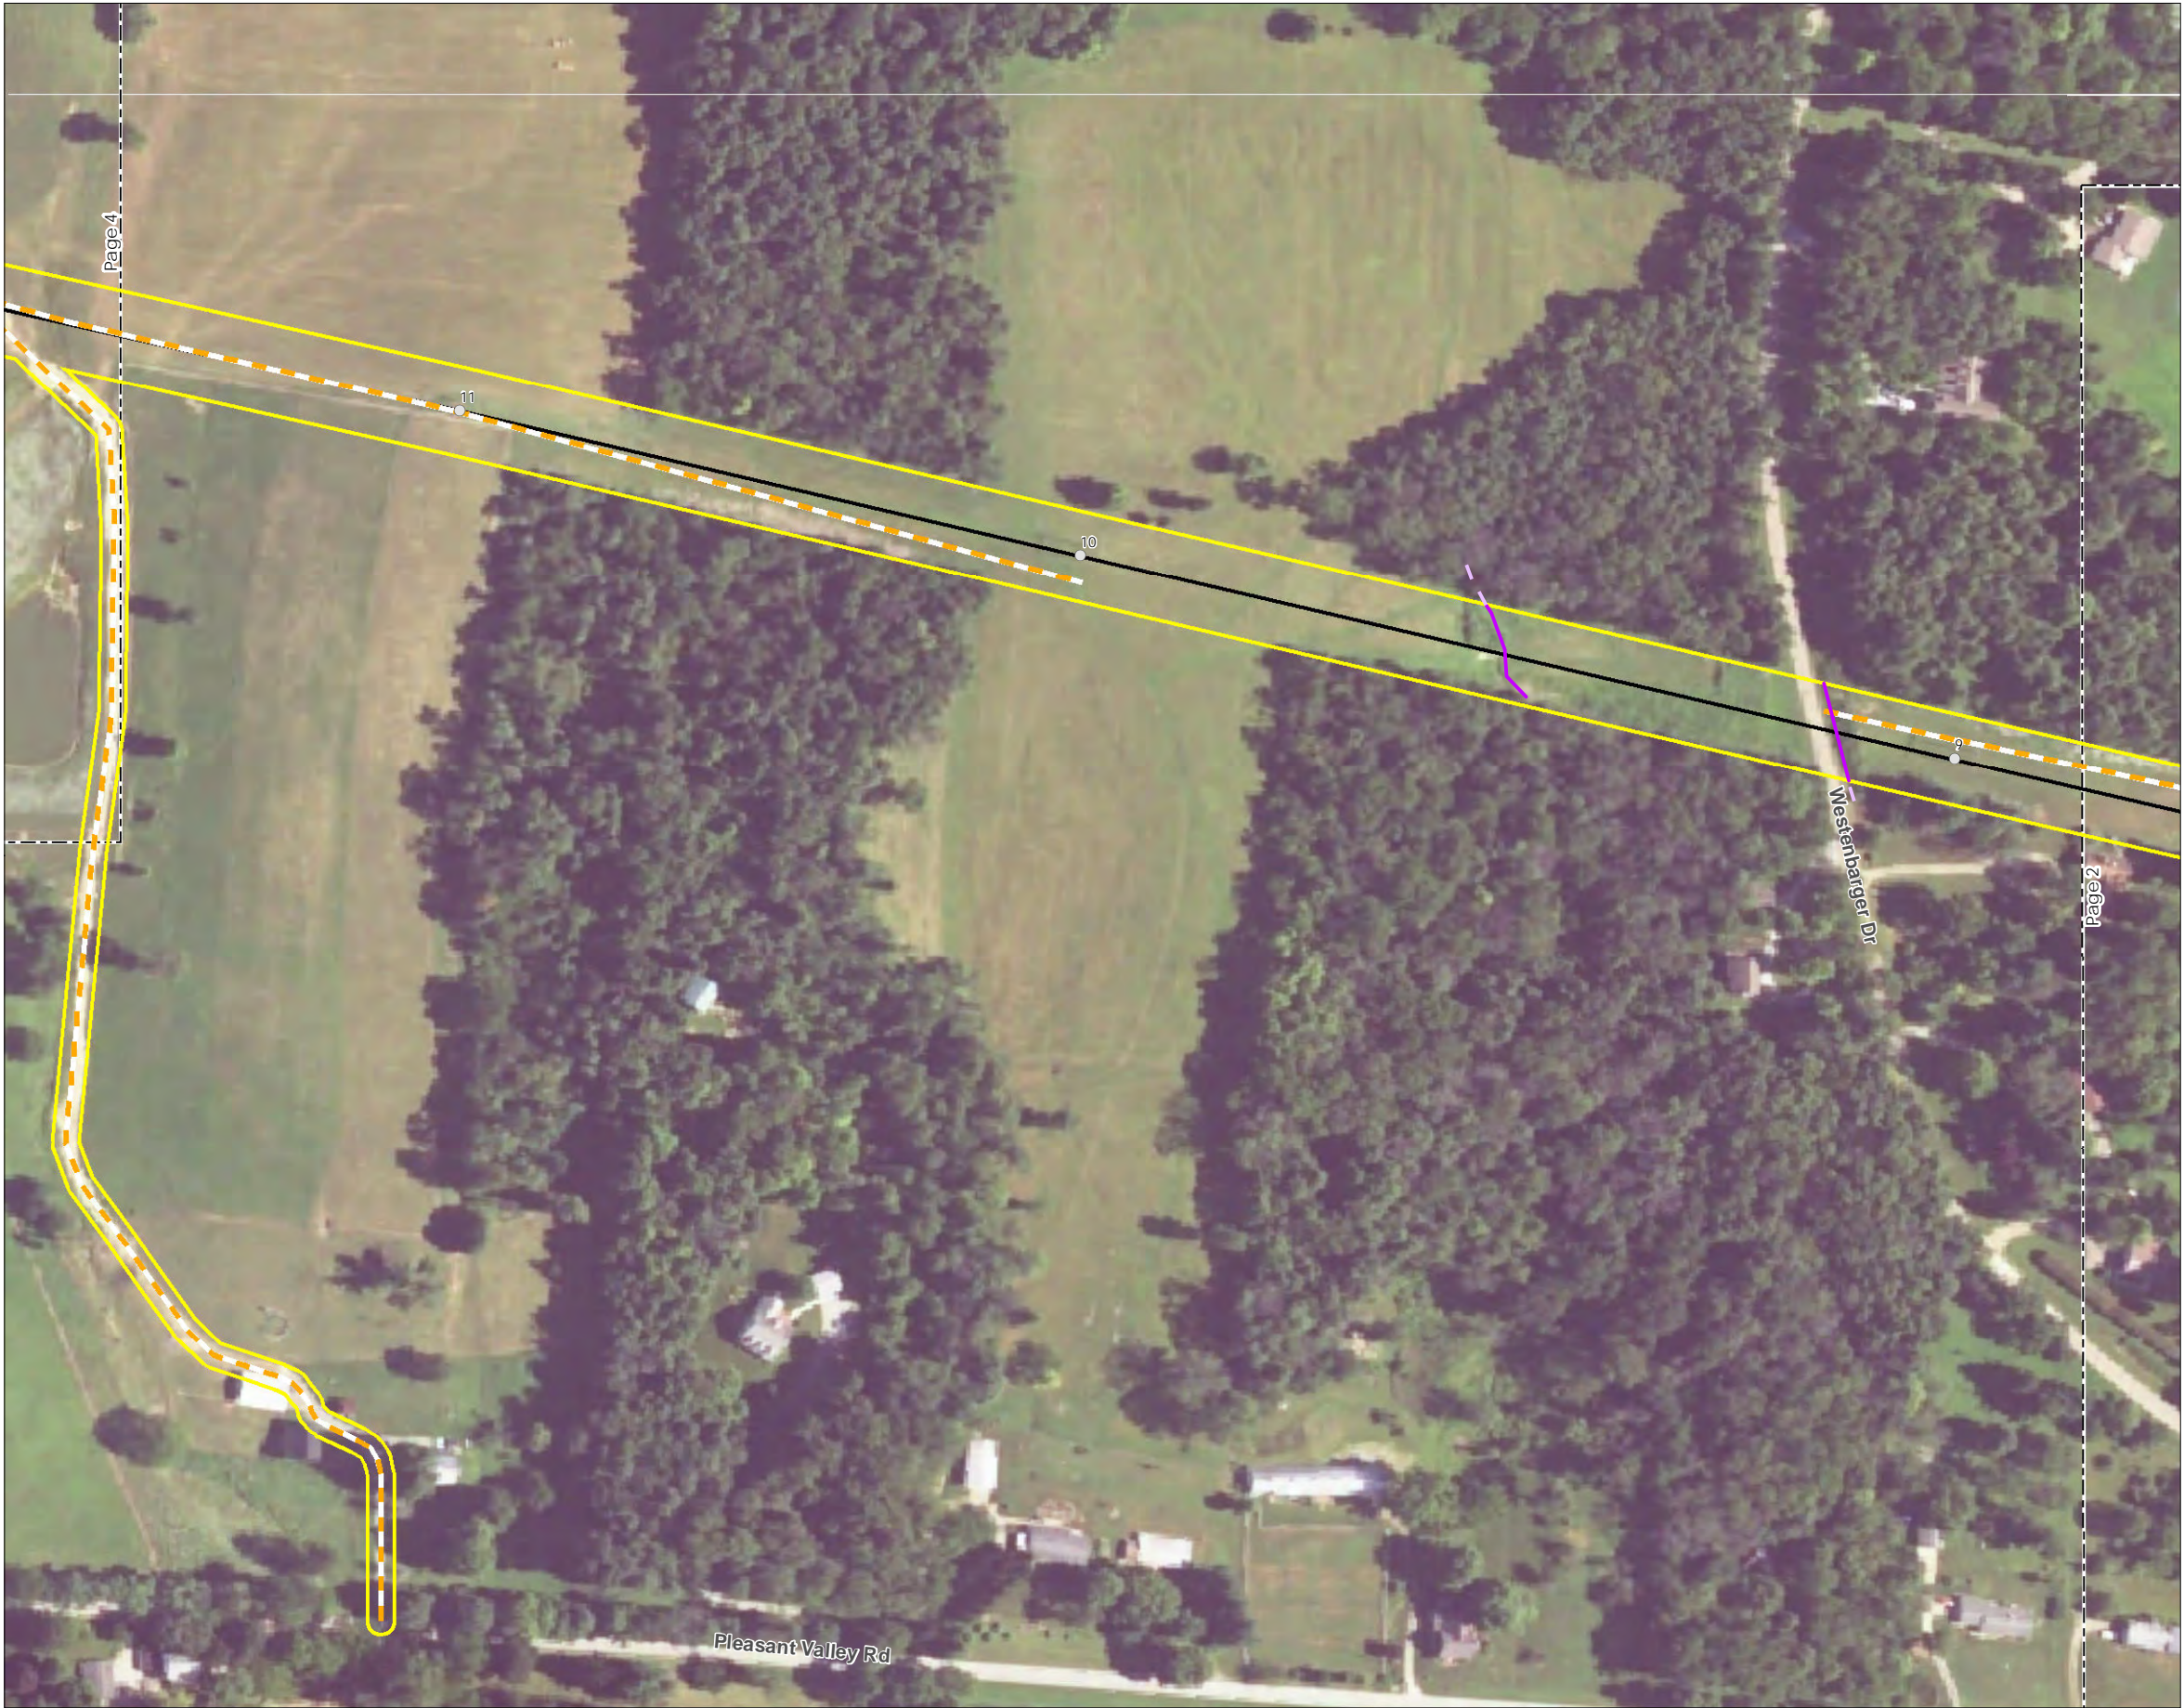
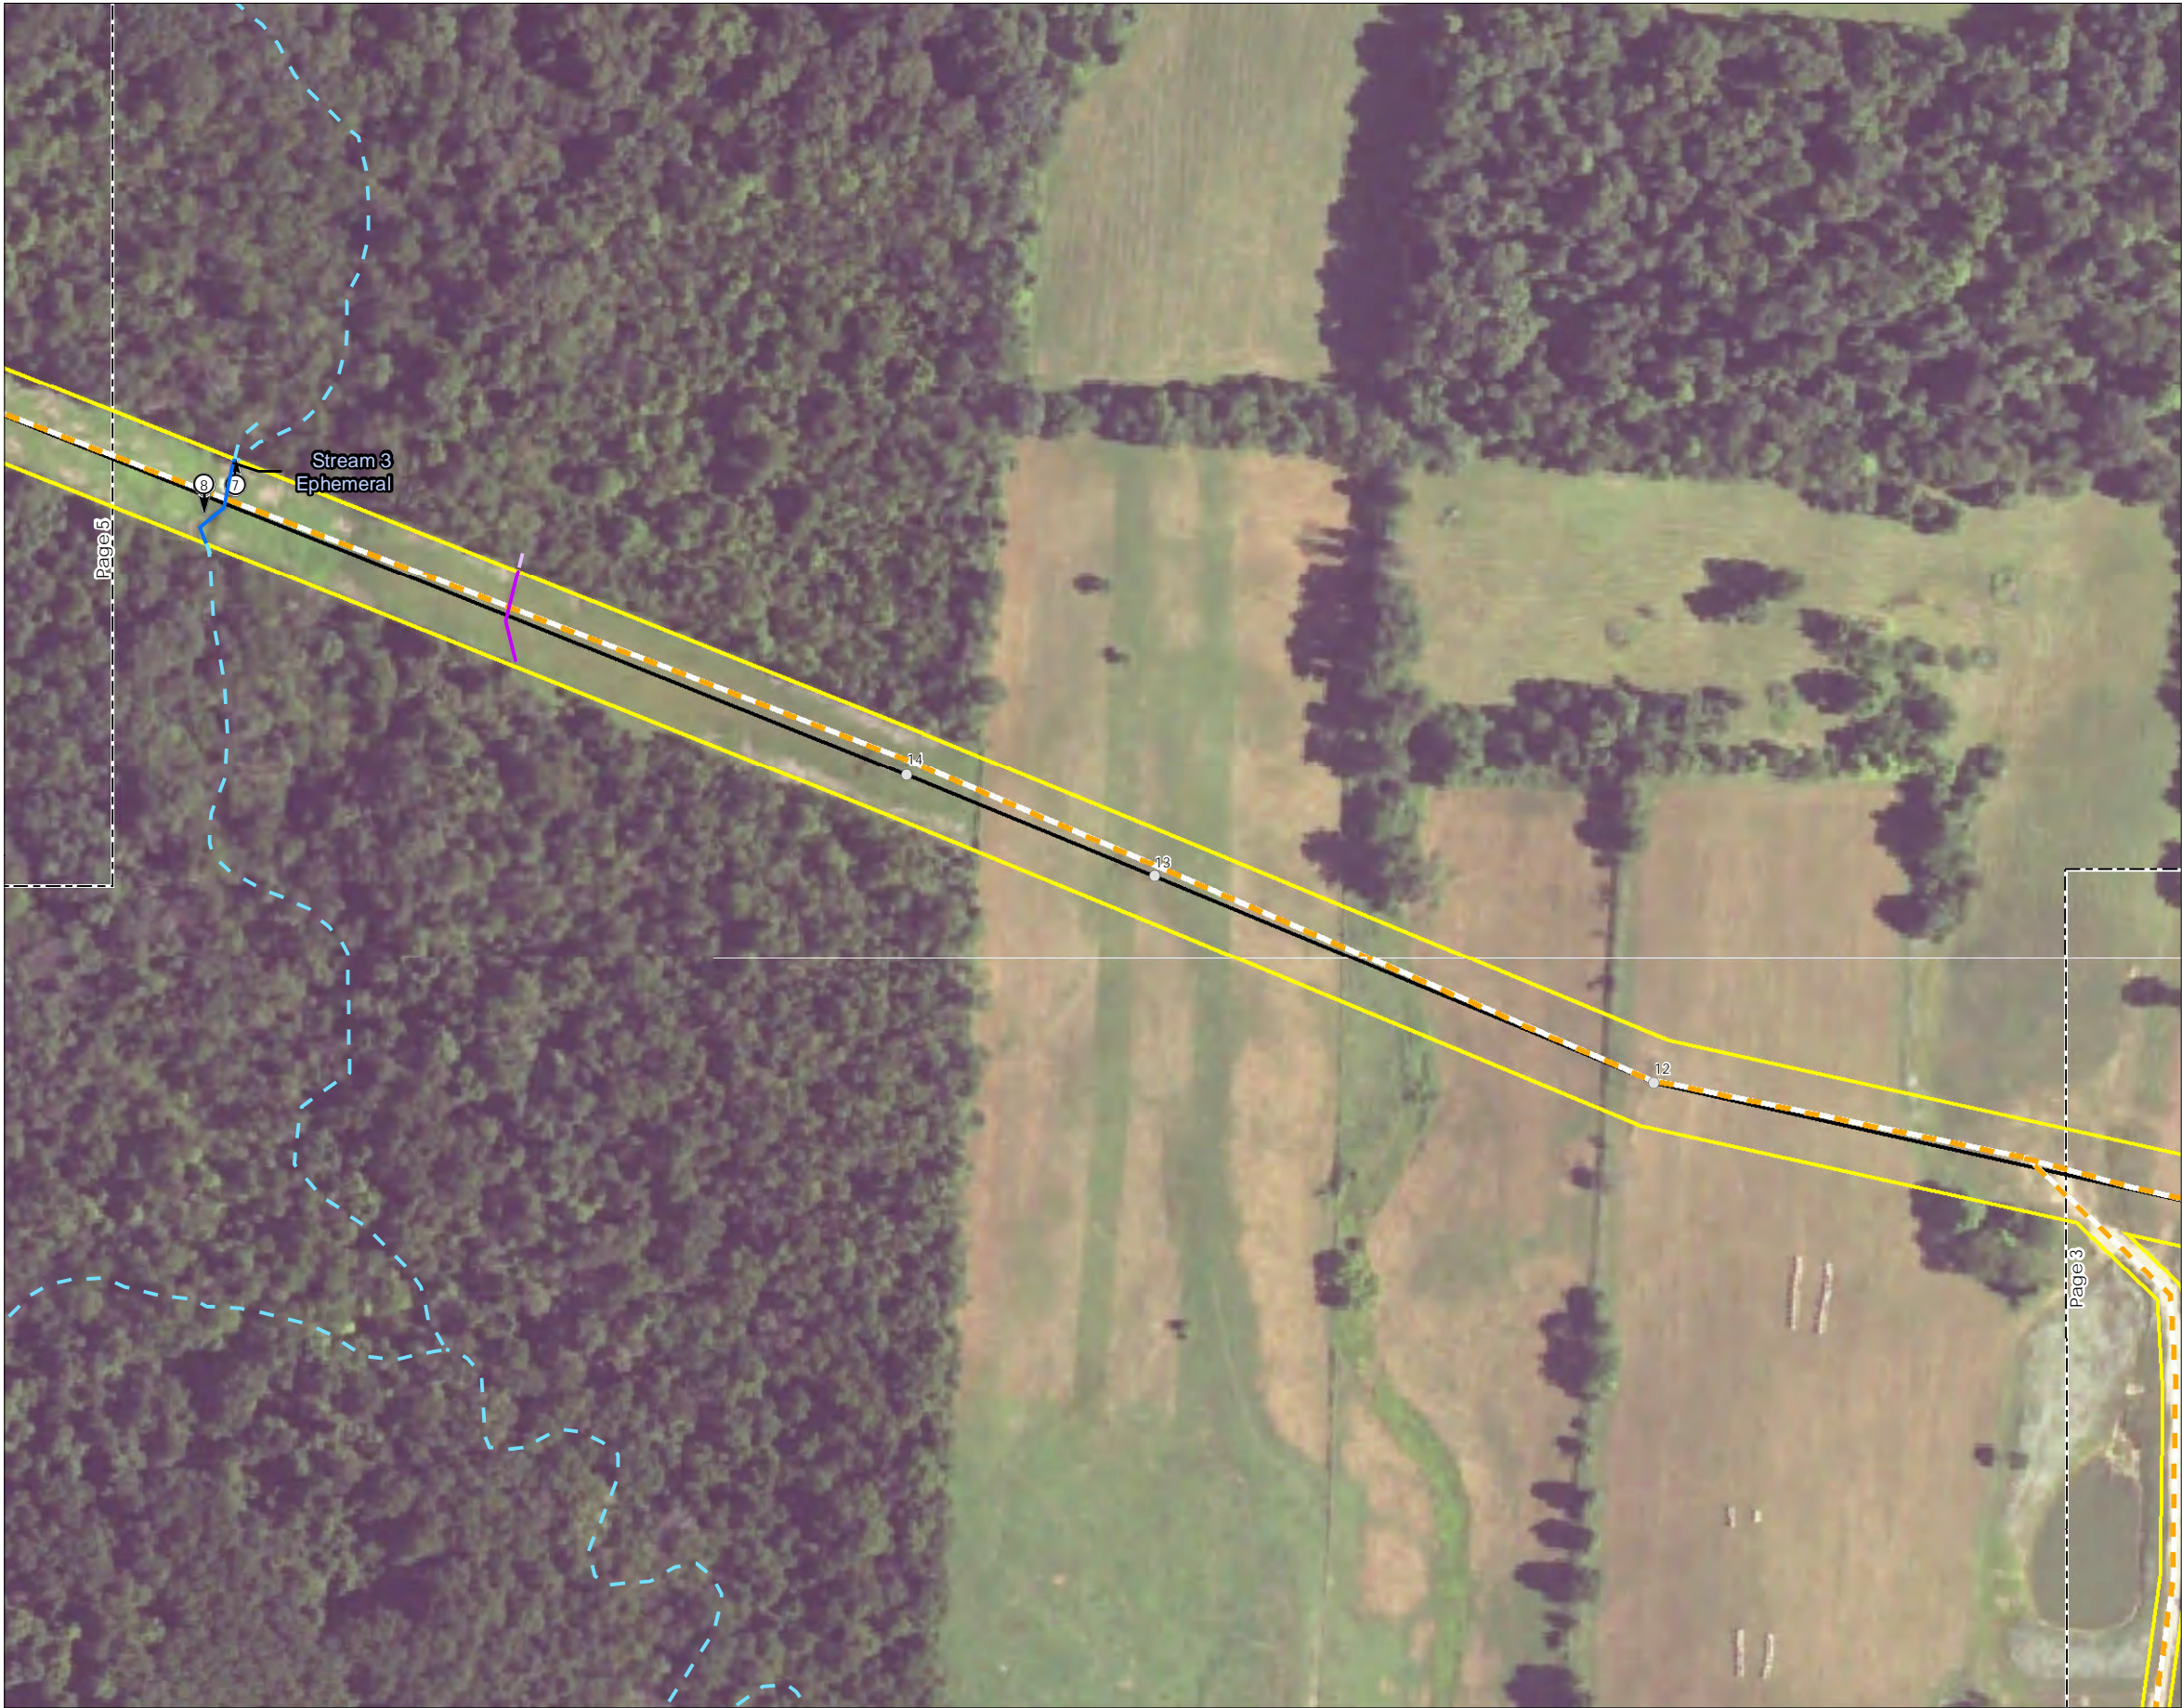
A.2 FIGURE 2 – WETLAND AND WATERBODY DELINEATION MAP

Title
Wetland and Waterbody
Delineation Map

Stantec completed field surveys within the Project area on August 10 through 12, 2016, for wetlands, waterbodies, and threatened and endangered species or their habitats. Figure 2 (Appendix A) shows the wetlands and waterbodies identified by Stantec within the Project area, as well as the locations of upland drainage features identified within the Project area. Figure 3 (Appendix A) shows the habitats and locations of any identified rare, threatened or endangered species habitat observed within the Project area during the rare, threatened, and endangered species habitat assessment surveys. Representative photographs of the wetlands, streams, upland drainage features, and other habitats identified within the Project area are included in Appendix C of this report (photo locations are shown on Figures 2 and 3, Appendix A). Completed wetland determination, ORAM, QHEI, and HHEI data forms are included in Appendix D.
