Client/Project
American Electric Power
Hedding Station - Fulton Station
138 kV Transmission Line Rebuild Project

**HEDDING STATION – FULTON STATION 138 KV TRANSMISSION LINE REBUILD PROJECT,
MORROW COUNTY, OHIO**

Appendix C Representative Photographs

Wetland and Waterbody Photographs

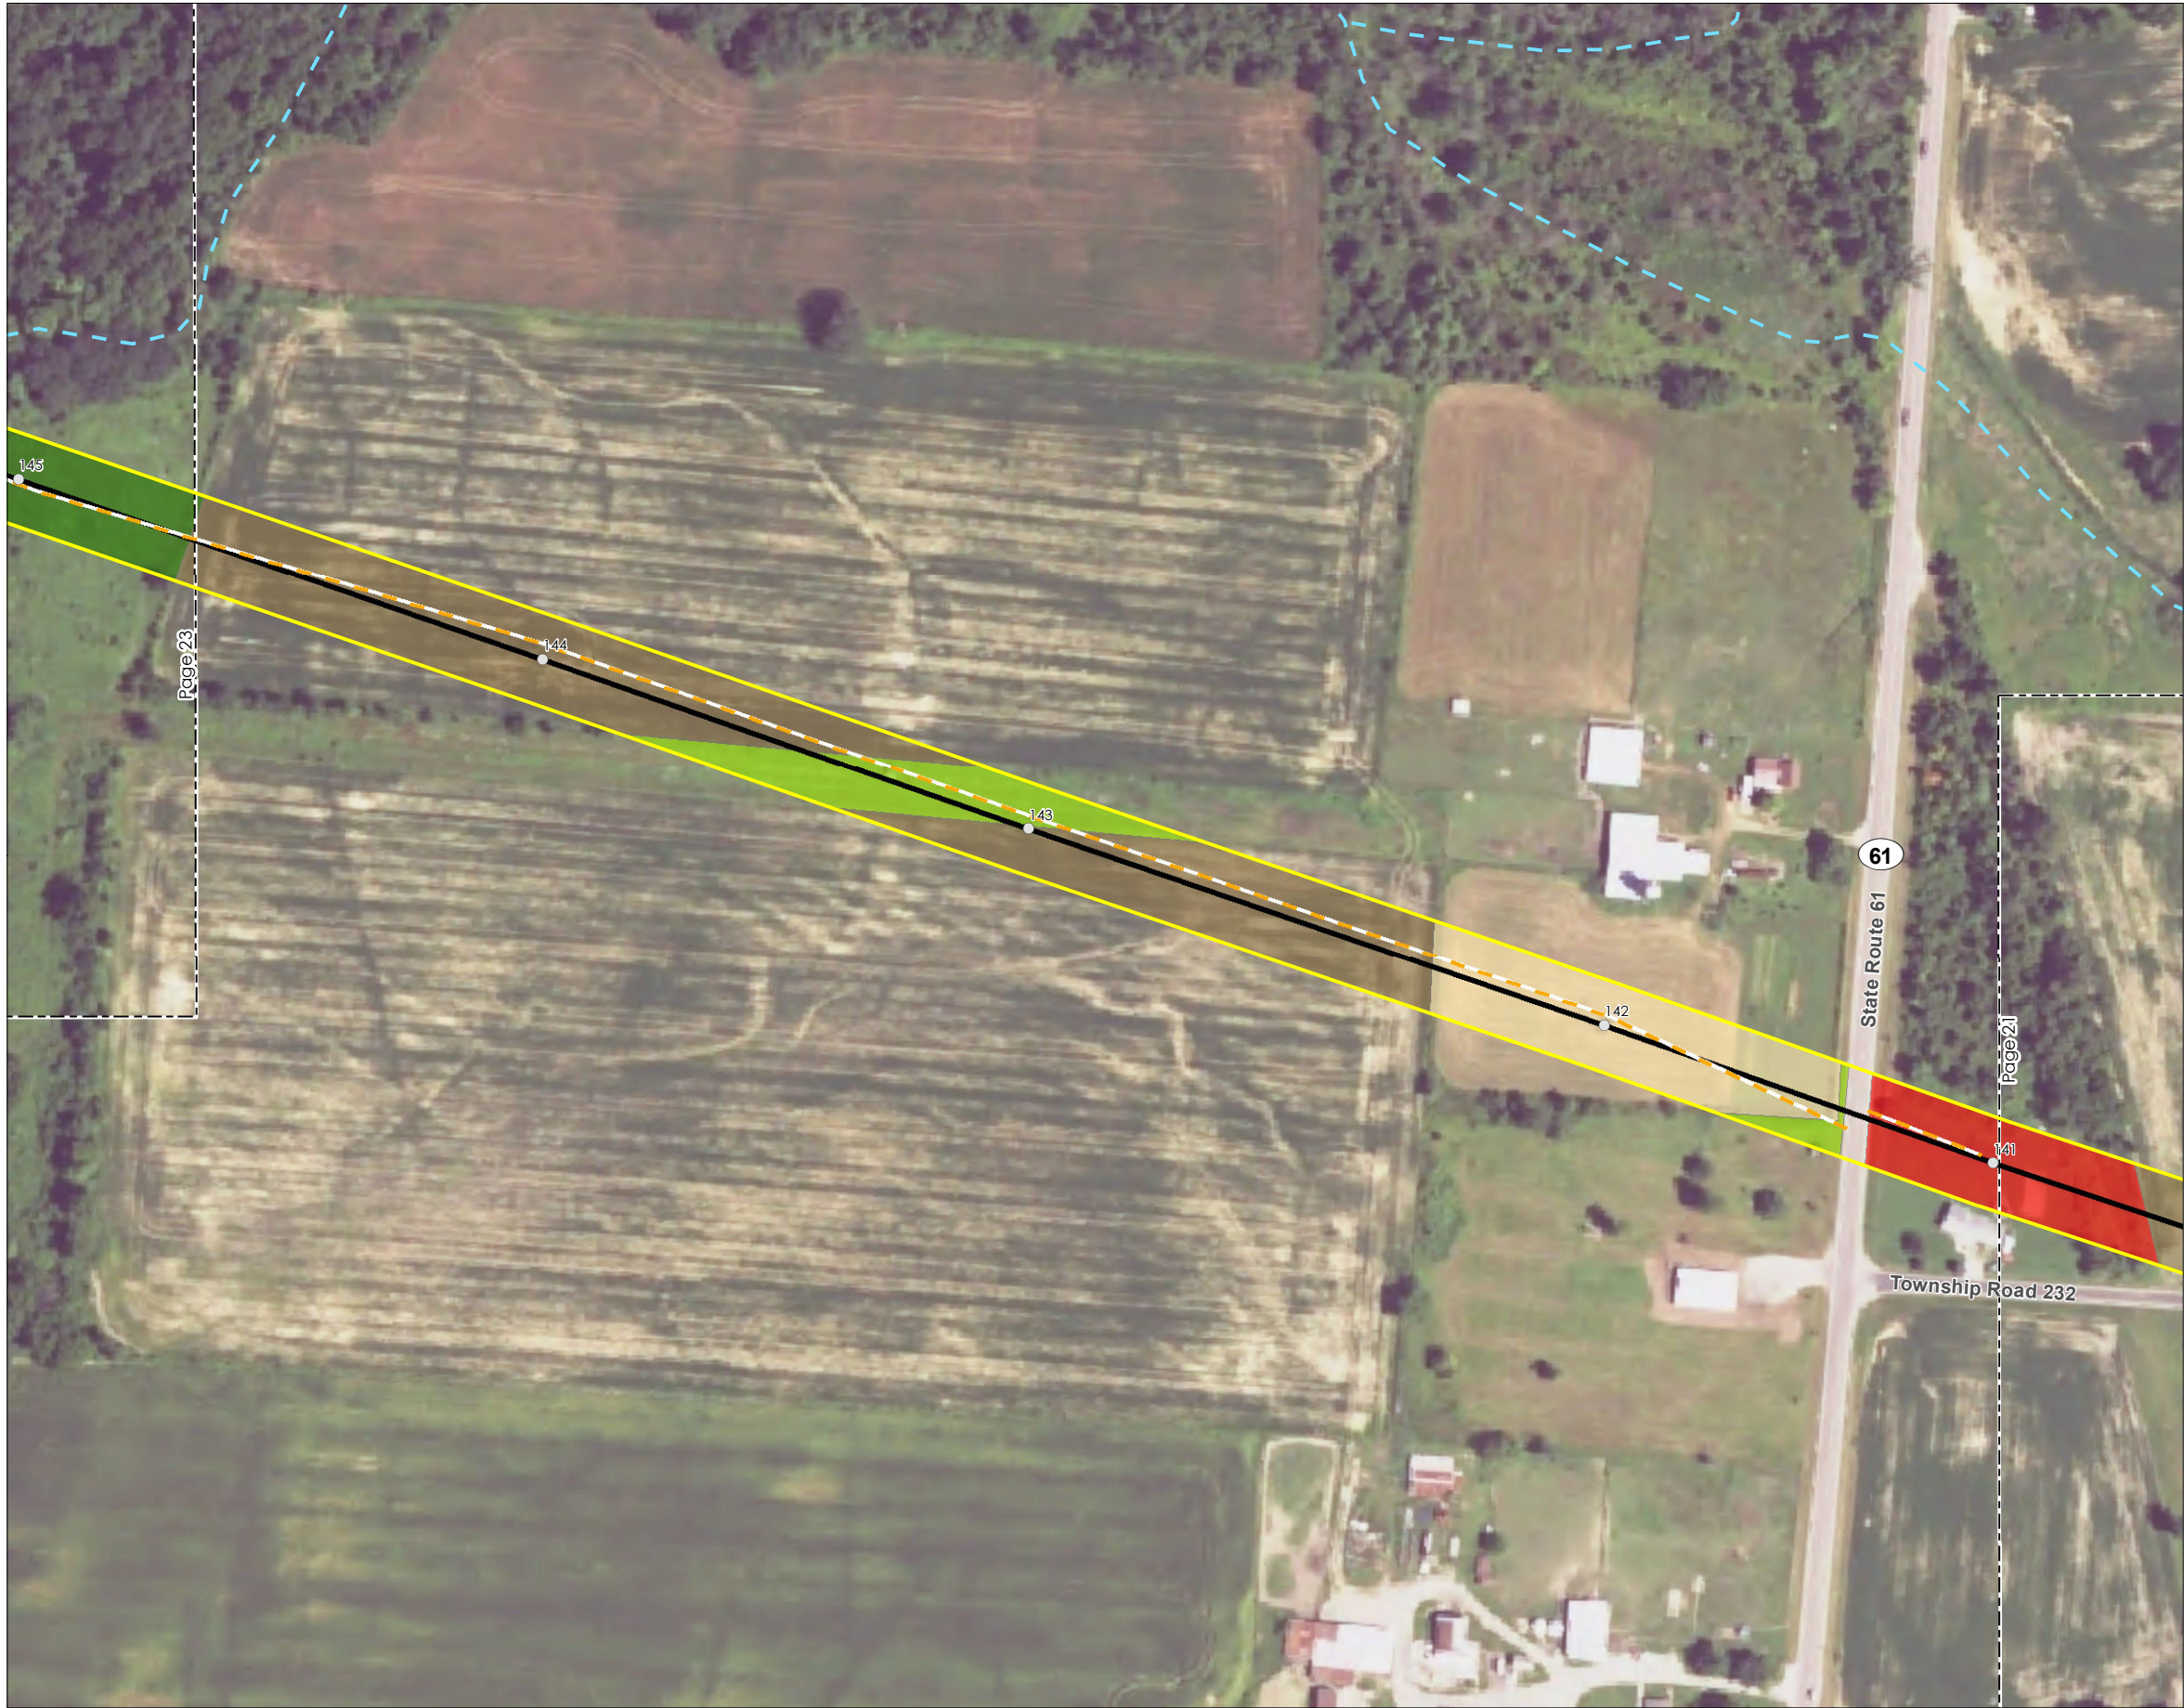
Figure No.
3

Title
Habitat Assessment Map

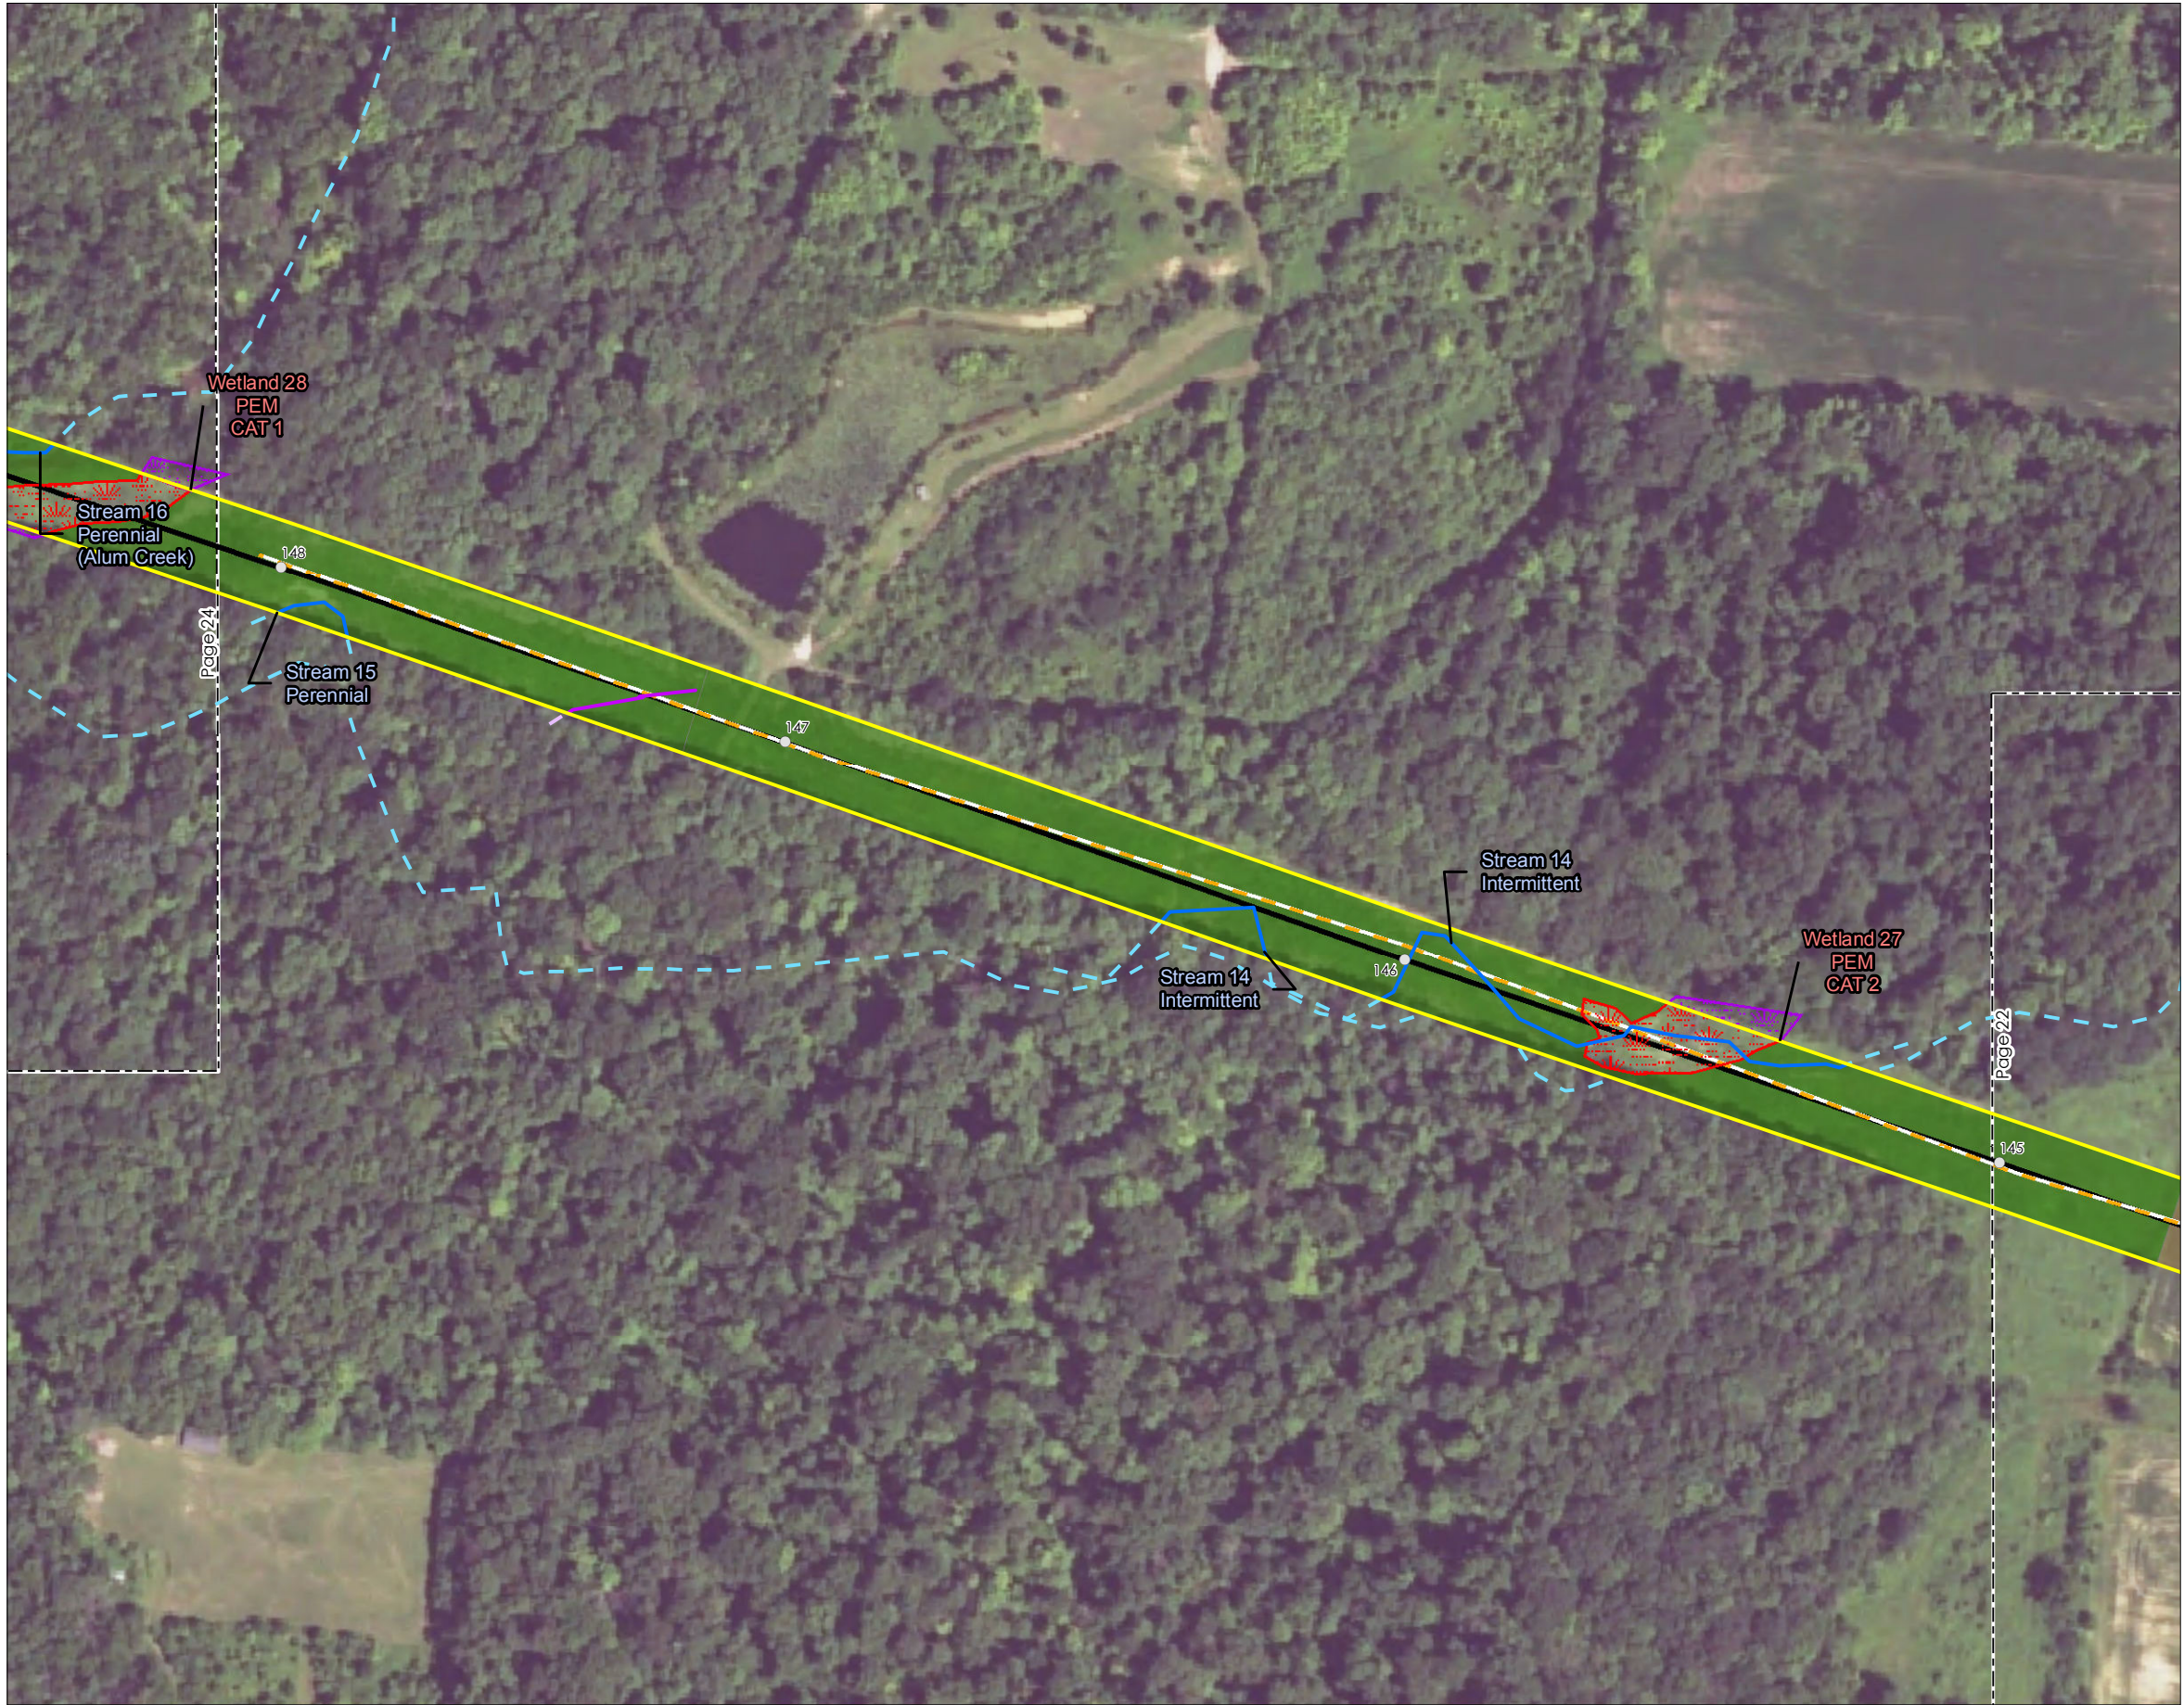
Figure No.
3

Title
Habitat Assessment Map

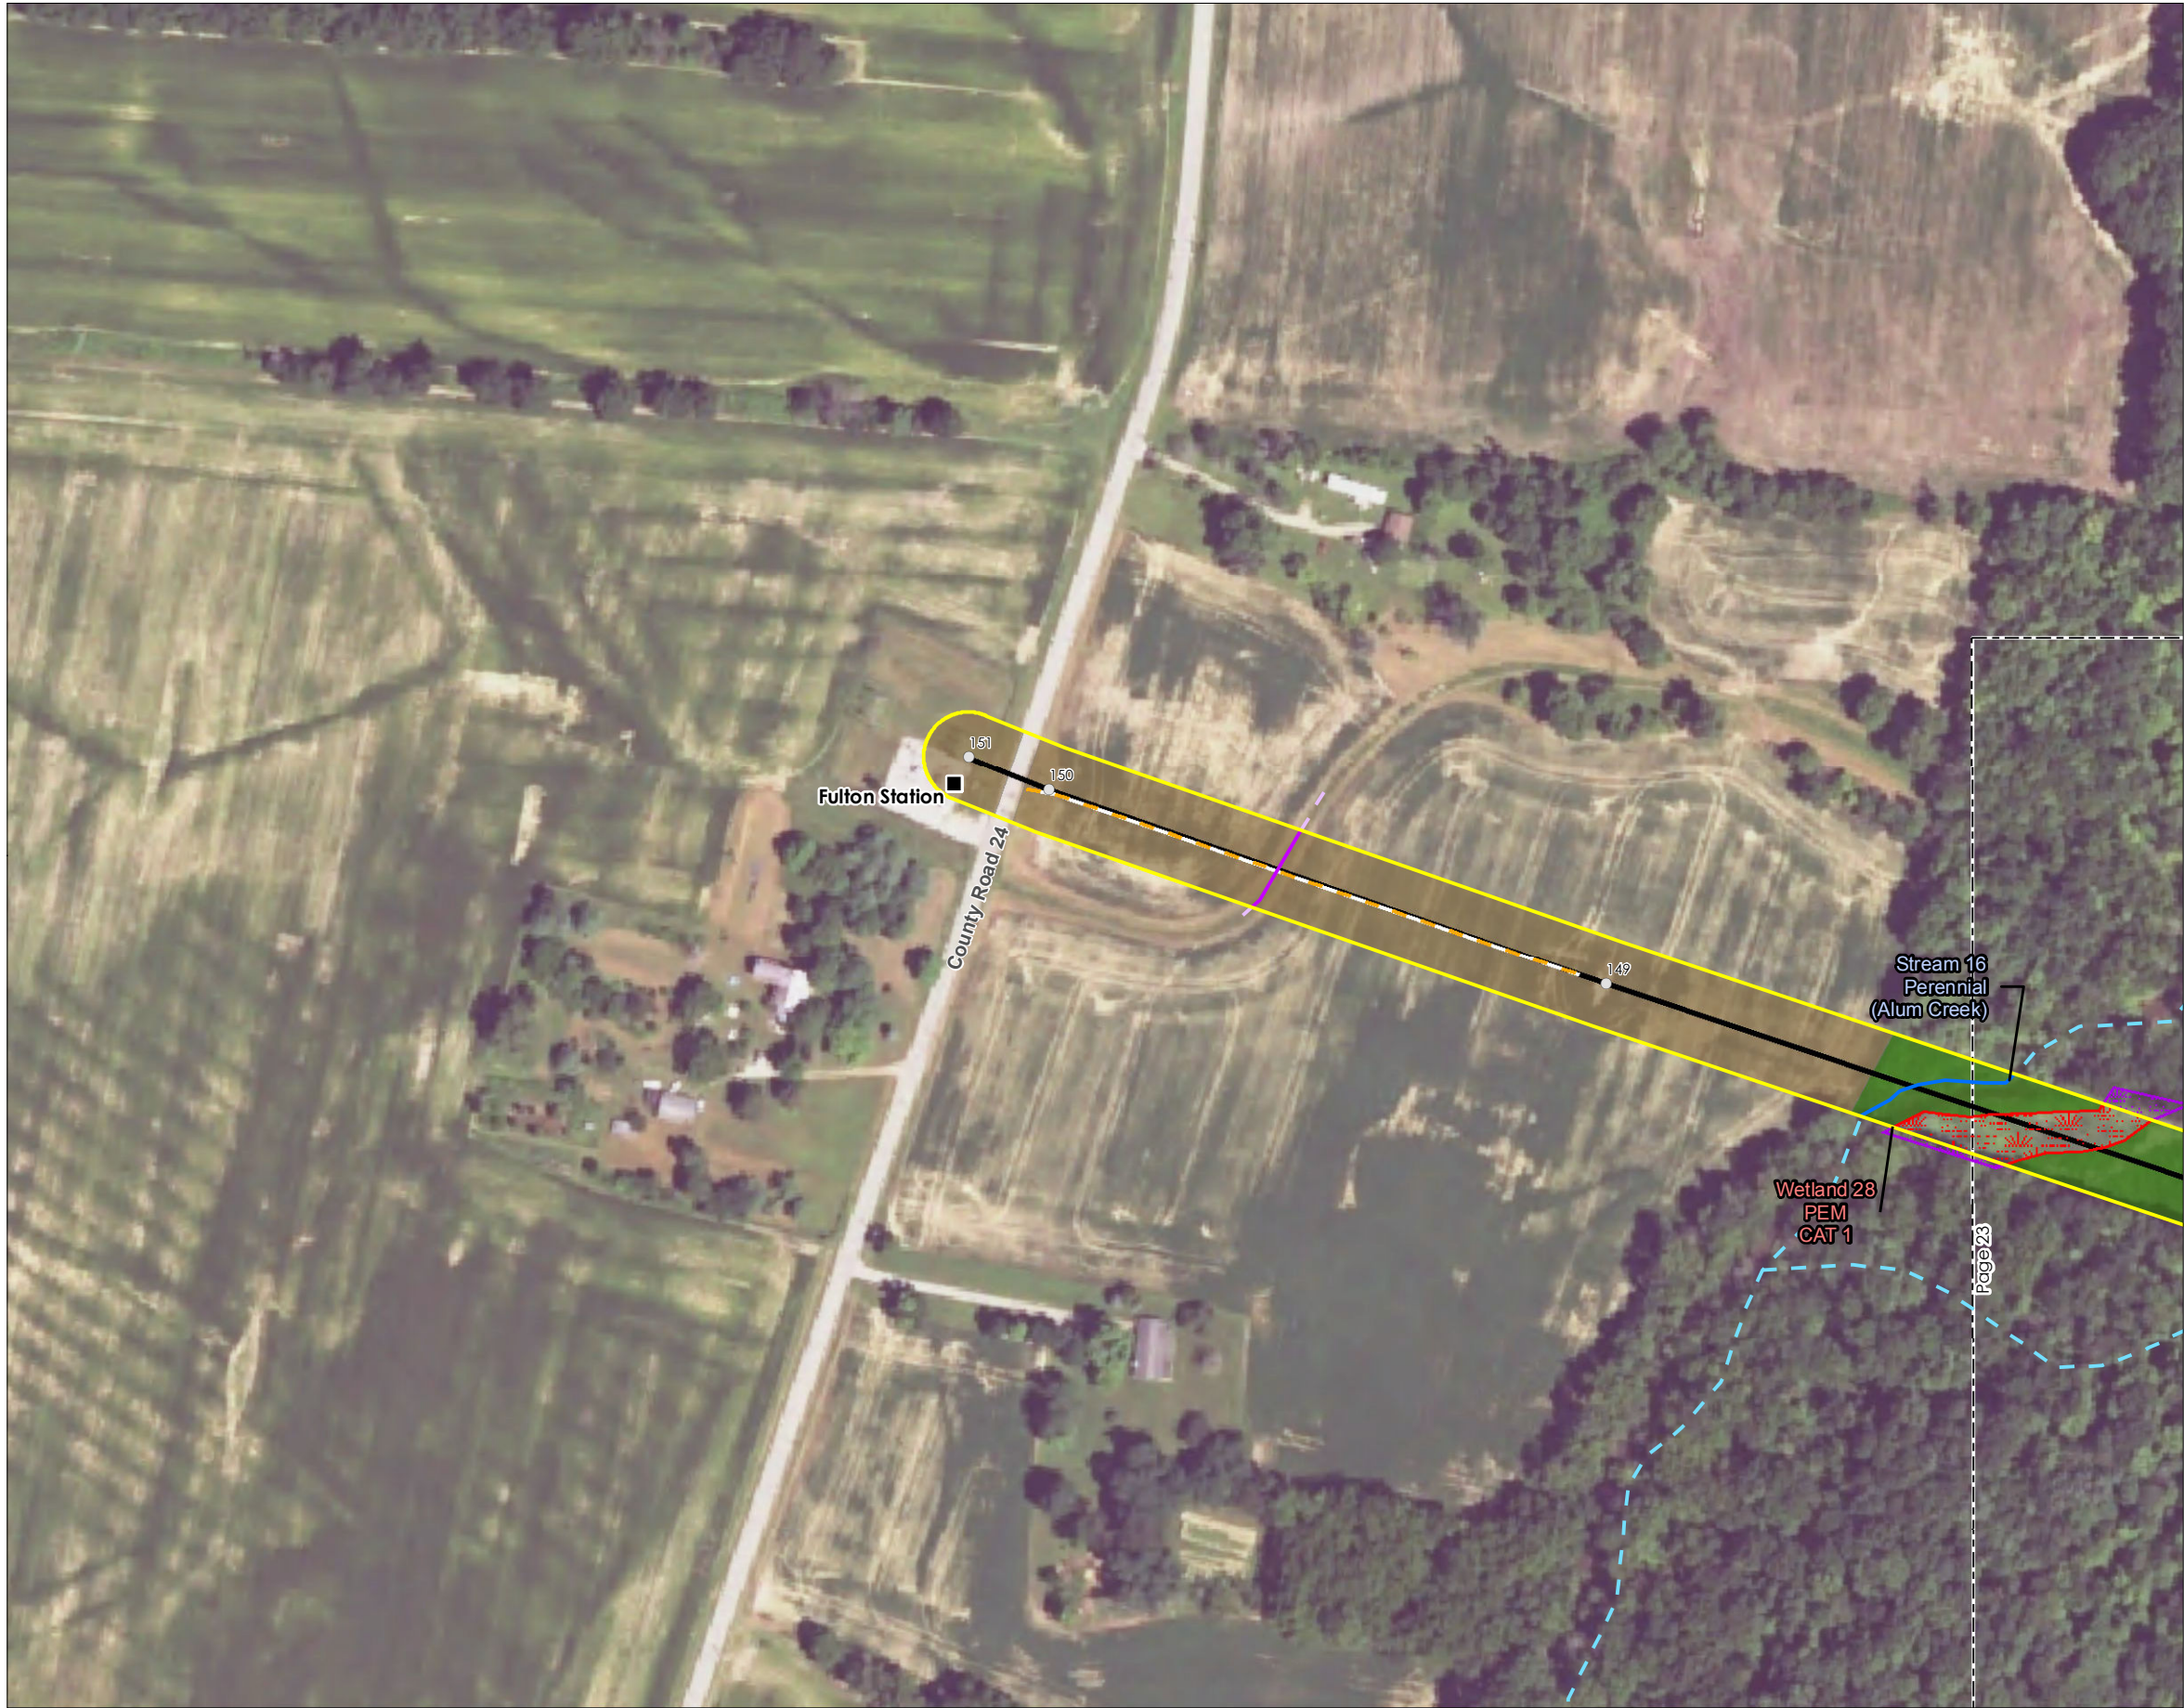
Figure No.
3

Title
Habitat Assessment Map

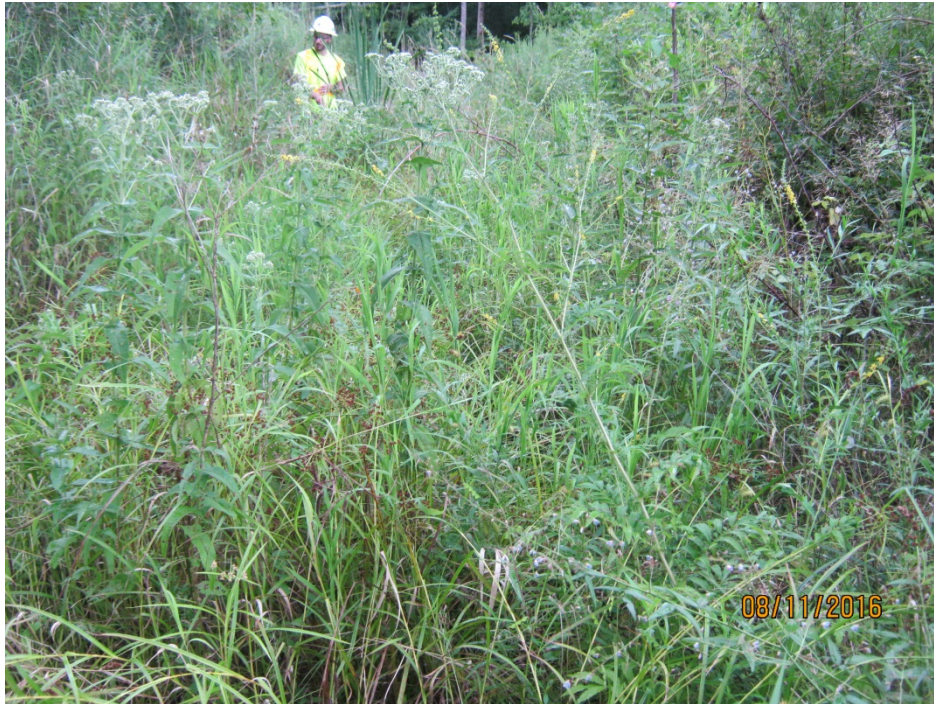
Photograph 1. View of wetland determination sample point (SP 1) within Wetland 1. Photograph taken facing northwest.

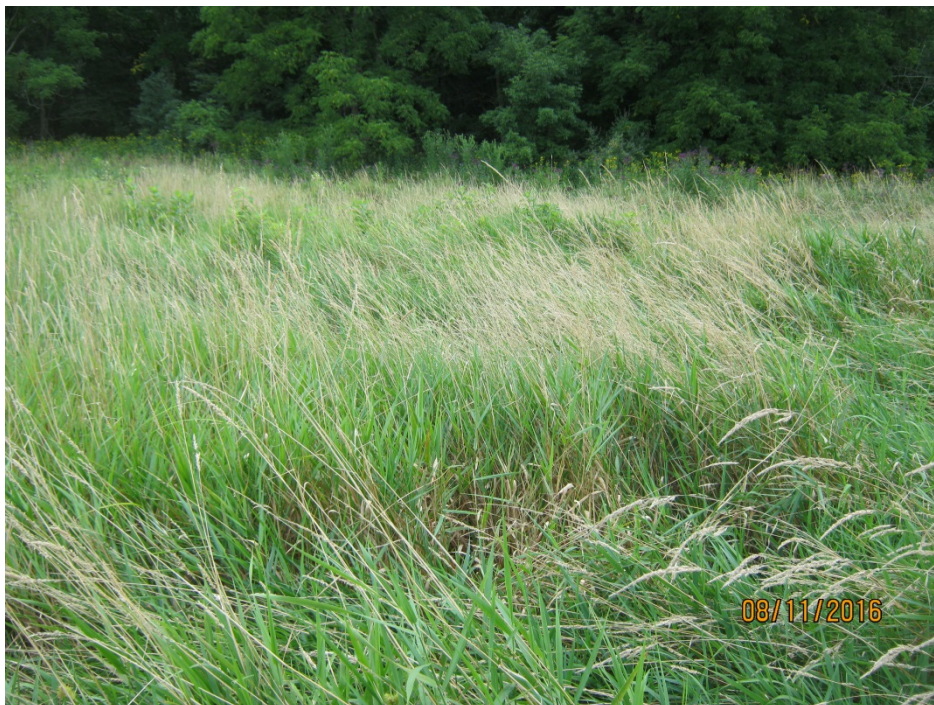
Photograph 2. View of wetland determination sample point (SP 3) within Wetland 2. Photograph taken facing southeast.

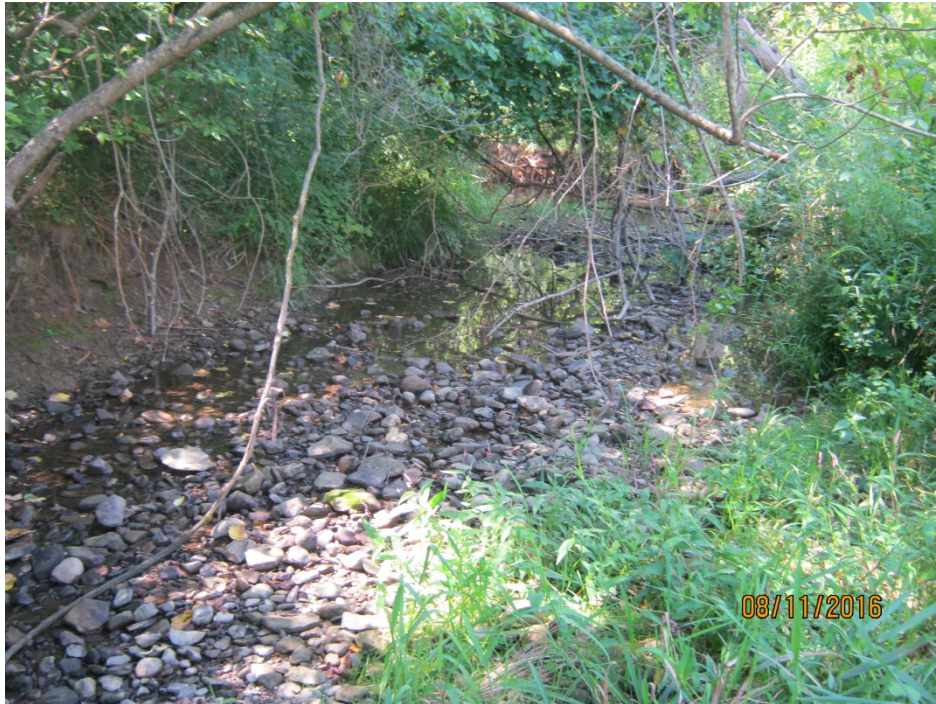
Photograph 3. View of Stream 1 (Mile Run). Photograph taken facing upstream/southeast.

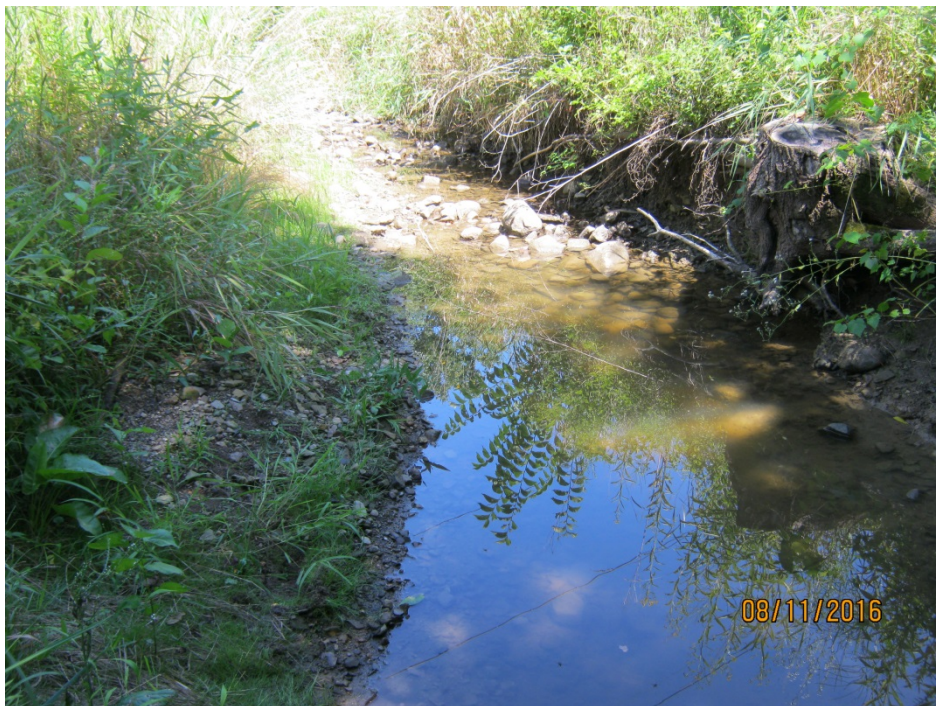
Photograph 4. View of Stream 1 (Mile Run). Photograph taken facing downstream/northwest.

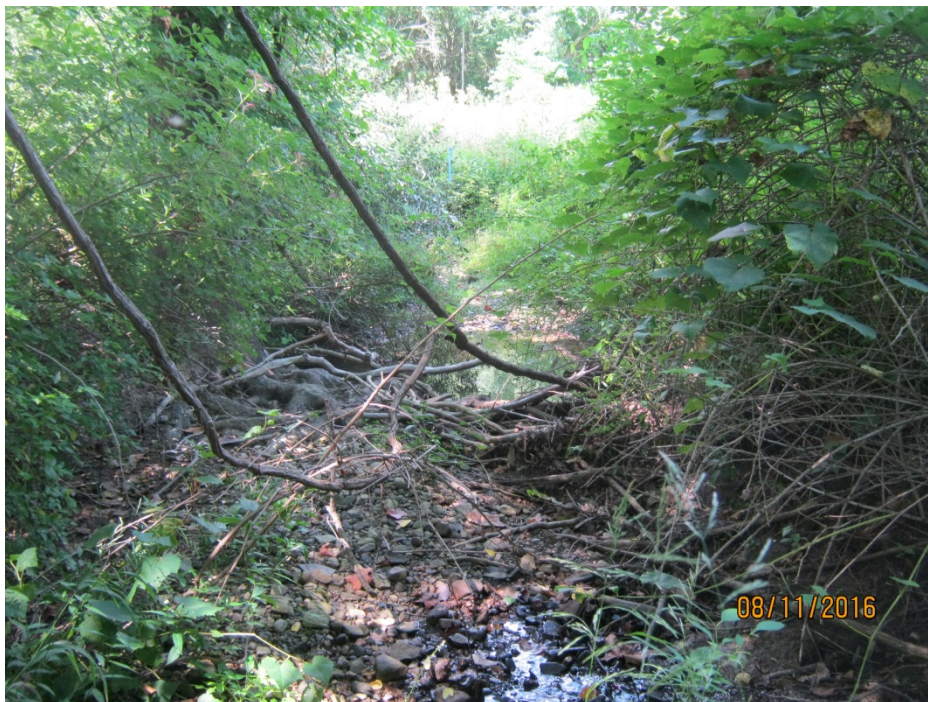
Photograph 6. View of Stream 2. Photograph taken facing downstream/southwest.

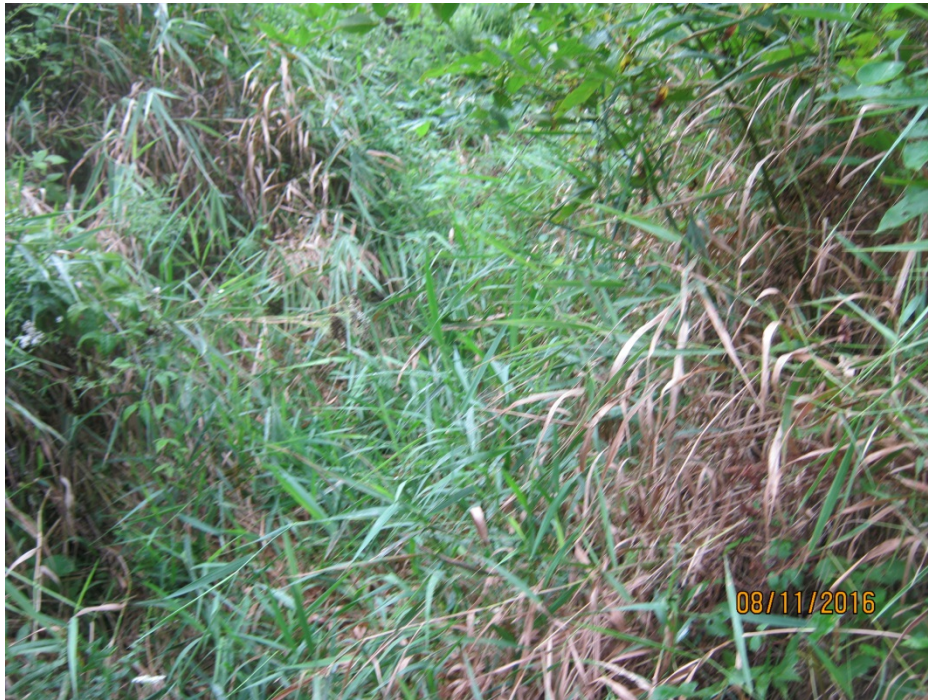
Photograph 7. View of Stream 3. Photograph taken facing upstream/north.

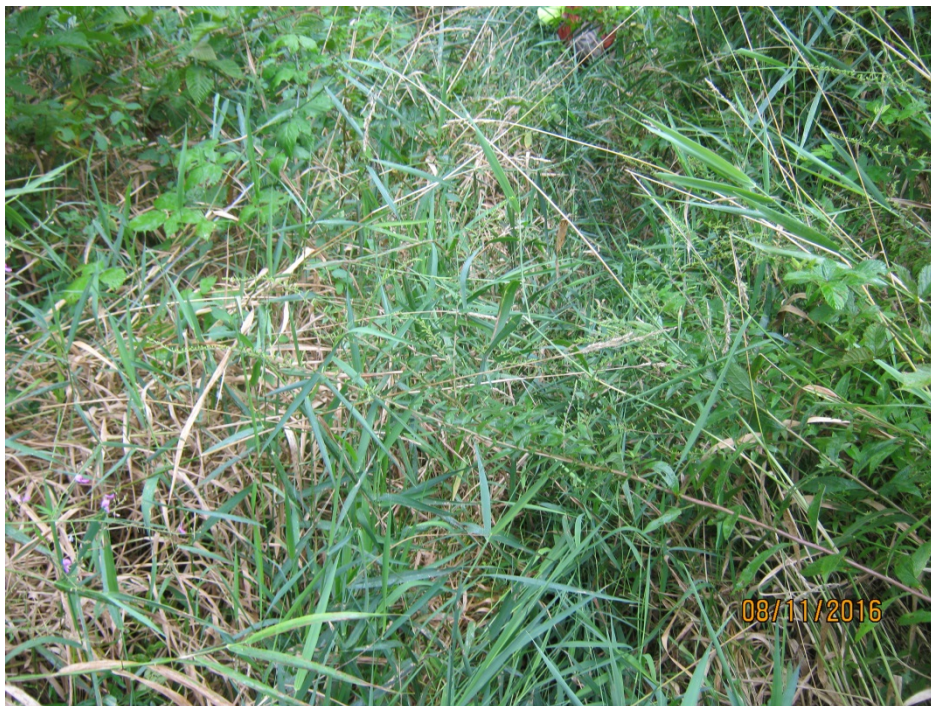
Photograph 8. View of Stream 3. Photograph taken facing downstream/southeast.
