**Herlan Station Project, Monroe  
County, Ohio**

**Ecological Resources Inventory  
Report**

Prepared by:  
Dan Godec  
Stantec Consulting Services Inc.

September 29, 2016

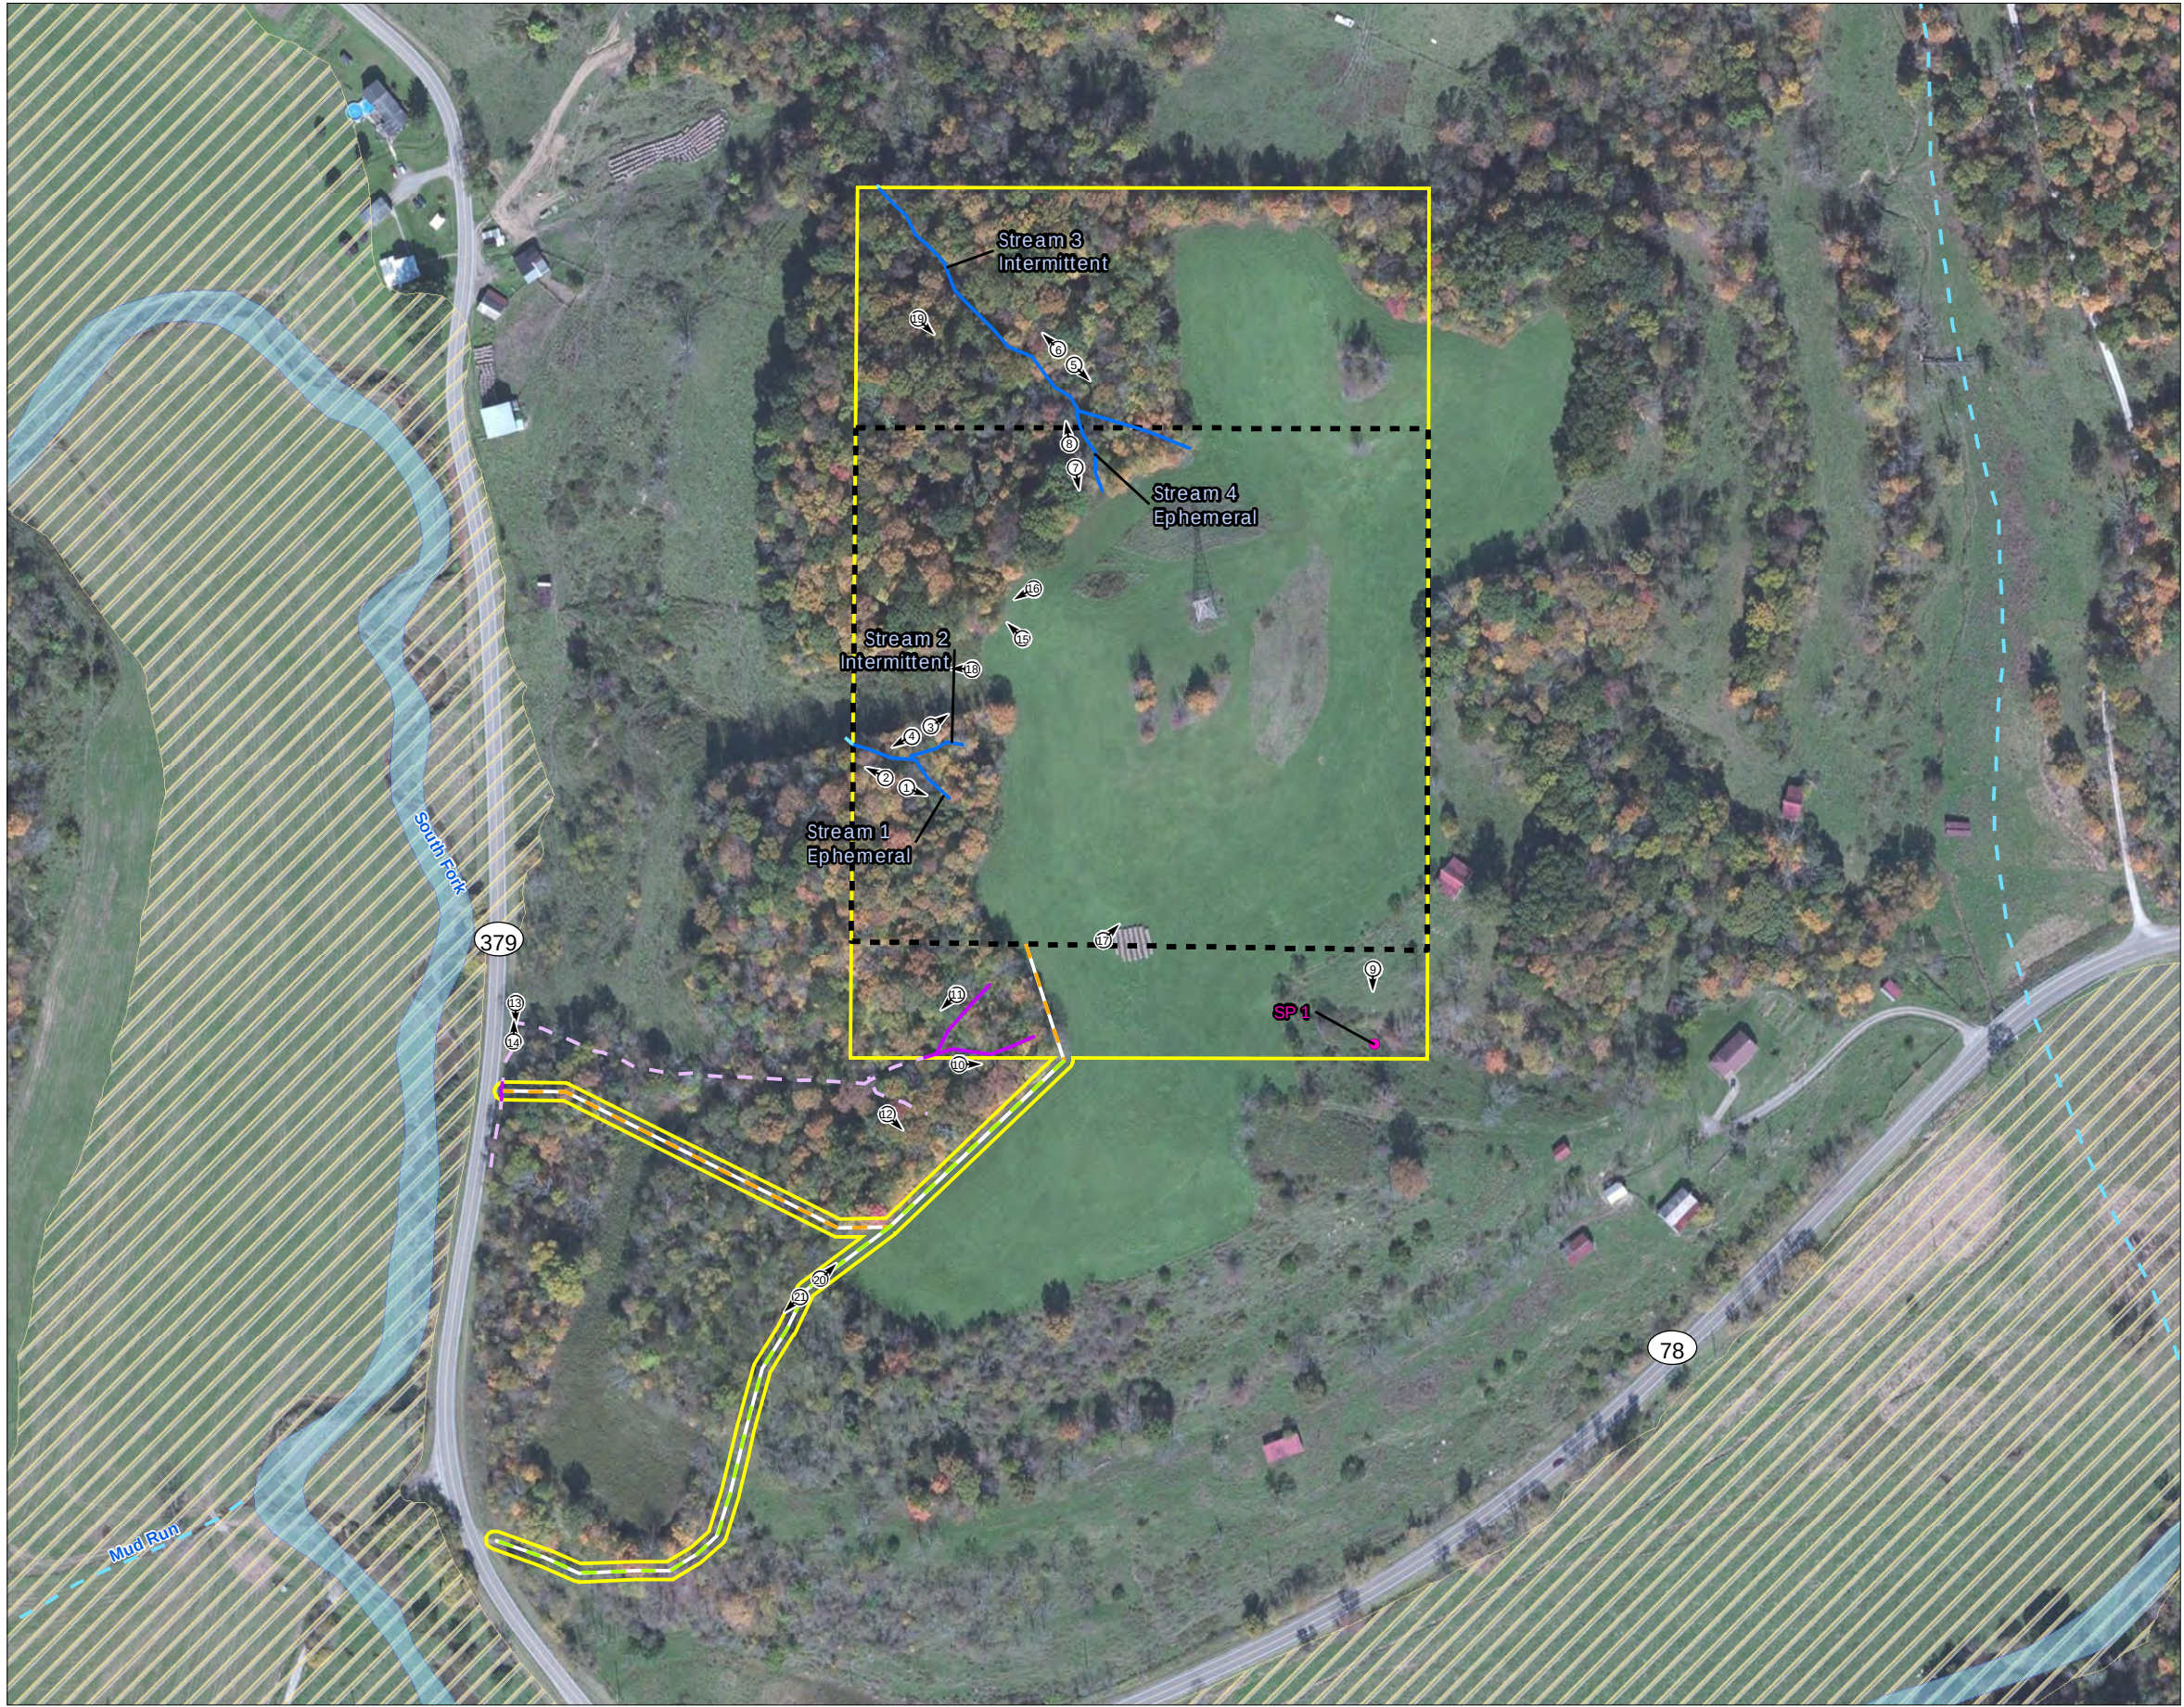
Title  
**Wetland and Waterbody  
Delineation Map**

Stantec completed field surveys within the Project area on August 4, 5, and 17, 2016, for wetlands, waterbodies, and threatened and endangered species or their habitats. Figure 2 (Appendix A) shows the wetlands and waterbodies identified by Stantec within the Project area, as well as the locations of upland drainage features identified within the Project area. Figure 3 (Appendix A) shows the habitats and locations of any identified rare, threatened or endangered species observed within the Project area during the rare, threatened, and endangered species habitat assessment surveys. Representative photographs of the wetlands, streams, upland drainage features, and other habitats identified within the Project area are included in Appendix C of this report (photo locations are shown on Figures 2 and 3, Appendix A). Completed wetland determination and HHEI data forms are included in Appendix D.

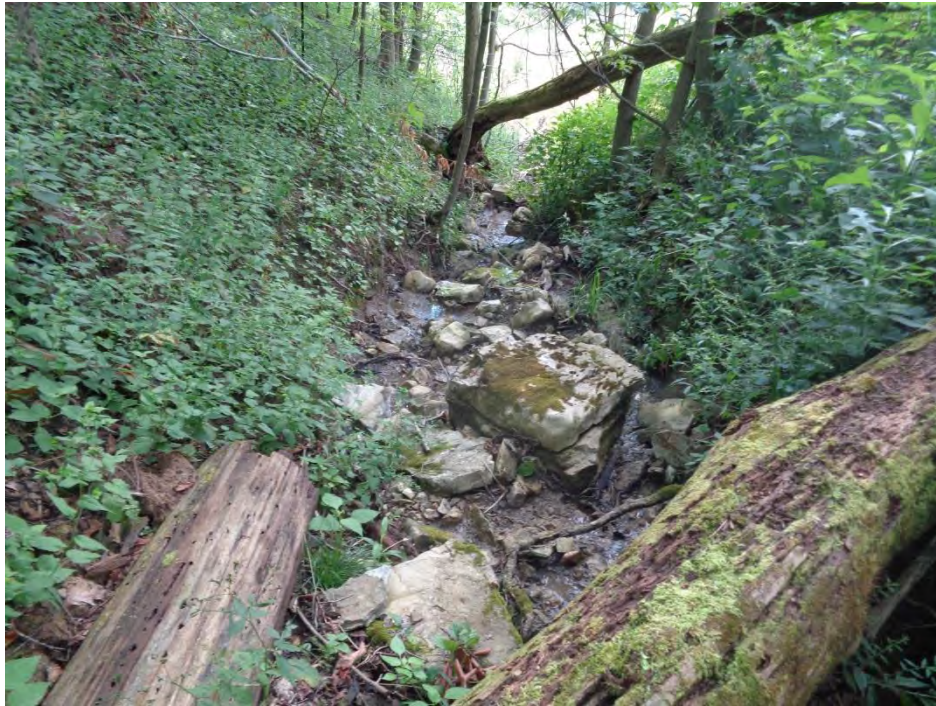
| Stream Name | Photo Numbers <sup>1</sup> | Receiving Waters | Stream Flow Regime <sup>2</sup> | Stream Evaluation Method | Stream Evaluation Score | OHWM Width (feet) <sup>3</sup> | Delineated Length (feet) within Project Study Area |
|---|---|---|---|---|---|---|---|
| Stream 1 | 1, 2 | South Fork | Intermittent | HHEI | 33 | 2 | 162.5 |

Photograph 1. View of Stream 1. Photo taken facing upstream.

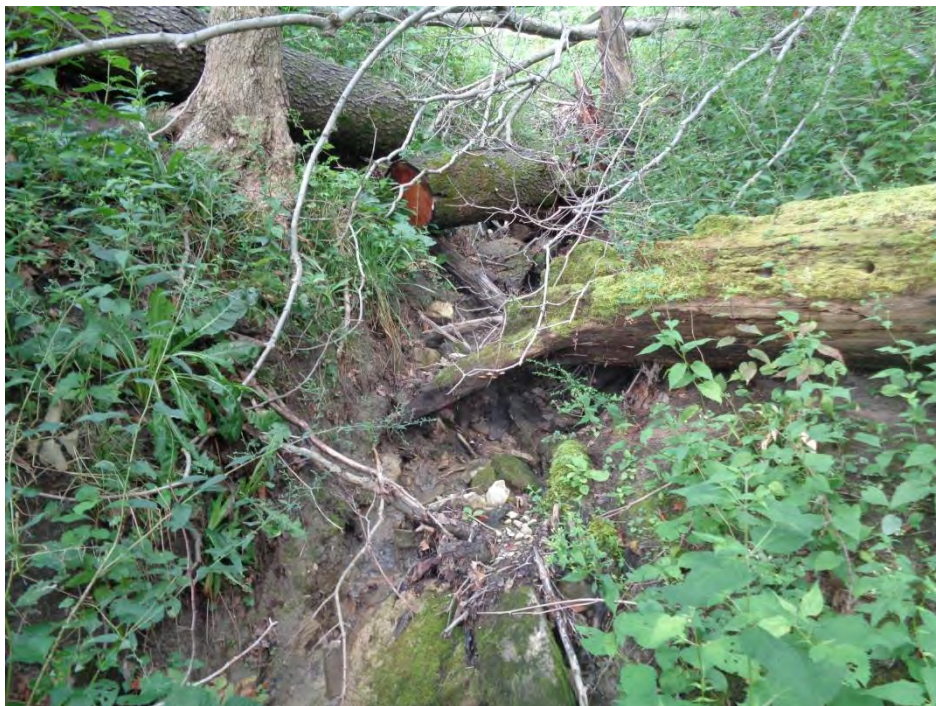
Photograph 2. View of Stream 1. Photo taken facing downstream.

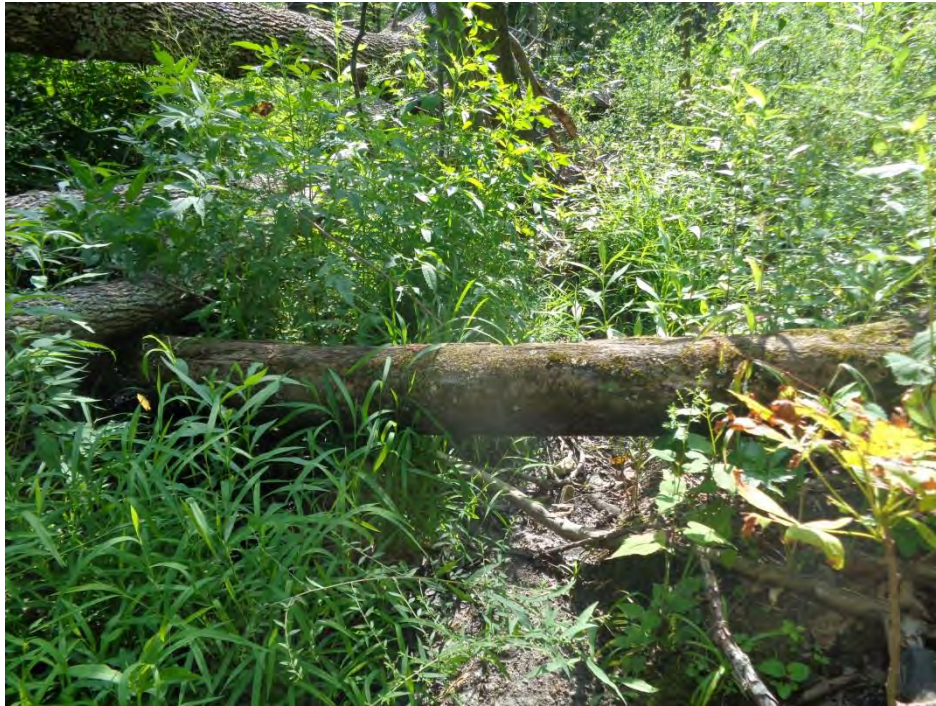
| Stream Name | Photo Numbers <sup>1</sup> | Receiving Waters | Stream Flow Regime <sup>2</sup> | Stream Evaluation Method | Stream Evaluation Score | OHWM Width (feet) <sup>3</sup> | Delineated Length (feet) within Project Study Area |
|---|---|---|---|---|---|---|---|
| Stream 2 | 3, 4 | South Fork | Intermittent | HHEI | 20 | 1.5 | 77.1 |

Photograph 3. View of Stream 2. Photo taken facing upstream.

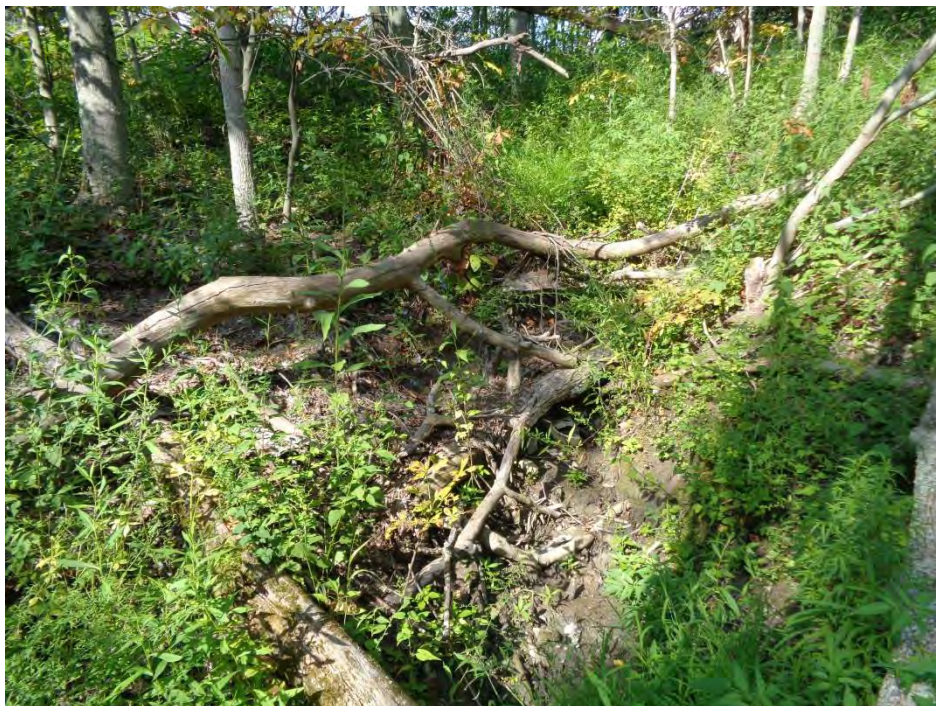
Photograph 4. View of Stream 2. Photo taken facing downstream.

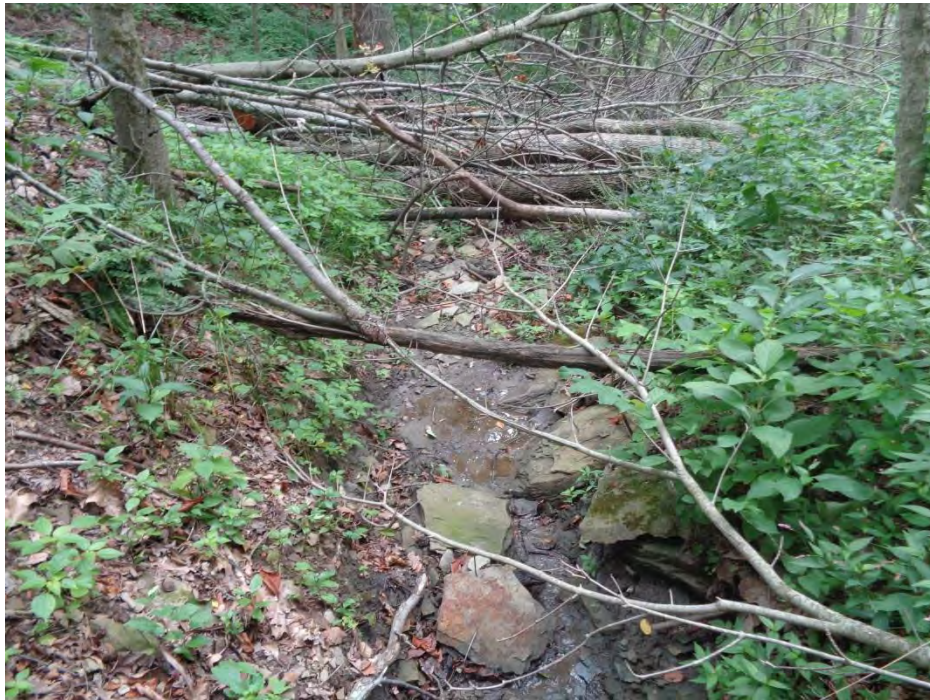
| Stream Name | Photo Numbers <sup>1</sup> | Receiving Waters | Stream Flow Regime <sup>2</sup> | Stream Evaluation Method | Stream Evaluation Score | OHWM Width (feet) <sup>3</sup> | Delineated Length (feet) within Project Study Area |
|---|---|---|---|---|---|---|---|
| Stream 3 | 5, 6 | South Fork | Intermittent | HHEI | 39 | 2 | 594.7 |

Photograph 5. View of Stream 3. Photo taken facing upstream.

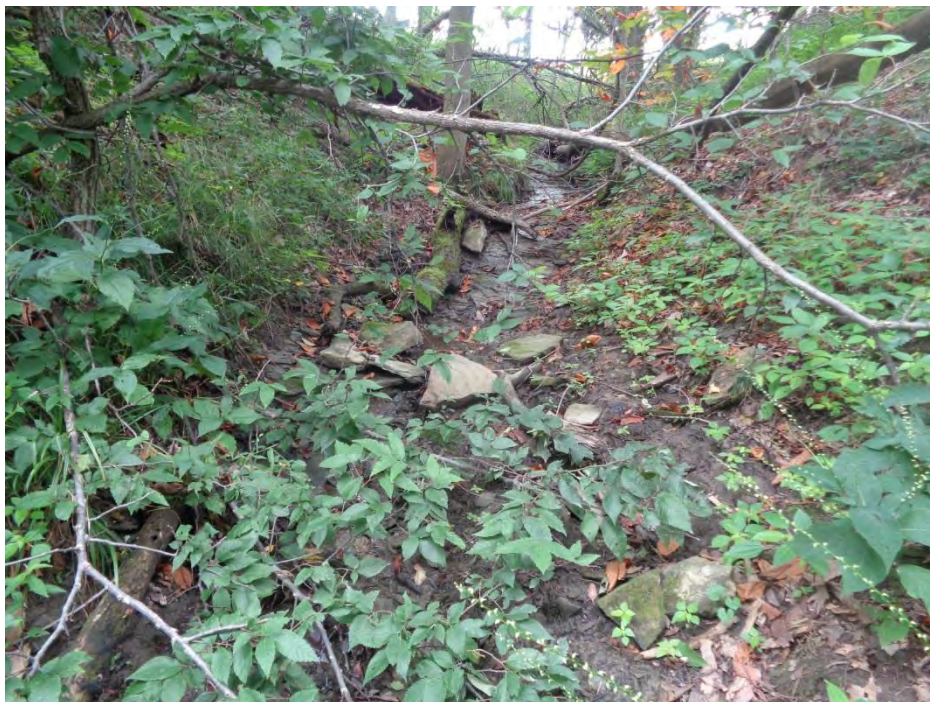
Photograph 6. View of Stream 3. Photo taken facing downstream.

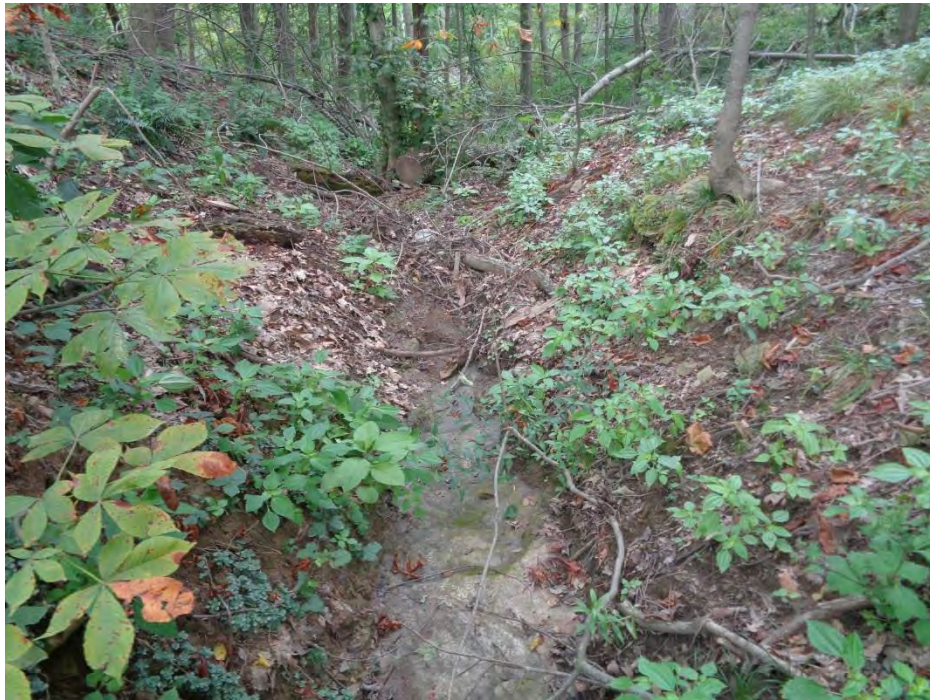
| Stream Name | Photo Numbers <sup>1</sup> | Receiving Waters | Stream Flow Regime <sup>2</sup> | Stream Evaluation Method | Stream Evaluation Score | OHWM Width (feet) <sup>3</sup> | Delineated Length (feet) within Project Study Area |
|---|---|---|---|---|---|---|---|
| Stream 4 | 7, 8 | South Fork | Ephemeral | HHEI | 18 | 1 | 119.4 |

Photograph 7. View of Stream 4. Photo taken facing downstream.

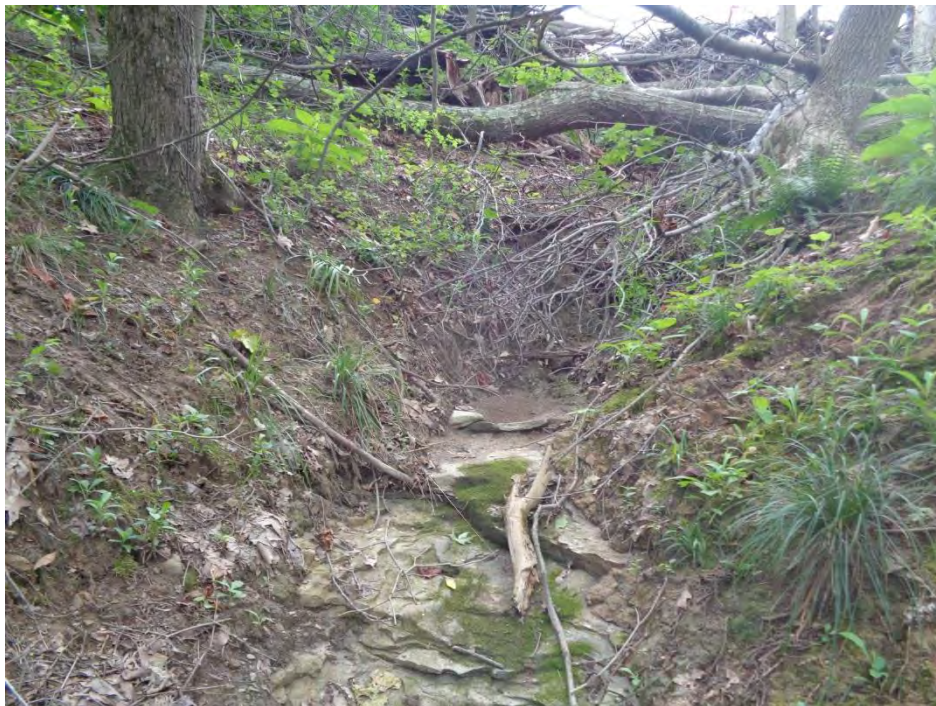
Photograph 8. View of Stream 4. Photo taken facing upstream.

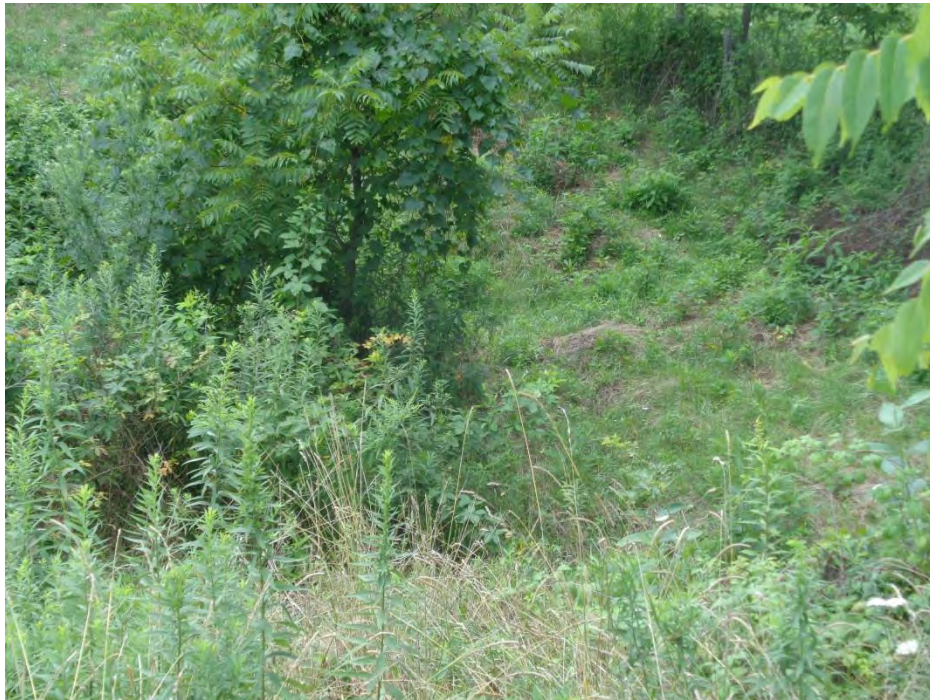
No wetlands were identified within the Project area. One wetland determination data form was completed in a low lying/old field area. This wetland determination sample point did not meet three criteria necessary to be considered a wetland.

Photograph 9. View of upland (old field habitat) at wetland determination sample point (SP 1).  
Photo taken facing south.

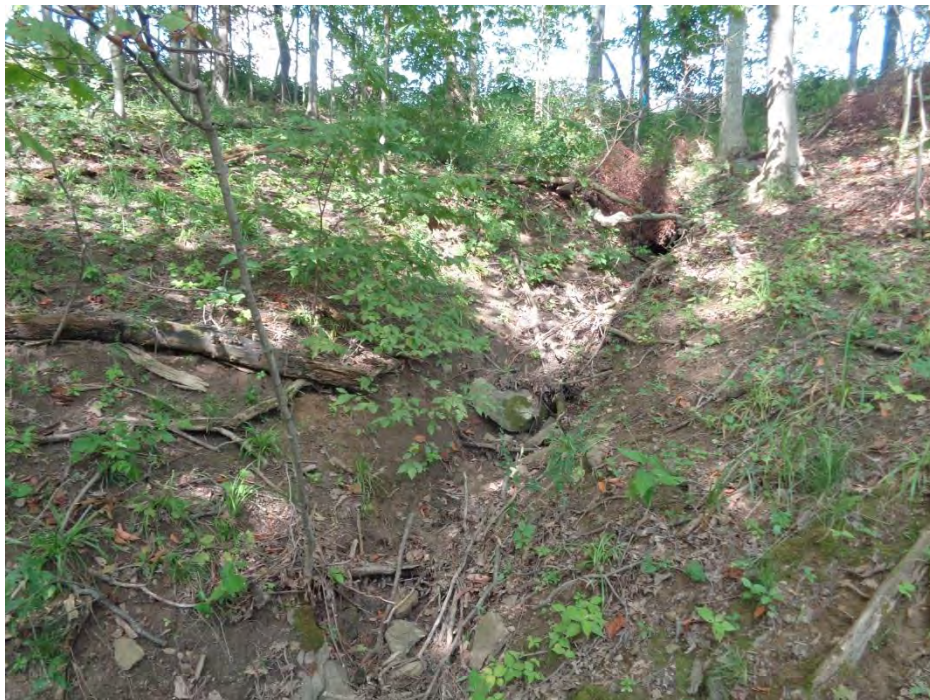
Three upland drainage features were identified in and/or near the southwest corner of the study area. These features appeared to exhibit the characteristics of a stream within the Project area. Upon further investigation outside of the study area, it was found that these features did not maintain a continuously defined bed, bank, and ordinary high water mark, and they did not have a connection to streams or other jurisdictional waters of the United States. Representative photographs of these features can be found in Appendix C.

Photograph 10. View of upland drainage feature within southwest portion of study area. Photo  
taken facing east.

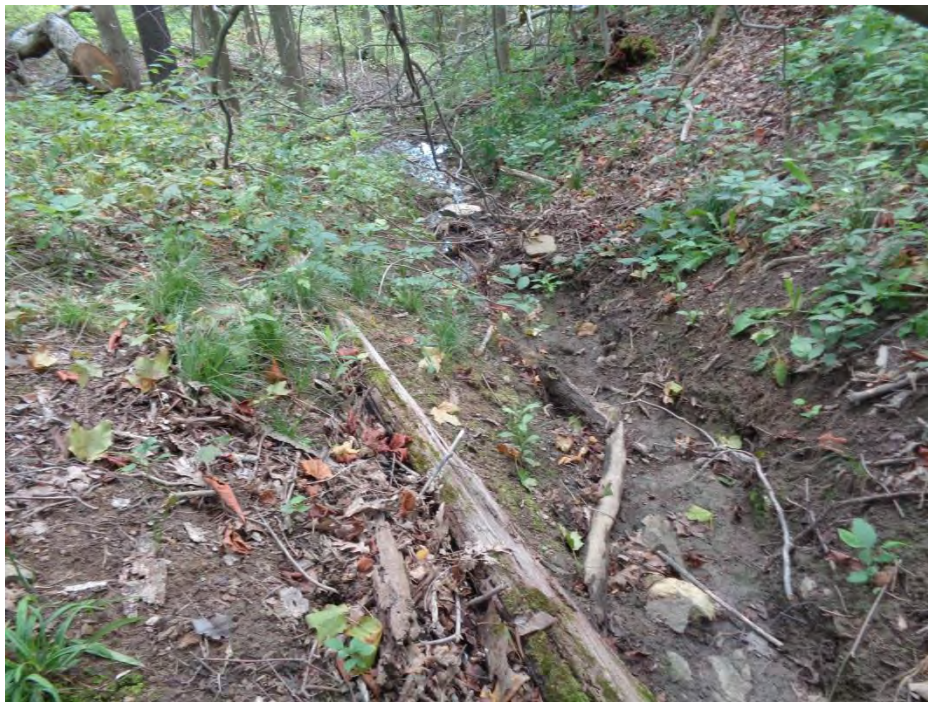
Photograph 11. View of upland drainage feature within southwest portion of study area. Photo taken facing southwest.

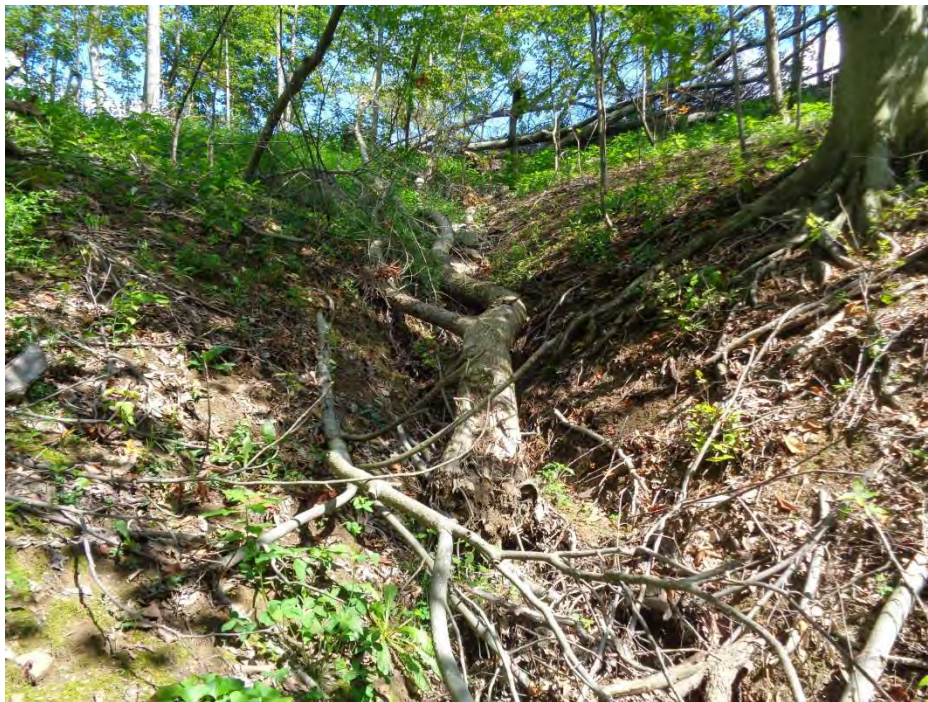
Photograph 12. View of upland drainage feature near southwest portion of study area. Photo taken facing southeast.

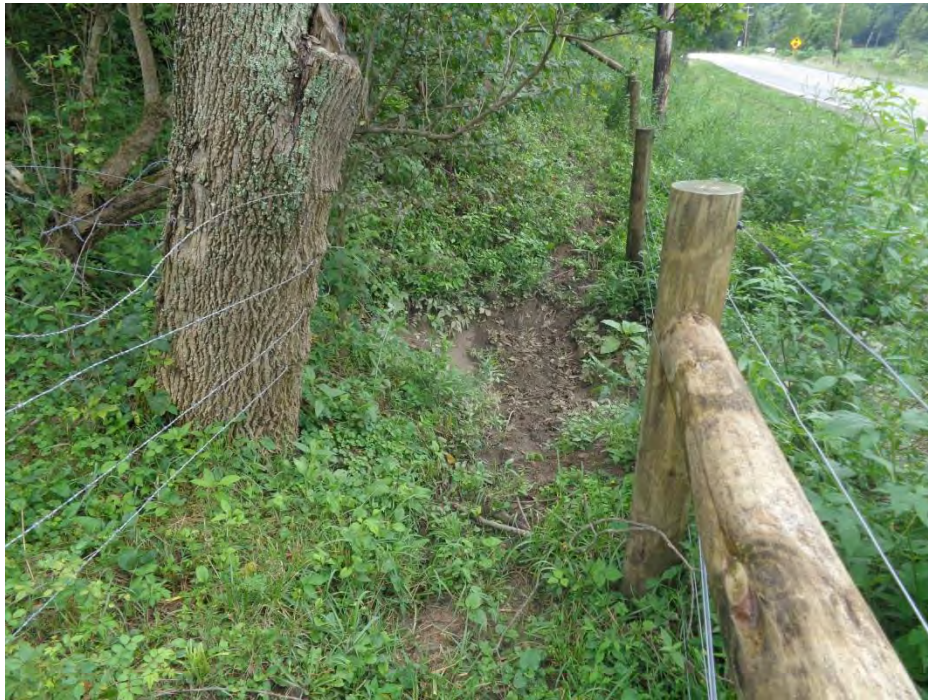
Photograph 13. View of terminus of upland drainage feature near State Route 379, showing loss of defined bed and bank and no connection to jurisdictional streams. Photo taken facing south.

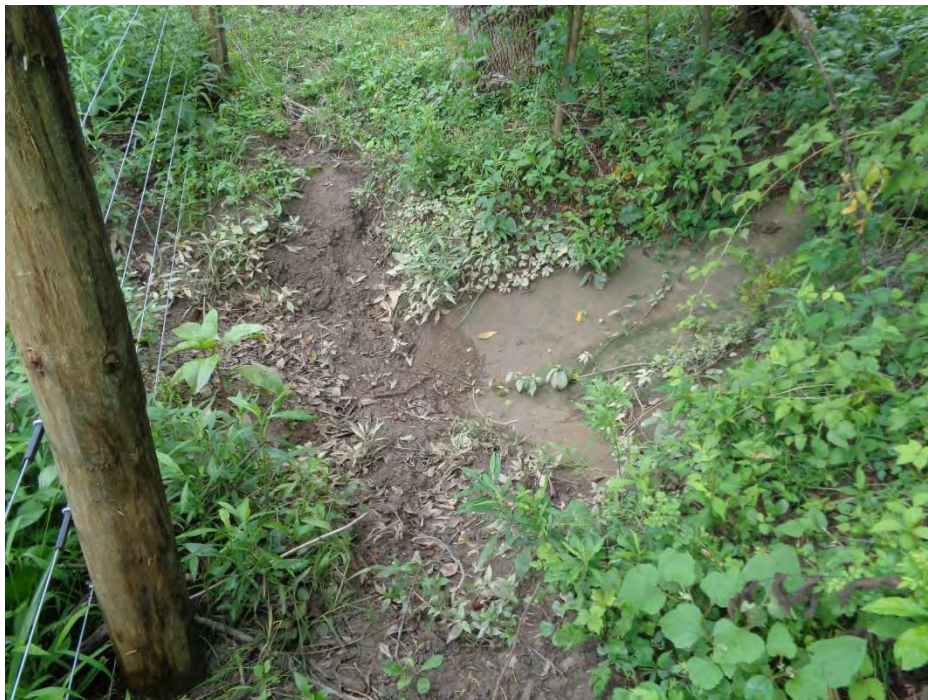
Photograph 14. View of terminus of upland drainage feature near State Route 379, showing loss of defined bed and bank and no connection to jurisdictional streams. Photo taken facing north.

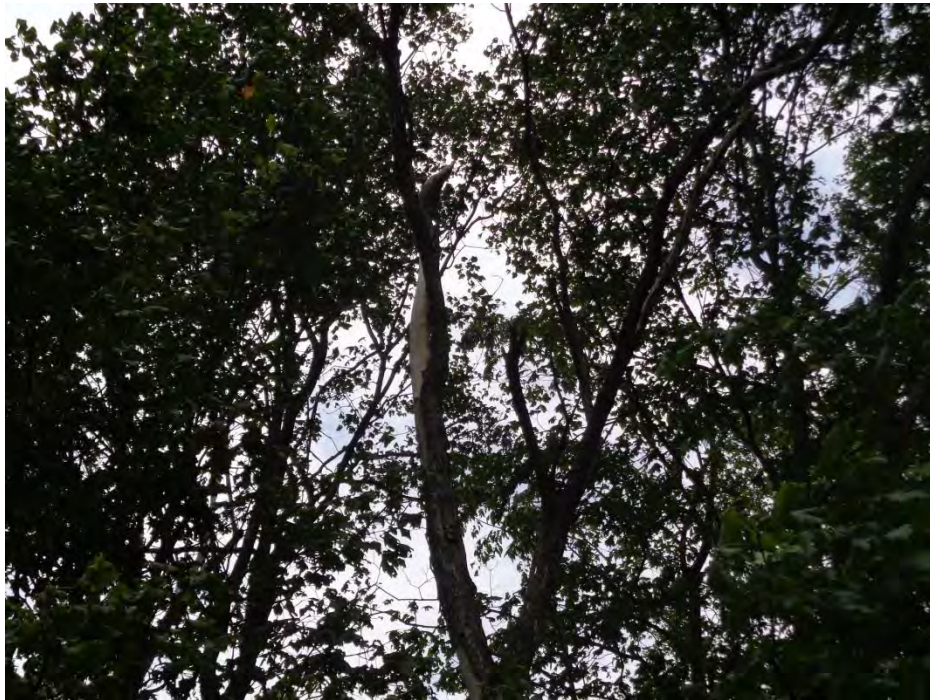
Photograph 15. View of potential bat roost tree (PRT-1) in west-central portion of study area.  
Photo taken facing northwest.

**The proposed project is in the vicinity of one or more confirmed records of Indiana bats.** Therefore, we recommend that trees  $\geq 3$  inches dbh be saved wherever possible. Because the project will result in a small amount of forest clearing relative to the available habitat in the immediately surrounding area, habitat removal is unlikely to result in significant impacts to these species. Since Indiana bat presence in the vicinity of the project has been confirmed, clearing of trees  $\geq 3$  inches dbh during the summer roosting season may result in direct take of individuals. If any caves or abandoned mines may be disturbed, further coordination with this office is requested to determine if fall or spring portal surveys are warranted. If no caves or abandoned mines are present and tree removal is unavoidable, we recommend that removal of any trees  $\geq 3$  inches dbh only occur between October 1 and March 31. Following this seasonal tree clearing recommendation should ensure that any effects to Indiana bats and northern long-eared bats are insignificant or discountable. **Please note that, because Indiana bat presence has already been confirmed in the project vicinity, any additional summer surveys would not constitute presence/absence surveys for this species.**

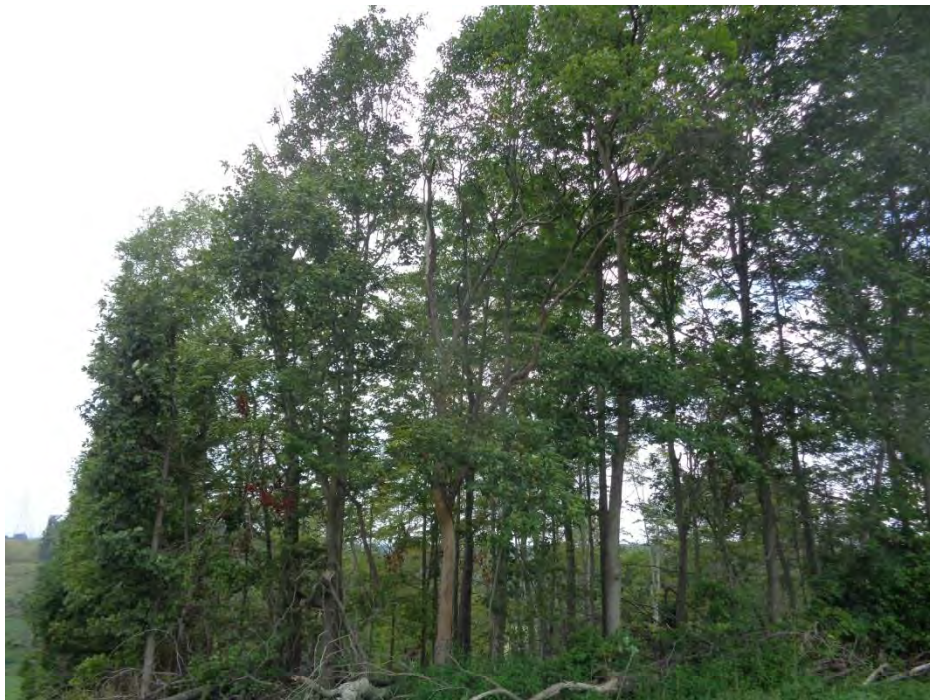
Photograph 16. View of potential bat roost tree (PRT-1). Photo taken facing southwest.

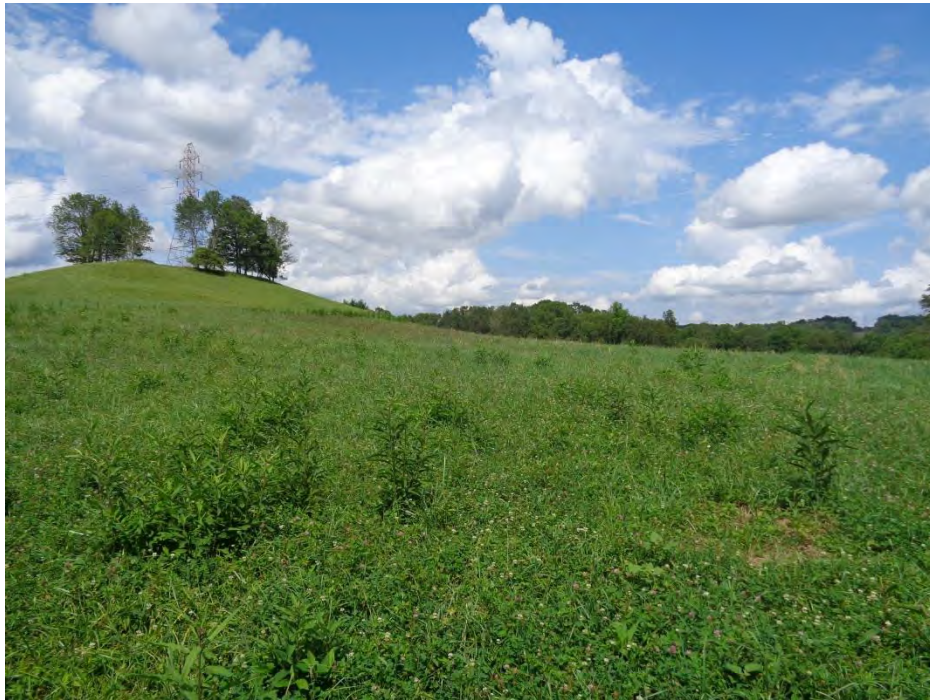
| Vegetation Communities and Land Cover Types within the Project Study Area | Degree of Human-Related Ecological Disturbance | Unique, Rare, or High Quality? | Approximate Acreage Within Project Study Area |
|---|---|---|---|
| Hay Field | Extremely disturbed area dominated by non-native graminoids. | No | 13.80 |

Photograph 17. Representative view of hay field habitat. Photo taken facing northeast.

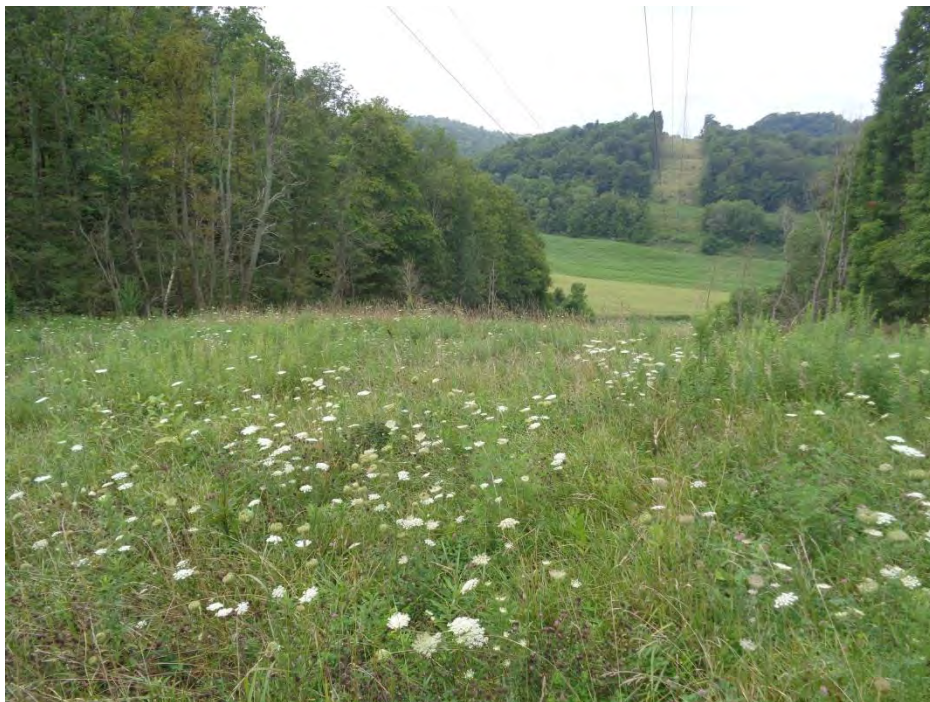
| Vegetation Communities and Land Cover Types within the Project Study Area | Degree of Human-Related Ecological Disturbance | Unique, Rare, or High Quality? | Approximate Acreage Within Project Study Area |
|---|---|---|---|
| Old Field | Area of extreme disturbance/ruderal community dominated by opportunistic invaders or native highly tolerant taxa; An infrequently maintained area dominated by herbaceous species with a limited presence of early successional woody species. | No | 1.28 |

Photograph 18. Representative view of old field habitat. Photo taken facing west.

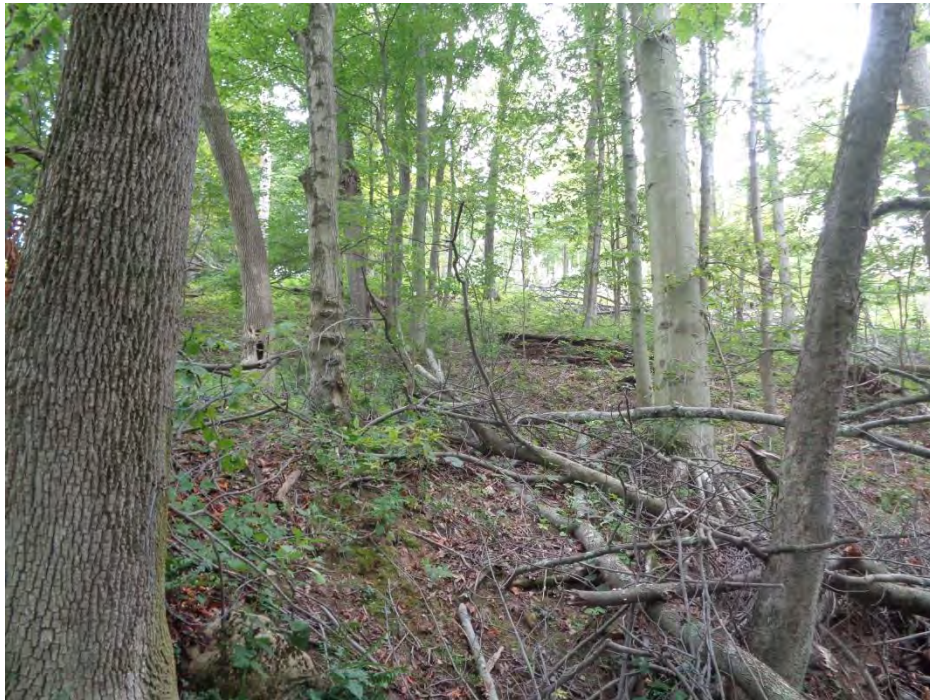
| Vegetation Communities and Land Cover Types within the Project Study Area | Degree of Human-Related Ecological Disturbance | Unique, Rare, or High Quality? | Approximate Acreage Within Project Study Area |
|---|---|---|---|
| Mixed Early Successional/Second Growth Deciduous Forest | Area with intermediate to moderate disturbance with a varying overstory of shade tolerant, deciduous trees dominated by red maple ( <i>Acer rubrum</i> ), beech ( <i>Fagus grandifolia</i> ), and various oak ( <i>Quercus</i> spp.) species, with a thick understory of woody shrubs and herbaceous vegetation. | No | 8.55 |

Photograph 19. Representative view of mixed early successional/second growth deciduous forest habitat. Photo taken facing southeast.

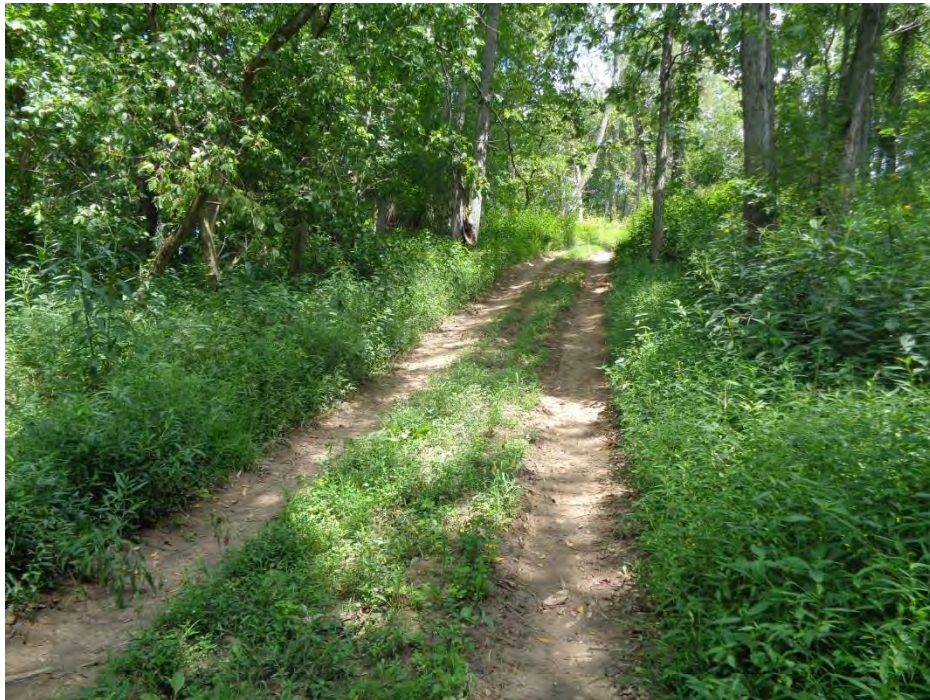
Photograph 20. Representative view of existing two-track dirt access road. Photo taken facing northeast.

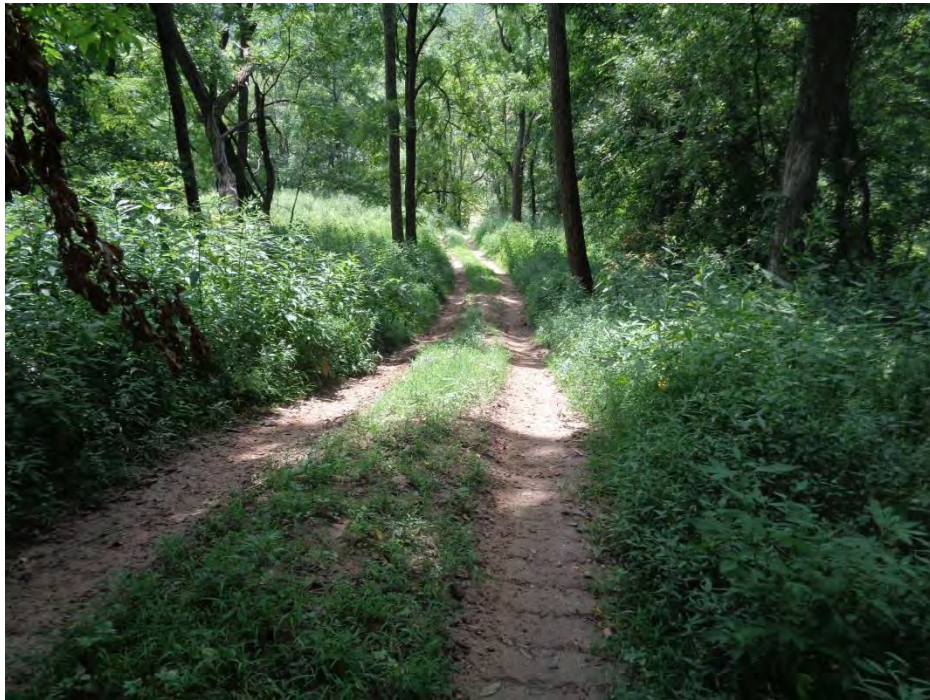
Photograph 21. Representative view of existing two-track dirt access road. Photo taken facing southwest.
