Re: ¹⁷~~16~~-328-GA-BLN, Duke Energy Ohio, Inc.'s Letter of Notification for the Line D000B
Natural Gas Pipeline Replacement Project

**Letter of Notification
Line D000B Natural Gas Pipeline Replacement Project**

17
CASE NO. 16-328-GA-BLN
LINE D000B NATURAL GAS PIPELINE REPLACEMENT
CINCINNATI, HAMILTON COUNTY, OHIO

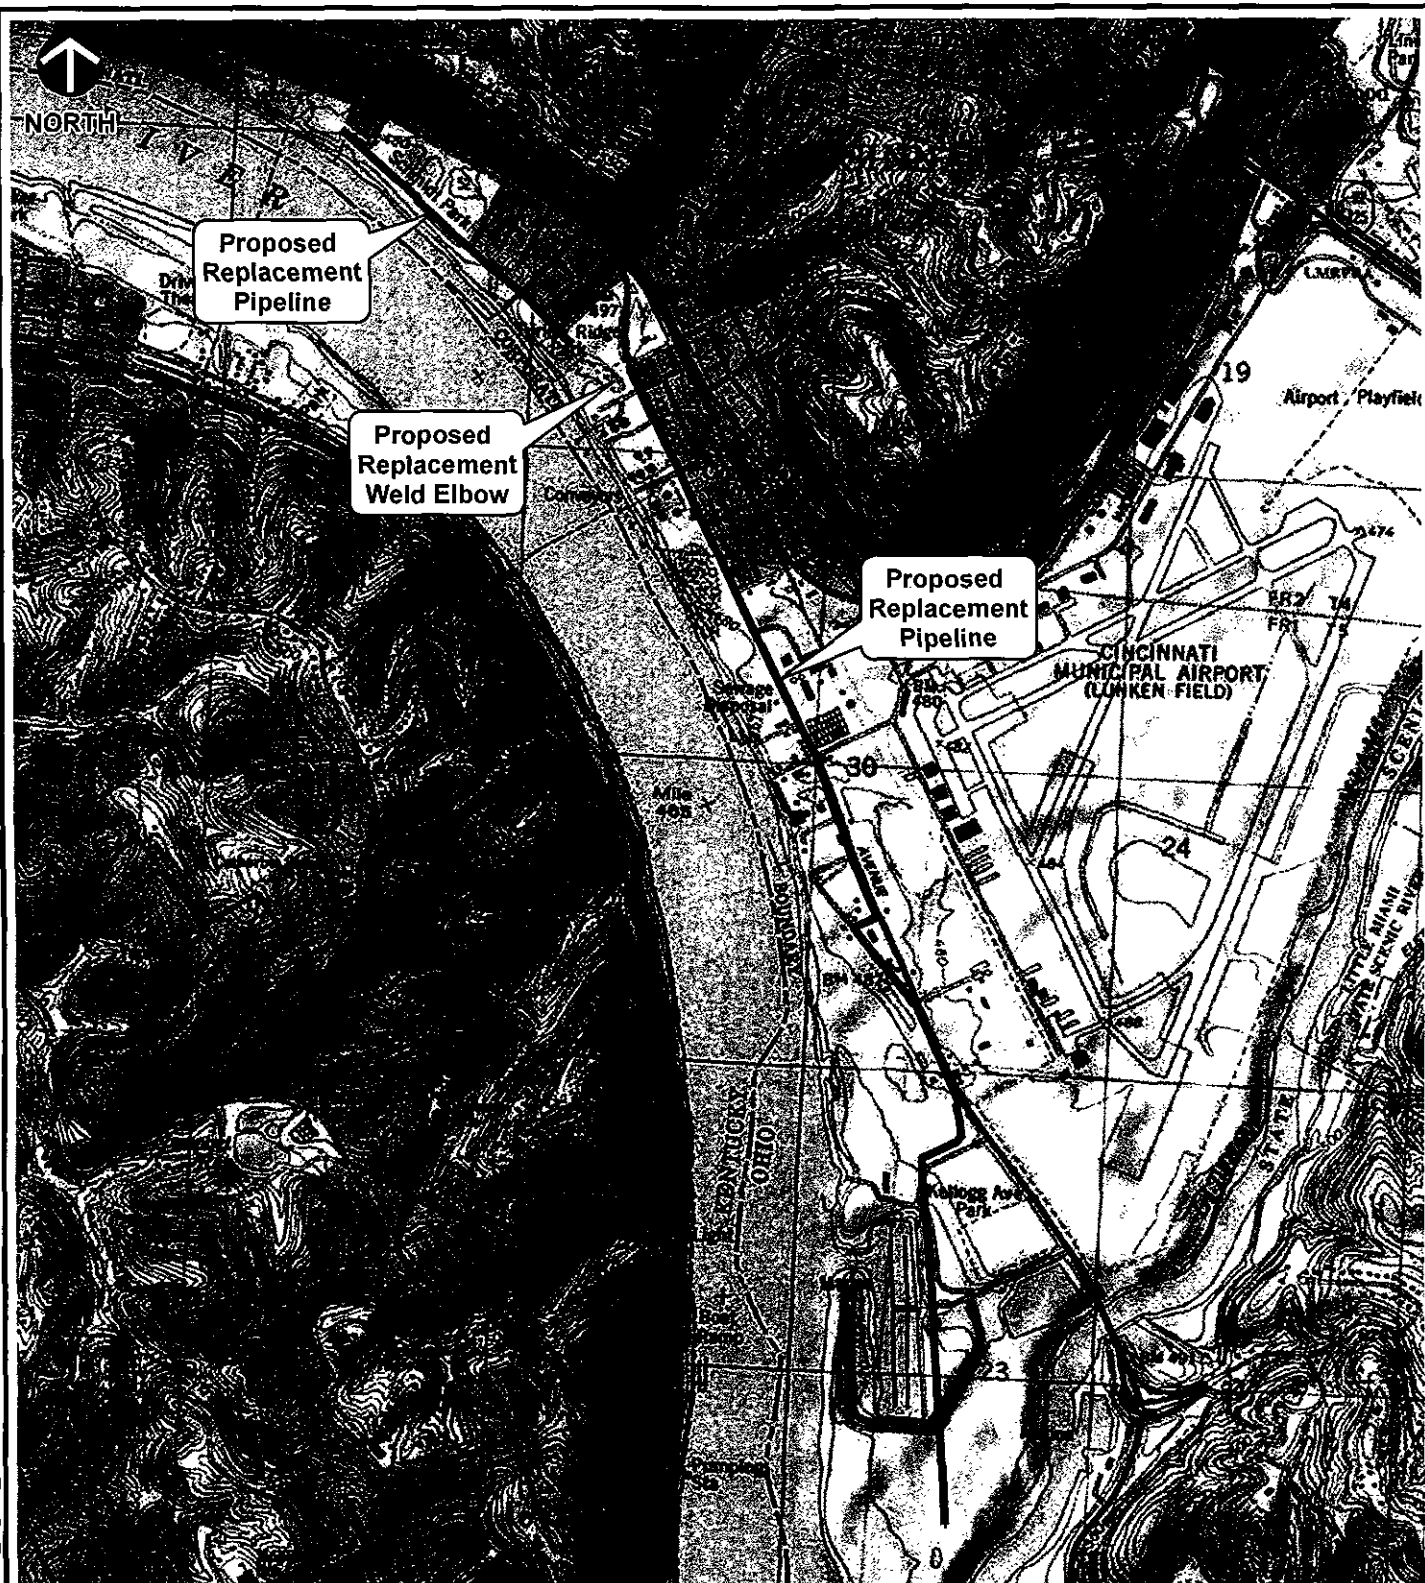
FIGURE 1:
PROJECT LOCATION MAP

The location of this Project is illustrated on Figures 1 and 2 in Attachment 1. Figure 1 shows the general Project vicinity illustrated on a U.S. Geological Survey (USGS) quadrangle map. Figures 2 and 3 illustrate the proposed replacement pipeline and the existing pipeline that is proposed to be abandoned in-place overlain on an aerial base map.

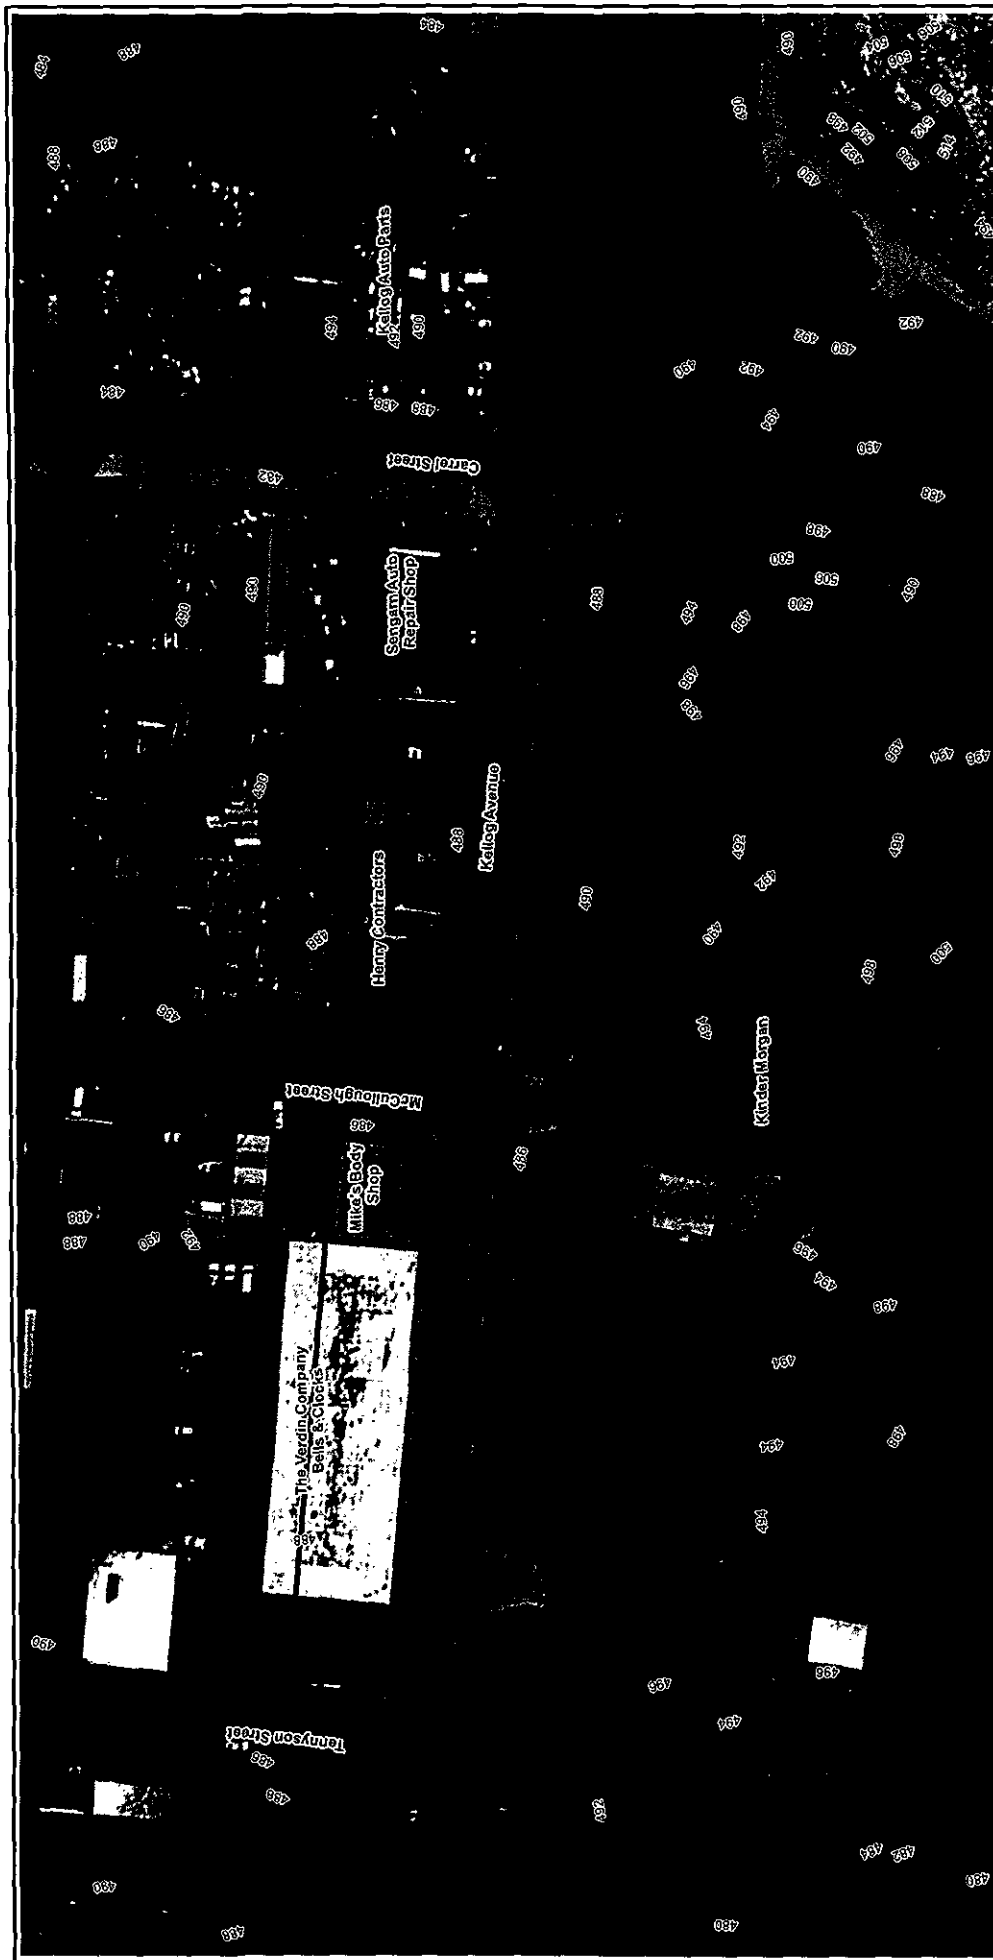
DRAWN BY: JBF CHECKED BY: JBF APPROVED BY: JBF
DATE: AUGUST 25, 2016 DWG SCALE: 1" = 75' PROJECT NO: 153-230
FIGURE NO: 11

NOTES: FULL EXTENT OF STUDY CORRIDOR IS WITHIN 100-YEAR FLOODPLAIN.
NO STREAMS OR WATERBODIES WERE IDENTIFIED WITHIN THE STUDY CORRIDOR.

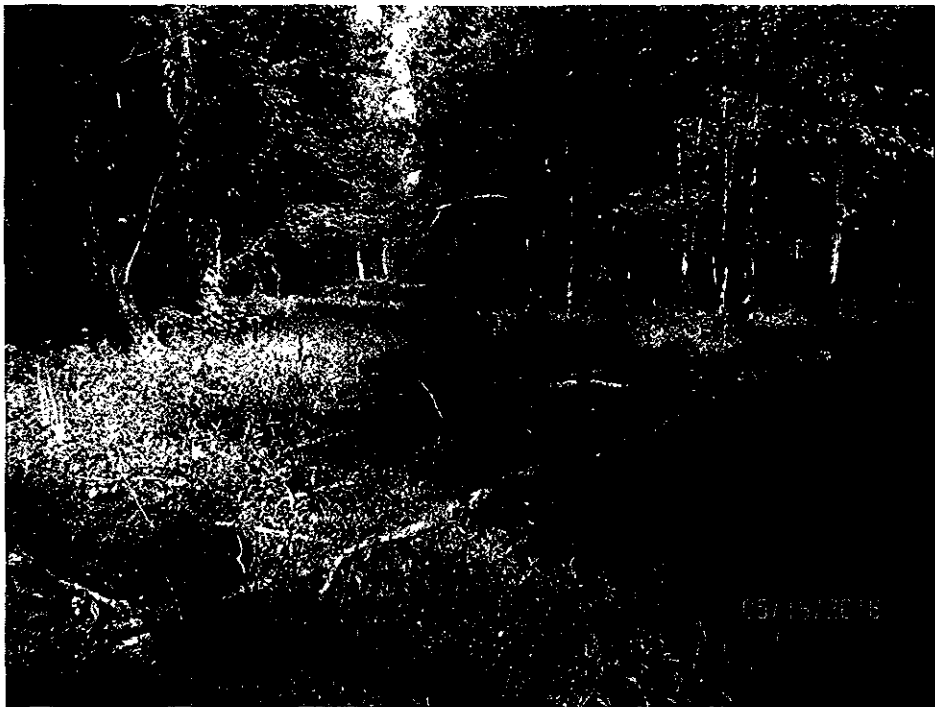
Photograph 3. Representative view of the PEM portion of Wetland 1.
Photograph taken facing north-northwest along existing, maintained utility ROW.

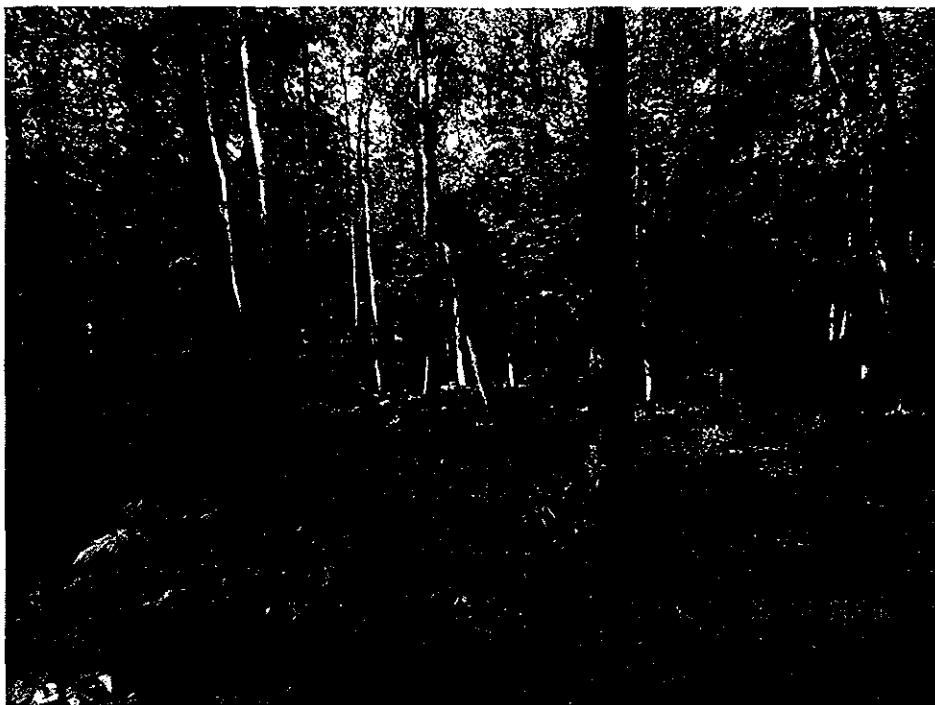
Photograph 4. Representative view of the PFO portion of Wetland 1 along the west side of the
Line D000B ROW near the southern terminus of the Project.
Photograph taken facing south-southwest.

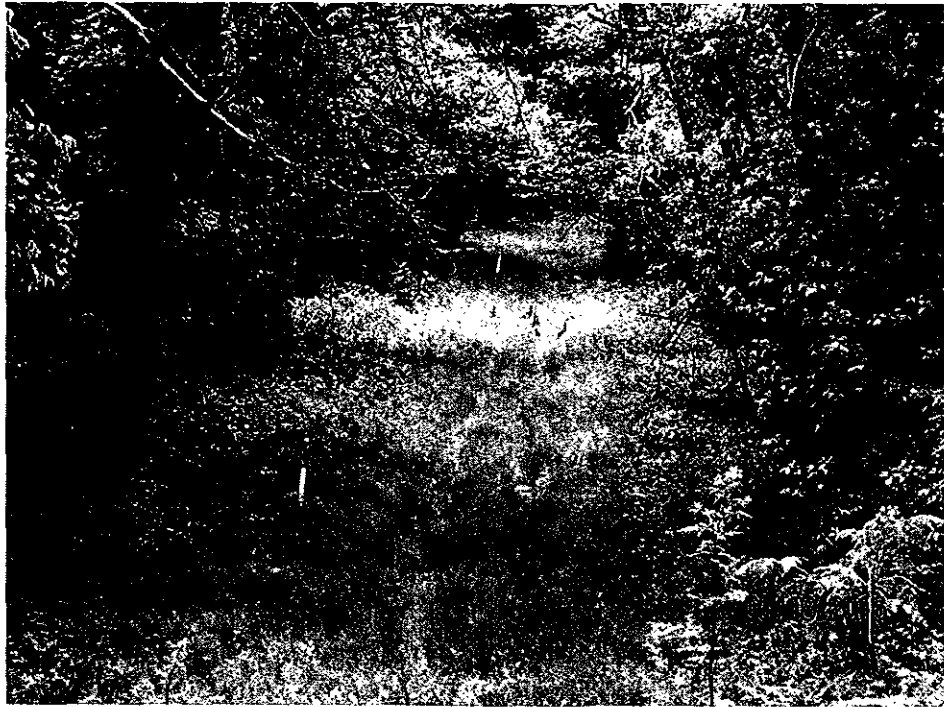
Photograph 11. Elevated view of existing bermed, maintained Line D000B ROW, bisecting Wetland 1. Photograph taken facing south.

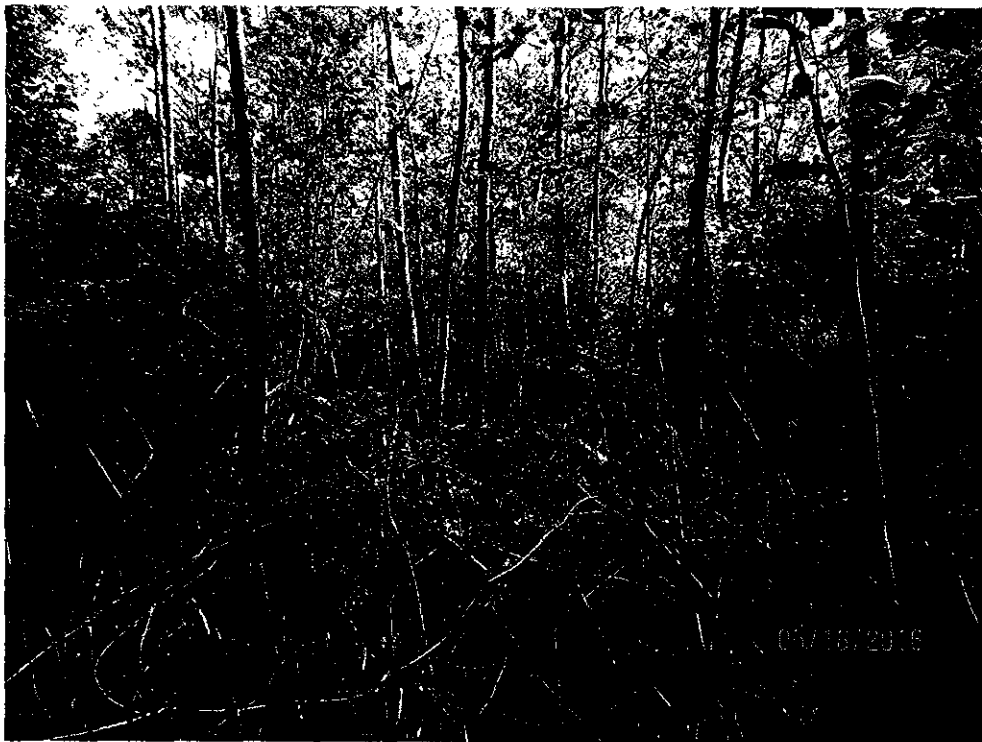
Photograph 12. View of Wetland 2. Photograph taken facing east-northeast.

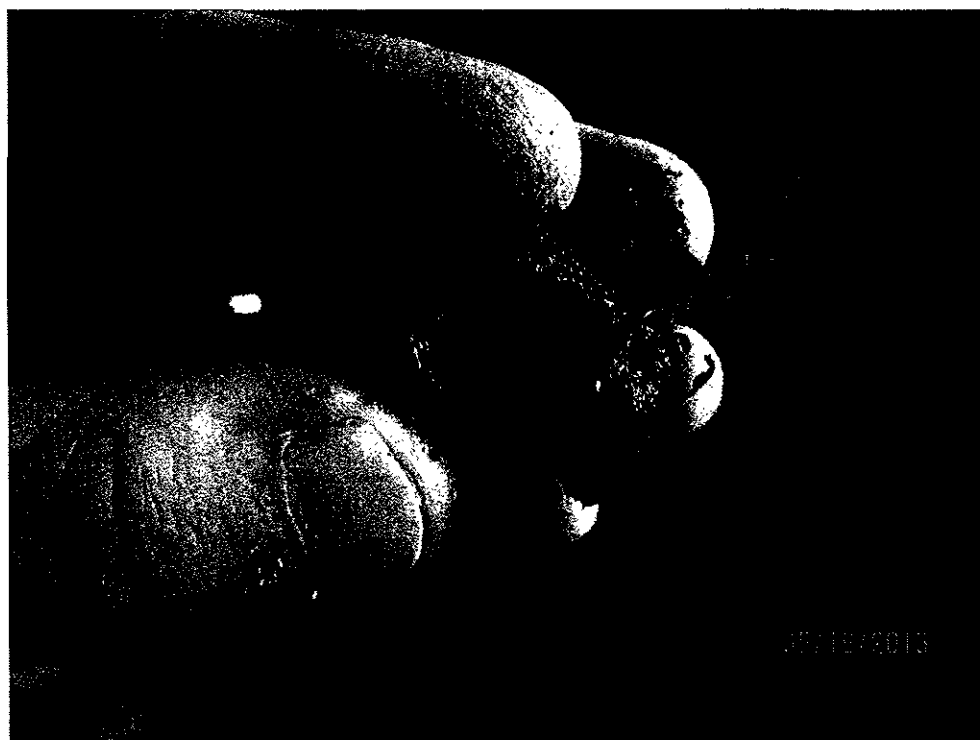
Photograph 14. Hydric soil ped exhibiting redox features from wetland determination SP-17.

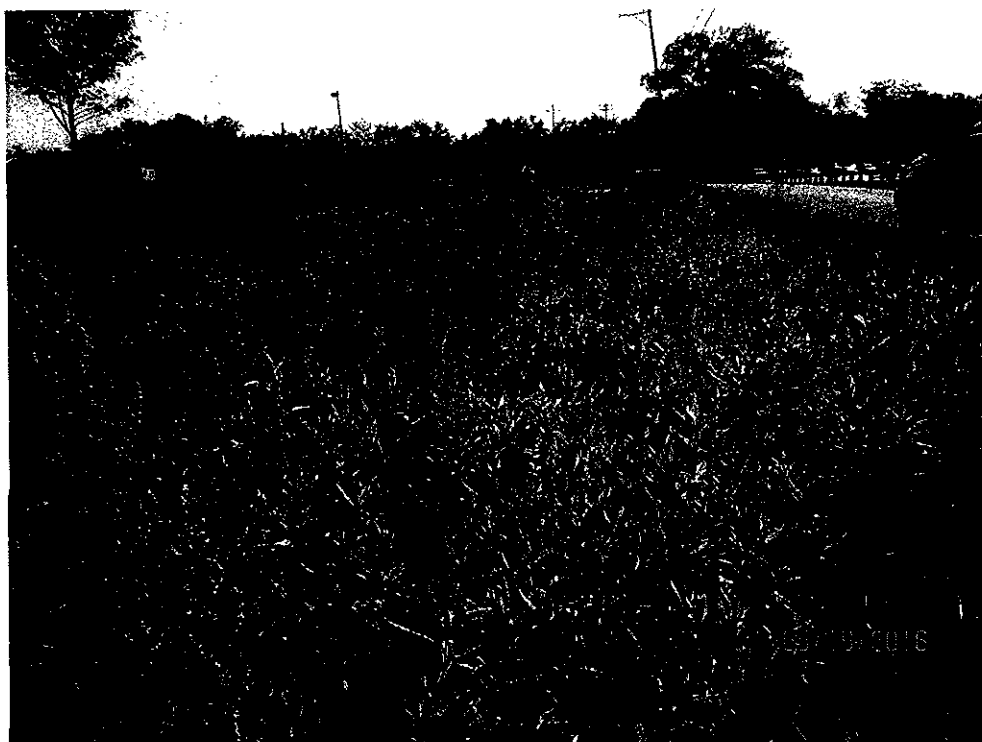
Photograph 16. View of Wetland 3, facing east-northeast.

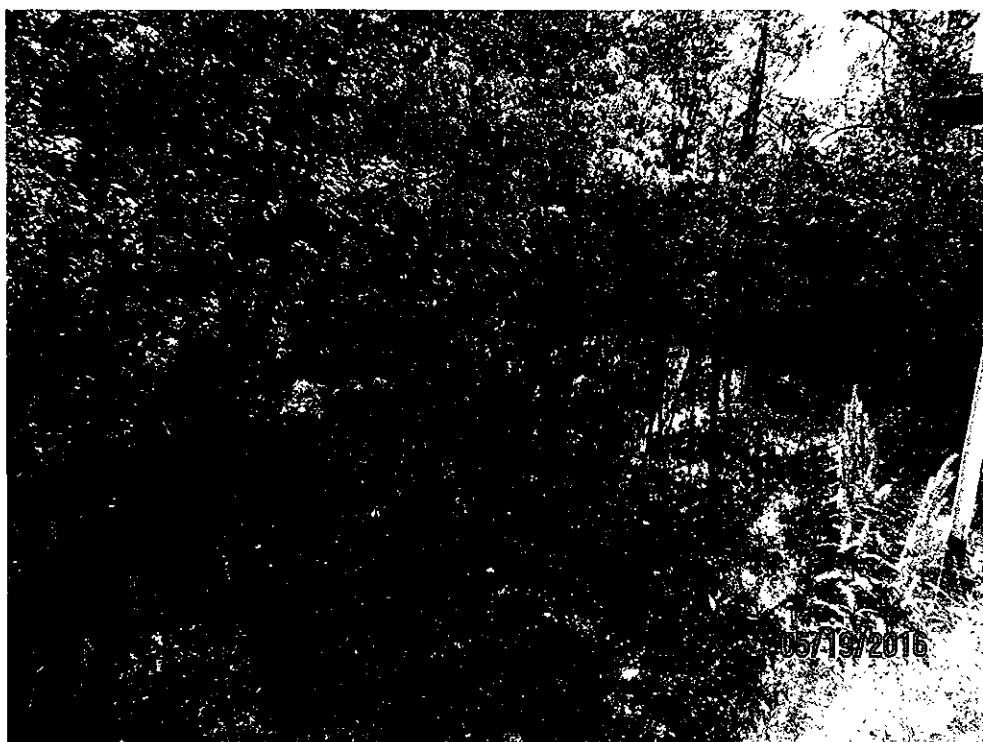
Photograph 17. View of Wetland 4, facing southeast.

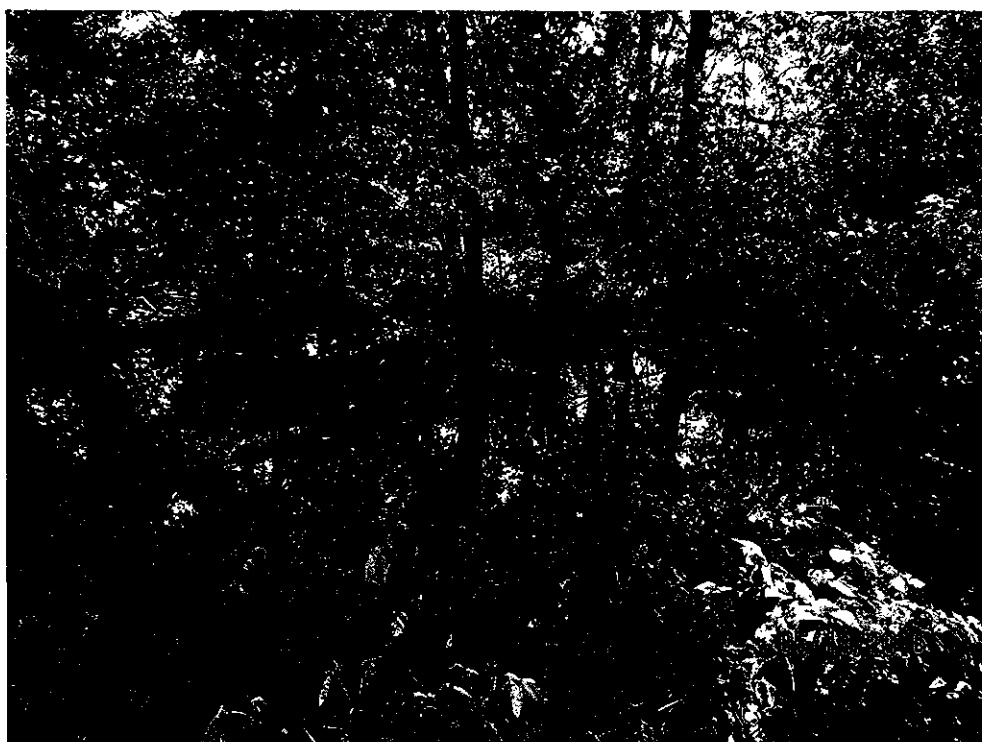
Photograph 18. View of Wetland 4, facing northeast.

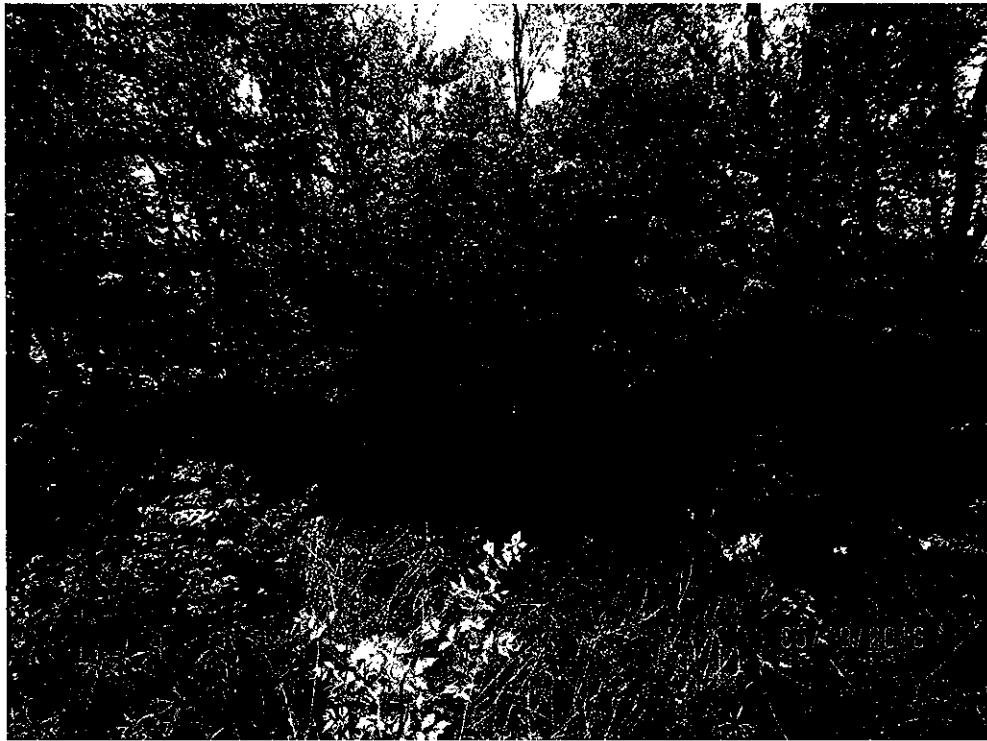
Photograph 19. View of Wetland 5, facing east-northeast.
