RUNNING BUFFALO CLOVER SURVEY REPORT
LINE D000B PIPELINE REPLACEMENT PROJECT
CINCINNATI, HAMILTON COUNTY, OHIO

DUKE ENERGY CORPORATION
139 EAST FOURTH STREET
CINCINNATI, OHIO 45202

CIVIL & ENVIRONMENTAL CONSULTANTS, INC.
CINCINNATI, OHIO

September 23, 2016

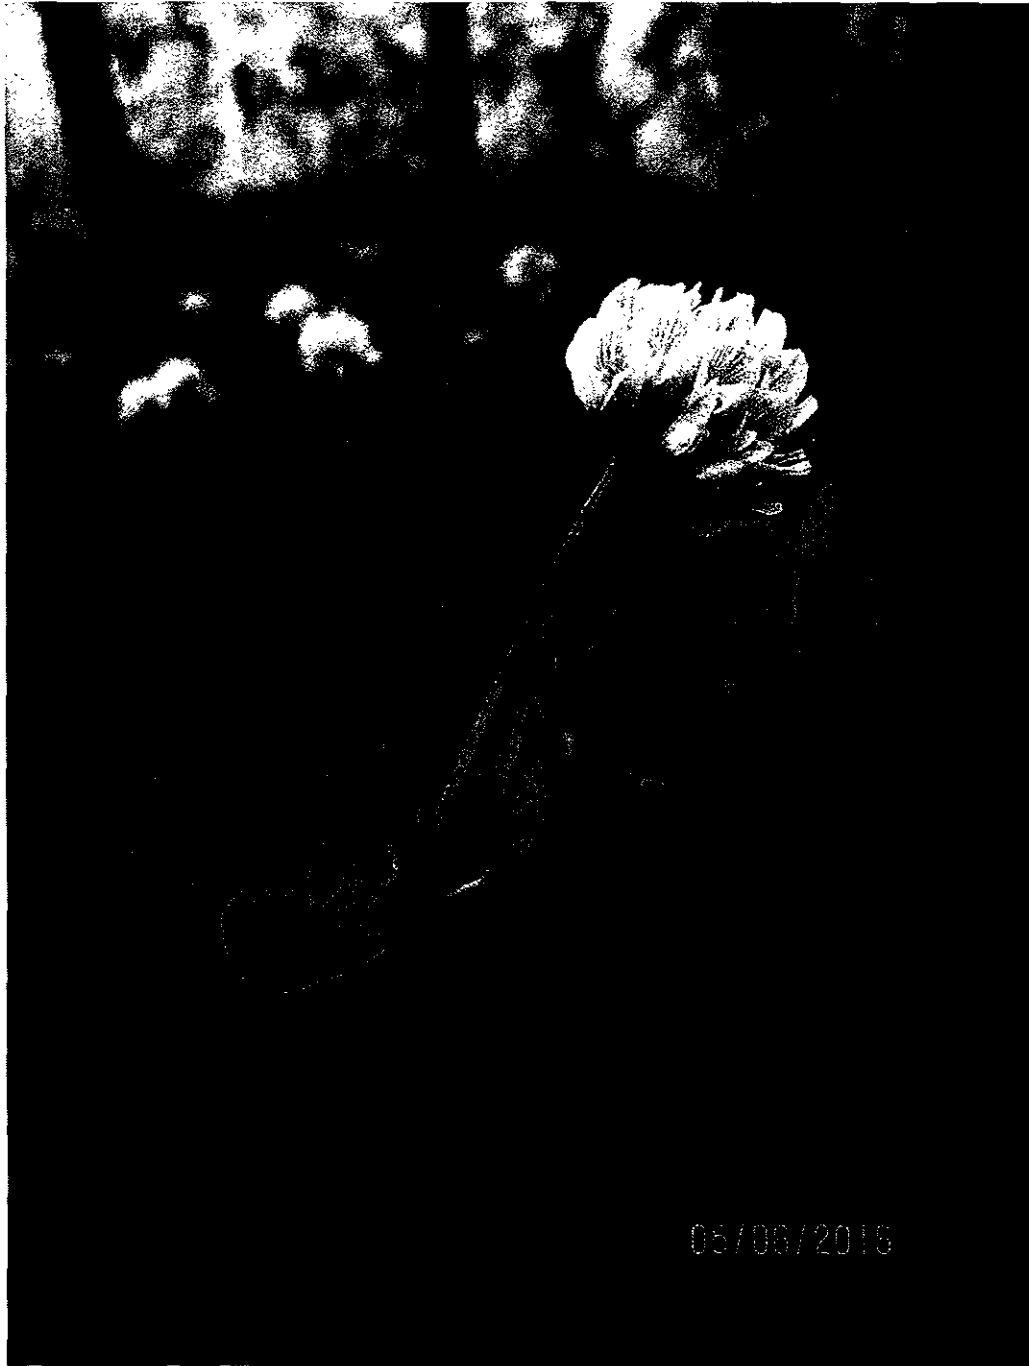
Photograph 1. RBC reference specimen from the Dinsmore Woods State Nature Preserve in Boone County, Kentucky. Note the opposite leaflets on the flowering stem.

In addition to the literature review, a pre-survey verification of a known RBC population was conducted at the Dinsmore Woods State Nature Preserve in Boone County, Kentucky. The purpose of this verification was to determine the precise flowering period and “phenophase” of the known population. This would allow the field survey to be conducted knowing the growth condition of the species to assist in better observation and species presence determinations. During the pre-survey site verification, photographs of the condition of the existing known population were made and the specific plant growth stage was noted. In addition, attention was directed toward observation of plant associations, soils, amount of vegetative shading, duration of disturbance, and amount of disturbance that were habitat characteristics of the known RBC population. Appendix A-1 contains representative photographs of the RBC population that was observed in Dinsmore Woods State Nature Preserve, as photographed by CEC on May 6, 2016.

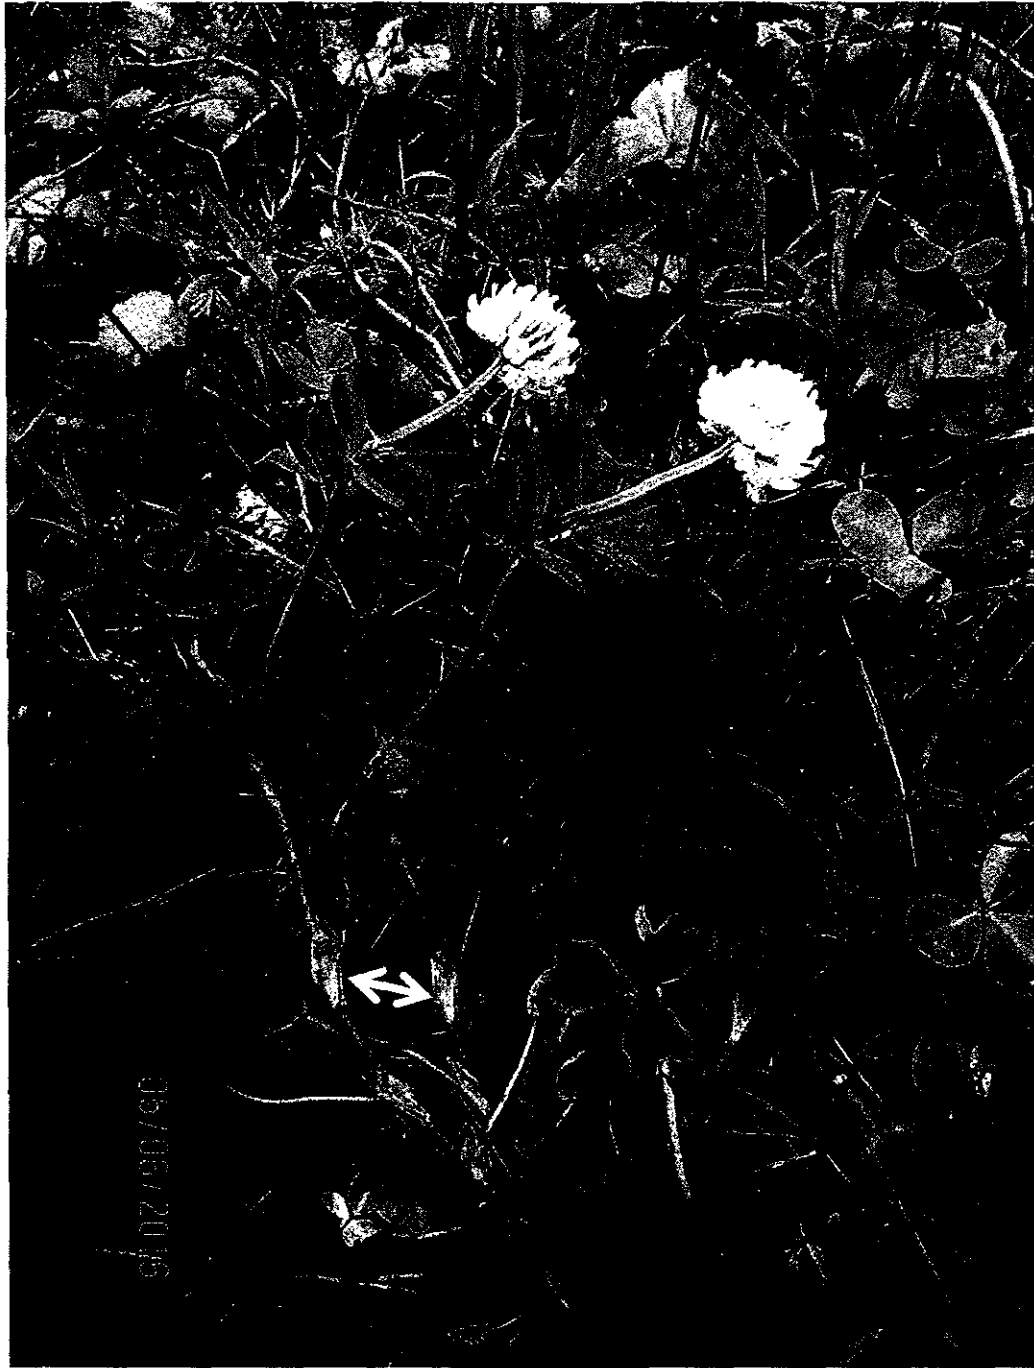
Photograph 2. Another view of RBC reference specimens from the Dinsmore Woods State Nature Preserve. Note the presence of stipules, an identifying characteristic.

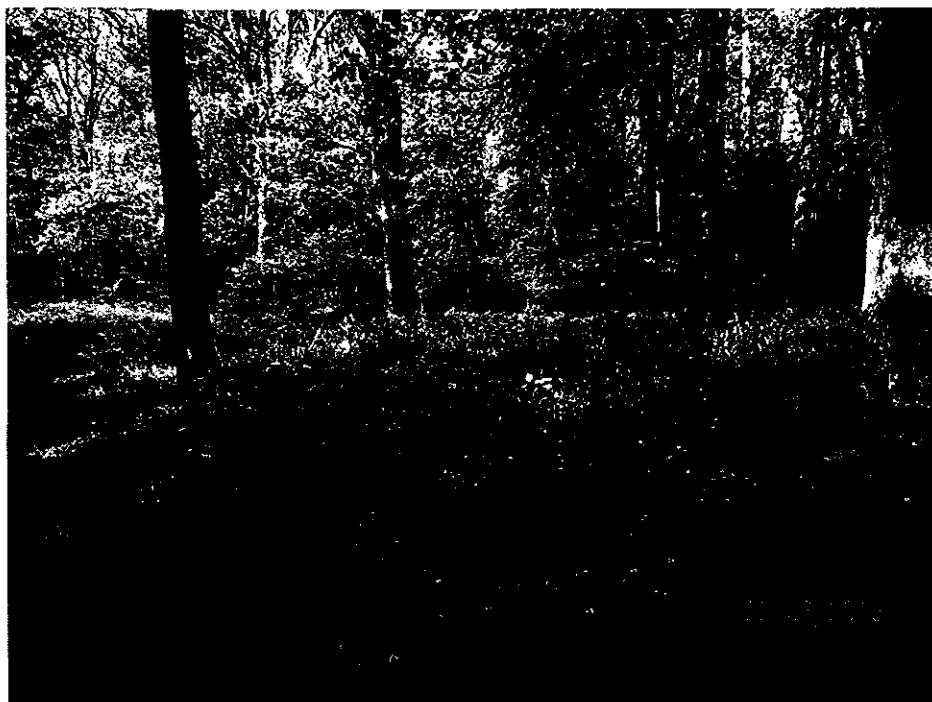
Photograph 4. RBC reference population habitat at the Dinsmore Woods State Nature Preserve.

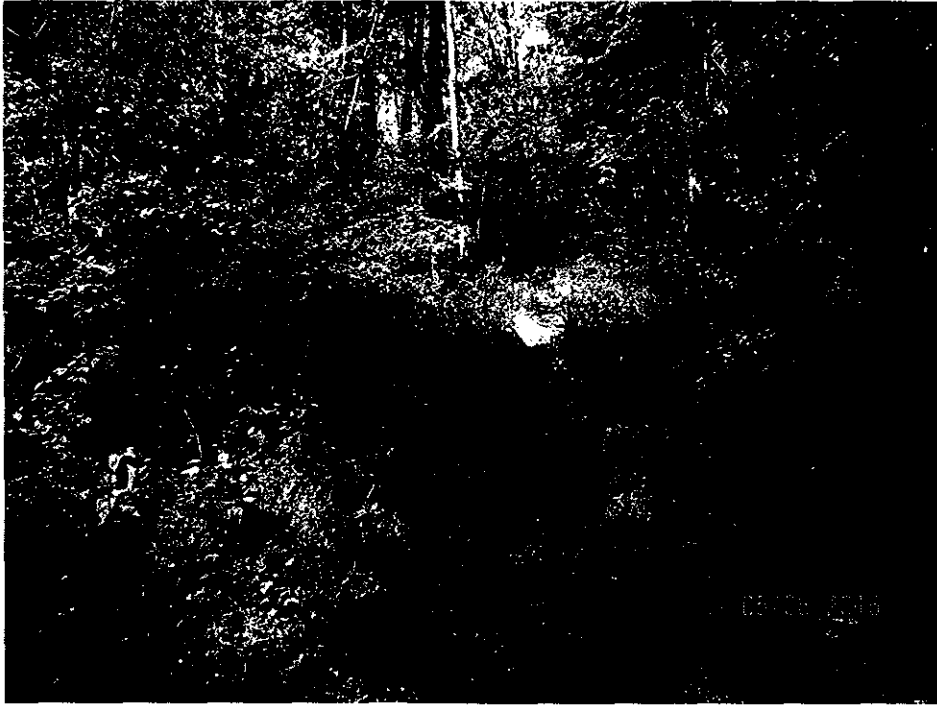
Photograph 5. RBC reference population habitat at the Dinsmore Woods State Nature Preserve.

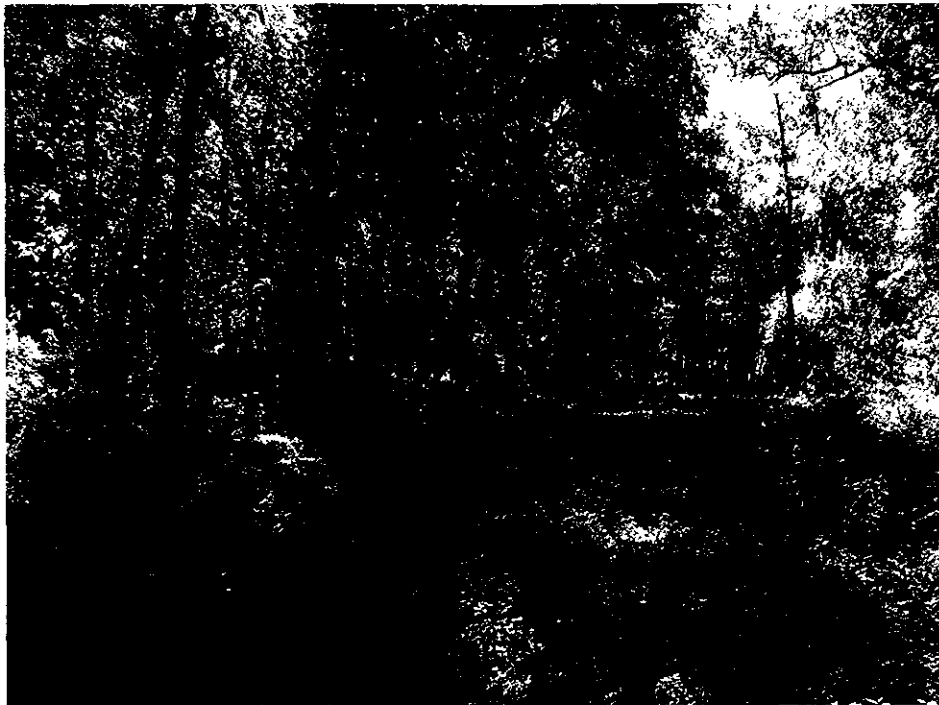
Photograph 6. View of maintained Line D000B ROW, south of proposed southern terminus of Project. Photograph taken facing south-southeast.

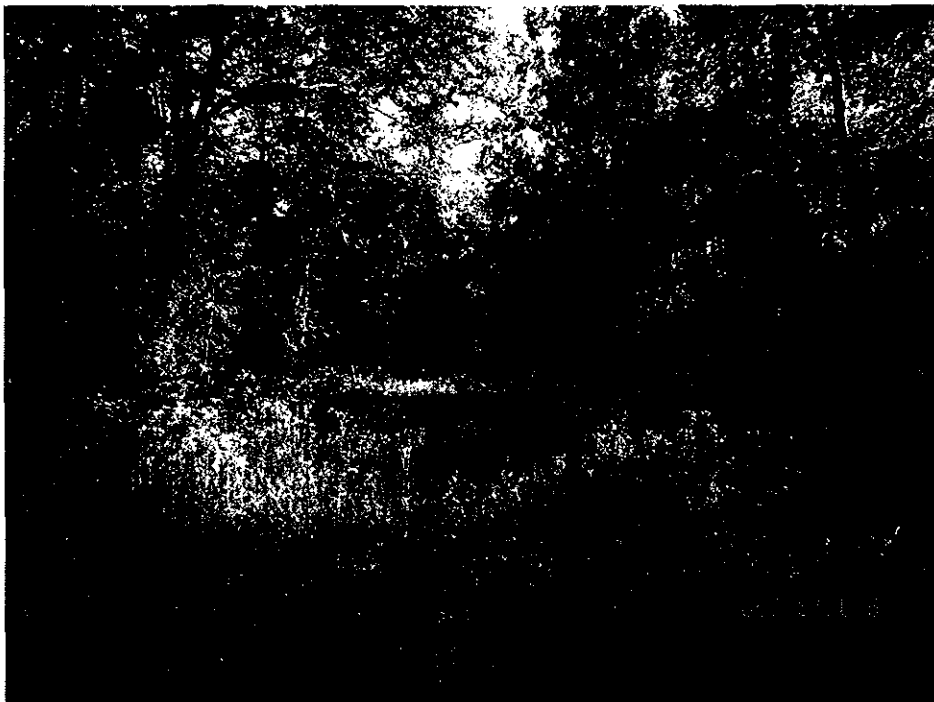
Photograph 7. View of existing Line D000B ROW at the southern terminus of study corridor. Photograph taken facing south.

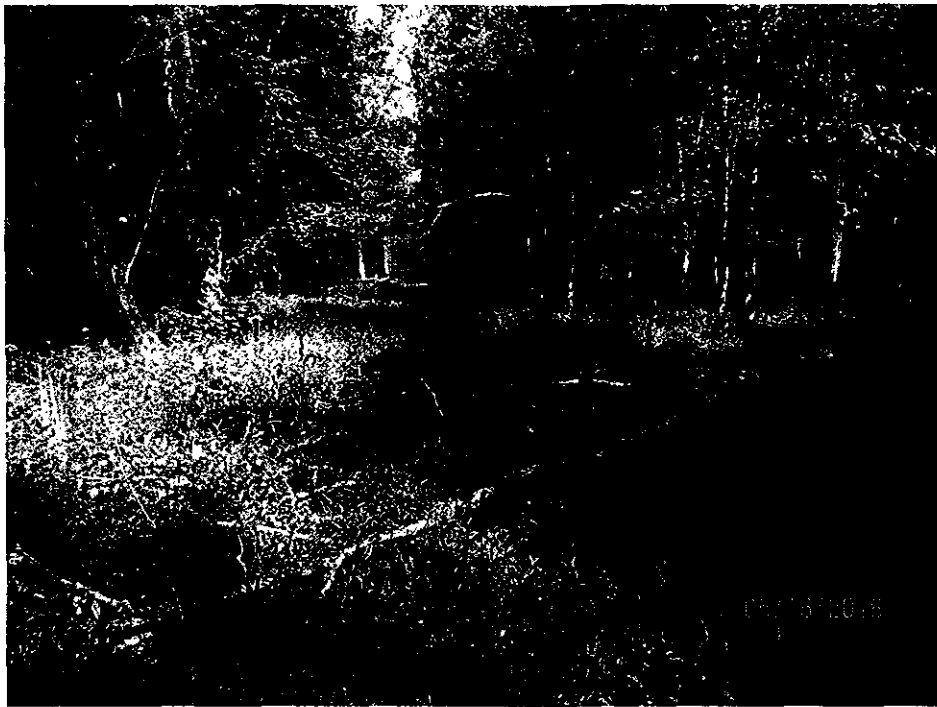
Photograph 8. Representative view of the PEM portion of Wetland 1.
Photograph taken facing north-northwest along existing, maintained utility ROW.

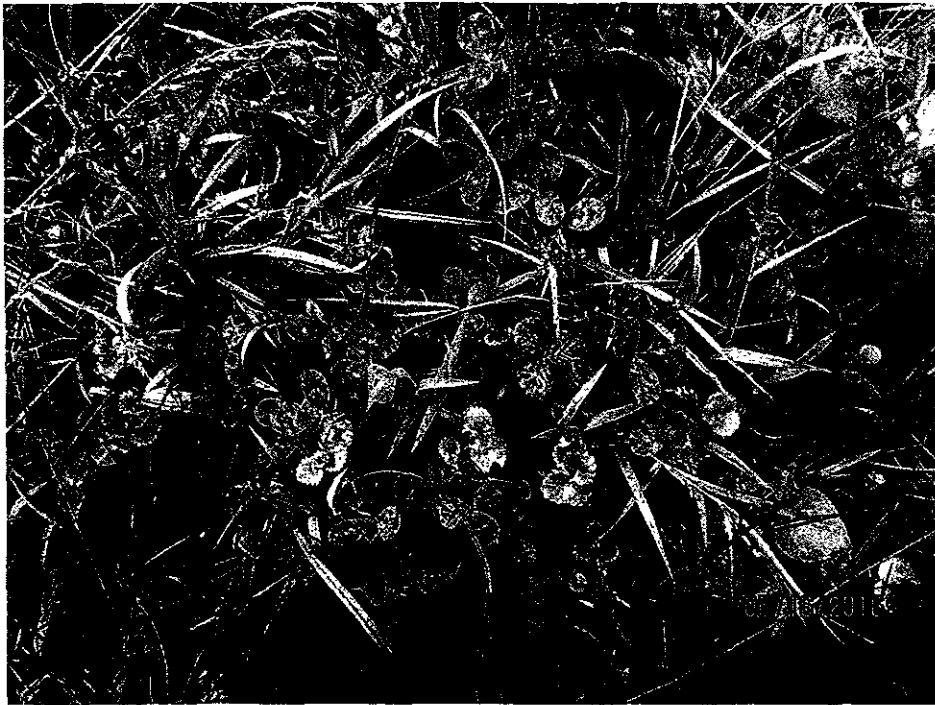
Photograph 10. White clover voucher specimen.

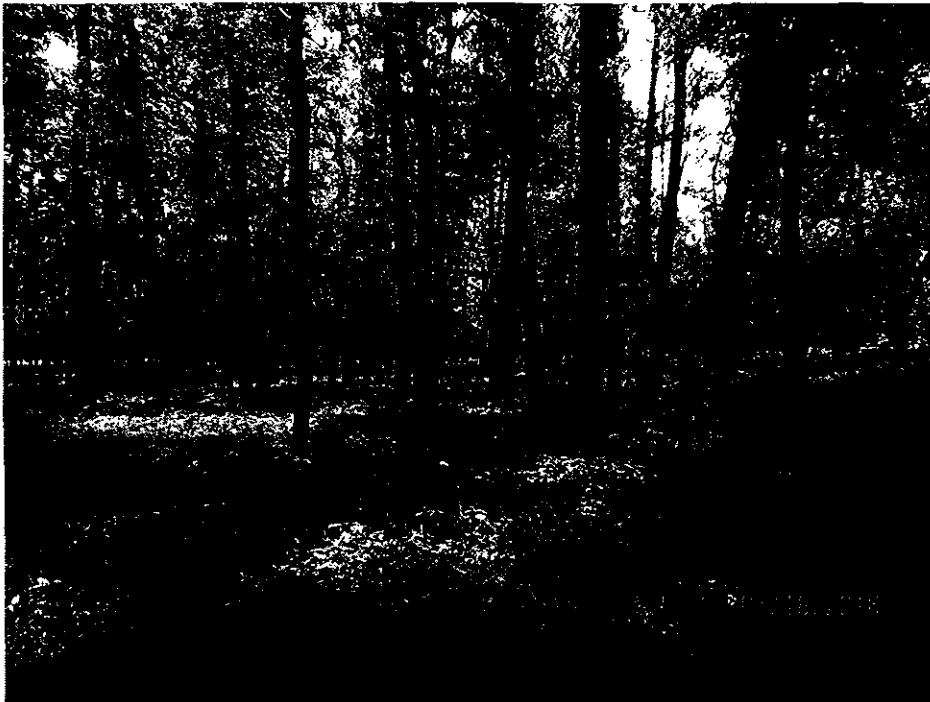
Photograph 11. View of the PFO portion of Wetland 1 along the west side of the Line D000B ROW near the southern terminus of the Project.

Photograph taken facing west.

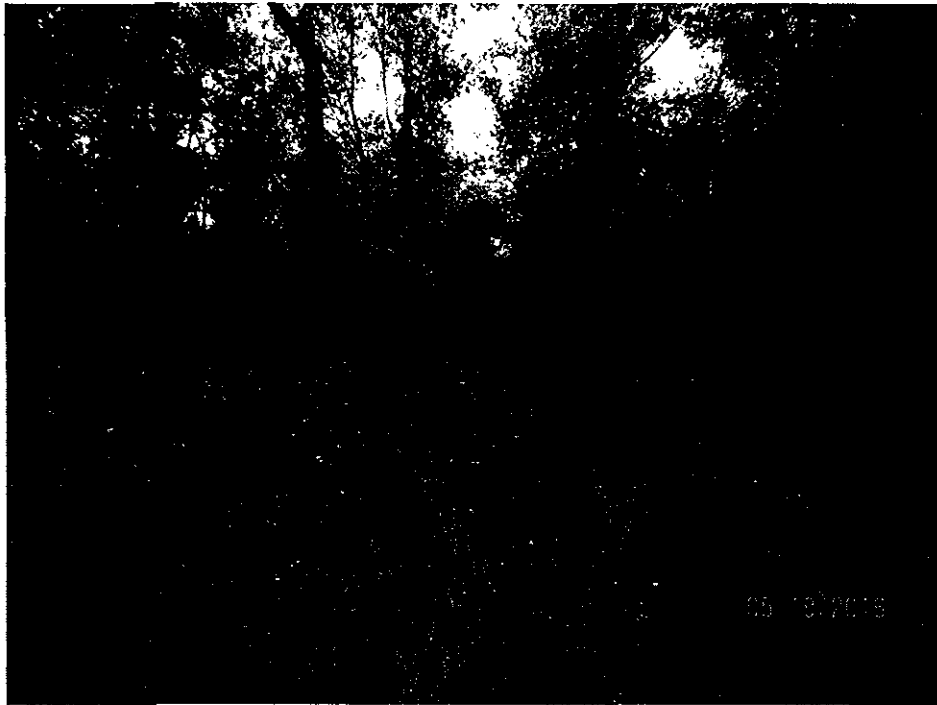
Photograph 12. Representative view of elevated and maintained ROW, bisecting Wetland 1 at wetland determination SP-6. Photograph taken facing south.

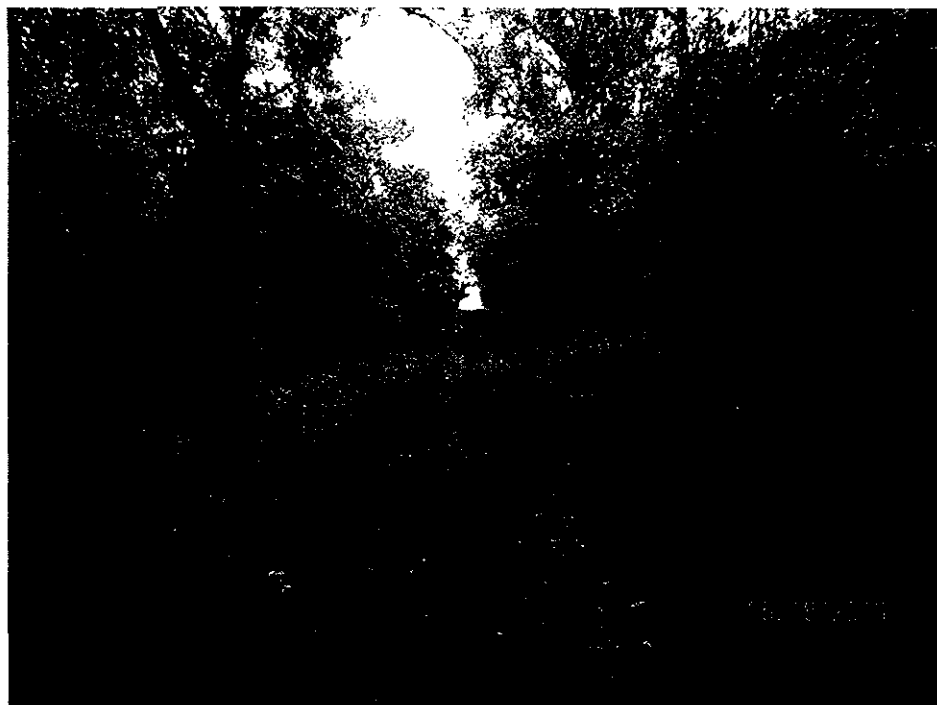
Photograph 13. Representative view of elevated and maintained Line D000B ROW, bisecting Wetland 1. Photograph taken facing north.

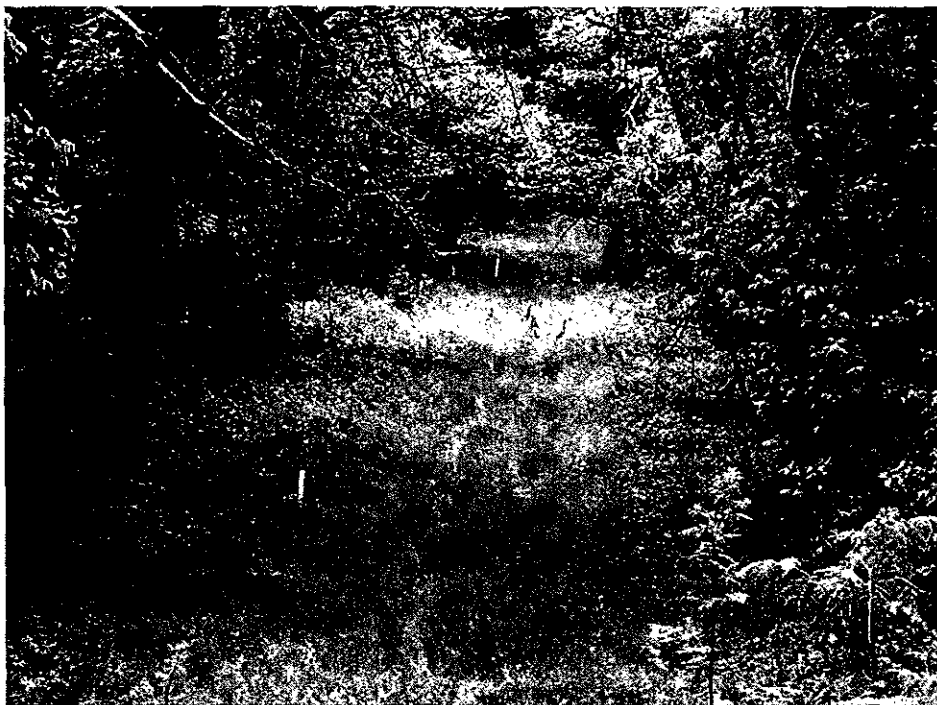
Photograph 15. Elevated view of existing bermed, maintained Line D000B ROW, bisecting Wetland 1. Photograph taken facing south.

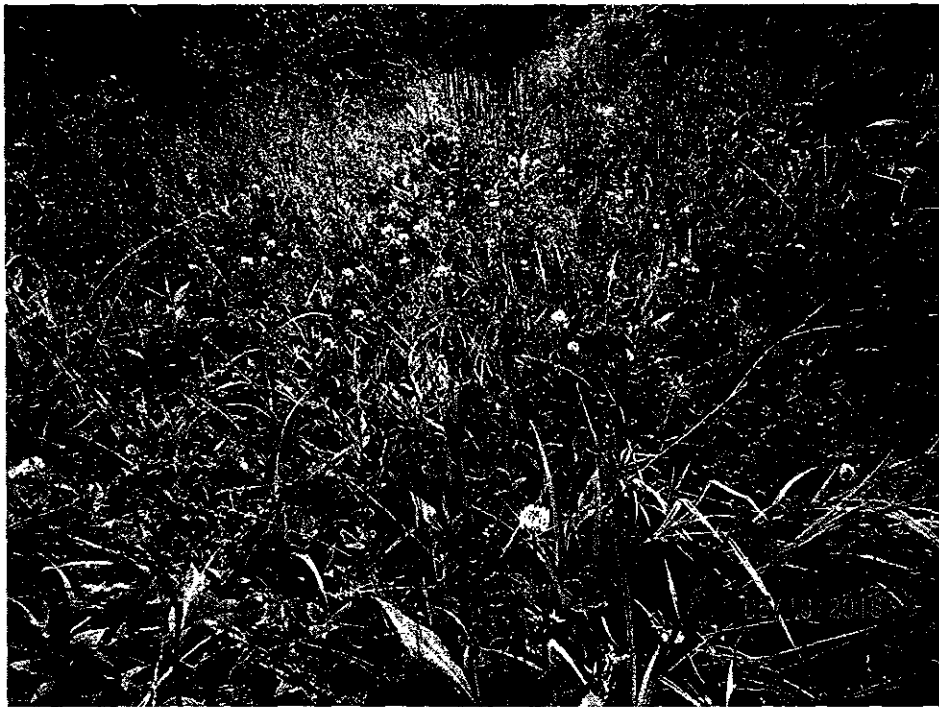
Photograph 16. View of white clover and other herbaceous vegetation growing along trail or two track that is located on an embankment that formerly functioned as railroad corridor, facing southwest.

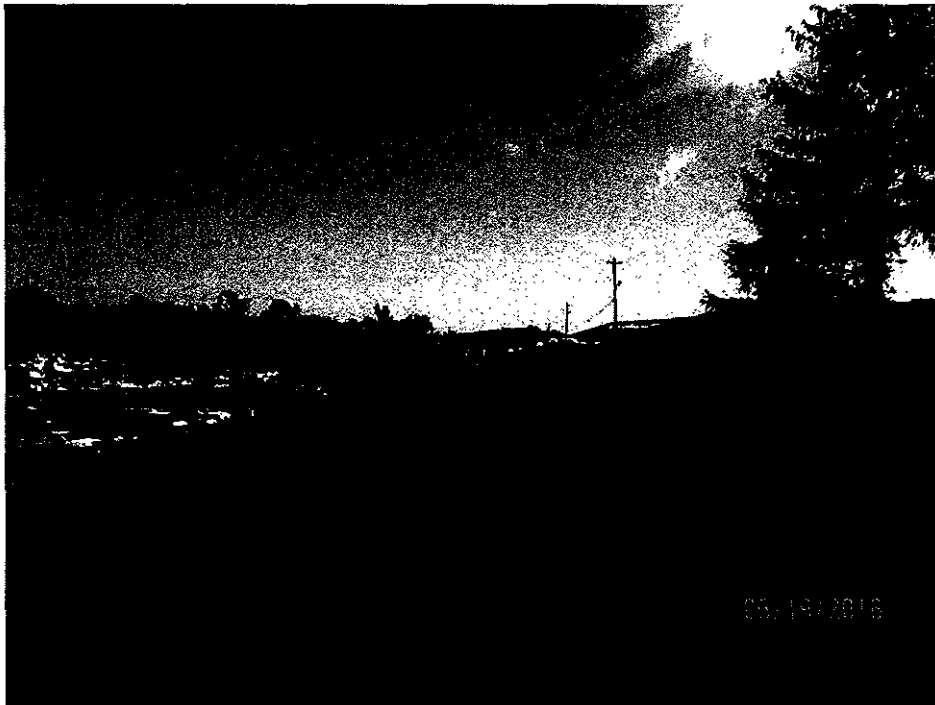
Photograph 18. View of maintained Line D000B ROW, east of Four Seasons Marina.
Photograph taken facing south-southeast.

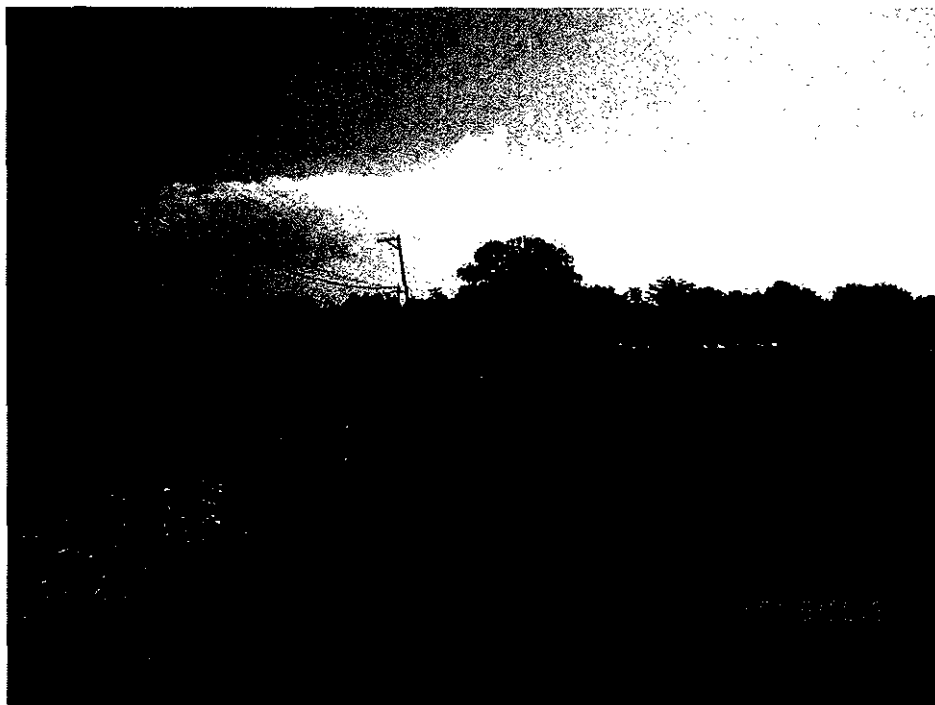
Photograph 19. View of maintained Line D000B ROW, along Kellogg Avenue Park and Stites Road. Photograph taken facing east-northeast.

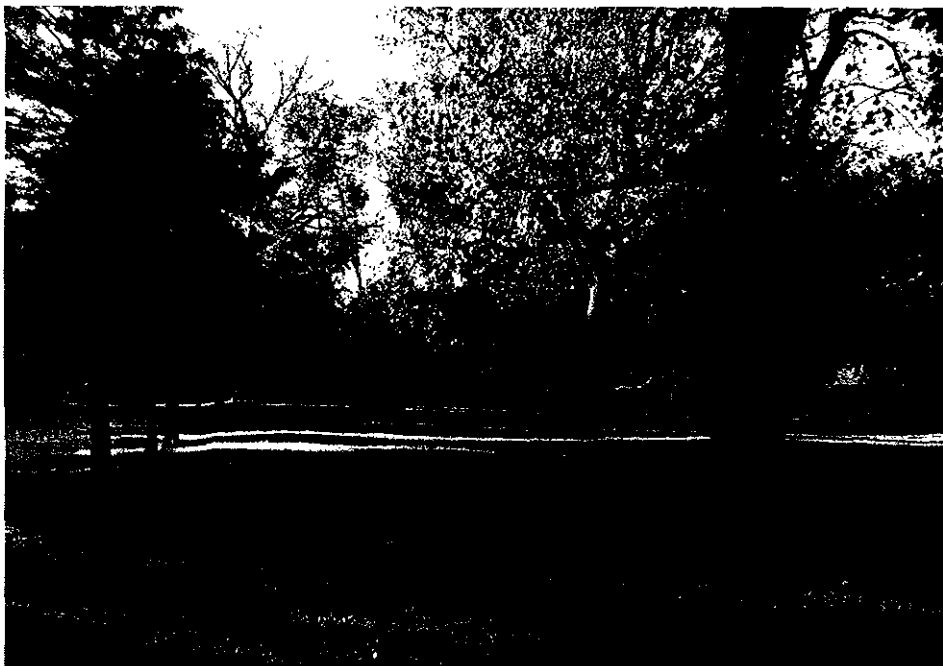
Photograph 21. View of mowed park habitat receiving filtered sunlight and periodic disturbance along east side of Humbert Avenue. Photograph taken facing north-northwest.

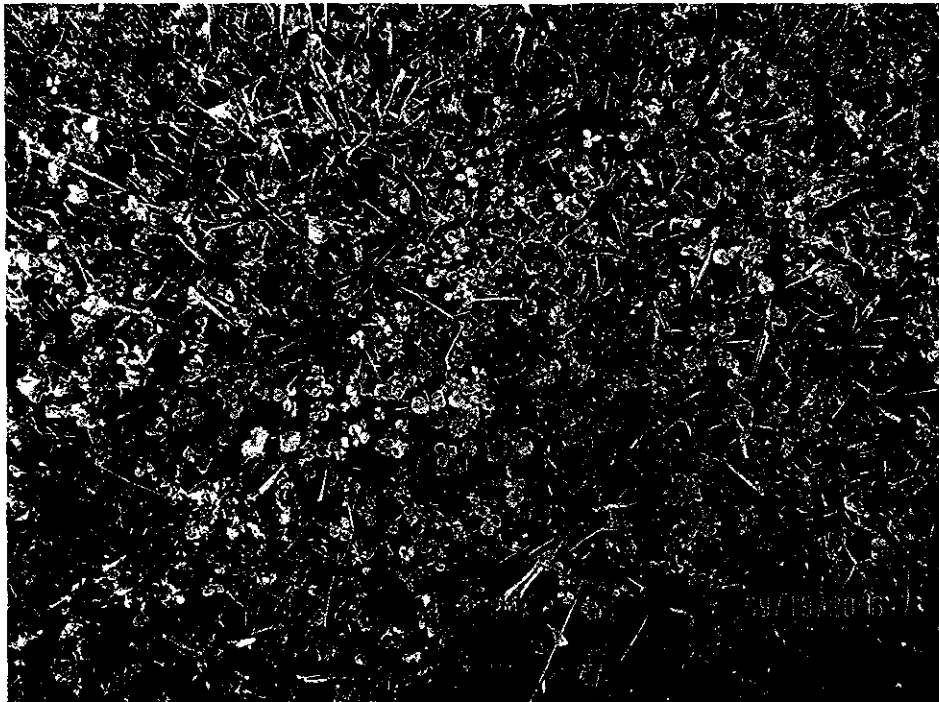
Photograph 22. View of groundcover from mowed park habitat along east side of Humbert Avenue.

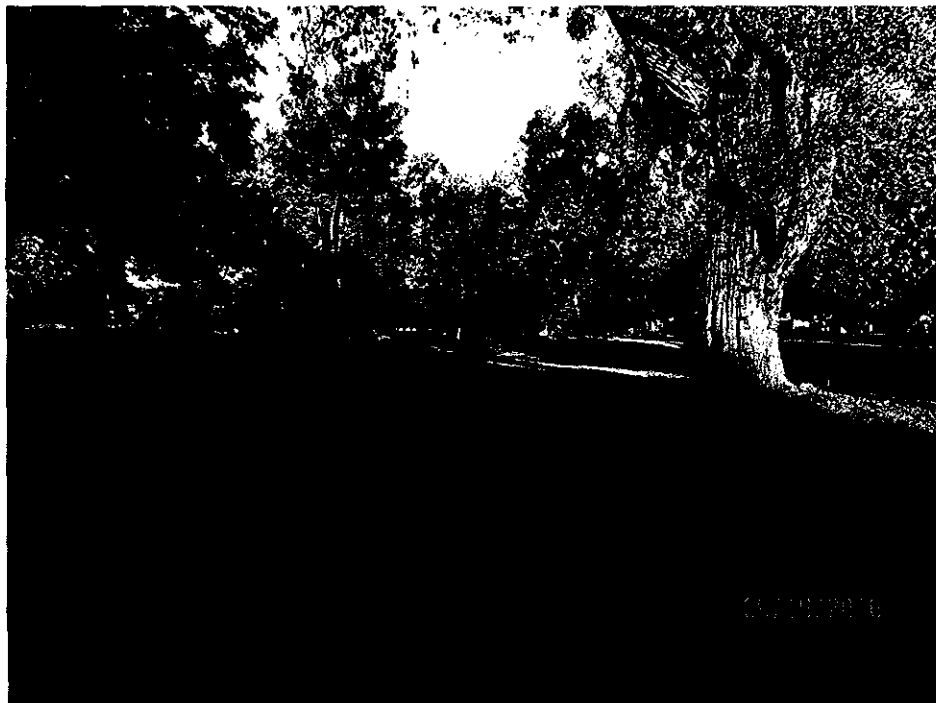
Photograph 23. Another view of mowed park habitat along east side of Humbert Avenue. Photograph taken facing east.

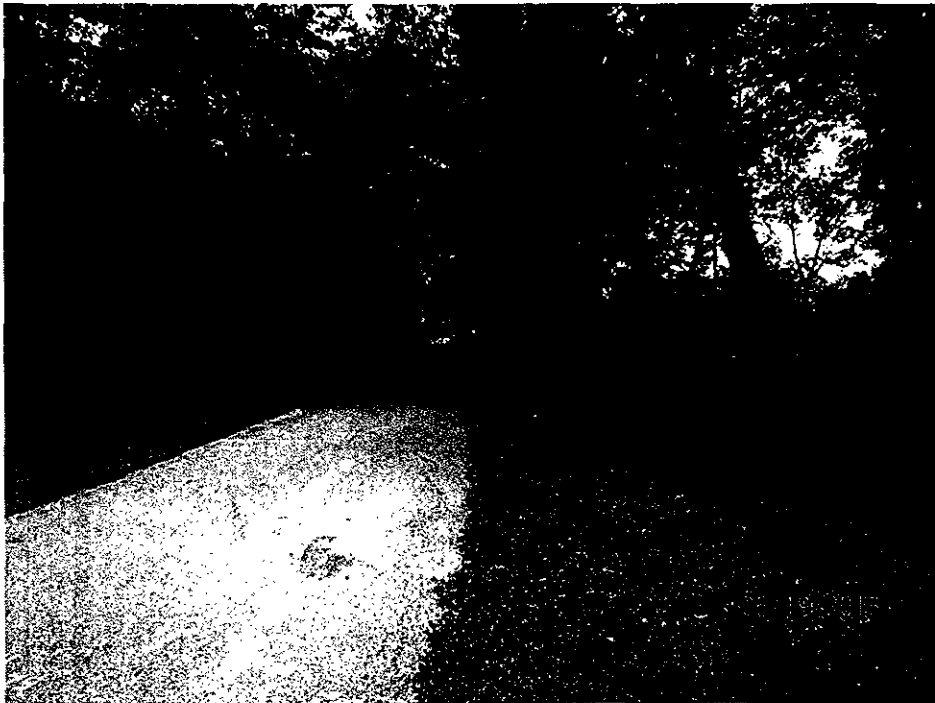
Photograph 24. View of trail and mowed park habitat on west side of Strader Avenue.
Photograph taken facing north-northwest.
