Subject: Agency Coordination Letter and
Threatened and Endangered Species Habitat Assessment
Line D000B Pipeline Replacement Project
Cincinnati, Hamilton County, Ohio
CEC Project 153-230

DUKE ENERGY
LINE D000B PIPELINE REPLACEMENT PROJECT
CINCINNATI, HAMILTON COUNTY, OHIO

**THREATENED AND ENDANGERED SPECIES
HABITAT ASSESSMENT MAP**

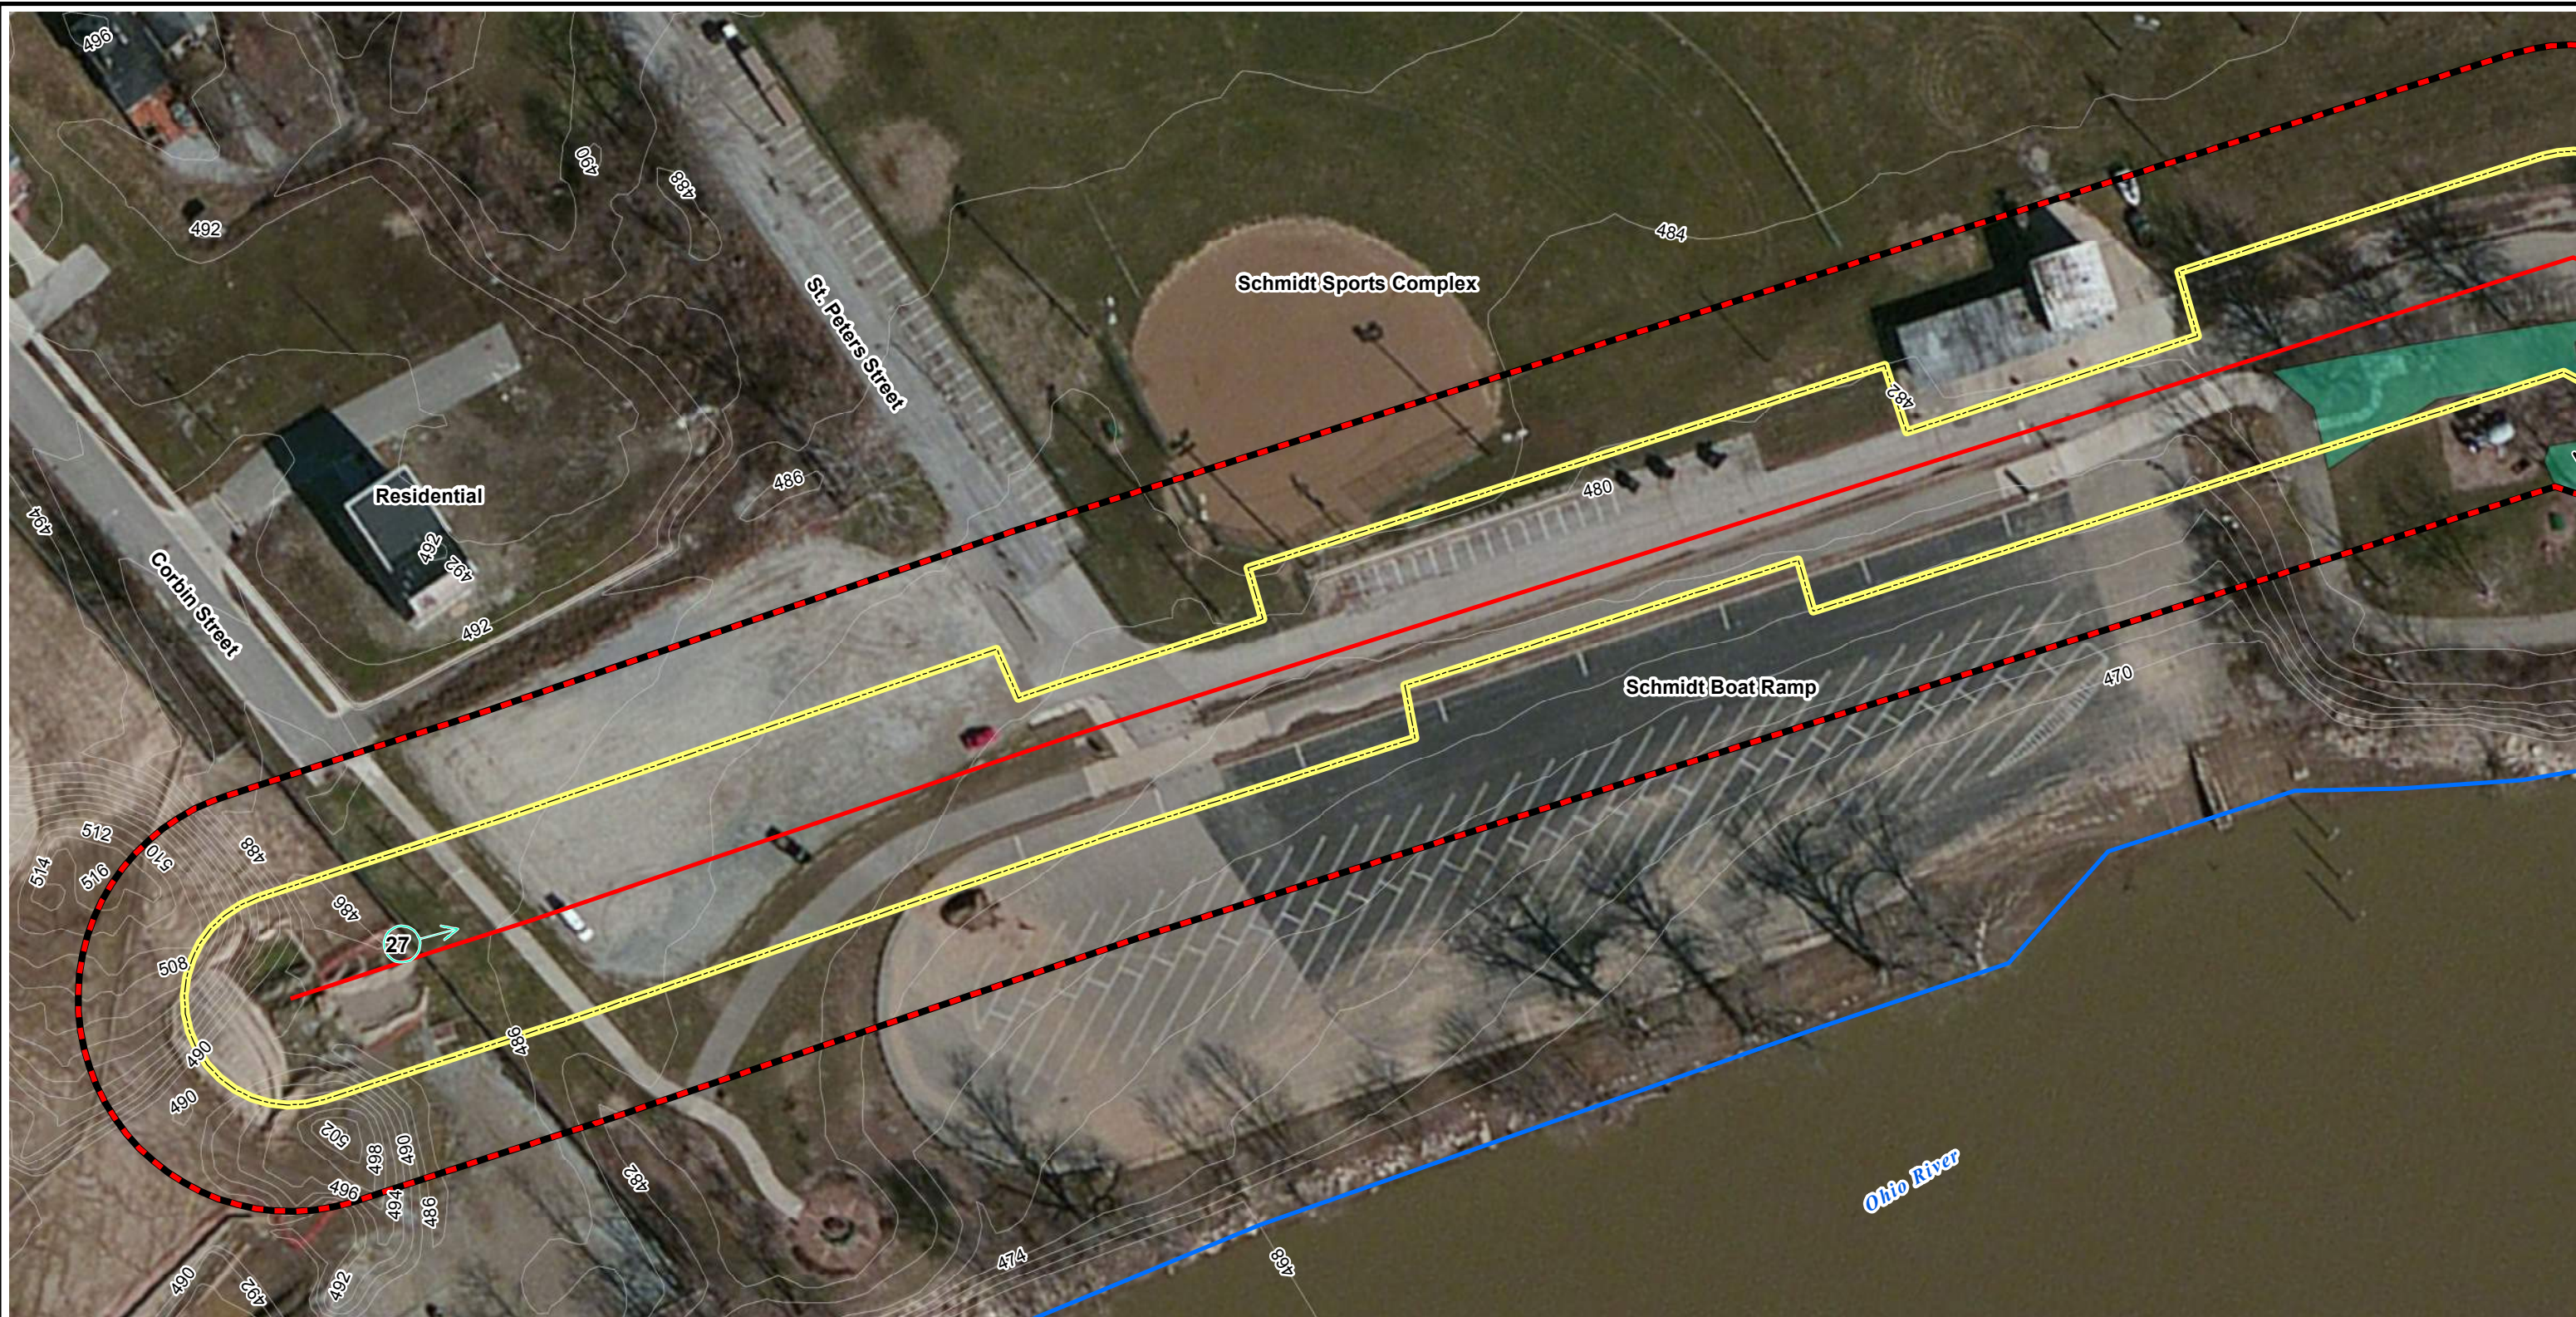
NOTES: FULL EXTENT OF STUDY CORRIDOR IS WITHIN 100-YEAR FLOODPLAIN.
NO STREAMS OR WATERBODIES WERE IDENTIFIED WITHIN THE STUDY CORRIDOR.

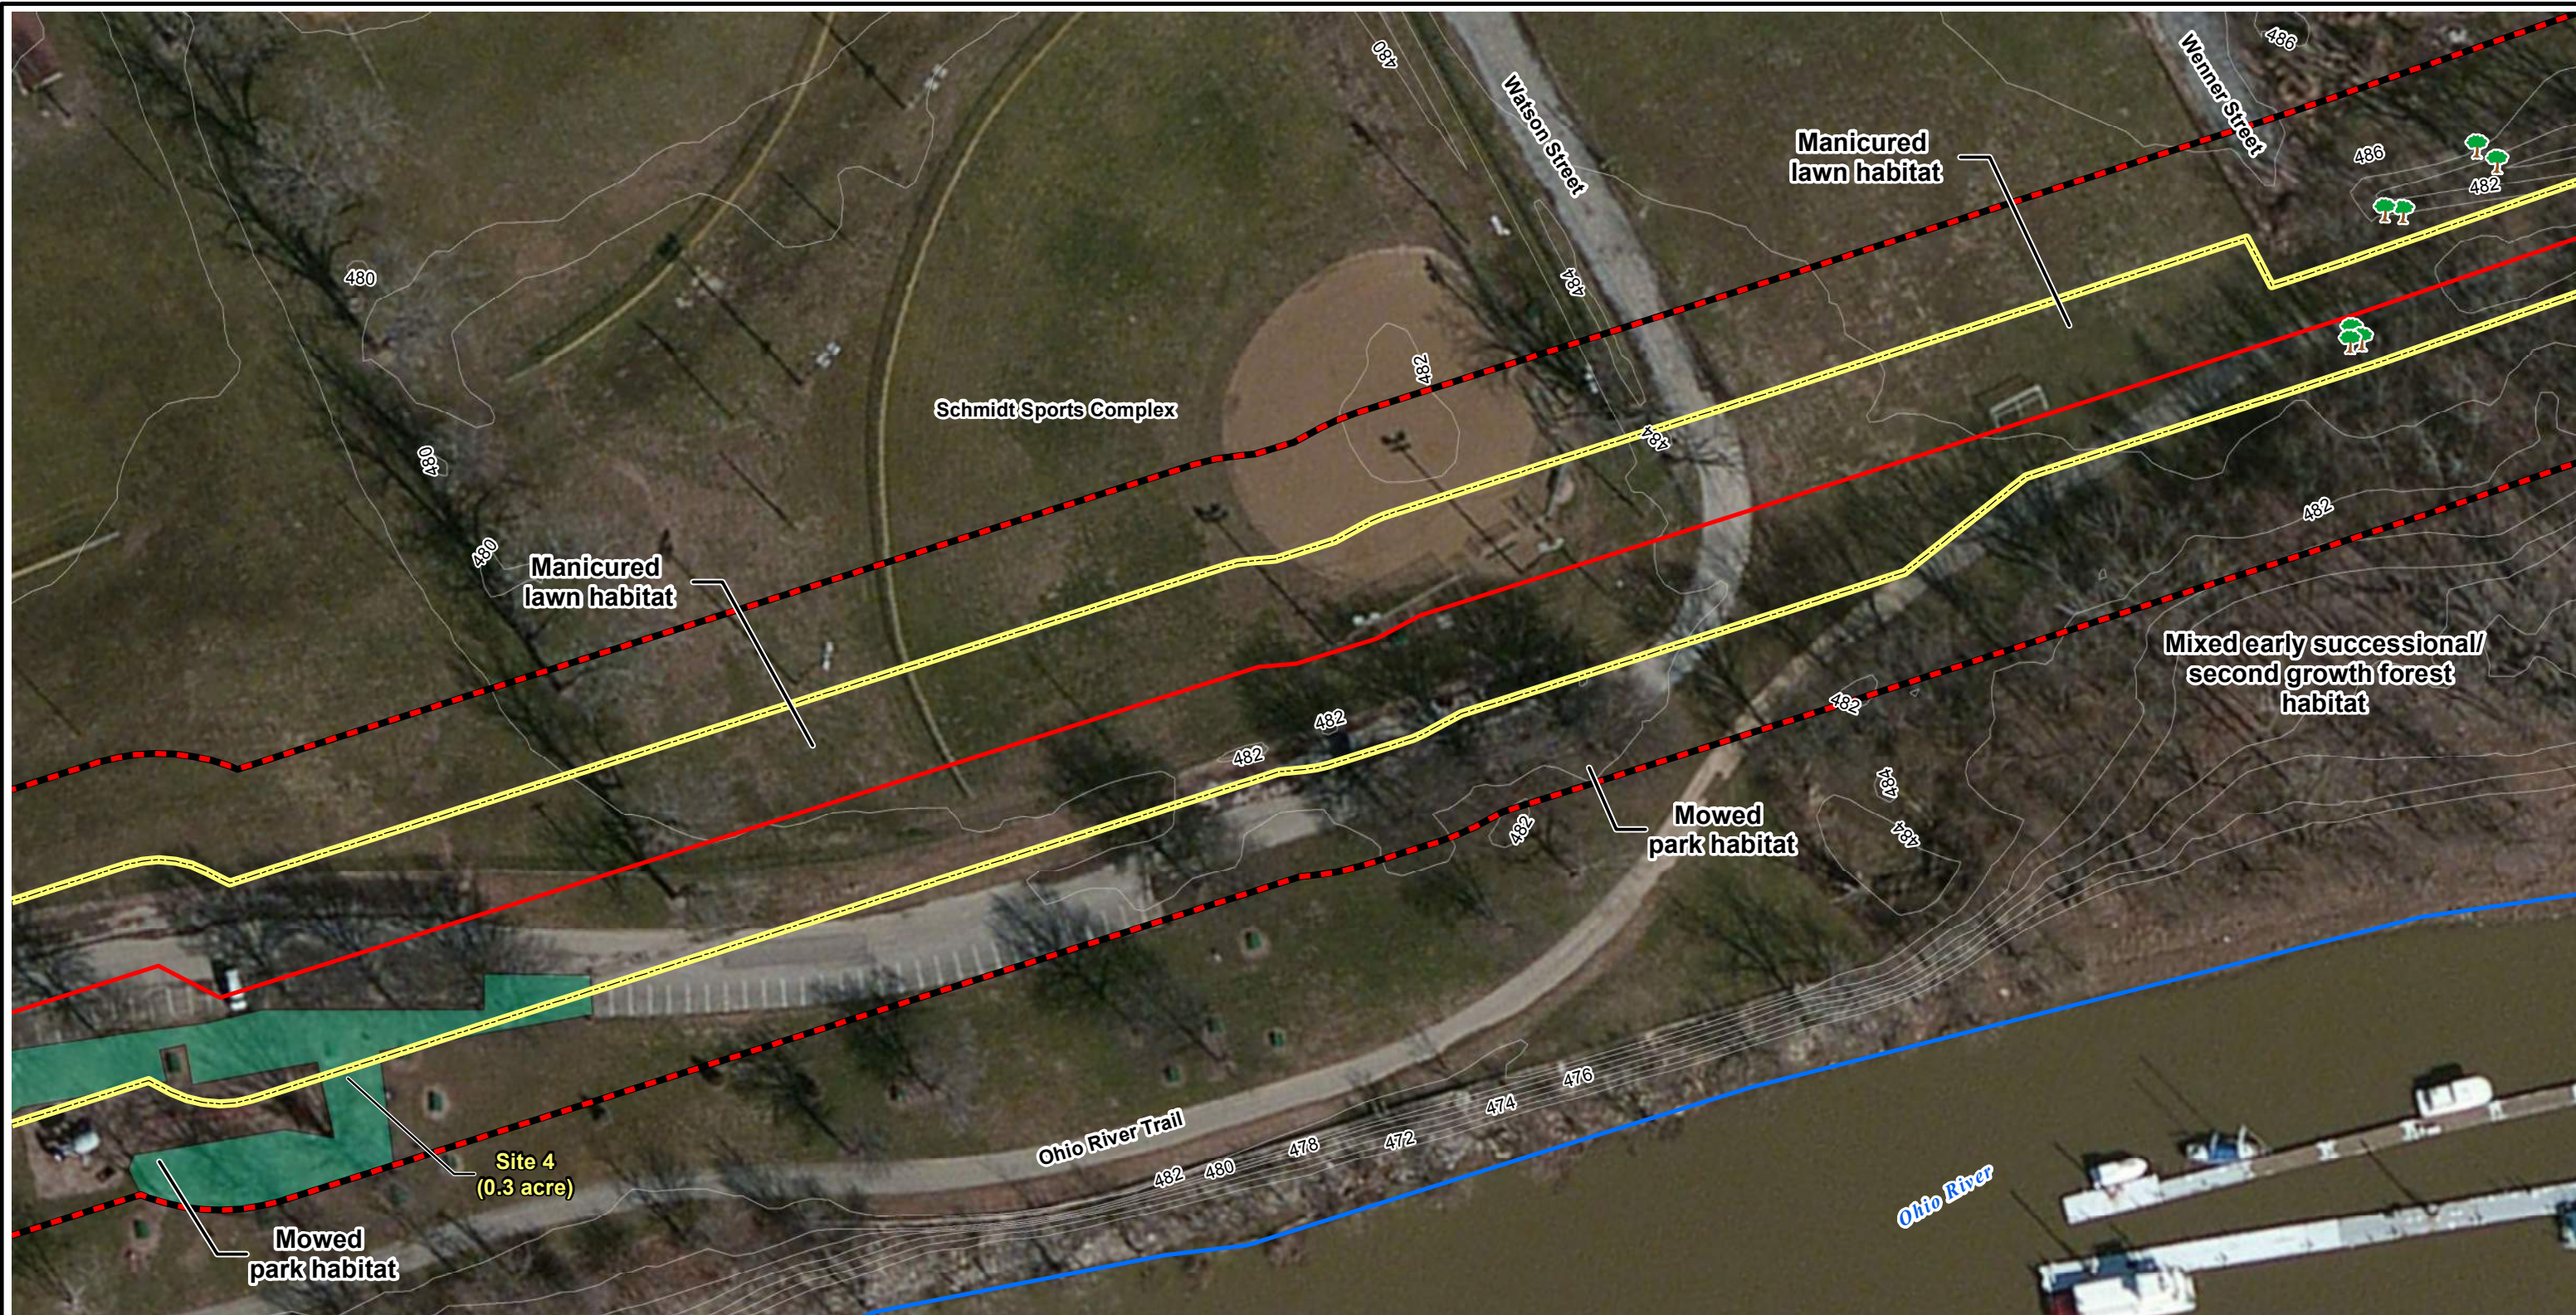
DRAWN BY: DMG	CHECKED BY: JAV	APPROVED BY: JAV*	FIGURE NO: 4
DATE: OCTOBER 24, 2016	DWG SCALE: 1" = 75'	PROJECT NO: 153-230

NOTES: FULL EXTENT OF STUDY CORRIDOR IS WITHIN 100-YEAR FLOODPLAIN.
NO STREAMS OR WATERBODIES WERE IDENTIFIED WITHIN THE STUDY CORRIDOR.

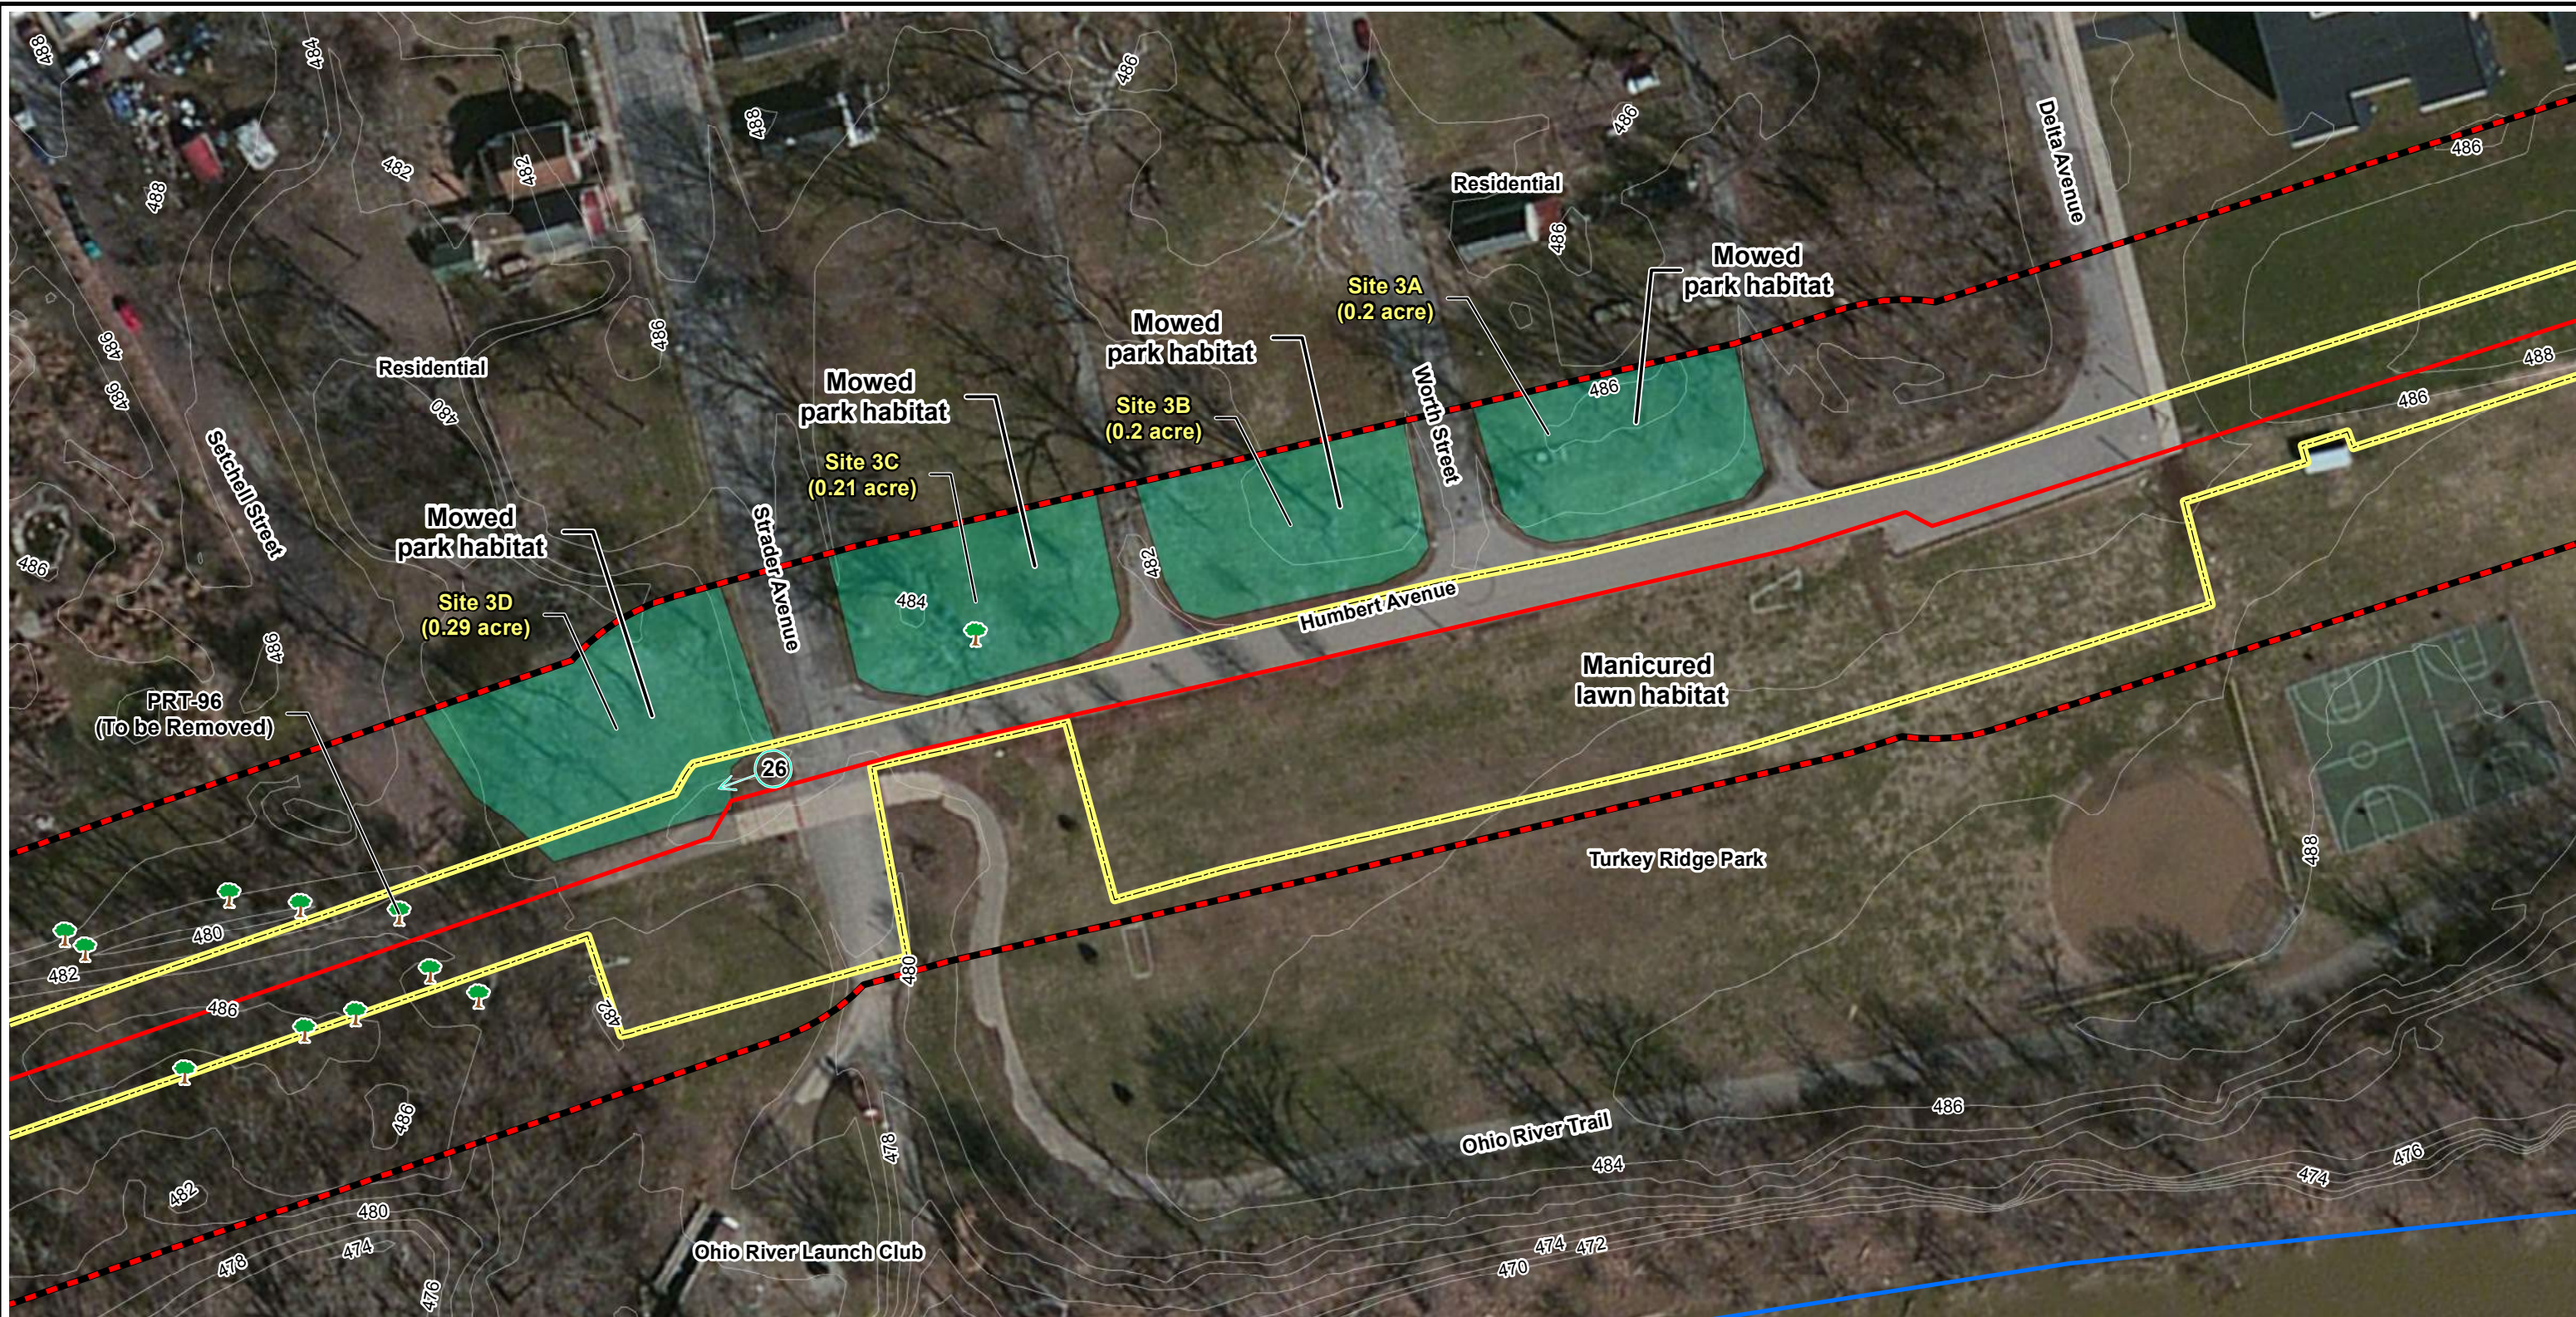
DRAWN BY: DMG	CHECKED BY: JAV	APPROVED BY: JAV*	FIGURE NO: 5
DATE: OCTOBER 24, 2016	DWG SCALE: 1" = 75'	PROJECT NO: 153-230

NOTES: FULL EXTENT OF STUDY CORRIDOR IS WITHIN 100-YEAR FLOODPLAIN.
NO STREAMS OR WATERBODIES WERE IDENTIFIED WITHIN THE STUDY CORRIDOR.

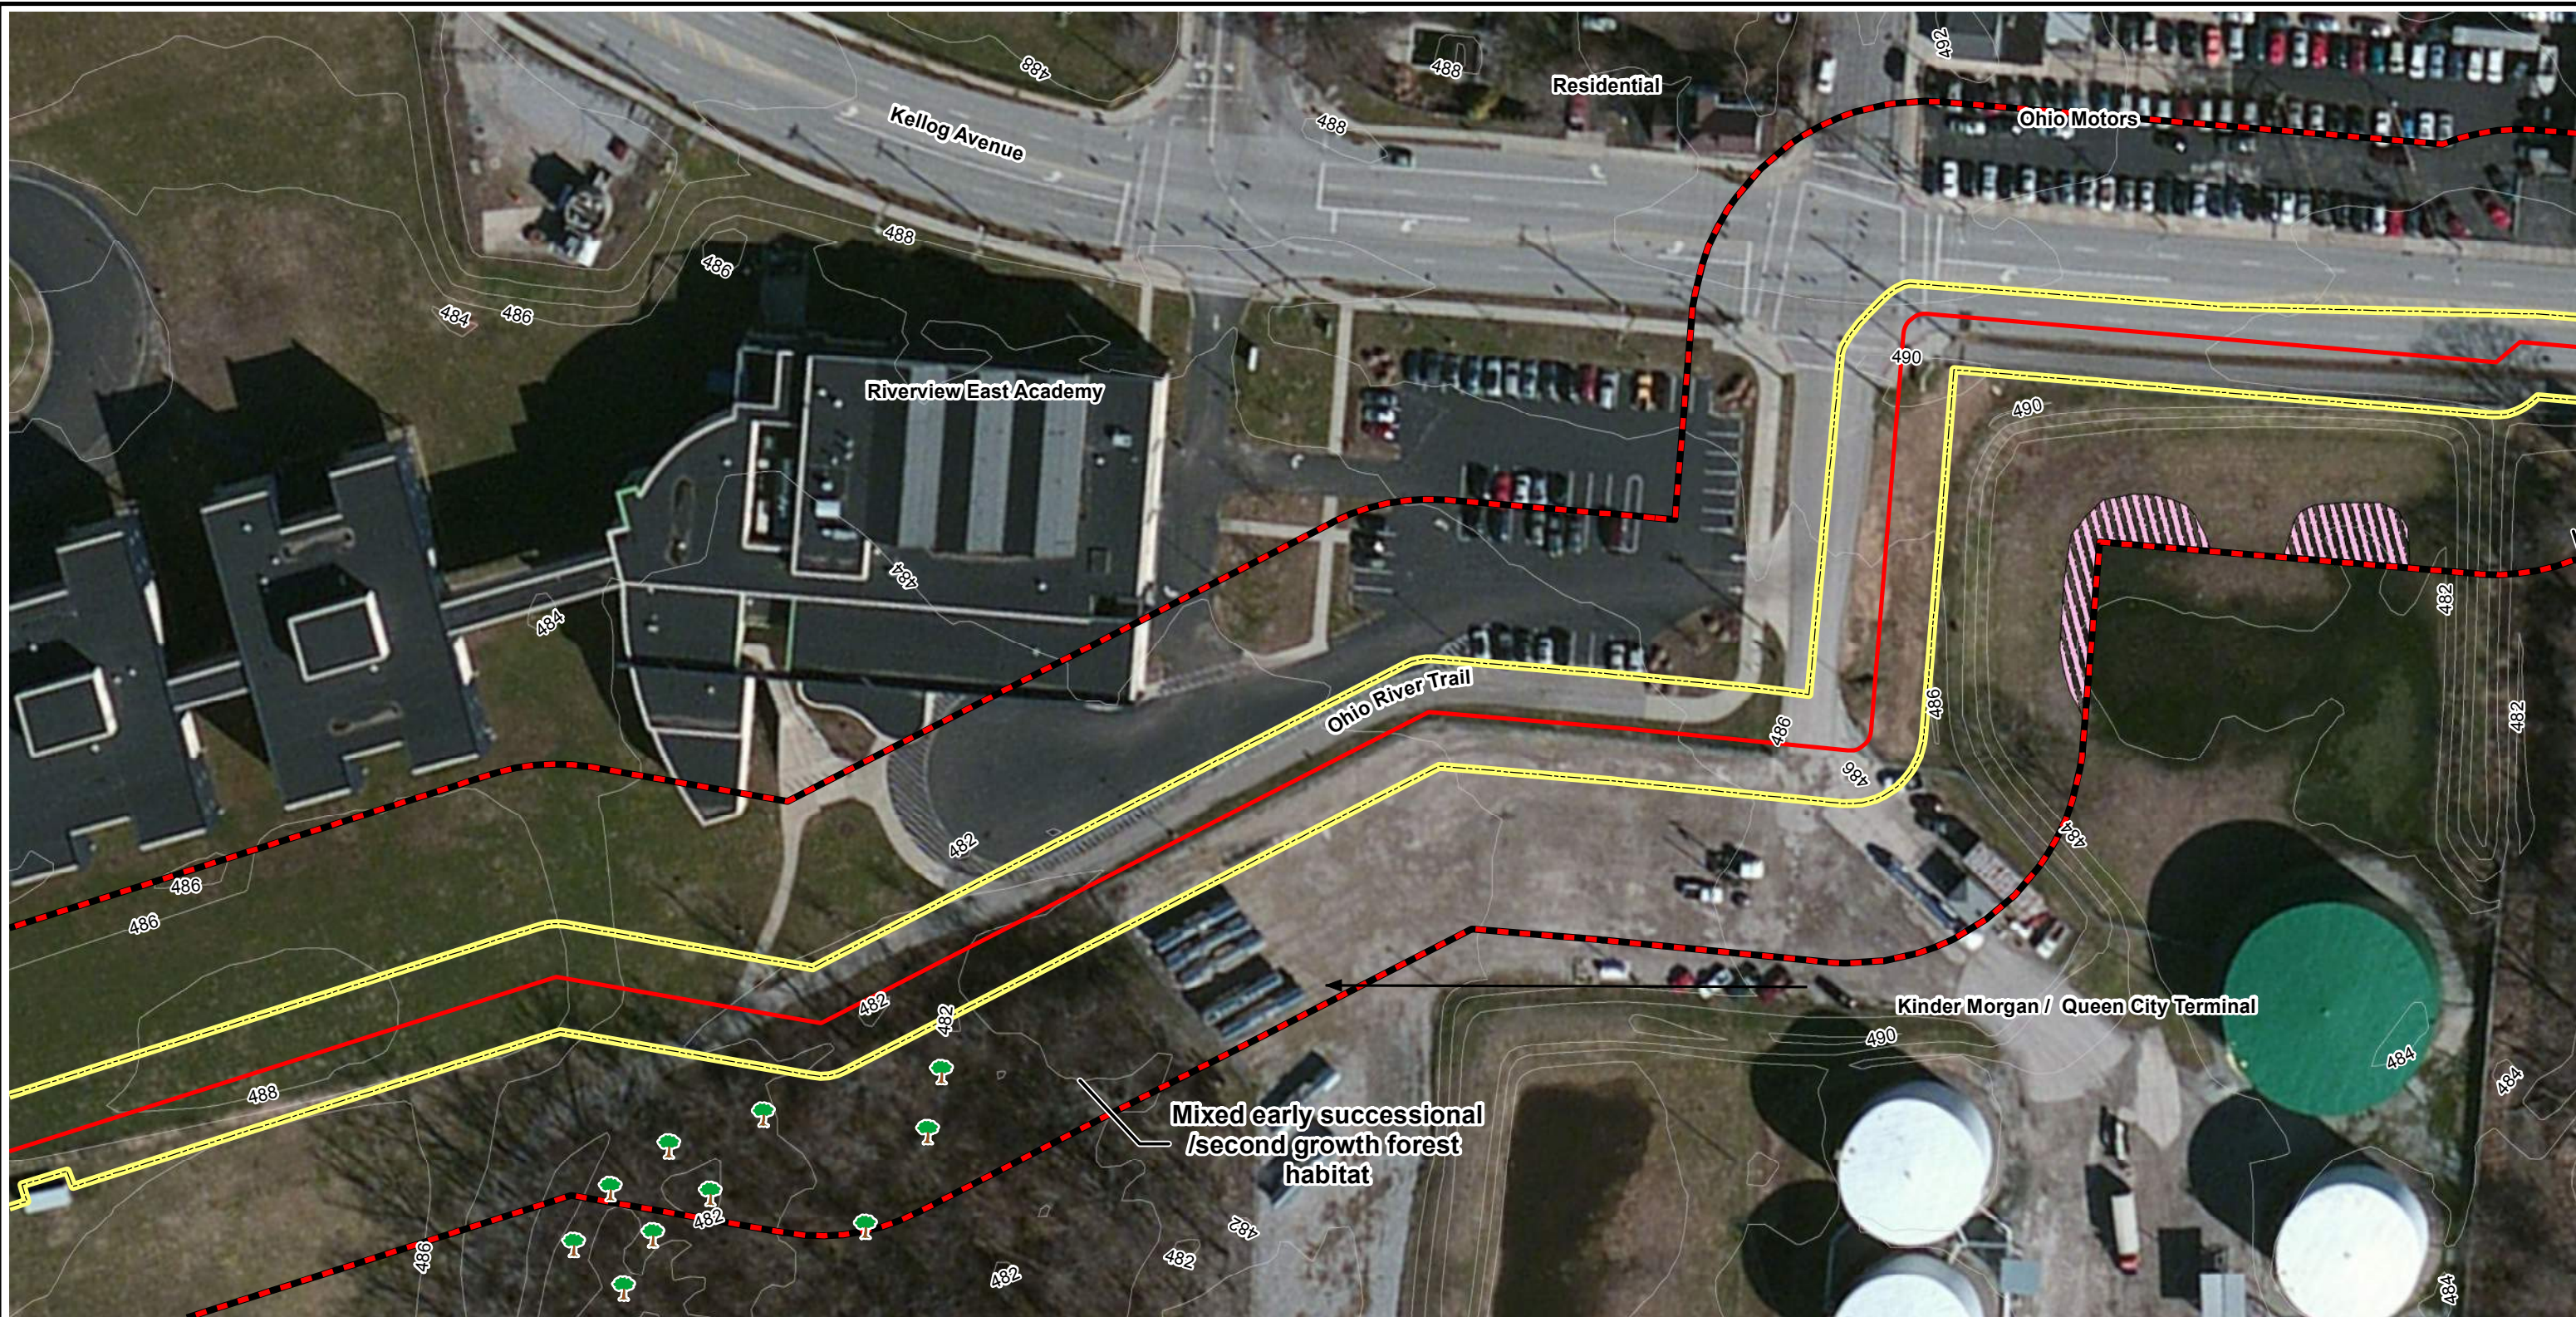
NOTES: FULL EXTENT OF STUDY CORRIDOR IS WITHIN 100-YEAR FLOODPLAIN.
NO STREAMS OR WATERBODIES WERE IDENTIFIED WITHIN THE STUDY CORRIDOR.

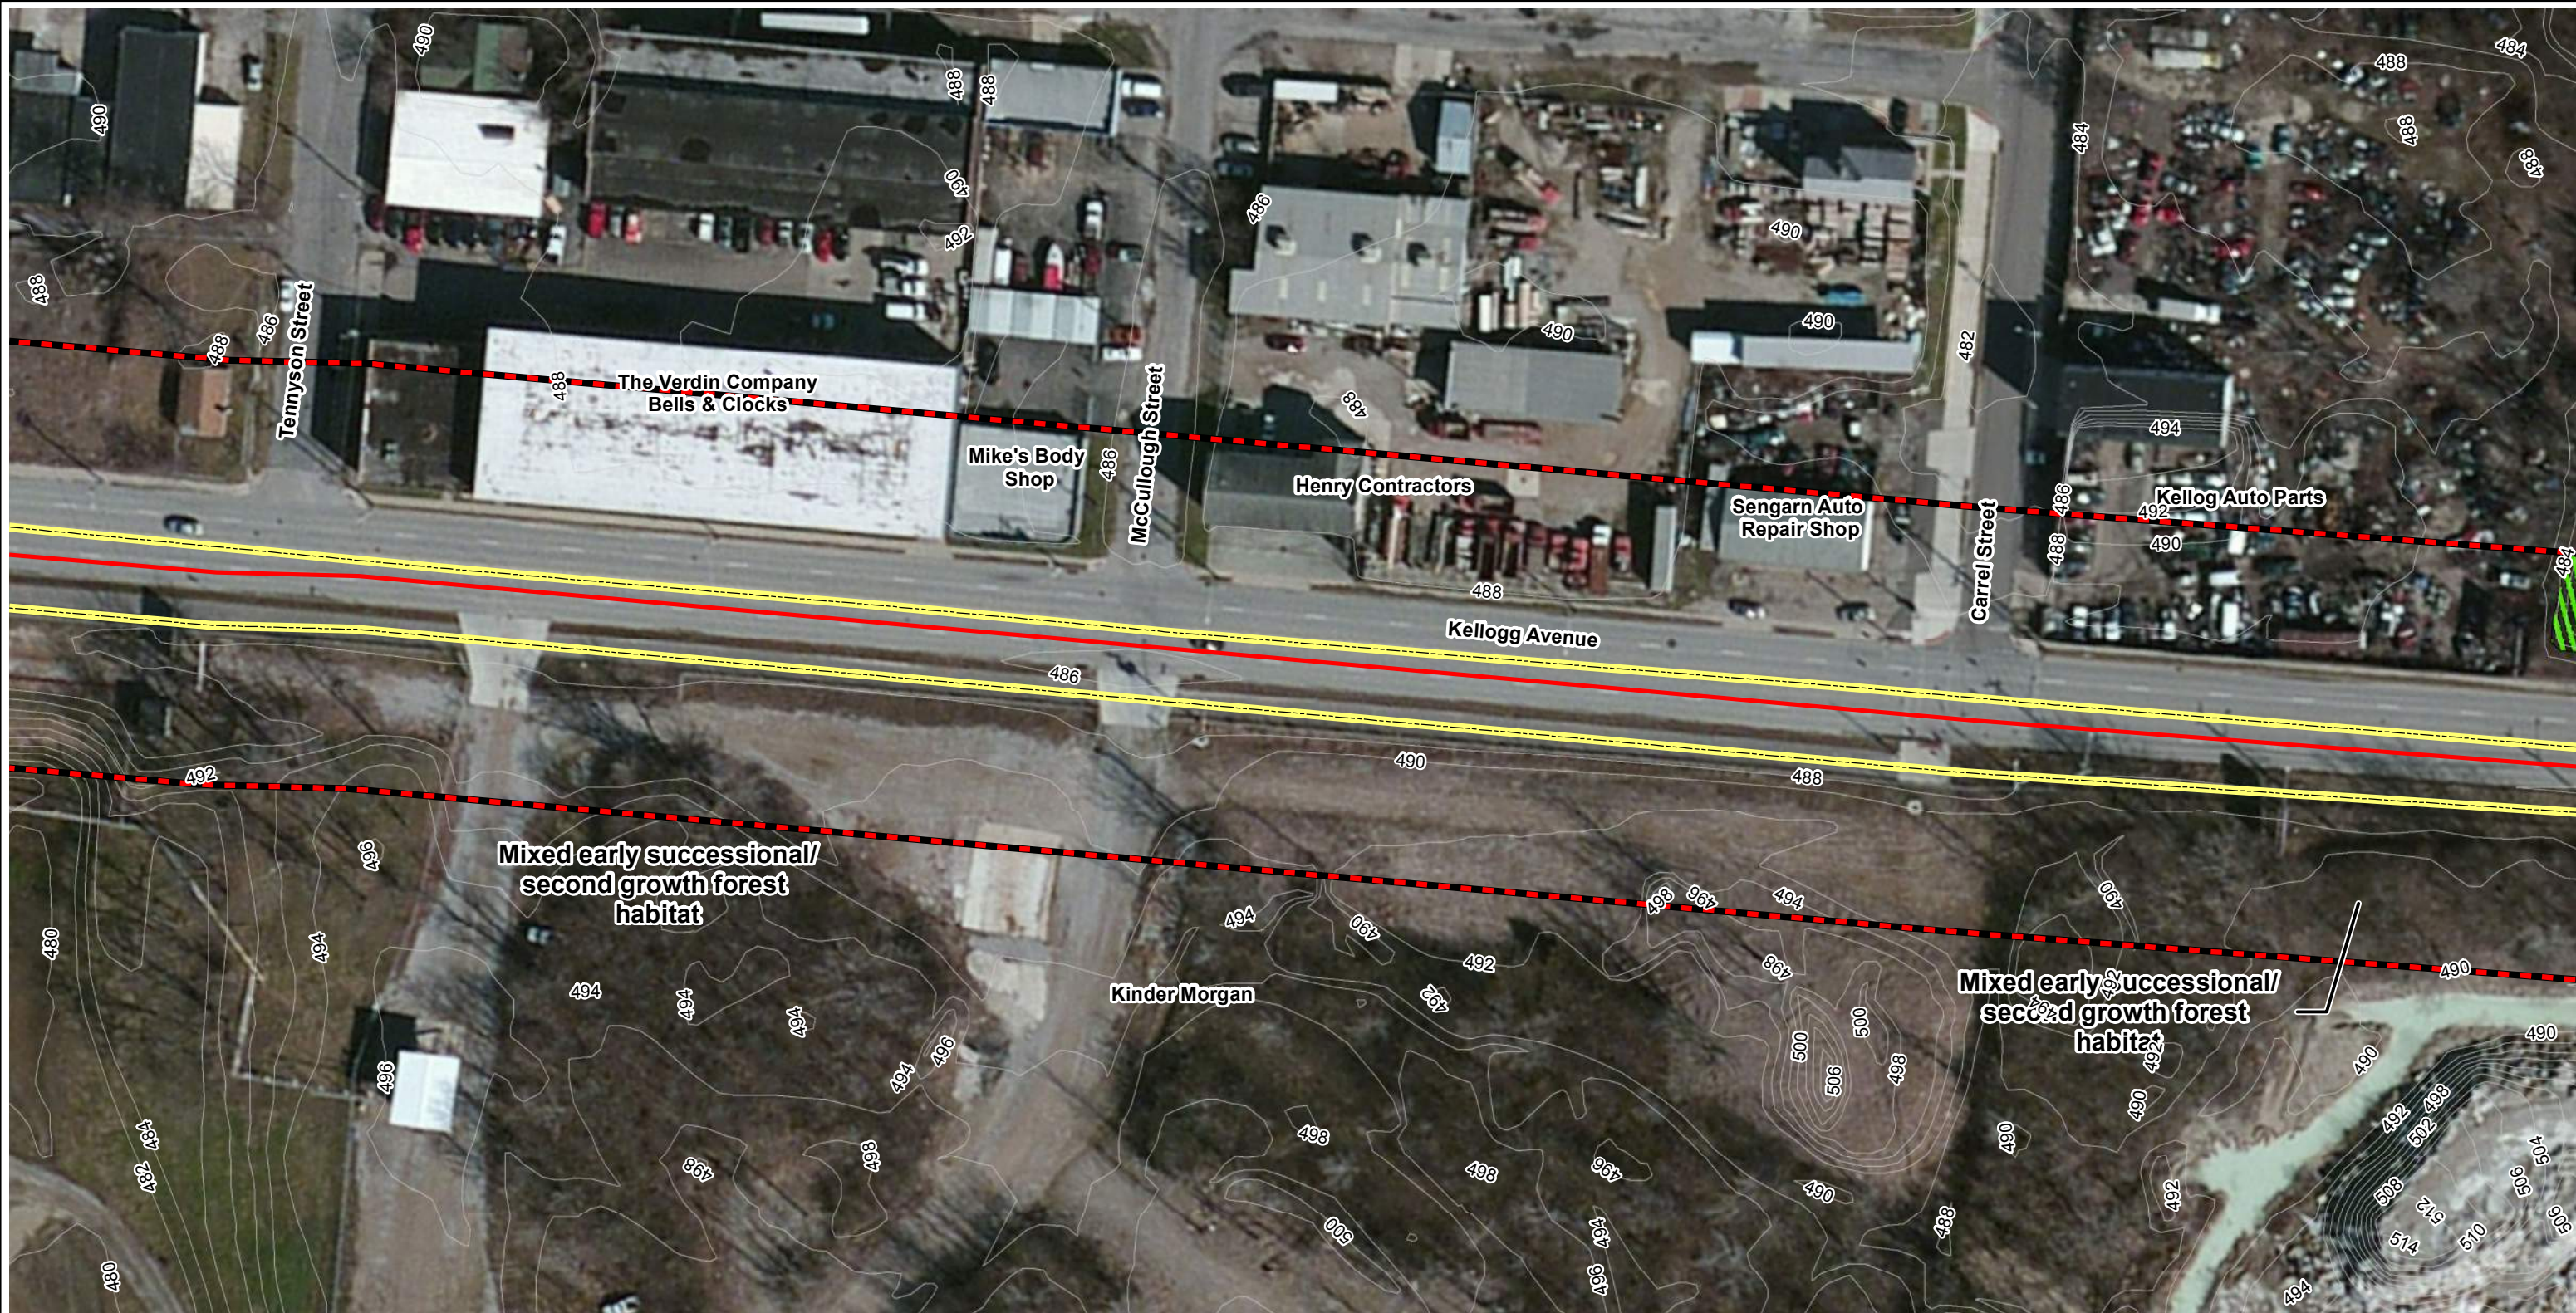
NOTES: FULL EXTENT OF STUDY CORRIDOR IS WITHIN 100-YEAR FLOODPLAIN.
NO STREAMS OR WATERBODIES WERE IDENTIFIED WITHIN THE STUDY CORRIDOR.
